Research Article

Occurrence Mechanism of Roof-Fall Accidents in Large-Section Coal Seam Roadways and Related Support Design for Bayangaole Coal Mine, China

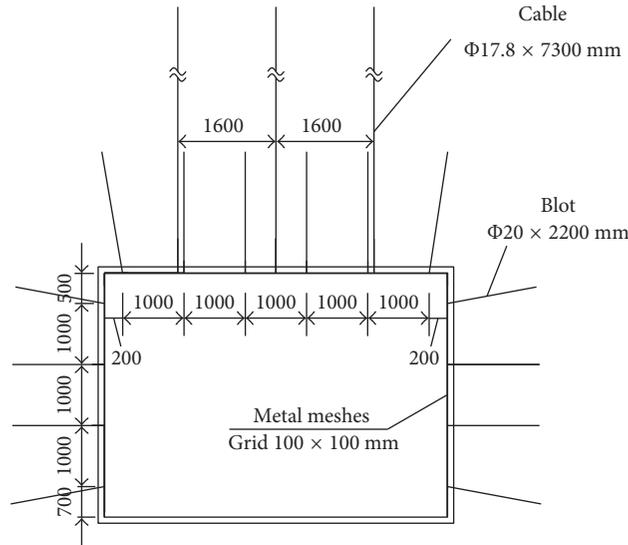
FIGURE 4: Original supporting scheme in the roadway.

In the original supporting scheme, steel strand anchor cables with a nominal diameter of 17.8 mm were used, and the parameters are listed in Table 1. Using the original supporting scheme, the maximum tensile load of the anchor cable was 353 kN, smaller than the applied load (363.74 kN); therefore, the anchor cable snapped. Afterwards, the fractured top stratum lost the support, thus inducing the roof-fall accident in the roadway.

- (3) The original supporting scheme is unreasonable, where the anchor bolts in the roadway roof were short and the fractures developed in the surrounding rocks within the anchorage range, thus leading to an insufficient anchoring force. Therefore, the appearance of separation of coal seam and stratum in roadway roof could be hardly suppressed, and the role of the anchor bolt support as the composite beam could be hardly fully played. In addition, the array pitch between anchor cables was too high, and the used anchor cables were poor in specifications and models. Therefore, an insufficient limit tensile load of the anchor cable could hardly support the gravity load of the fractured stratum and easily induced tensile failure.

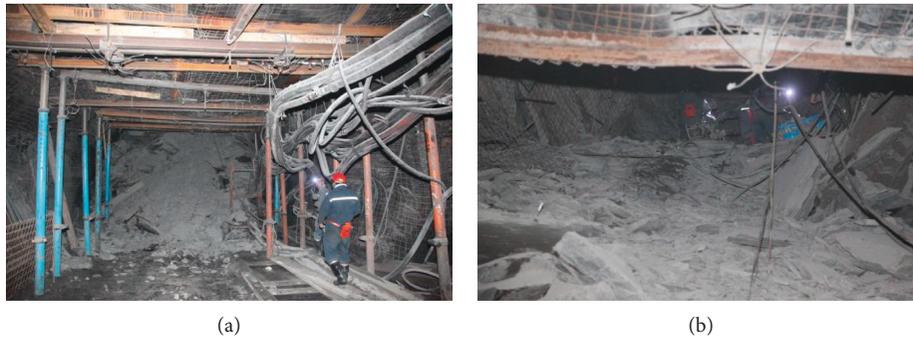
FIGURE 5: Pictures of rain-fall accidents in the air-return roadway of number 311102 working face.

At about 8:00, April 23, 2015, when number 311102 working face was advanced to 210 m, the anchor cables in ventilation roadway were fractured, and roof stratum 51–62 m in front of the working face fell (i.e., the position filled with red grid lines shown in Figure 3). The roadway where the roof fell had a length of approximately 12 m, the maximum fall height of the roof was almost 5.0 m, and the section of the roadway with the fall height over 1.5 m was approximately 6 m in length. At about 0:44, April 24, 2015, when number 311101 working face was advanced to 50 m away from the withdraw roadway, the anchor cables in the main belt conveyor roadway were fractured, and the roof strata 5–21 m in front of the withdraw roadway fell (i.e., the position filled with red graticule lines shown in Figure 3). The roadway where the roof fell was approximately 16 m in

length, the maximum fall height also exceeded 5.0 m, and the section of the roadway with the fall height over 1.5 m was approximately 9.0 m in length. The fallen rocks pressed the belt conveyor, thus stopping the production in the working face. As also shown in Figure 3, two equipment caverns with a width of 5.0 m, a height of 3.8 m, and a depth of 5.0 m were set at the roof-fall positions in both the belt conveyor roadway of number 311101 working face and ventilation roadway of number 311102 working face. Apparently, the roadway span near the caves increased significantly, providing advantageous conditions for the fracture and falling of roadway roof. Figure 5 shows the pictures of roof-fall scenes in the ventilation roadway of number 311103 working face. To increase the supporting intensity of roadway roof and avoid the second roof-fall accident, single hydraulic props and steel i-beams were added after the first roof-fall accident. Sudden roof-fall accidents in the roadway severely threatened the physical health of underground miners and affected the safe and regular production in mines. Therefore, it is very important to investigate the causes and mechanisms of roadway roof-fall accidents in depth, improve the supporting scheme for surrounding rocks, and optimize the supporting parameters to avoid the reoccurrence of roof-fall accidents.

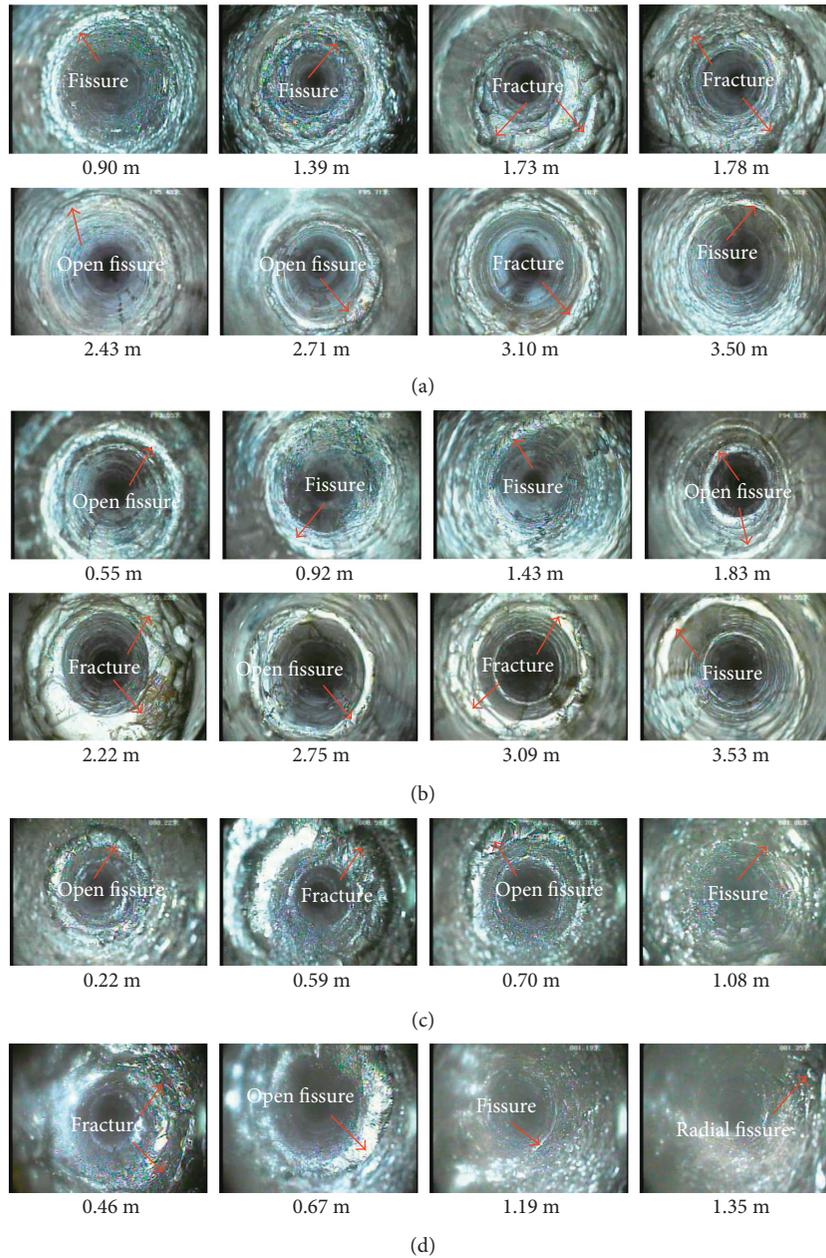
FIGURE 8: Detection results of different drilling holes on roof and two sides of monitoring section 1. (a) Observations in drilling hole 1, (b) observations in drilling hole 2, (c) observations in drilling hole 3, and (d) observations in drilling hole 4.

Apparently, the roof underwent more severe destruction than the two sides of roadway in both range and degree.

Figures 8(a), 8(b), and 9(a) show that most of the fractures in the drilling holes on roadway roof developed radially, easily leading to roof separation; moreover, the aperture of fracture determined the amount of roof separation. After the roof separation, the full stratum was divided into multiple thin separated sublayers, significantly reducing the stability of roof. Therefore, roof separation is an inducing factor of roof-fall accidents in roadways. By making statistics of the drilling detection results at two monitoring sections, the roof separation and fracture distribution characteristics were concluded, as shown in Figure 10. A lot of separation

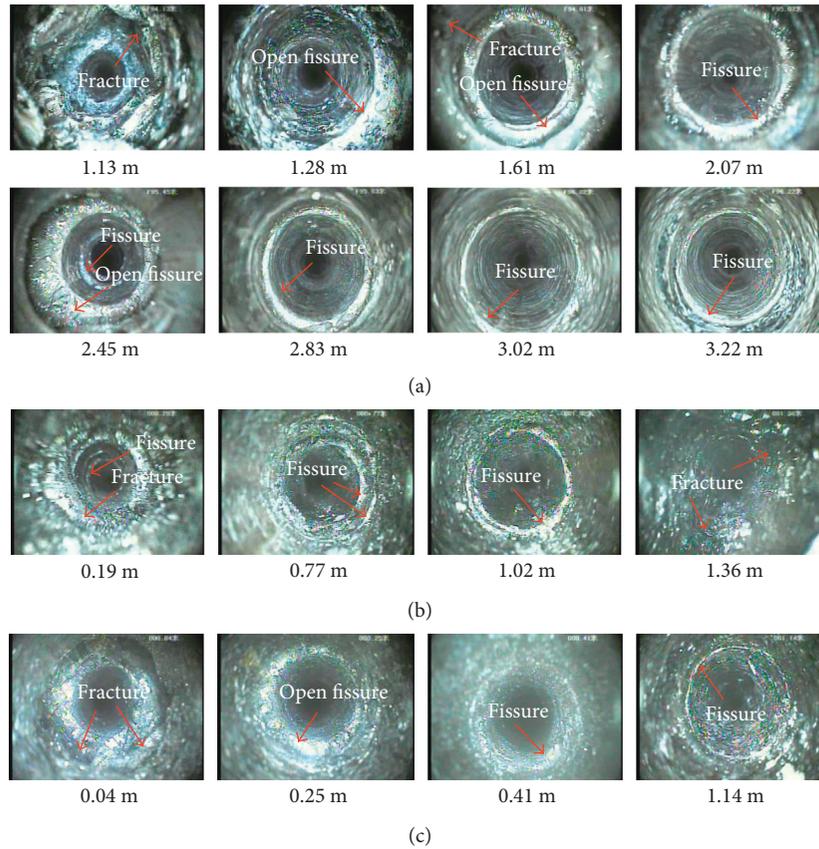
FIGURE 9: Detection results of different drilling holes on roof and two sides of monitoring section 2. (a) Observation in drilling hole 5, (b) observation in drilling hole 6, and (c) observation in drilling hole 7.

Figures 8 and 9 show the drilling TV detection results of different drilling holes on roof and two sides of each

monitoring section. The surrounding rocks of roadway exhibited discontinuous failure characteristics, and fractures and crushed zones appeared alternatively and irregularly in the drilling hole with no obvious distribution regularity. According to the development morphology and degree of fractures, the roadway surrounding rocks can be divided into fracture zone, separation zone, and complete zone. Specifically, based on the drilling detection results, the zone along the drilling hole in which no obvious fractures were observed within a continuous range of 30 cm was defined as the complete zone; the zone in which 1-2 sets of fractures

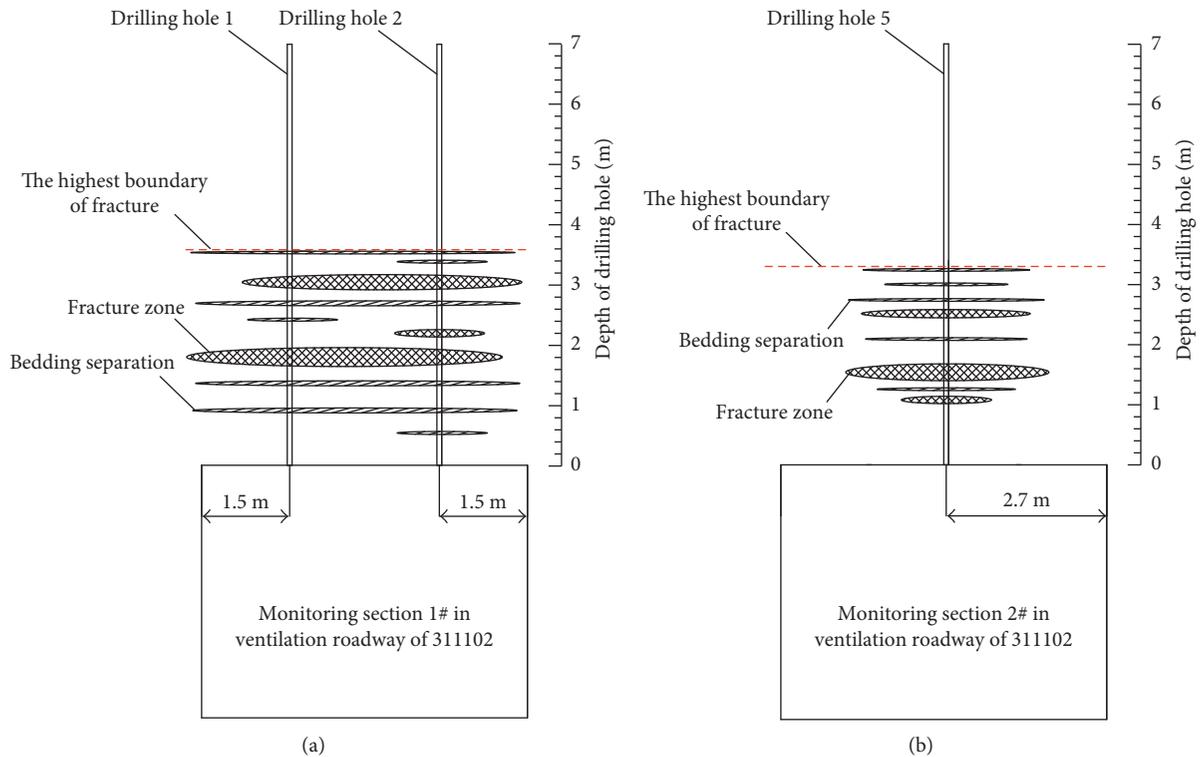
FIGURE 10: Detection results of roadway roof separation and fracture distribution. (a) Monitoring section 1 and (b) monitoring section 2.

and fracture zones were distributed at intervals within a depth of 3.5 m near the ventilation roadway of number 311102 working face, while the surrounding rocks at a depth over 3.5 m were relatively complete and exhibited no obvious fractures and crushes. As stated above, number 3-1 coal seam was 5.48 m in thickness, the ventilation roadway of number 311102 working face was advanced along the coal seam floor, and the roadway had a height of 4.2 m. Therefore, the residual coal seam in the roadway was 1.28 m in thickness. On the roadway roof, the coal seam differed significantly from the sandy mudstone in lithology, resulting in asynchronous wrapping and subsidence of roof and sandy mudstone and easily inducing roof separation. As shown in

Figure 10, obvious roof separations occurred at a depth of 1.3-1.4 m of the roadway roof. As shown in Figure 3, when roof fall occurred in the main belt conveyor roadway of number 311101 working face, the working face was approximately 85 m away from the accident. Although number 311101 working face was the first mining face in this mine, the working face exhibited a long arrangement length of approximately 260 m, and the mining-induced stress had a great influence range. Moreover, the roadway where roof fall occurred was near DF8 section. Under the combined effects of mining-induced stress and tectonic stress, the surrounding rocks in the roadway were easily deformed and fractured. Figure 10 clearly shows that under the action of

superimposed stresses, many separation and fracture zones appeared in the coal seam on roadway roof, which divided the roof into several separated layers. These layers were all smaller than 1.0 m in thickness and significantly reduced the stability of stratum in the roadway roof. When the roof-fall accident occurred in the ventilation roadway of number 311102 working face, the working face was only 51 m away from the accident position. Mining-induced stress is a key factor leading to the occurrence of roof-fall accidents in the roadway, and the secondary mining in number 311102 working face aggravated the deformation and failure of the surrounding rocks in the roadway.

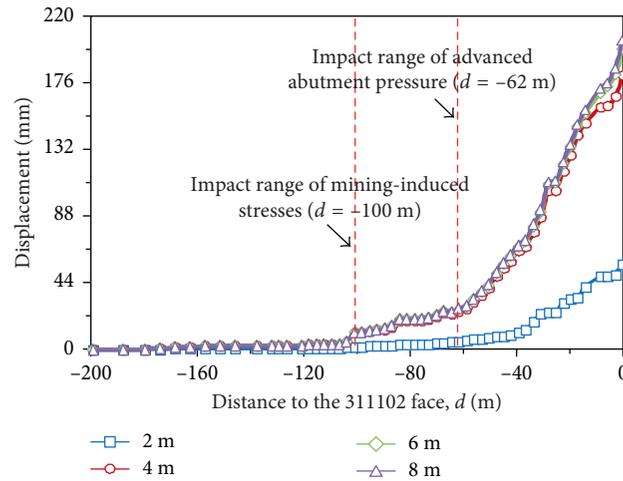
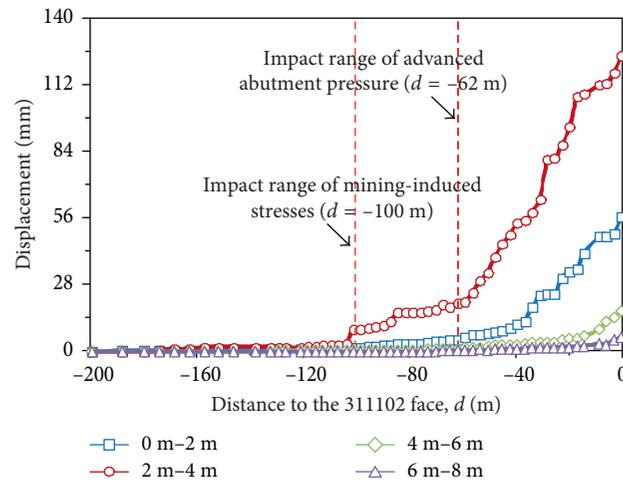
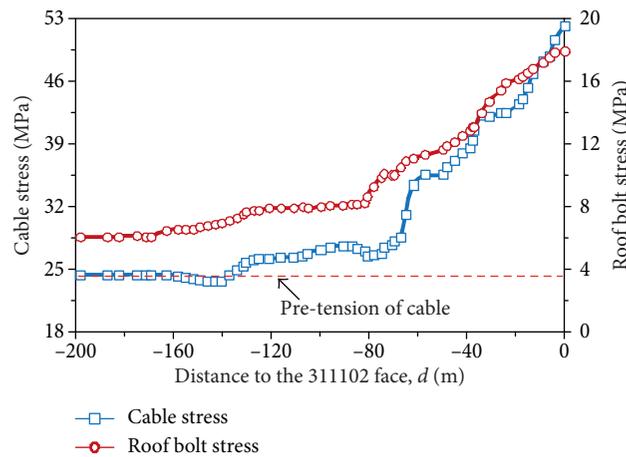
FIGURE 15: Monitoring results of roof displacement and stress on anchor cable (bolt) at section II. (a) Monitoring results of roof displacement, (b) displacements of roof stratum at different depths, and (c) monitoring results of stress on anchor cable (bolt).

Section II was located in the roadway's equipment cavern with a large span, also close to DF14 section. Therefore, the maximum roof displacement on section II was higher than that on section I; moreover, as shown in Figure 15(b), the roof displacement mainly appeared in the shallow stratum 2–4 m above the roof. This indicates that due to the effect of mining, great separation and failure appeared above the roof outside the bolt's anchorage range;

however, the existence of high-strength anchor cable effectively prevented the further development of separation and failure, so that roof-fall accidents can be avoided. The maximum stress on roof anchor cable at section II also far exceeded that at section I, also proving the abovementioned conclusion.
