Research Article

An Investigation of Damage Mechanism Induced by Earthquake in a Plate Girder Bridge Based on Seismic Response Analysis: Case Study of Tawarayama Bridge under the 2016 Kumamoto Earthquake

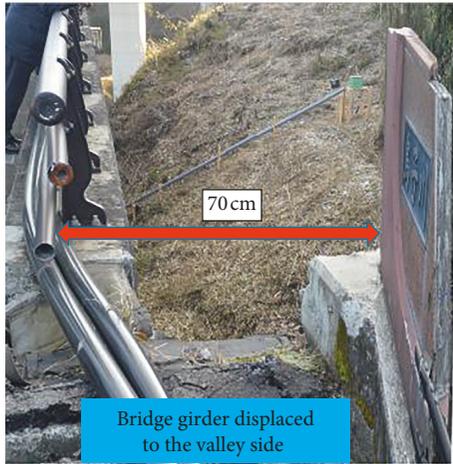
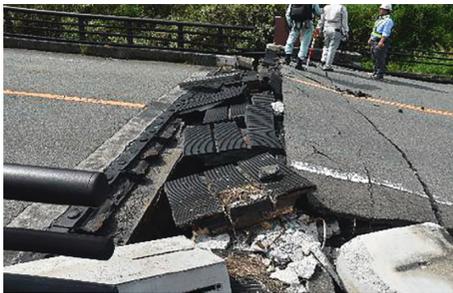
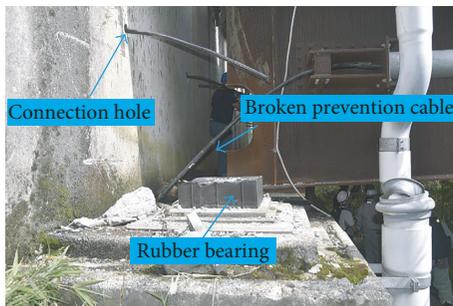
2.3. Overview of Damage to Ookirihata Bridge. Ookirihata Bridge is a five-span continuous curved bridge with a total length of 265.4 m. Girders supported by laminated rubber bearings and rubber joint load bearings are used as end supports. During this large-scale earthquake, the laminated rubber bearings underwent shear destruction, and the girder experienced a relative displacement of about 70 cm in the transverse direction. The main girder section prevented direct contact (collision) in the abutment parapet, preventing damage to the superstructure. This can be clearly seen in Figure 3(a). Figure 3(b) shows that a large step occurred at the expansion joint of Ookirihata Bridge [2, 3]. The bridge collapse-prevention cable was also deformed in a direction perpendicular to the bridge's axis. This led to rupture, and the girder fell down from its rubber bearing. This situation is depicted in Figure 3(c).

FIGURE 3: (a) Relative displacement of the girder, (b) damage to the expansion joint, and (c) damage to the bearing in Ookirihata Bridge.

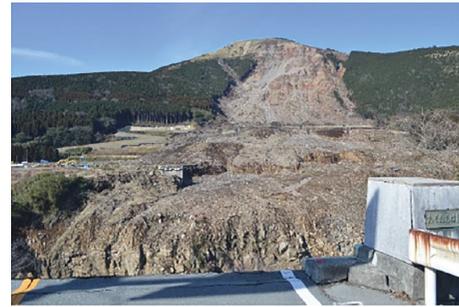
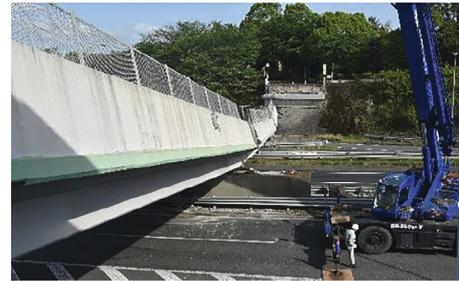
2.4. Overview of Damage in Other Bridges. Among the damaged bridges, Aso Bridge and Furo First Bridge, situated on the prefectural road across the Kyushu Expressway, collapsed totally. Aso Bridge collapsed because of a huge landslide, about 710 m high, with a dip angle of 33°. Figures 4(a) and 4(b) show the collapse of Aso Bridge and Furo First Bridge, respectively.

FIGURE 4: The collapse of (a) Aso Bridge and (b) Furyo First Bridge.

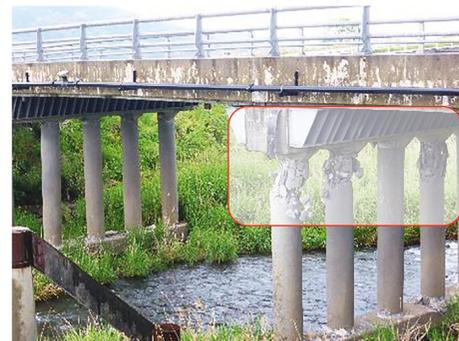
Some bridges, such as Hatanaka Dai-ichi Bridge, had to be urgently demolished. In Hatanaka Dai-ichi Bridge, the tops of piers completely collapsed, as shown in Figure 5. Figure 6 shows the damaged condition of Yokoe Bridge in Yatsushiro. In this bridge, the intermediate pier settled by about 2.3 m, causing the detachment of the bridge and sidewalk stairs [2, 3].

FIGURE 5: Damage to the tops of the piers of Hatanaka Dai-ichi Bridge.

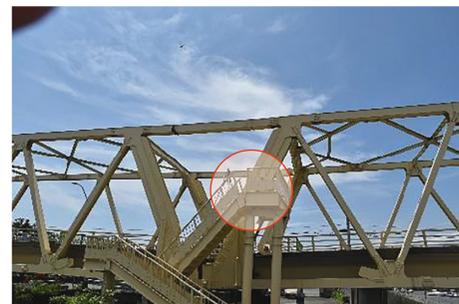
FIGURE 6: Damage and detachment of the bridge and sidewalk stairs of Yokoe Bridge.

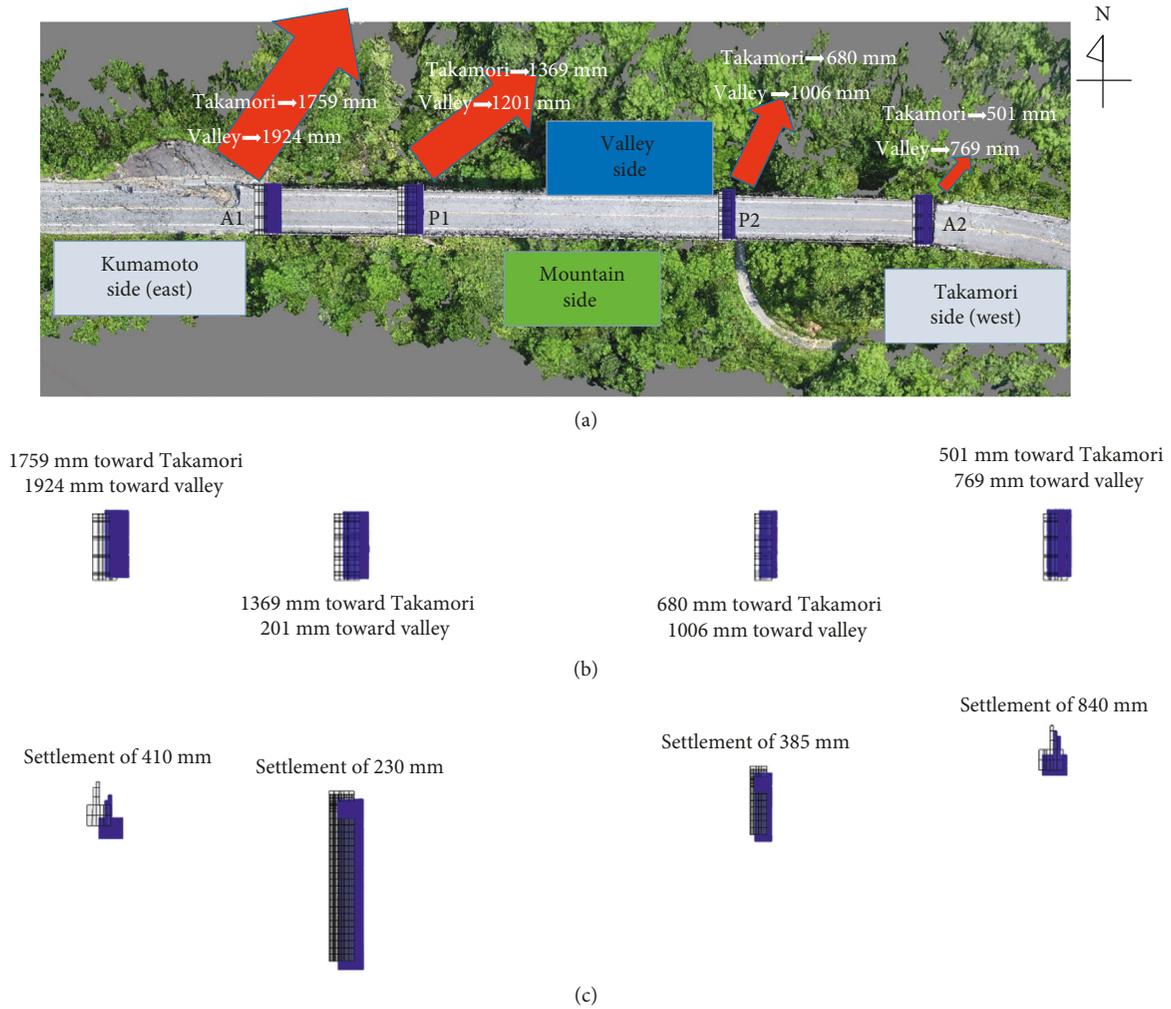
damaged owing to its proximity to the active fault line. The deformation of the whole bridge can be seen in Figure 11, which was generated using a three-dimensional (3D) scanning technique that was developed by Yuta Ushitsuka.

According to the site survey data, all piers and abutments moved in the NE direction, and the movement and settlement of each abutment and pier were as follows:

- (i) Abutment 1 moved 1,759 mm toward Takamori and 1,924 mm toward the valley and underwent a settlement of 410 mm.
- (ii) Pier 1 moved 1,369 mm toward Takamori and 1,201 mm toward the valley.
- (iii) Pier 2 moved 680 mm toward Takamori and 1,006 mm toward the valley.

- (iv) Abutment 2 moved 501 mm toward Takamori and 769 mm toward the valley.

The settlements of each bridge's abutments and piers are shown in Figure 11(c).

FIGURE 11: (a) Overall deformation of Tawarayama Bridge, (b) horizontal displacement of abutments and piers, and (c) settlement of abutments and piers.

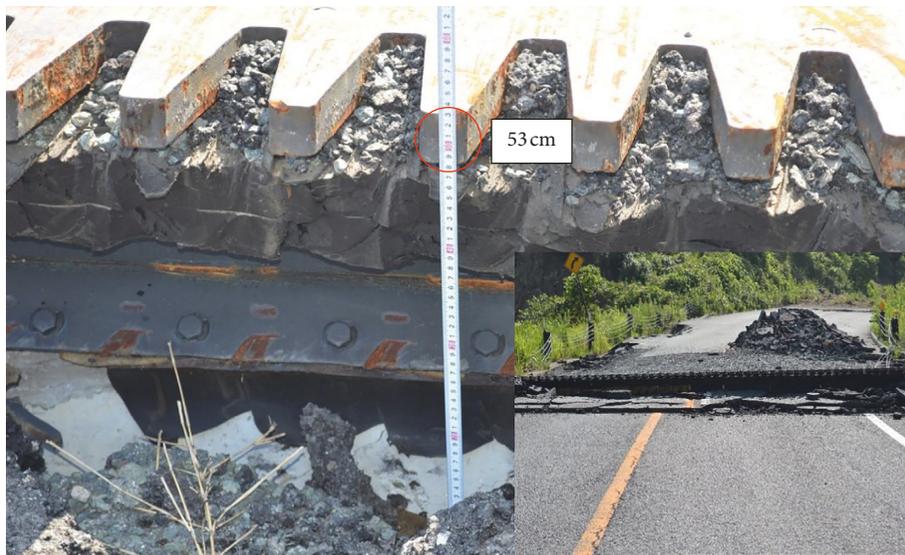
4.1. *Damage at Abutments.* The settlement of the deck slab occurred at the east side (A2 side) of the bridge because of the girders falling off from the rubber bearings and tilting of the abutment. A deck slab settlement of 53 cm was observed (Figure 12). The movement of the abutment by about 80 cm toward Takamori and the falling of the girder from the rubber bearing at abutment A2 are shown in Figure 13.

FIGURE 12: Damage to abutment A2 (exterior).

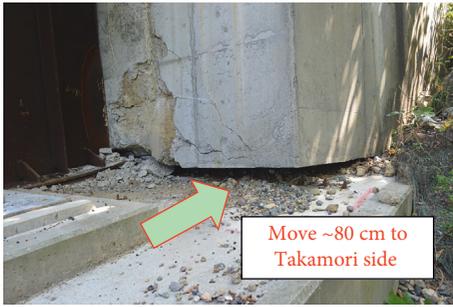
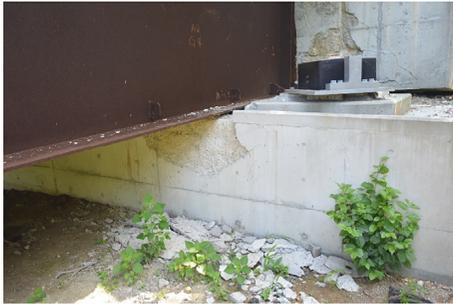
FIGURE 13: Damage to abutment A2 (interior).

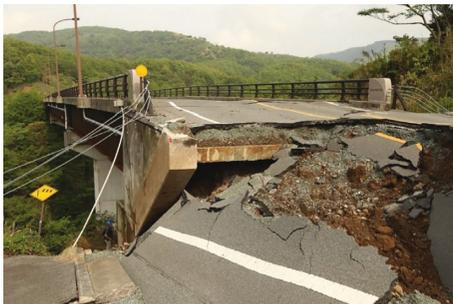
At the west side (A1 side, Figure 14), the road embankment collapsed because of the soil movement, exposing the pile foundation under the abutment. The base of abutment A1 was severely damaged, as shown in Figure 15. The shear deformation of the rubber bearing at abutment A1 is clearly seen in Figure 16.

FIGURE 14: Damage to abutment A1 (exterior).

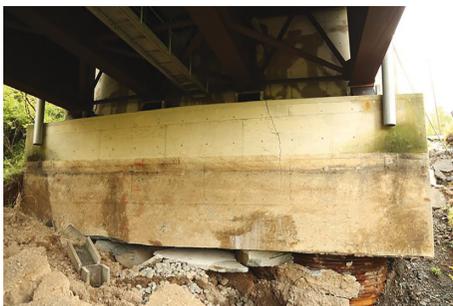
FIGURE 15: Damage to abutment A1 (interior).

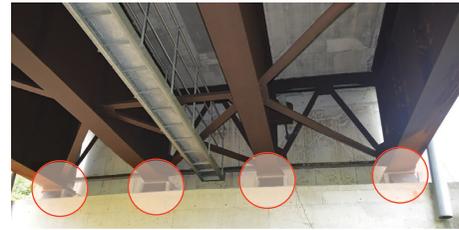
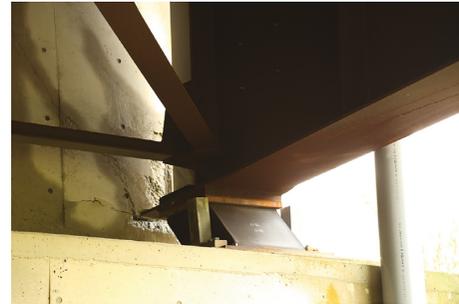
FIGURE 16: Damage to the dampers at abutment A1 (interior).

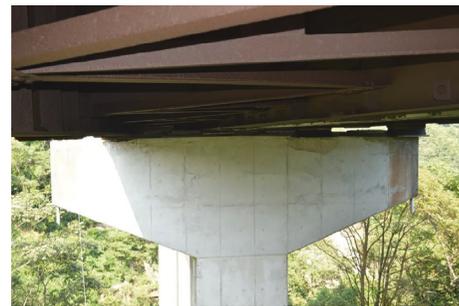
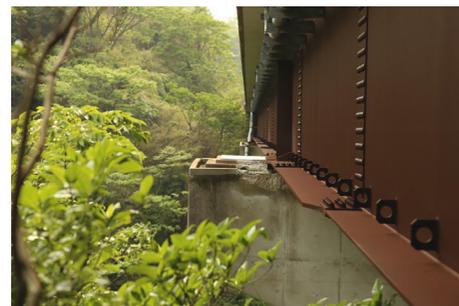
4.2. *Damage to the Piers.* The rubber bearings at P2 were seriously damaged. One of the four rubber bearings under girder 1 completely collapsed. Many cracks that formed at the base of the pier were investigated. The following figures show the damage to the rubber bearing and the cracks that formed at the base (Figures 17–19).

FIGURE 17: Damage to the piers.

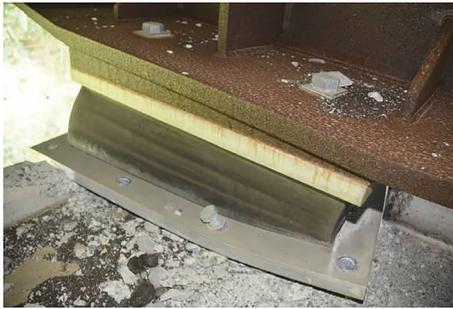
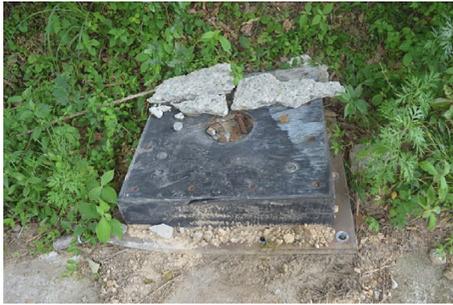
FIGURE 18: (a) Deformed rubber bearing under girder 1 at pier 2. (b) A rubber bearing that fell on the ground.

displacement criteria in both longitudinal and transverse directions may be the reason why one of the rubber bearings at the P2 pier fell down. The displacements of springs in the longitudinal and transverse directions for all cases are shown in Figure 32.

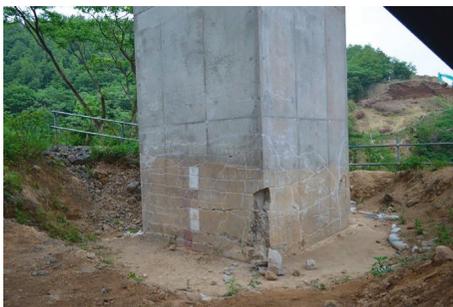
FIGURE 19: Cracks at the base of the pier.

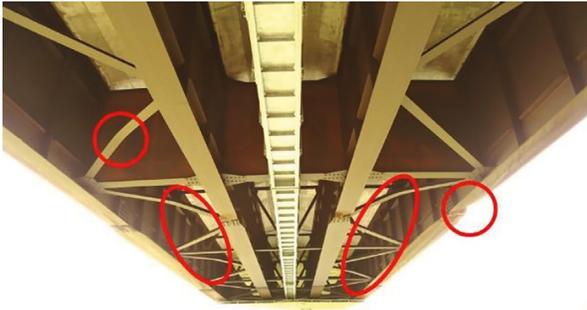
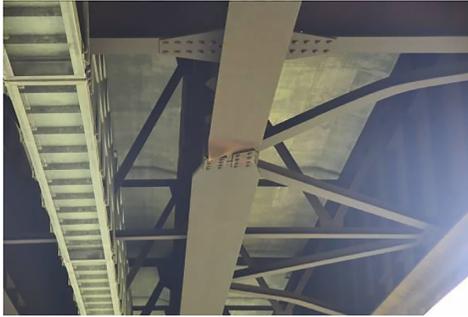
4.3. *Damage to Girders.* Figure 20 shows the deformation of the main girder and pier P1 as seen from the A1 side. The main girder bent and underwent inward deformation about 20 m from the A1 side while moving toward P1. Bucking in the vicinity of the lower lateral structure was confirmed near P1 and P2. The deformation of girder G3 is shown in Figure 21.

FIGURE 20: Deformation of the main girders and buckling of the lower lateral members.

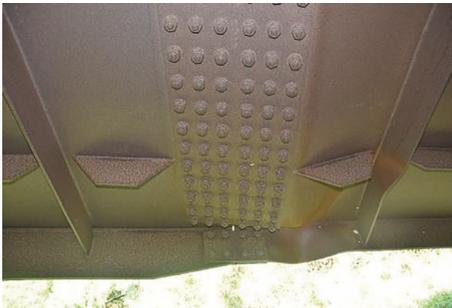
FIGURE 21: Deformation of girder 3.

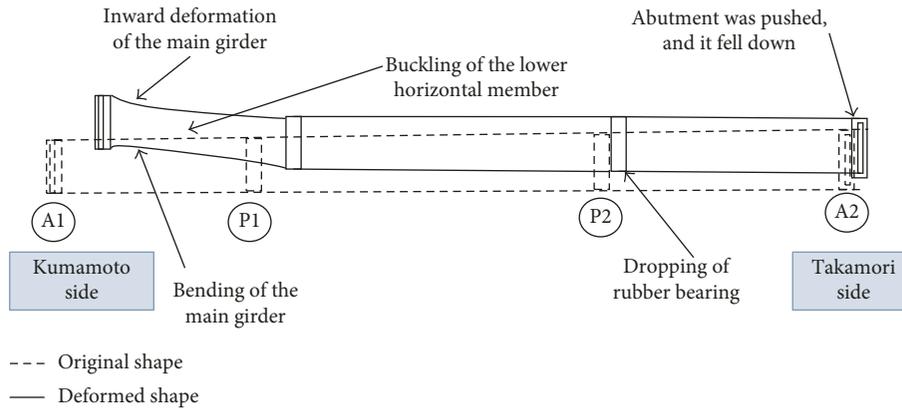
4.4. Damage Mechanism. Figure 22 shows the original and deformed shapes of Tawarayama Bridge. The dotted line shows the original shape, and the solid line shows the deformed shape.

According to the damage survey presented in Sections 5.1–5.3, the impinging of the lower horizontal members buckling may be attributed to the compressive force acting on the bridge deck from both abutments A1 and A2 or to the displacement of the abutments toward the bridge girder. Figure 23 illustrates the deformation mechanism of the main girder and lower lateral members.

FIGURE 22: Deformation mechanism of the whole bridge.

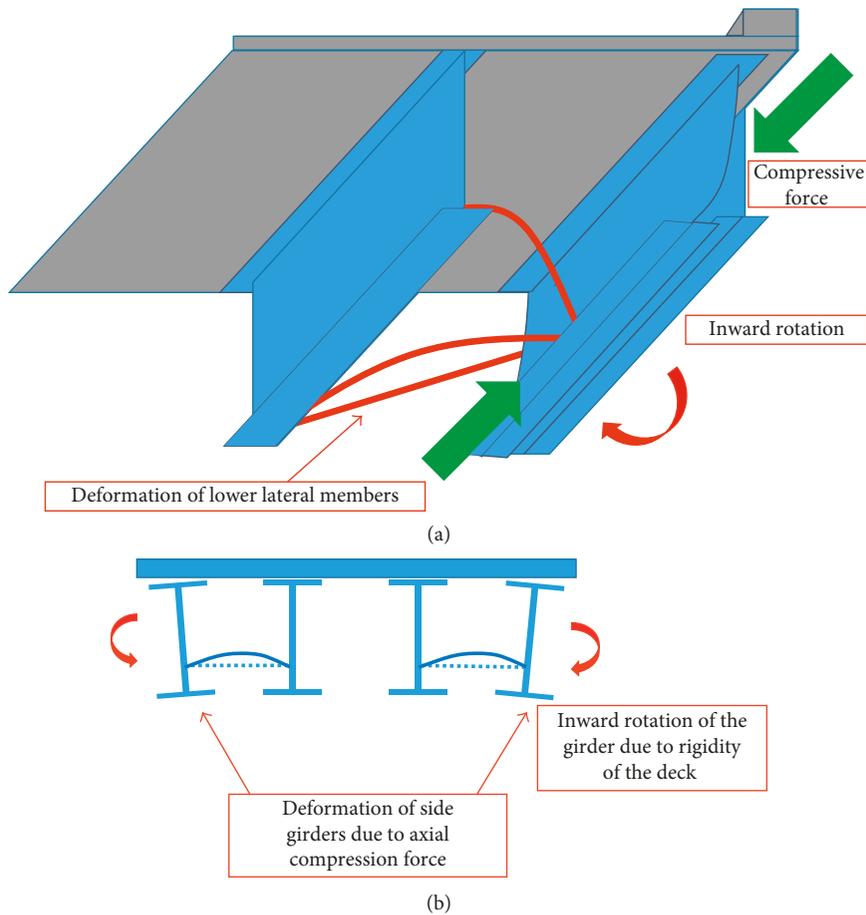
In this study, this event is considered the most important destructive mechanism. The extent of the compressive force that should be assumed for the seismic design of the bridge girder has not been verified yet. In addition, the actual ground motion was larger than what was assumed. Therefore, there is a need to identify the ground motion at the sites. According to this survey, in the future, the seismic design of bridge girders should be considered on the basis of

FIGURE 23: Deformation mechanism of the main girder and lower lateral members.
