# Research on the Deformation and Control Technology of Surrounding Rock in Entry Retaining along the Gob Side

*2.1. Engineering Geological Overview of E1316 Intake Entry.* The current production capacity of Gaohe mine is 8.0 mt/a, which belongs to high-yield and high-efficiency mine. E1316 intake entry is surrounded by the E1316 working face at the south side, the goaf of E1315 working face on the north side, and five main roadways on the west side, which serve as the auxiliary transportation roadway of the south wing at +450 m level. The E1316 intake entry is located in the 3# coal seam with a total length of 1087 m and drivage along the roadway floor. The specific roadway location is shown in Figure 1. Gaohe mine is a typical high-gas mine. The absolute gas emission volume of the mine is as high as 253.92 m<sup>3</sup>/min. Considering that it has the high gas content and emission, the ventilation mode of E1316 working face was changed from the “Y-type + High pumping roadway” ventilation mode to the “W-type + High pumping roadway” ventilation mode to optimize the ventilation system and recover coal resources as much as possible. In addition, the noncoal pillar mining was implem

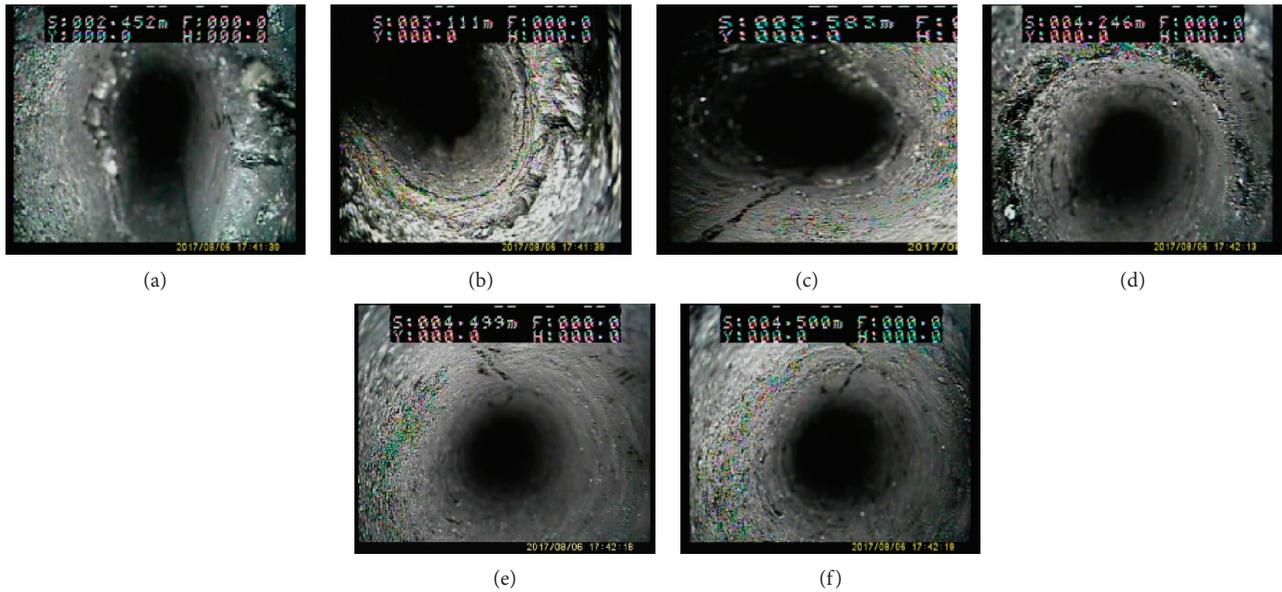
The surrounding rock in the 0.1–0.8 m range of the roof anchorage zone was seriously damaged, forming obvious fractured zones. The images were selected from the detection holes and are presented in Figures 10(a) and 10(b). The surrounding rock in the anchorage zone of roof was partially broken in the range of 1.1–2.0 m, showing the plastic distribution and leading to the fracture zones with obvious development characteristics about 1 m. Image presented in Figures 10(c)–10(f) were also selected from the detection holes.

FIGURE 10: The distribution of the surrounding rock in the roof anchorage area. (a) 0.2 m. (b) 0.8 m. (c) 1.1 m. (d) 1.5 m. (e) 1.8 m. (f) 2.0 m.

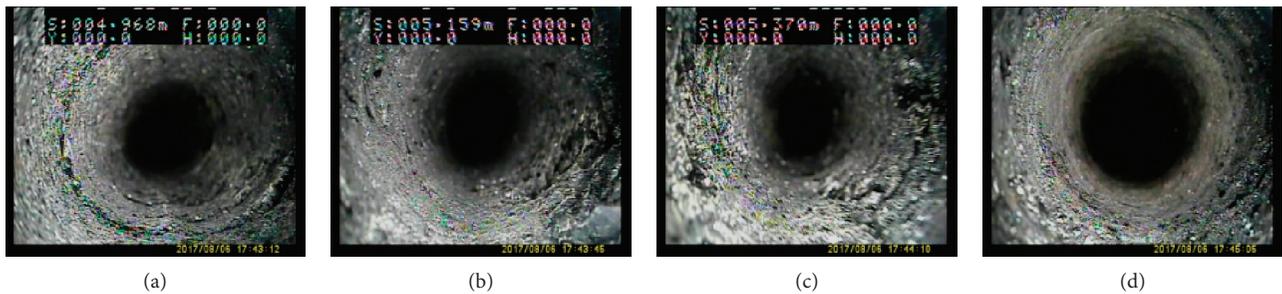
In this range, obvious cracks and fragments were found in the surrounding rock. The coal-rock boundary was 3.8 m. In other words, the top coal

FIGURE 11: The distribution of the surrounding rock (2.5–3.8 m) outside the anchor zone. (a) 2.5 m. (b) 2.9 m. (c) 3.4 m. (d) 3.8 m.

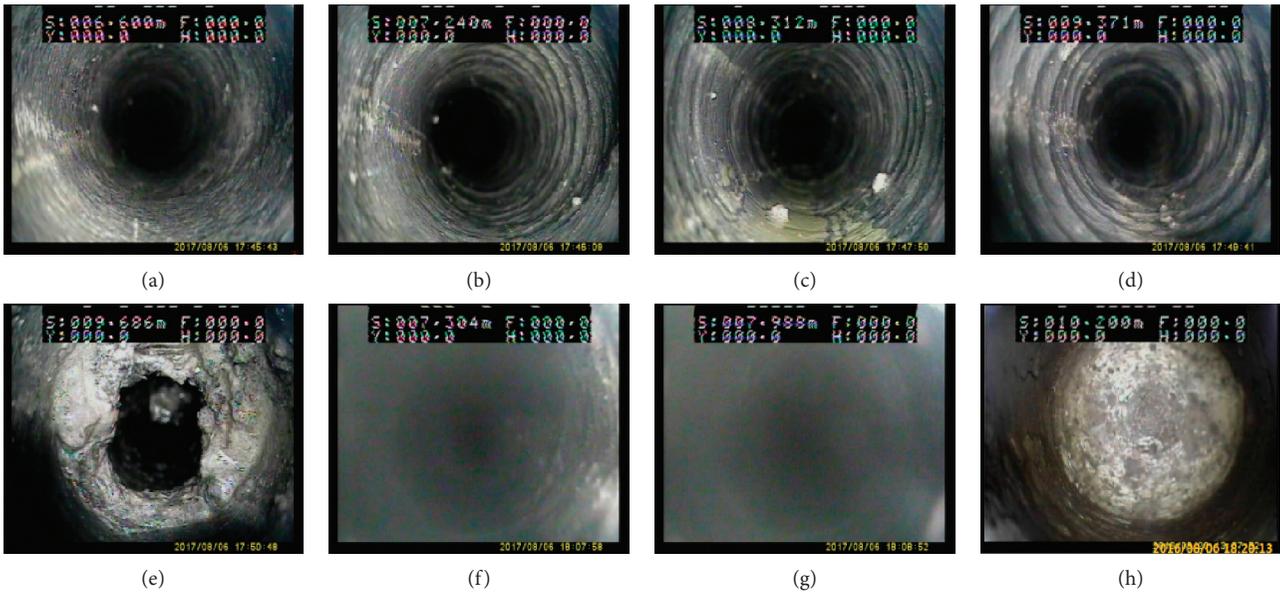
The hole with the depth of 7.2 m was located at the junction of the direct roof and the main roof, which was relatively fragmented. A large amount of smoke and dust in the hole was within the main roof, due to the friction between the drill bit and the sandstone of the main roof. The helix characteristics were clearly observed. The detection results are shown in Figures 12(a)–12(h).

FIGURE 12: The distribution of the surrounding rock (3.8–10 m) outside the anchor zone. (a) 4.1 m. (b) 4.7 m. (c) 5.9 m. (d) 6.9 m. (e) 7.2 m. (f) 7.6 m. (g) 8.0 m. (h) 10.0 m.

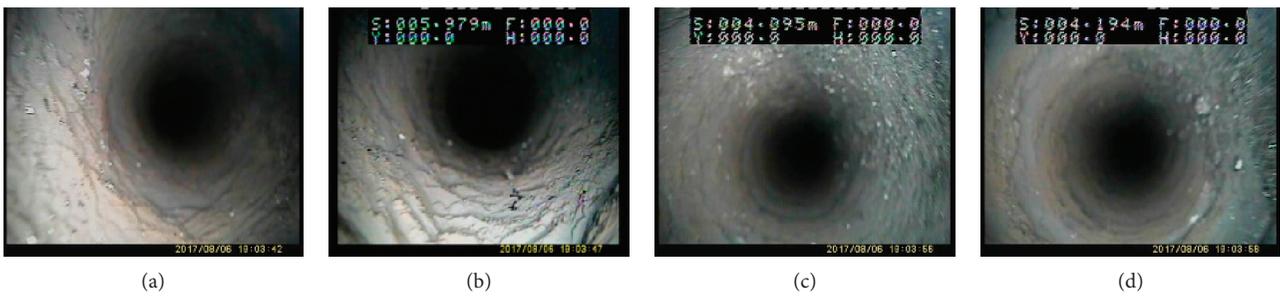
In this range, no obvious cracks and fractured zones were found in the surrounding rock with better integrity. The preload of the bolt support was high at the initial stage. Better supporting effects were identified in the bolting range. This range of images was selected from the detection hole, and the results are shown in Figures 13(a)–13(d).

FIGURE 13: The distribution of the surrounding rock in the roof anchorage area. (a) 0.2 m. (b) 0.9 m. (c) 1.8 m. (d) 2.2 m.

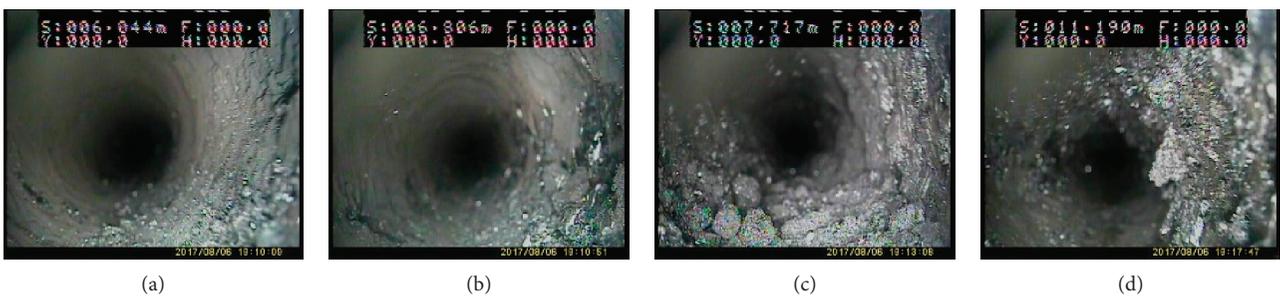
In this range, obvious crack development and fragmentation were found in the surrounding rock. The coal body was loose and fragmented,

FIGURE 14: The distribution of the surrounding rock (2.3–7.8 m) outside the anchor zone. (a) 2.6 m. (b) 4.2 m. (c) 5.8 m. (d) 7.6 m.

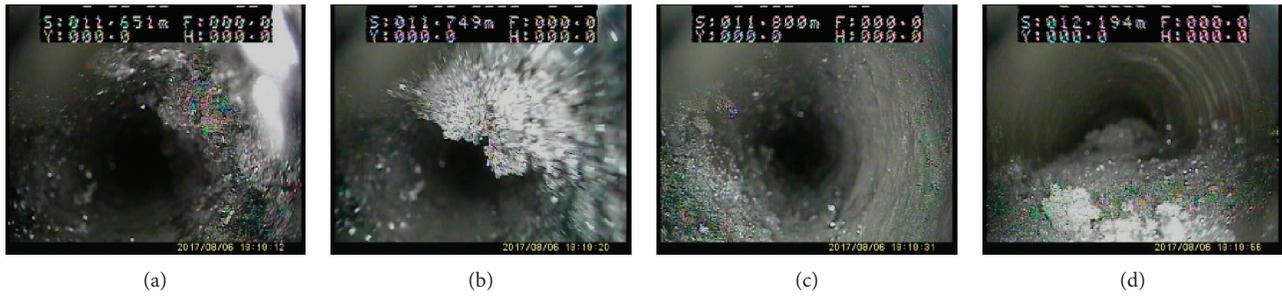
In this range, no obvious cracks and fractured zones in the surrounding rock due to unmined working face were present. The overall integrity remained untouched. The coal powder accumulation in the pillar side hole was severe. This range of images was selected from the detection hole, and the results are shown in Figures 15(a)–15(d).

FIGURE 15: The distribution of the surrounding rock (7.8–10 m) outside the anchor zone. (a) 7.9 m. (b) 8.3 m. (c) 9.2 m. (d) 10.0 m.

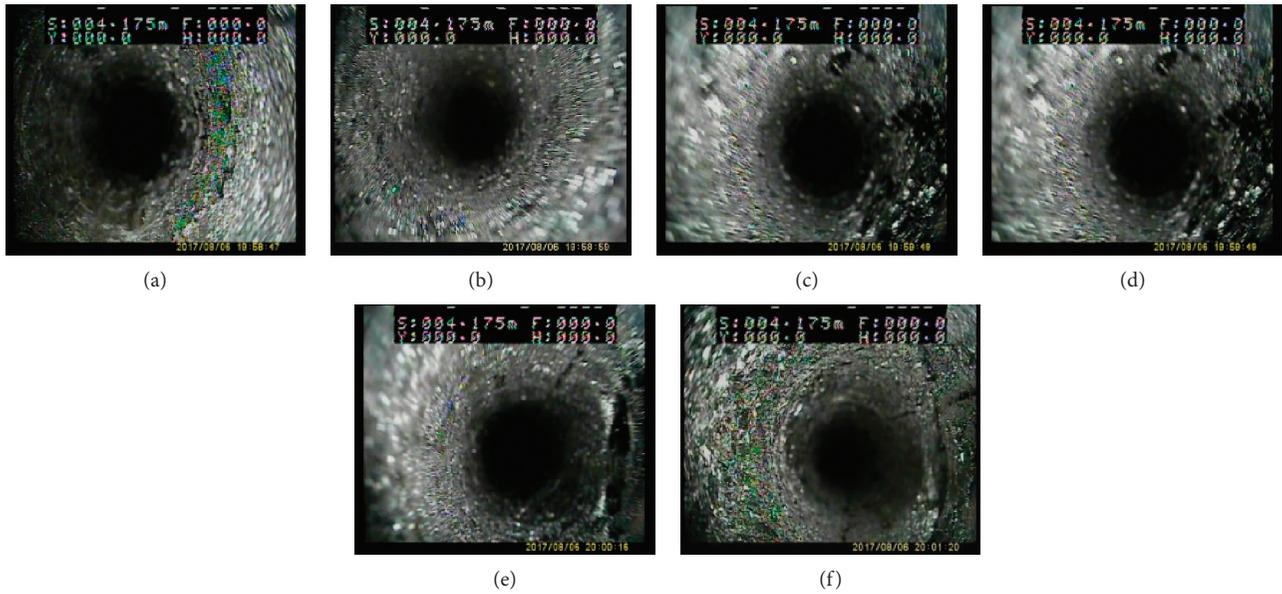
The integrity of the surrounding rock in 0.1–0.7 m range of the roof anchorage zone was good. The detection results are shown in Figures 16(a) and 16(b). The surrounding rock in 0.7–2.3 m range of the roof anchorage zone was partially broken, and the cracks had expanded and developed. This range of images was selected

FIGURE 16: The distribution of the surrounding rock in the roof anchorage area. (a) 0.2 m. (b) 0.7 m. (c) 0.8 m. (d) 1.0 m. (e) 1.8 m. (f) 2.2 m.

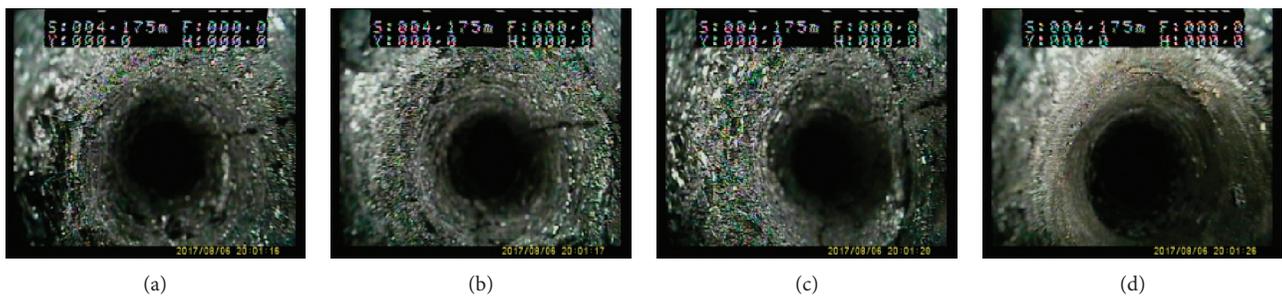
- ② The development of the surrounding rock outside the bolt anchorage zone (2.3–2.8 m) fissures Fissure zones were identified in the surrounding rock. The fissures developed initially from 1.7 m

in the anchorage area with a 1.1-meter penetration. Due to the softness differences between the coal body and the drill bit, the fissures can develop during drilling, and the coal-rock interface is 2.8 m. The detection results are shown in Figures 17(a)–17(d).

FIGURE 17: The distribution of the surrounding rock (2.3–2.8 m) outside the anchor zone. (a) 2.3 m. (b) 2.5 m. (c) 2.7 m. (d) 2.8 m.

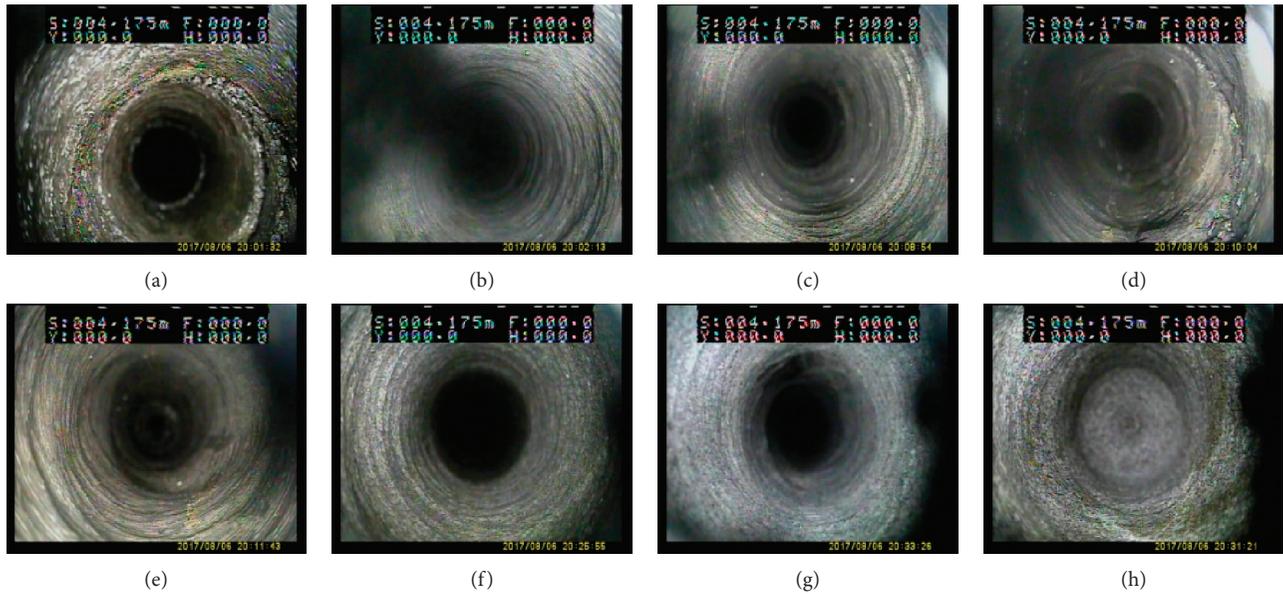
③ The development of the surrounding rock outside the bolt anchorage zone (2.8–10 m) with basic integrity. In this range, no obvious cracks and fractured zones were found in the surrounding rock with good integrity. The hole with a 5.7 m depth was located at the junction of the direct top and the main roof, which was relatively fragmented. The surrounding rock in the hole was intact within

the main roof without any crack. The drilling process took longer. The fine sandstone of the main roof was harder, and the helix characteristics were visible. The detection results are shown in Figures 18(a)–18(h).

FIGURE 18: The distribution of the surrounding rock (2.8–10 m) outside the anchor zone. (a) 2.9 m. (b) 3.4 m. (c) 4.0 m. (d) 5.7 m. (e) 6.4 m. (f) 7.5 m. (g) 8.8 m. (h) 10.0 m.

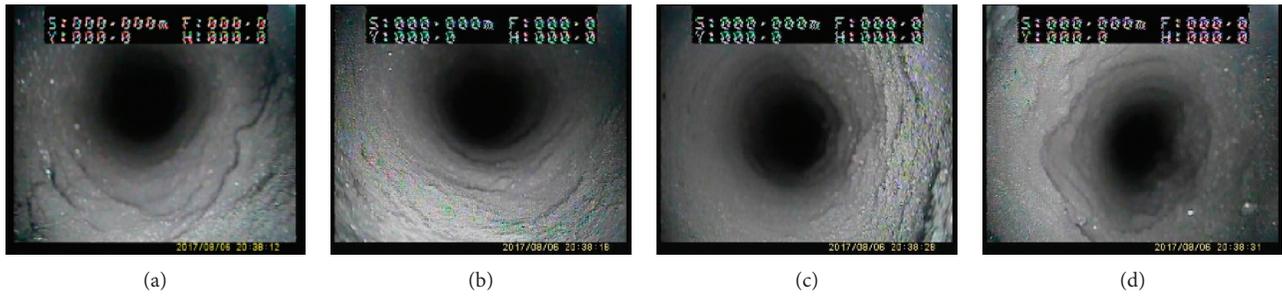
In this range, no obvious cracks and fractured zones in the surrounding rock were found, but the coal body is loose and had no bearing capacity. This range of images was selected from the detection hole, and the results are shown in Figures 19(a)–19(d).

FIGURE 19: The distribution of the surrounding rock in the roof anchorage area. (a) 0.2 m. (b) 0.8 m. (c) 1.6 m. (d) 2.2 m.

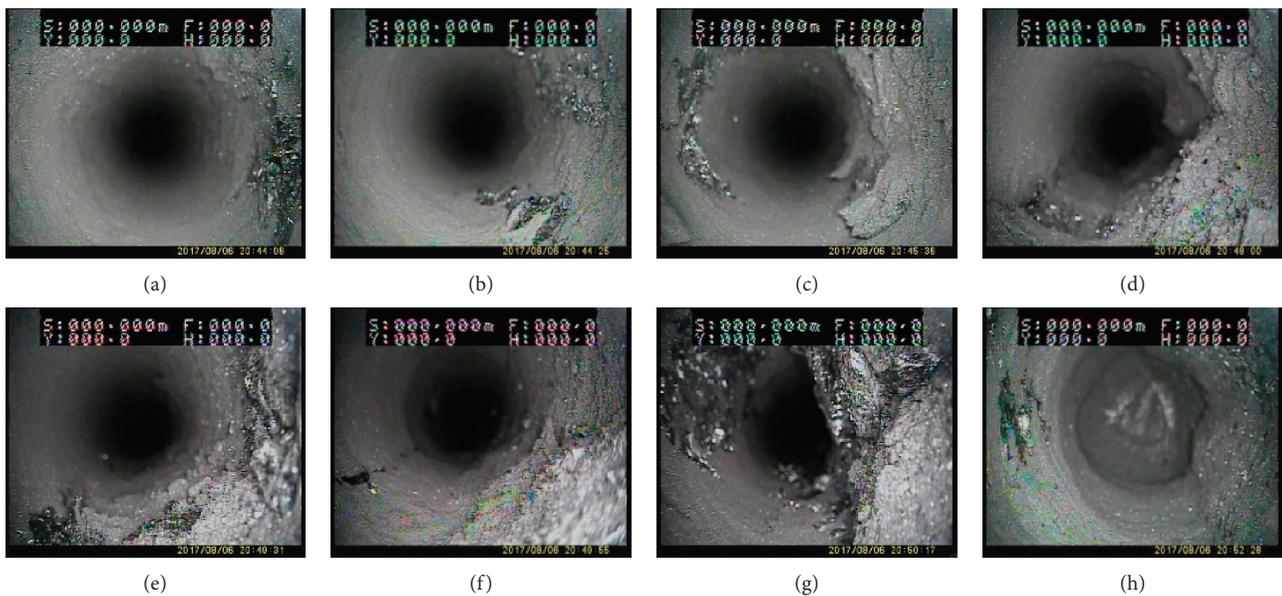
No obvious characteristics of crack development and fragmentation were found in the surrounding rock. Due to the high lateral stress caused by the mining in the upper working face, borehole fragmentation and deformation were severe with poor integrity. This range of images was selected from the detection hole, and the results are shown in Figures 20(a)–20(h).

FIGURE 20: The distribution of the surrounding rock outside the anchor zone. (a) 2.6 m. (b) 3.2 m. (c) 4.8 m. (d) 5.6 m. (e) 6.6 m. (f) 7.8 m. (g) 8.9 m. (h) 10.0 m.
