Research Article

Mechanism and Control of Cable Breakage in a Roadway with Thick Top Coal in a Rockburst Mine

Cable breakage occurred frequently in the No. 3 roadway in Xingcun coal mine of Shandong Tian'an Mining Group CO., Ltd., during the roadway excavation. The paper aims at addressing the cause and solution of the case of general rockburst (rockburst phenomenon). Firstly, based on the analysis of stress and elastic energy evolution law of surrounding rock and stress state of cable, cable breakage mechanism was revealed. After that, grouting technology and parameters of cable breakage control were designed and applied in the No. 3 roadway. The research results can provide certain theoretical and practical value for mine pressure control of roadway, especially in rockburst mines.

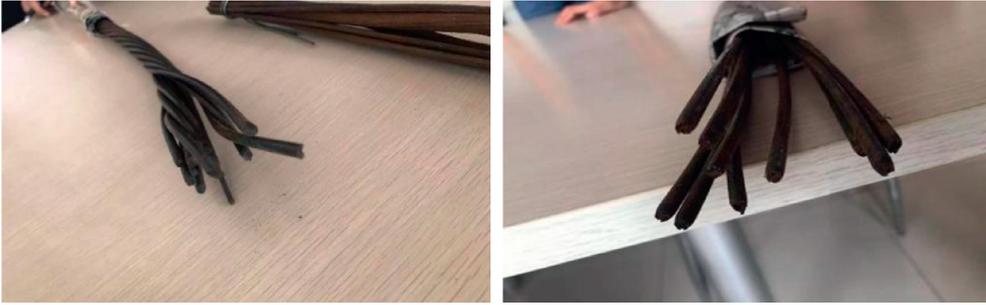
2.2. Situation of Cable Breakage. According to the field observations data that lasted for a month during the No. 3 roadway excavation, it was found that 34 cases of cable breakage (Figure 2) occurred in the range of 10 m–30 m from the heading of roadway and 9 cases of cable breakage occurred in the range of 30 m outside the heading. Among the 34 cases, all of them were roof cable, 15 cases on the arch of the roof, 12 cases on the right side of the roof, and 7 cases

on the left side of the roof. Among the 9 cases, 6 cases, 2 cases, and 1 case of cable breakage occurred on the arch of roof, the left side of the roof, and the right side of the roof, respectively.

- (1) When a fully mechanized excavating machine was driving or coal cracked with firecrackers or thunder sound, which were two sources of dynamic load, the cable breakage occurred.
- (2) From the analysis of the shape and characteristics of the cable breakage, it can be judged as a “tension-shear” breakage.
- (3) The cable breakage was mainly concentrated between 1.5 m and 3.5 m away from the anchorage of the cable.
- (4) The constant resistors of cable were deformed and the constant resistance displacement was 0~200 mm which was less than the allowable deformation of cable.

FIGURE 2: Cable breakage of No. 3 exploration roadway.

Through the above analysis, surrounding rock grouting can reduce the stress concentration of surrounding rock and cable. So surrounding rock grouting technology was proposed as control technology of cable breakage.

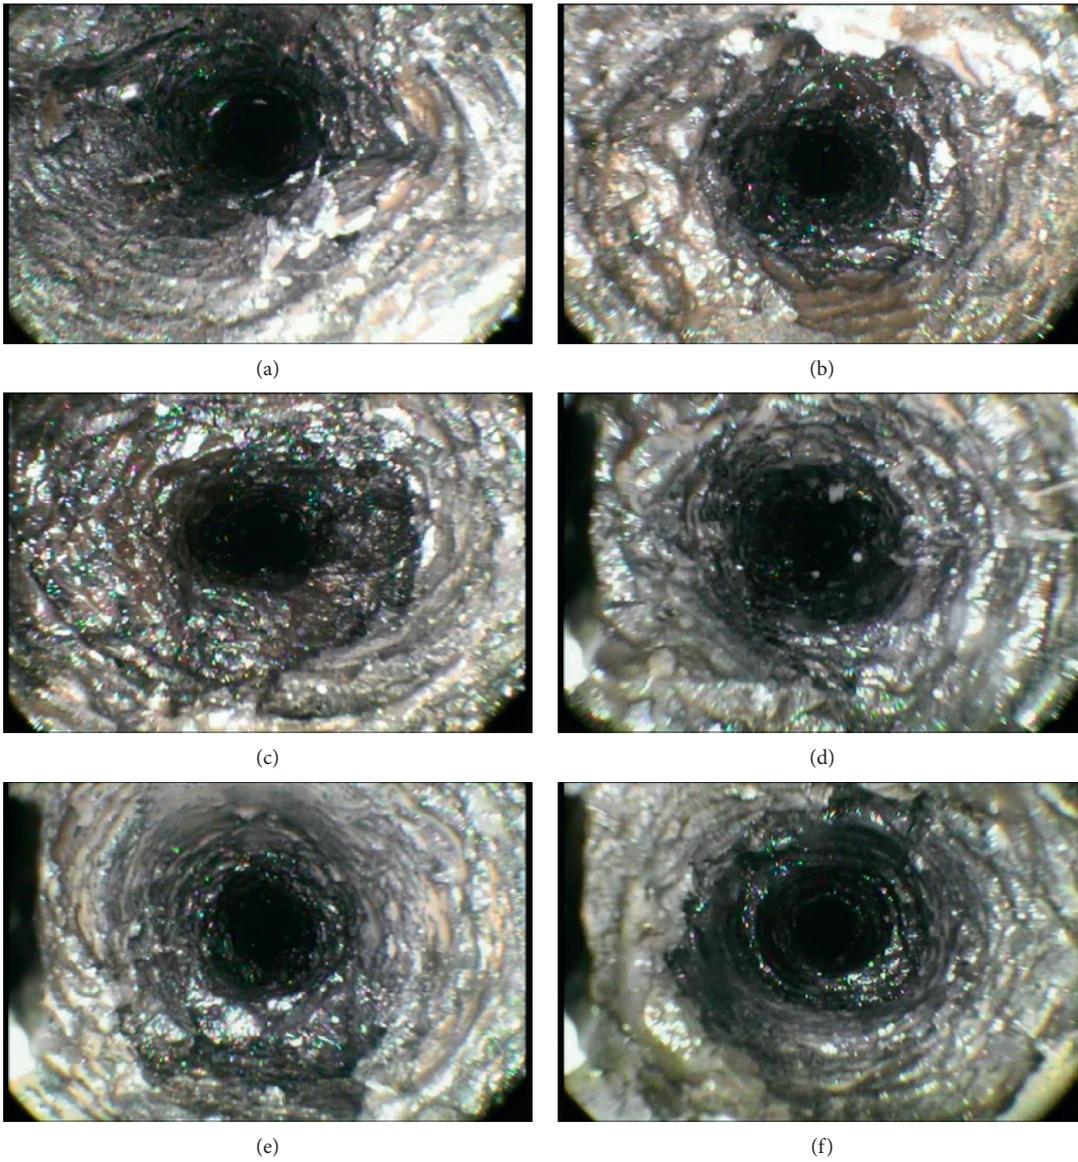
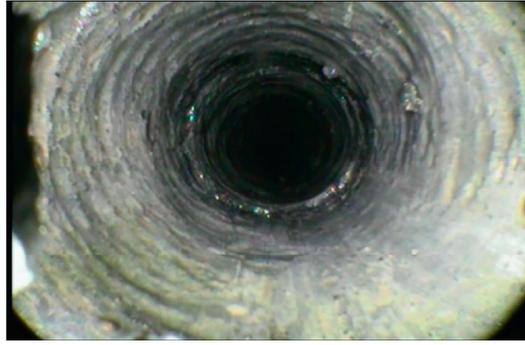
2.3. Deformation of Top Coal. During the No. 3 roadway excavation, the top coal and rock of the roof were drilled and peeped at 15 m behind the heading of the roadway. From the peeping images of the boreholes (Figure 3), it can be seen that the top coal between 1.6 m and 4.0 m had poor integrity, severe separation, loose and broken parts, and well-developed fissures; vertical fissures between 4.0 m and 4.8 m were developed in the top coal. But the rock of the roof in 4.8 m~6.2 m had better integrity. In general, the thick top coal of the No. 3 roadway was damaged and loose, but the rock above top coal was more stable. In other words, the thick top coal of roadway was mainly deformed and difficult to control surrounding rock, which was like other thick top coal roadways in other coal mines [21, 22].

FIGURE 3: Borehole peep image under different borehole depths. (a) 1.6 m. (b) 2.5 m. (c) 3.1 m. (d) 4.0 m. (e) 4.3 m in depth. (f) 4.8 m in depth. (g) 6.2 m in depth.

4.2.1. Grouting Material. According to the above borehole peeking results of the No. 3 roadway, it can be seen that the top coal of the roadway was loose and broken, and cracks were developed. So cement-based grouting material can be selected for surrounding rock grouting of the roadway [32]. Particularly, the grouting material had a wide source and low price. The water-cement ratio was 0.8 : 1.

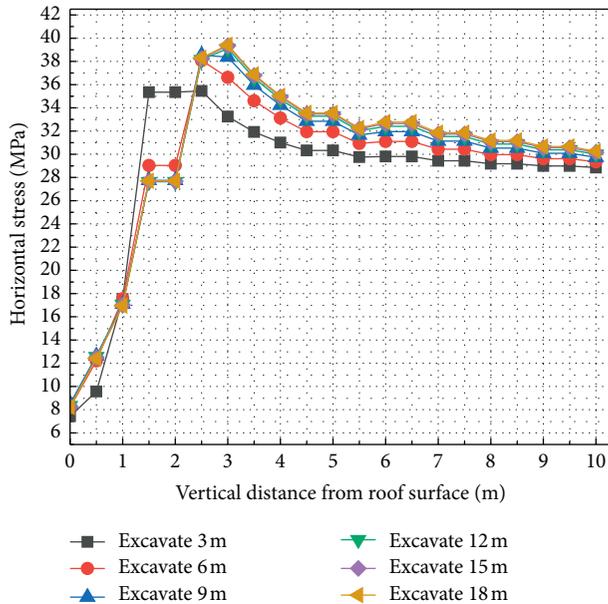
- (1) When the roadway was excavated forward 3 m, the horizontal stress peak in the same cross-section of the roof was 35.45 MPa. When the roadway was excavated forward 9 m, the peak stress was 38.54 MPa. When the roadway was excavated forward 18 m, the peak stress was 39.42 MPa. In a word, horizontal stress peak in the same cross-section of the roof had a tendency to increase with the roadway excavation.
- (2) When the roadway was excavated forward 6 m, horizontal stress peak was located at 2.5 m in the top coal. When the roadway was excavated forward 15 m, horizontal stress peak was located at 3.0 m in the top coal. In a word, horizontal stress peak shifts to deep with the roadway excavation.

From the perspective of the evolution law of horizontal and vertical stress on the roof of the roadway, as the roadway excavation, the horizontal stress peak increased and finally tended to balance and shifted to the deep. Particularly the horizontal stress peak no longer spread to the deep when it was transferred to a depth of about 3 m in top coal. But the vertical stress peak gradually decreases as the roadway advances and eventually tends to balance. This causes the stress difference between the horizontal and vertical stress to gradually increase as the roadway excavation continues. The maximum stress difference occurred at about 3.5 m in depth in top coal, which was about the place of cable breakage.

FIGURE 5: Horizontal stress distribution under different excavation distance.

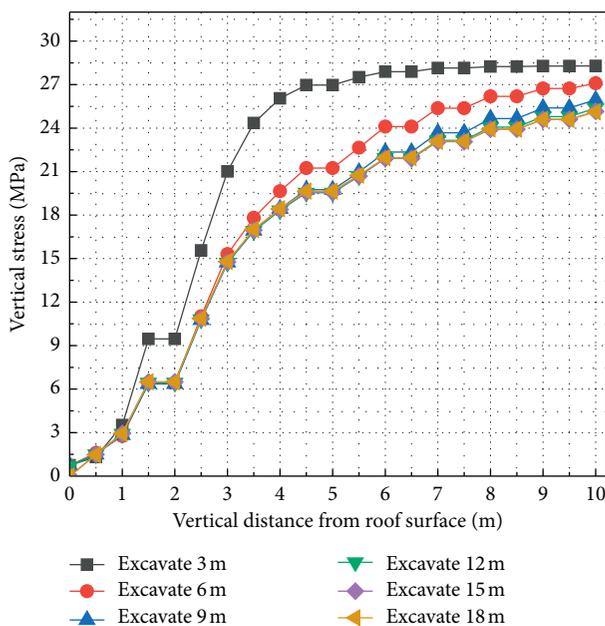
In addition, according to the numerical simulation results (Figure 6), vertical stress evolution laws were as follows: when the roadway was advanced for 3 m, the vertical stress

peak was 64.69 MPa. When the roadway was advanced for 9 m, the vertical stress peak was 57.35 MPa. When the roadway was advanced for 18 m, the vertical stress peak was 55.43 MPa. In a word, with the roadway advancing, the vertical stress peak at the same position of the roadway roof gradually decreases.

FIGURE 6: Vertical stress distribution under different excavation distance.

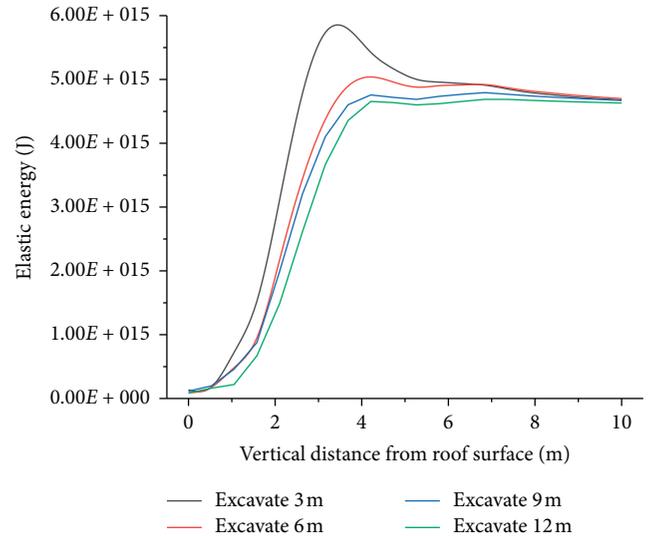
- (1) The elastic energy of the shallow surrounding rock was released instantly after the roadway was excavated, and the elastic energy accumulated in the deep coal and rock. In particular, the elastic energy accumulation range was between 3 m and 4 m in depth in the top coal.
- (2) As the roadway excavation, the elastic energy in the range of 10 m in depth of roof was released, and when the roadway advanced distance changed from 3 m to 6 m, the elastic energy released at the area around 3.5 m in depth in the top coal was the largest. The position was exactly the place of cable breakage.

FIGURE 7: Elastic energy distribution under different excavation distance.

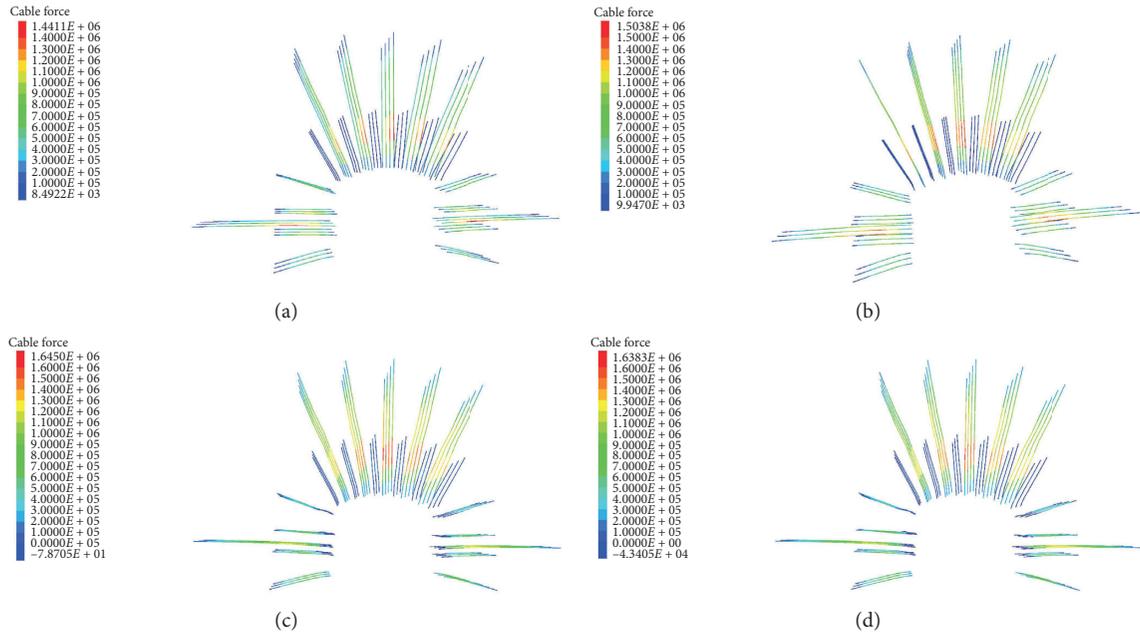
- (1) Whether the roadway excavation distance was 3 m, 6 m, 9 m, and 12 m, the cable stress increased first and then decreased from the surface to the deep part of the top coal and the rock, and the concentrated part of the larger axial force of the cable was within the range of 2 m~4 m.
- (2) When the roadway was advanced for 3 m, 6 cables with an axial force greater than 1.4×10^6 MPa appeared. When the roadway advanced for 9 m, 12 cables with an axial force greater than 1.4×10^6 MPa appeared. When the roadway advanced for 12 m, there were 14 cables with an axial force greater than 1.4×10^6 MPa, which was 2 times more than that which appeared when the roadway advanced for 9 m. In a word, as the roadway advanced, more and more

cables with an axial force greater than 1.4×10^6 MPa appeared.

Through the above analysis of stress distribution, elastic energy distribution, and cable stress, cable breakage mechanism was revealed: in the process of roadway excavation, the stress was constantly redistributed and the stress was constantly shifting to the deep part of the roof. The vertical stress dropped at about 3.5 m in depth in top coal of the roadway with a large descending gradient, and the horizontal stress reached its peak. Especially when the surrounding rock in the load-bearing area suddenly broke, due to the large amount of elastic energy that accumulated here, the surrounding rock in this area would be dislocated instantly, and the cable would be broken in the area where the axial force was concentrated.

FIGURE 8: Stress condition of cable under different excavation distance. (a) Excavate 3 m. (b) Excavate 6 m. (c) Excavate 9 m. (d) Excavate 12 m.
