Exposure Factors Influence Stone Deterioration by Crystallization of Soluble Salts

To perform this studio we focus on the stone obtained from the Church of *Santos Juanes* in Valencia. The Church of *Santos Juanes* is situated, within its enclave, in the historic centre of Valencia, in an area delimited by and known as the *Barrio del Mercat* (market neighborhood). The group of dwellings in this quarter, as with many others that form part of the city, are characterized by belonging to, and forming part of, the urban history of the city of Valencia [1].

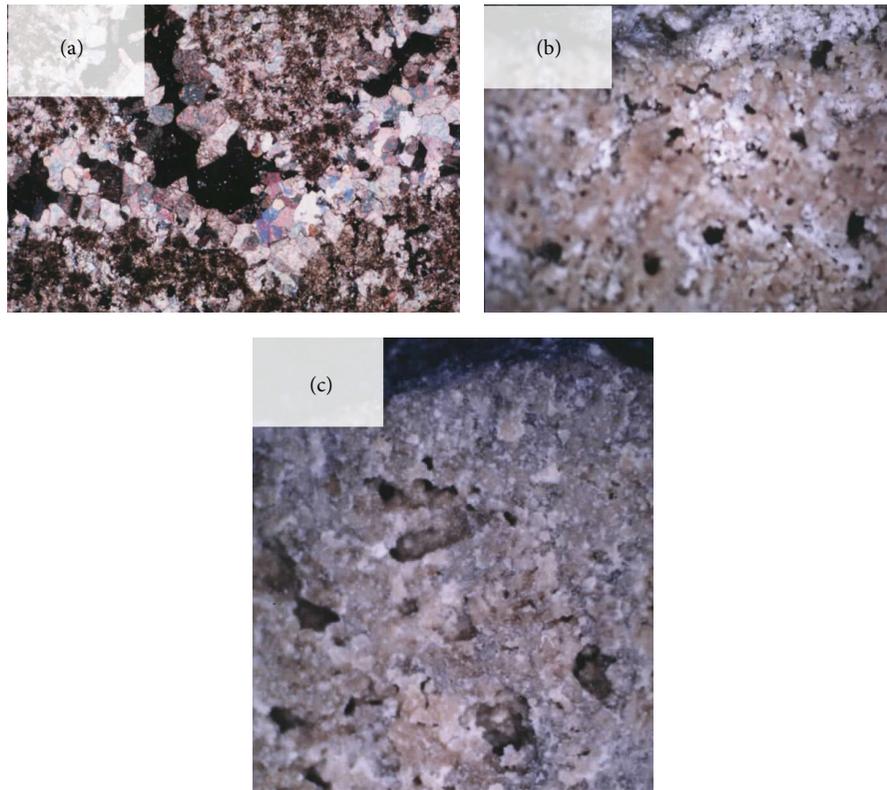
secondary porosity of modic type. This stone is a microgranulated limestone without predetermined structure with a high porosity and large cavities. It has good cementing recrystallization areas where perfect crystals (Figure 6(a)) and little stratification develop. In parts of fresh samples, we can see how the recrystallization is massive, with just cement, giving an aggregate of crystals. The calcite crystals are tabular rhombohedra with perfect faces and growth planes around the pores are observed.

3.4. Texture of the Material. The formation of crystals is linked to the texture of the material itself, regarding its morphology, shape, and size of its pores. Therefore, a crystalline structure grows by adding layers of material to the external surface when it is in contact with a solution which carries the necessary material for its growth. When the crystals grow in contact with the surface of the pores, there is always a thin coating of solution due to capillary attraction and absorption. We must take into consideration the fact that a solution can become supersaturated with respect to a crystal under low pressure, the case of crystal growth in large pores, while the same tends to dissolve a crystal that is under high pressure, the case of crystal growth in small pores [13]. For this reason the process is more feasible in material made up of many small pores that feed the growth of crystals in their large pores; these are fewer in number. The stone material under study fits this case. This fact can be seen in the microphotographs taken of the different samples of stone material extracted from the building where we can observe the formation of geodes in the interior of the microspores (Figure 6(a)).

FIGURE 6: (a) View of thin section NP40X. Geologic process or natural process of pore filling by calcium cement. (b) View through a binocular magnifier. Advance of the process of precipitation by formation of salts in a porous mass. (c) Transverse cut from the least affected part (interior zone) to the most affected.

The formation of efflorescence was observed in less exposed areas (Figure 6(b)) and where a balance between the rate of evaporation and the flow of water to the surface existed, the formation of scales was observed.

The thickness of this layer varies depending on the content and nature of the soluble salts, the reach of the water which is directly related to the texture of the material, and the evaporation conditions (Figure 6(c)).

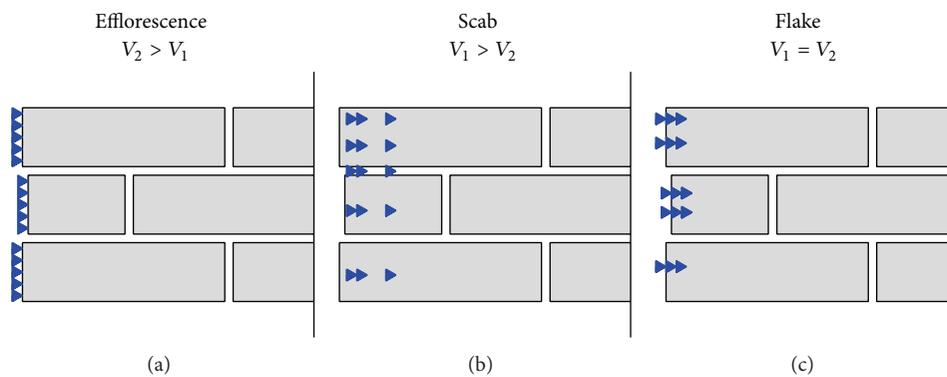
FIGURE 7: Material deterioration morphology produced by the crystallization of salts.

When the stationary state is reached, that is to say, when the rate of diffusion of water vapor from the dry stone surface is dynamically balanced by the rate of capillary migration of the solution from the dry and wet zone, a compact sheet of material, known as scale, is formed on the external surface (Figure 7).
