Research Article

Evaluation of Subsurface Damage in Concrete Deck Joints Using Impact Echo Method

Larry Rickard¹ and Wonchang Choi²

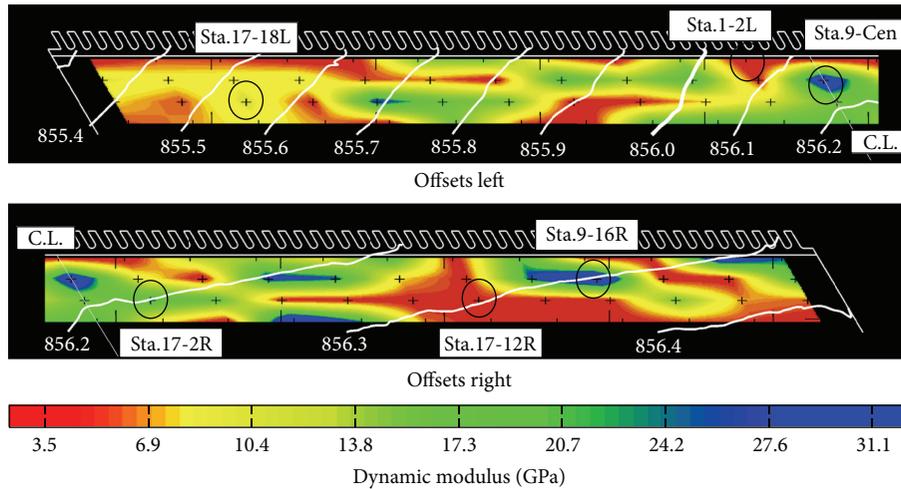
FIGURE 5: Contour maps of PSPA results and locations of core samples taken in this study.

3.2. Data Analysis Obtained from PSPA Test Results. The deterioration maps based upon the PSPA test results with dynamic elastic modulus values are shown in Figure 5. According to this set of data, most of the moderate to severe delamination appears to lie in the area to the left of the centerline. The entire area approximately 2.1 m to the right of the gutter appears to be in relatively poor condition, with no reading over 13.8 GPa. The most severe deterioration is at

the joint interface and in several intermittent areas toward the centerline. The other readings show modulus values in the range of 13.8 GPa to 20.7 GPa, with no reading over 23.7 GPa.

Similar results were obtained using the data for the right half side of the joint. Although a few readings indicate the presence of sound concrete (modulus > 23.7 GPa), the overall quality of the concrete is very poor. Areas of severe, moderate, and slight deterioration can be detected in the immediate vicinity of the joint interface. An extensive area of severe deterioration can be expected beginning at the approximate center of the lane and extending toward the right-hand. Few readings were obtained over 6.9 GPa in this region, which extended lengthwise from the joint interface to the testing limits.

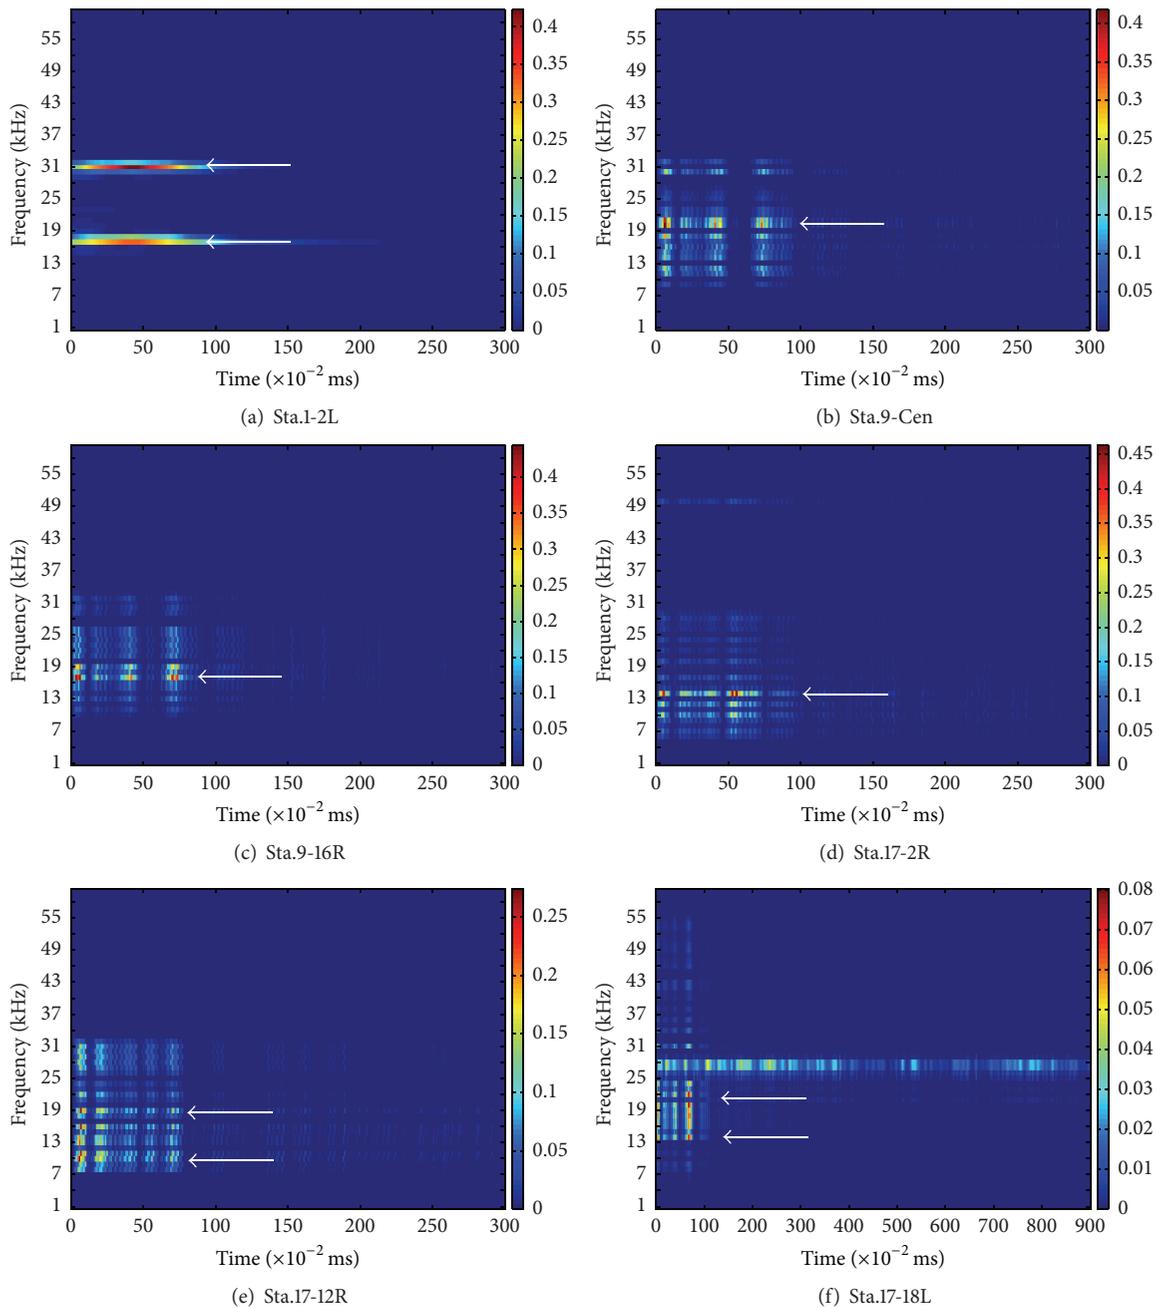
FIGURE 6: Scalograms at different test points.

The scalogram with the time-frequency analysis for Sta.1-2L presented in Figure 6(a) shows two separate frequency peak points at around 17 kHz and 31 kHz and a relatively slow-decaying phase of the frequency. This scalogram represents a debonding condition in the slab. Similarly, the scalogram of Sta.17-18L, shown in Figure 6(f), shows a similar pattern of slow decay of the frequency at approximately 28 kHz.

For the remaining locations, Sta.9-Cen, Sta.9-16R, Sta.17-2R, and Sta.17-12R, shown in Figures 6(b)–6(e), respectively, the high-frequency wave components at the beginning of the signal are well separated from the continuous reflections throughout the signal. Therefore, a slab in good condition can be represented by a scalogram that shows the decaying feature of the full slab thickness frequency [8].

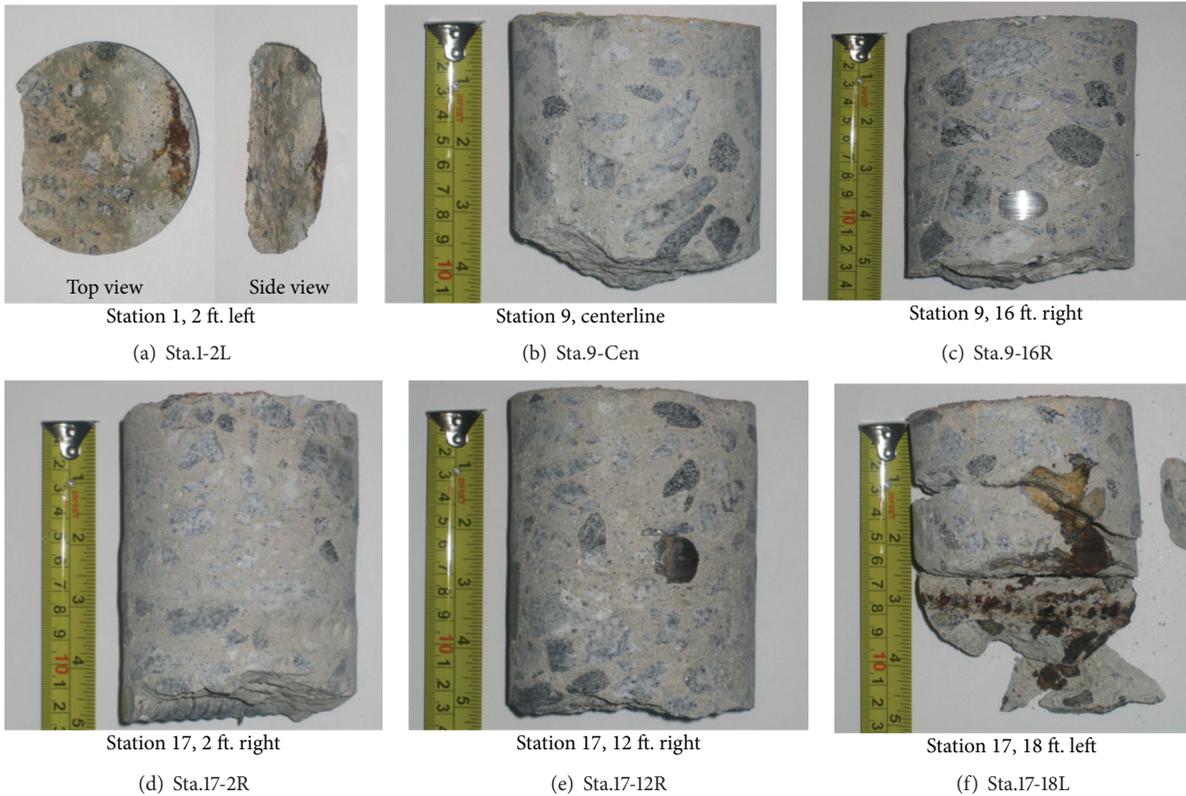
FIGURE 7: Core samples.

For Sta.1-2L, shown in Figure 7(a), the PSPA measured a modulus value of 2.34 GPa, which indicates severe deterioration. The core sample proved that the concrete at this particular location was indeed severely deteriorated; the only retrievable section of the core from this location, a wedge-shaped disc of approximately 12 mm maximum thickness,

was extracted from the surface. The remainder of the core consisted of coarse aggregate and small pieces of mortar that were impractical to piece together. These remnants exhibited discoloration that is indicative of extensive steel corrosion. The drill encountered severe resistance due to the large amount of reinforcing steel and was subject to binding; therefore, the coring depth was limited to 76 mm to avoid damage to the coring bit.

For Sta.9-Cen, shown in Figure 7(b), the PSPA measured a modulus of 29.16 GPa, indicating no deterioration. The core sample appeared to be sound overall, except that during

extraction the break occurred at a depth of 83 mm to 108 mm. This depth is relatively shallow compared to the actual 127 mm depth achieved by the coring bit. This observation, when combined with some slight fracturing of some of the coarse aggregate, is indicative of some degree of deterioration at this depth.

For Sta.9-16R, shown in Figure 7(c), the PSPA measured a modulus of 28.48 GPa, indicating no deterioration. Like the previous sample, this core appeared to be sound overall. During extraction the fracture occurred at the full 127 mm depth of the bit penetration. Some slight fracturing of

the coarse aggregate was also present at the break, again suggesting some deterioration at this depth.

For Sta.17-2R, shown in Figure 7(d), the PSPA measured a modulus of 22.06 GPa, indicating no deterioration. This specimen appeared to be in excellent shape overall, with no visible signs of delamination, discoloration, or other defects. The fracture, although located slightly deeper than the 127 mm coring depth, was reasonably clean and in the same plane as the reinforcing steel. No aggregate fracture was evident, further suggesting that the concrete was sound at this depth.

For Sta.17-12R, shown in Figure 7(e), the PSPA measured a modulus of 5.52 GPa, indicating severe deterioration. However, the time-frequency domain analysis provides a scalogram that is similar to that of a sound concrete core sample. This specimen appears to be very similar to the specimen extracted from Sta.9-16R. The specimen appeared to be in excellent shape overall, with no visible signs of delamination, discoloration, or other defects. The fracture was at the 127 mm coring depth and was reasonably clean, with no visible signs of aggregate fracture.

For Sta.17-18L, shown in Figure 7(f), the PSPA measured a modulus of 11.03 GPa, indicating moderate deterioration. A scalogram similar to that of Sta.1-2L was found from the analysis, which indicates severe deterioration. This specimen fractured into at least five separate pieces during the actual coring (not during extraction). The matching faces of each piece exhibited discoloration that indicated corrosion of the

reinforcing steel. Remnants of the core below approximately 100 mm were similar to the remnants of the core at Sta.1-2L; these remnants consisted of coarse aggregate and small pieces of mortar.
