Failure Analysis on 42CrMo Steel Bolt Fracture

The bolt is a fastening of the wind generator, with specification model of M30 × 435. The manufacturing process is described as follows: raw materials → fracturing materials → forging blanks → rough finish → heat treating → longitudinal mechanical property test → flaw detection → finish machining → finished products. When the bolt was installed and used, the customer found bolt fracture during routing inspection.

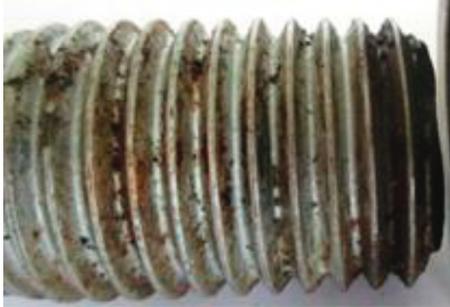
2.1. Macroscopic Observation of Fracture. The bolt fracture occurs at the position of 33 mm near the end of the bolt as shown in Figure 1. The bolt fracture is at the root of the thread. The morphology is as shown in Figure 2. Under macroscopic observation, obvious fatigue characteristics can be seen on the fracture. The fracture originates from the outer surface of the bolt. The fatigue origin area in the shape of semiellipse is relatively smooth. Clear fatigue lines can be

FIGURE 2: Morphology of bolt fracture position.

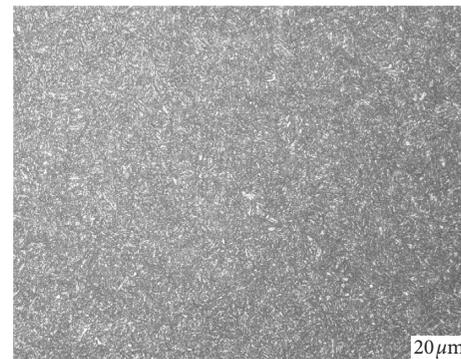
As shown in Table 2, no obvious abnormality is observed in the test results of nonmetallic inclusions, microstructure, and grain size of this bolt.

FIGURE 4: Metallographic structure of bolt matrix.

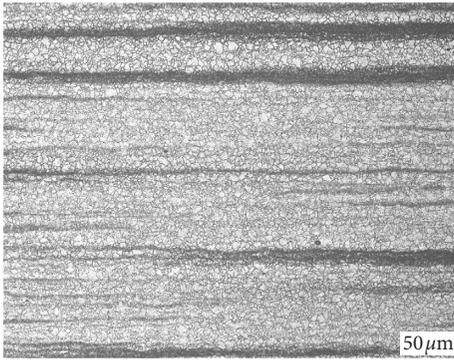
FIGURE 5: Grain size of bolt matrix.

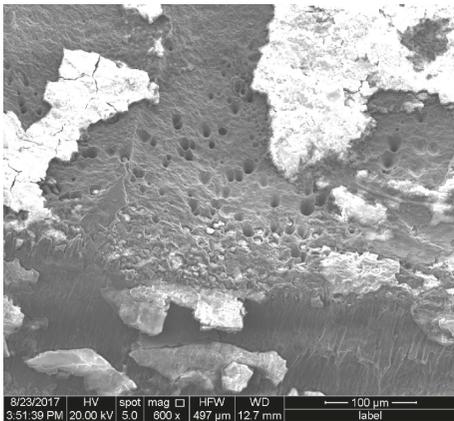
holes are observed in the fracture origin area (Figure 6). Less obvious fatigue striations are distributed in the extended area, with the morphology as shown in Figure 7. Under magnified observation, the fracture surface is relatively flat and a large number of secondary cracks are distributed on the fracture surface, with the morphology as shown in Figure 8. According to the semiquantitative analysis of energy spectrum performed on the gray products in the crack of metallographic specimen, the crack mainly contains elements including Os, Cr, Mn, and Fe. See Figure 9 for the energy spectrum.

FIGURE 6: Micromorphology of fracture origin area.

According to the above results of electron microscopy and energy spectrum, it is known that there are a large number of hole defects in the fracture source region, which is the direct cause of the fracture of the whole bolt. The fatigue fringe distributed in the extended region is one of the important microscopic bases for the fatigue fracture of the part, because fatigue streaks appear in the second stage of fatigue crack propagation, where the crack growth rate is faster, and each stress cycle is on the order of microns. The gray product of the crack mouth is the oxidation product, and the crack

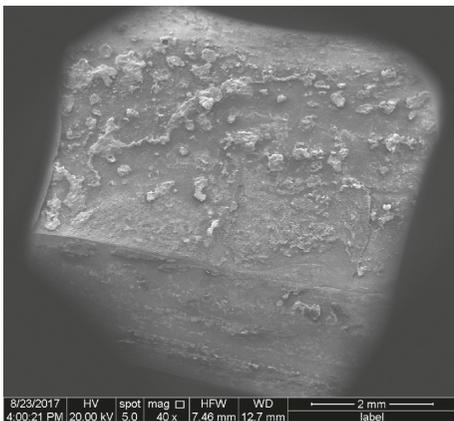
FIGURE 7: Micromorphology of fracture extended area.

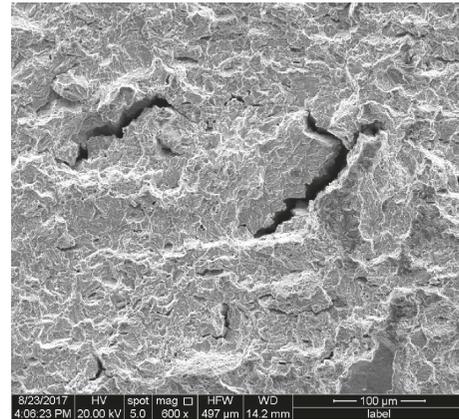
FIGURE 8: Macromorphology of secondary fracture crack.

tail is the manganese sulfide inclusion. The existence of these structures destroys the continuity of the surface of the material, causing the formation of cracks in the Hertz region of the subsurface, and especially the brittle oxide and the matrix are separated into voids. The stress concentration at the sharp corners of the cavity edges exceeds the elastic limit of the matrix, and the plastic deformation is large, causing the surface of the material to harden, thereby causing cracks.

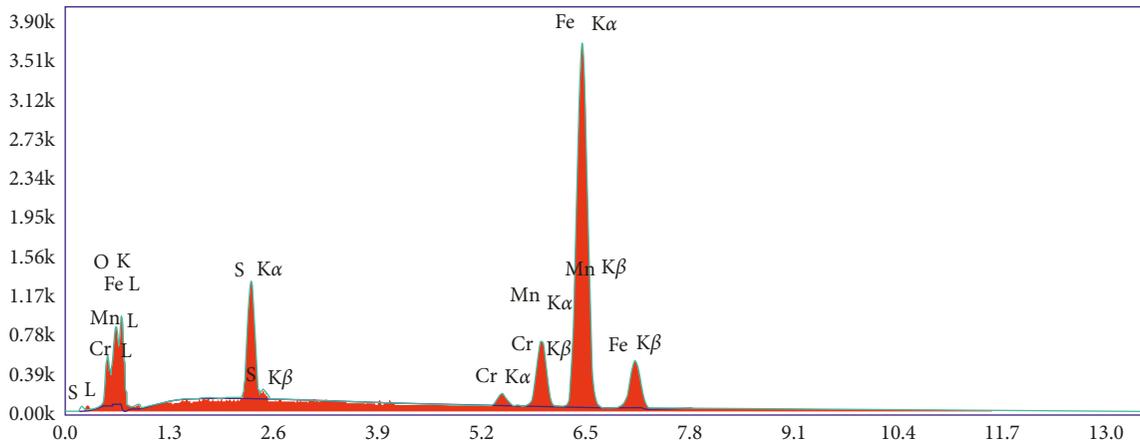
FIGURE 9: Energy spectrum.

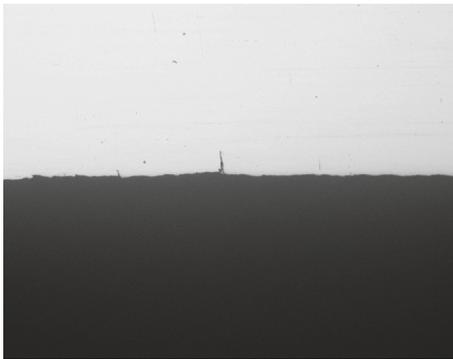
2.5. Microscopic Observation of Fracture Origin. Cut the bolt at the fracture origin area longitudinally and grind it. Under the metalloscope, many small cracks extending from the fracture to the matrix can be observed. The deepest crack depth measures 0.10 mm, with the morphology shown in Figure 10. Under magnified observation, the cracks are filled with gray products (Figure 11). Concentratedly distributed manganese sulfide inclusions are found near the fracture origin (Figure 12). Many manganese sulfide inclusions are also observed in the matrix.

It can be seen from the above microscopic results that the deepest crack depth in the fracture source region is 0.10 mm, and the crack initiation phase is 0.05–0.08 mm in the engineering. It is known that the deepest crack in the fracture source region has crossed the crack initiation stage to reach the crack. During the expansion phase, the presence of cracks causes stress and strain concentration on the surface of the bolt, forming a fatigue source at the crack and accelerating the initiation and propagation of fatigue cracks. There is carbon depletion at the source of the fracture, the

FIGURE 10: Micromorphology of small cracks.

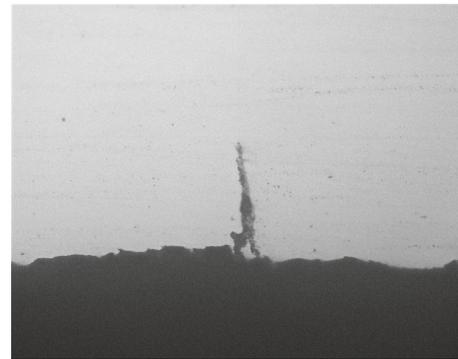
FIGURE 11: Magnified micromorphology of small distributed cracks in fracture origin area.

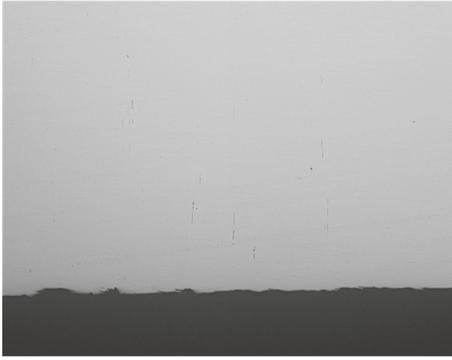
FIGURE 12: Micromorphology of nonmetallic.

with severe defects and stress concentrations. Therefore, in use, the bolt forms a stress concentration point at the hole and the inclusion defect in the fracture source region and then becomes a crack source. In the subsequent use, the crack further extends and expands and finally causes the bolt to be unstable and fractured.

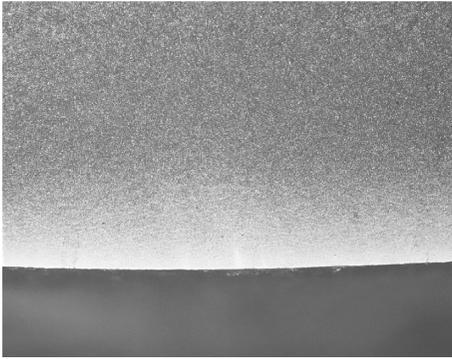
Upon corrosion of the sample in 4% nitric acid alcohol solution, carbon depletion is observed at the fracture origin. The deepest depth of the carbon-depleted layer is 0.40 mm, with the morphology shown in Figure 13. At the fracture origin, bands are distributed in the same direction as the crack propagation, and some microcracks extend along the banded structure, with the morphology as shown in Figure 14. Bands are also distributed in the matrix. According to GB/T13299-1991, the banded structure is rated as 3C2.5, with the morphology as shown in Figure 15. Carbon depletion is observed at addendum and both tooth sides of the bolt, with the morphology as shown in Figure 16.

FIGURE 13: Micromorphology of carbon inclusions near the fracture surface depletion near the fracture origin.

There is carbon depletion at the source of bolt breakage, the root of the tooth, and both sides of the tooth. Although the carbon-poor layer is very shallow, only 0.40 mm, even negligible for large-size shafts, in practice the thin-layer decarburization of the surface is a fatal defect. Decarburization is a fatal flaw, and decarburization of 0.1 mm will significantly reduce the fatigue limit. In addition, the presence of the decarburization layer reduces the fatigue strength of the surface of the part. Under the action of alternating stress in the long-term use, the surface has fatigue cracks, and the existence of fatigue cracks causes stress concentration in the source region, also in actual use. If subjected to a large impact force, the crack will develop rapidly, causing the bolt to break.

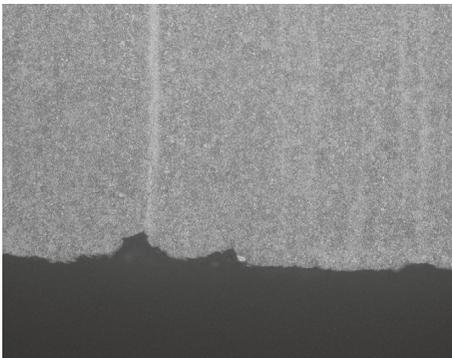
FIGURE 14: Micromorphology of the band.

The banded structure of the bolt is obvious, and the grow direction of the banded structure is consistent with the direction of crack propagation. The banded structure includes a primary banded structure and a secondary banded structure. The primary band structure is the original band shape, which is caused by the dendrite segregation generated when the steel ingot is cast; the secondary band structure is formed on the basis of the primary strip shape, which is generated along the rolling direction of the steel after rolling or heat treatment. The eutectoid ferrite band and the pearlite band are stacked on each other in a band structure. The secondary band structure can be alleviated or eliminated by a reasonable heat treatment process, and the primary band structure is difficult to be eliminated by common heat treatment. However, it is difficult to eliminate the primary banded structure by common heat treatment, which needs to be avoided or improved by electroslag remelting, liquid steel crystallization speed increasing, final rolling (forging) temperature increasing, forging ratio increasing or diffusion annealing, and other technologies. The presence of banded structure causes two structural stress differences and material anisotropy, providing a convenient channel for crack propagation.

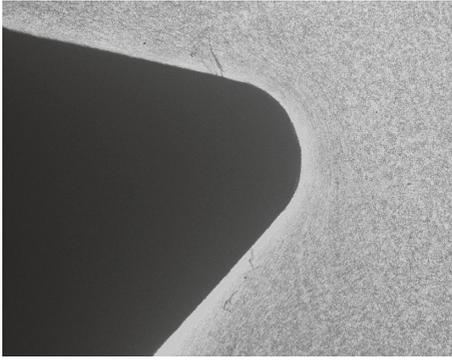
FIGURE 16: Micromorphology of carbon depletion at addendum and both tooth sides of the bolt.
