# FAILURE MECHANISMS THAT CAUSE HIGH ELECTRICAL LEAKAGE IN MULTILAYER CERAMIC CAPACITORS

HIROFUMI IKEO, SANPEI SAKAMOTO, KEN SATO<sup>†</sup>, HISAKAZU NISHIURA<sup>†</sup>, and KATSUHIRO OHNO<sup>‡</sup>

*Kita-Itami Works, Mitsubishi Electric Corporation, Itami, Japan 664*

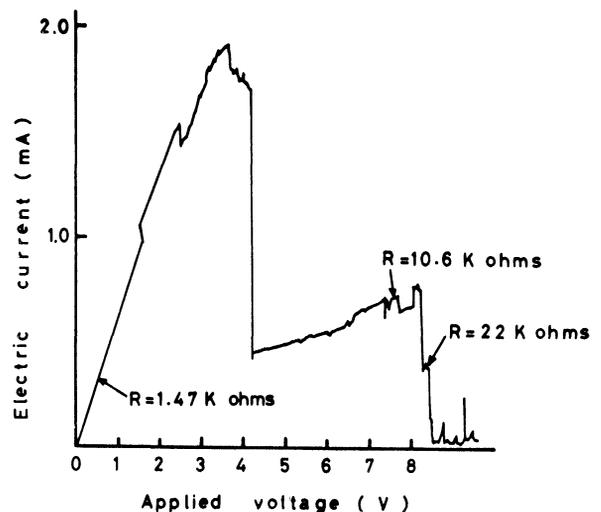
1) Voltage-current characteristic at low voltages was ohmic as shown in Figure 1.

FIGURE 1 Voltage-current characteristic of failed capacitor.

2) Most of the leaky capacitors recovered as the voltage was increased beyond several volts (they change discontinuously, with irreversible change, to the higher resistance level) as shown in Figure 1.

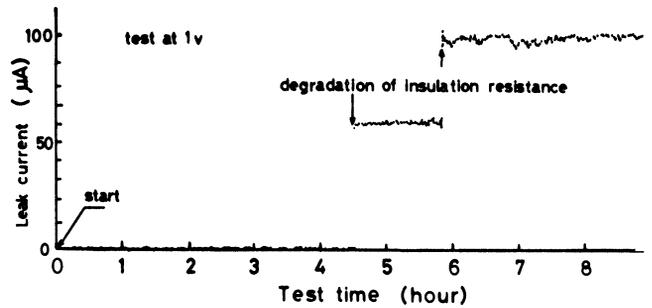
Every capacitor was subjected to dc voltage stresses from 0.25 V to 10 V in an atmosphere of 85% RH and at  $+85^{\circ}\text{C}$  in a thermo-hygrostat. Under voltage stresses, some of the capacitors failed at less than  $10^4$  ohms for applied voltage between 0.5 V and 3 V as shown in Figures 3 and 4. Acceptable capacitors after boiling did not fail at any voltage. The electrical properties of failed capacitors in this reappearance test were the same as those of the failed capacitors in the reliability test. This reappearance test method was evolved by taking account of the electrical properties and the environment of the failed capacitor.

FIGURE 3 Abrupt degradation of insulation resistance at 1 V, at  $+85^{\circ}\text{C}$  and in 85% RH.

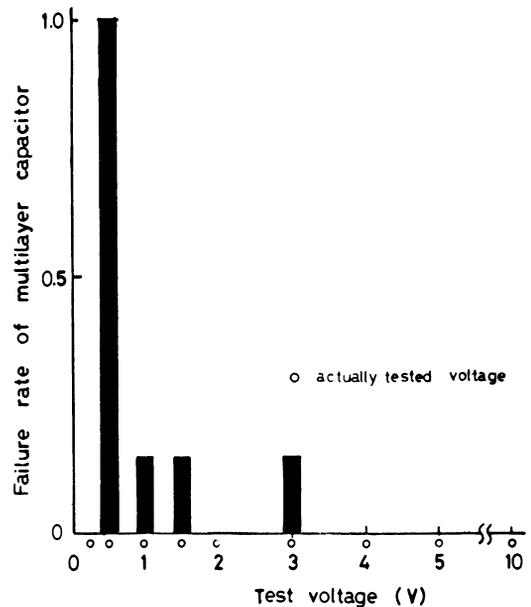
FIGURE 4 Failure rate at dc voltage stresses from 0.25 V to 10 V under high temperature and humidity

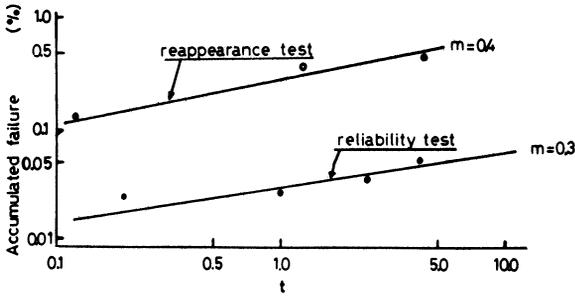
Weibull distributions were plotted for the failed capacitors in two cases. The first was for the failures in the reappearance test, and the second was for the failures in the device reliability test. From Figure 5, the shape parameter  $m$  of the Weibull distribution can be seen to be 0.3 to 0.4 in both cases. It is therefore possible to detect failed capacitors because every failed capacitor belongs to a decreasing failure rate group.

FIGURE 5 Weibull distribution analysis of failed capacitors.

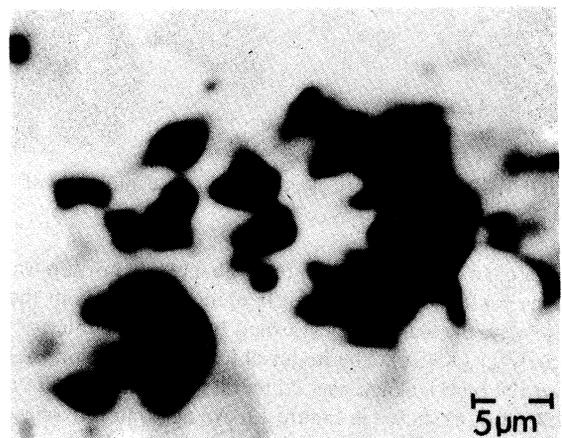
Third step: When the electron beam of a Scanning-Electron Microscope (SEM) is allowed to impinge on the insulator, a charging phenomenon occurs. However the charging phenomenon does not occur if the dielectric exhibits high leakage (see Figure 8). It is thus possible to determine the exact position of the high leakage portion of the dielectric exposed in step 2.

FIGURE 8 Charging image by SEM (insulation resistance of sample is 80 ohms).

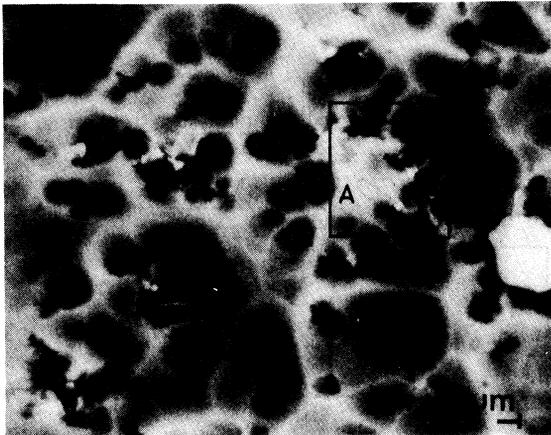
After charging, the ordinary secondary electron image of the SEM was used to study the structure of the high leakage portions as shown in Figures 9 and 10. The

FIGURE 9 Secondary electron image of Figure 8.

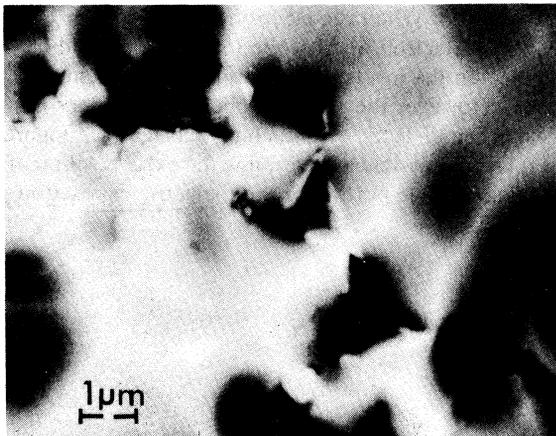
FIGURE 10 Secondary electron image (magnification of portion A in Figure 9).

existence of small voids in the high leakage portion was thus confirmed. Subsequently element analysis in the vicinity of voids was performed by an X-ray micro analyzer (XMA). The material found to be responsible for the high leakage was Pd metal together with  $\text{Cl}^-$  in the voids as shown in Figure 11. An agglomerate phase containing Ca was also found near the voids. After bombarding the high leakage portion with  $\text{Ar}^+$  ions step by step, it was also confirmed by SEM-XMA that

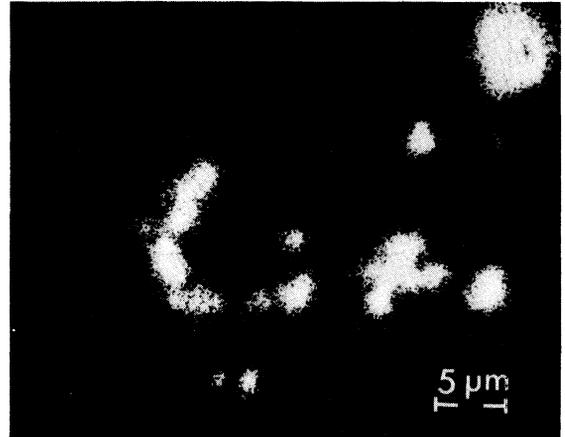
FIGURE 11 Characteristic Pd  $L\alpha$  X-ray image.

the leakage path branched and penetrated more than one dielectric layer. The concentration of  $\text{Cl}^-$  ions together with Pd metal was found to be about 0.1 wt%. A failed capacitor having relatively high insulation resistance contained smaller quantities of Pd than failed capacitors having low insulation resistance.

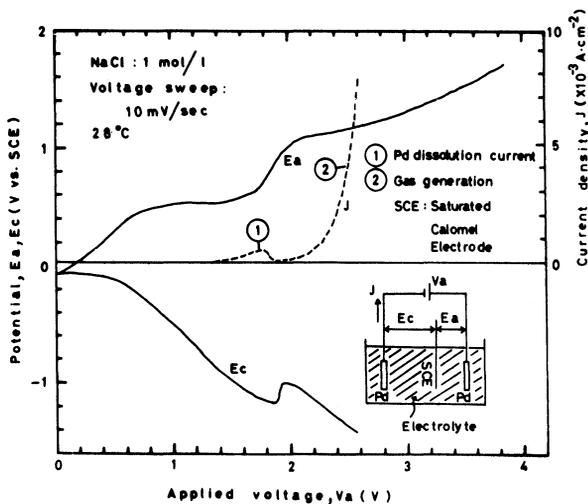
In order to study Pd migration, the dissolution of palladium was measured as a function of electrochemical electrode potential in water and in aqueous solutions of Na<sub>2</sub>SO<sub>4</sub>, NaNO<sub>3</sub>, and NaCl. The relationships between the applied voltage  $V_a$ , the current density  $J$ , the anode potential  $E_a$  and the cathode potential  $E_c$ , are shown in Figure 12 for the case of aqueous NaCl solution. To measure the minimum dissolution voltage for Pd, the current (1) in Figure 12 is shown in Figure 13 on an enlarged scale. The beginning of the current increase appears around 0.3 V. This anode potential is equivalent to the applied voltage of about 0.5 V given in Figure 12.

As an attempt to observe Pd dissolution directly, two sheets of filter paper containing 1N NaCl solution were sandwiched between Pd metal plates, and a low dc voltage was applied to the Pd plates. As expected, one could observe directly the Pd migration from the colour change (black) on the paper at the cathode. Pd migration was observed at 1.5 V, but applied voltages above 3 V no longer gave Pd dissolution. Pd migration in the region of 0.5 V to 3 V coincided with the voltage region in which capacitors failed.

FIGURE 12 Electrochemical reaction test in an aqueous NaCl solution.

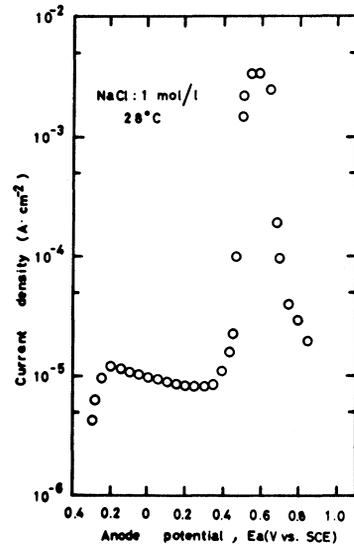
FIGURE 13 Enlargement of current (1) in Figure 12.

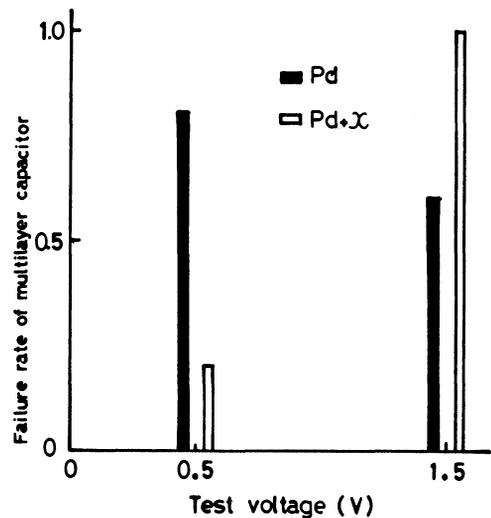
FIGURE 14 Dependence on test voltage of failure rate (for two cases: Pd inner electrode, Pd + x inner electrode).

groups: those associated with capacitors having electrodes of pure Pd metal and those associated with capacitors having electrodes in which the Pd is contaminated by a small amount of another unknown metal represented by  $x$  in Figure 14.

The fact that the failure rate of the Pd electrodes contaminated with small amounts of another metal is much higher at 1.5 V than 0.5 V is interpreted as showing that the voltage migration depends on the electrode material. Furthermore measurements of the time taken to arrive at failure gave figures of between one minute to 45 minutes for capacitors boiled in NaCl solution and 10 minutes to 10 hours for those boiled in water.
