Case Report

Fracture of the Tibial Baseplate 16 Years after Miller-Galante II Total Knee Arthroplasty

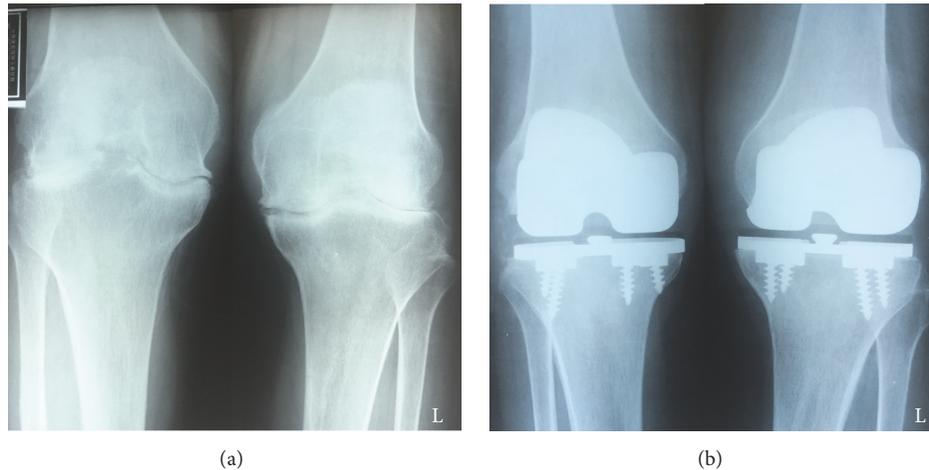
Our patient was a 60-year-old woman who had undergone bilateral MG II (Zimmer) total knee arthroplasty for rheumatoid arthritis of the knee (Larsen grade IV) in our department 16 years earlier (Figure 1). She had no other relevant medical history. Body weight was 45.8 kg, height 158 cm, and body mass index 18.3 kg/m². Weight and height were approximately the same as when the primary surgery

FIGURE 1: Plain radiographs of the bilateral knee of the patient with rheumatoid arthritis before and after Miller-Galante II Total Knee Arthroplasty performed 16 years earlier. (a) Preoperative plain radiograph shows bilateral rheumatoid arthritis of the knee categorized as Larsen grade 4. (b) Postoperative plain radiograph shows a femorotibial angle (FTA) of 174° on the right side and 183° on the left side. The left side shows varus malalignment.

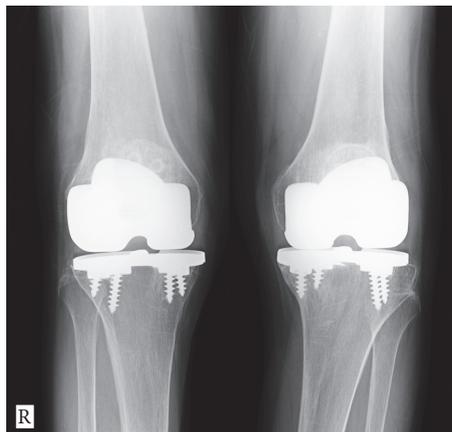
FIGURE 2: Follow-up plain radiograph obtained 15 years after surgery shows no change in the alignment of the right side and obvious deterioration of the varus malalignment (FTA of 190°) of the left side.

A follow-up plain radiograph taken 15 years after arthroplasty revealed a deterioration of the varus malalignment of the tibia (Figure 2). However, the patient had no complaints about the left knee at this point, and we considered the problem was related to polyethylene wear. However, 16 years after arthroplasty, she presented to our department with a 3-month history of severe pain in the left knee. Clinically, she walked with a limp and a varus thrust. Examination of the left knee indicated joint effusion and tenderness along the medial joint line with localized warmth. There was a well-healed anterior skin incision over the left knee with no evidence of skin infection. Active and passive motions of the knee caused

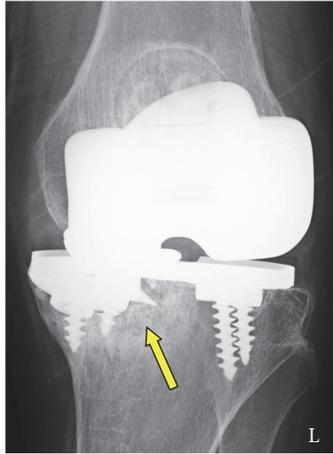
pain in the medial part of the knee. Plain radiographs taken at this time showed further distortion of the tibial component of the left knee with obvious fracture of the tibial baseplate and osteolysis under the broken component (Figure 3). She had not consulted us about the problem immediately because she had been undergoing conservative treatment for Graves' disease for 3 months. At the time of presentation, rheumatoid arthritis and Graves' disease were well controlled and all other laboratory values were in the normal range.

FIGURE 3: Follow-up plain radiograph obtained 16 years after the surgery shows disappearance of the medial joint space, subsidence of the broken baseplate, and osteolysis under the medial compartment (arrow).

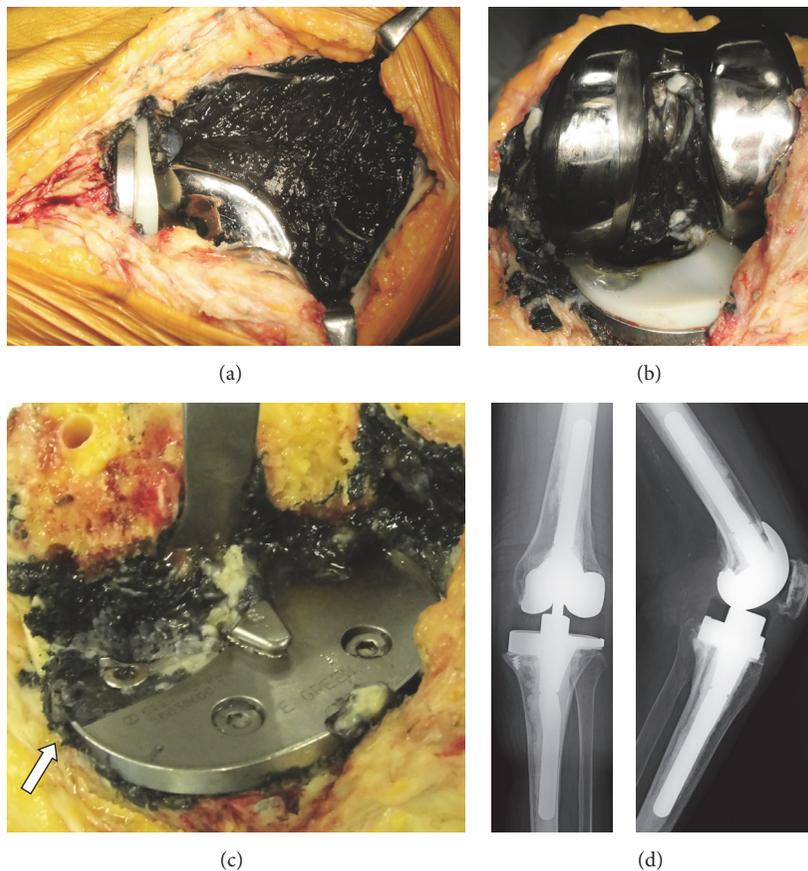
The patient underwent revision knee arthroplasty on the left side via the previous skin incision. Perioperatively, we observed severe metallosis within the knee joint (Figure 4(a)). The polyethylene insert was obviously worn and broken at the posteromedial site (Figure 4(b)). After the broken polyethylene insert was removed, a coronal fracture was found at the posteromedial portion of the tibial component and there was subsidence of the posterior metal tray fragment (Figure 4(c)). When the four screws were removed, we noted

FIGURE 4: Gross appearance at revision surgery. (a) Severe metallosis is observed within the knee joint. (b) Polyethylene insert is heavily worn and broken at the posteromedial portion. (c) Coronal baseplate is fractured from the posteromedial corner to the posterior cruciate ligament recess (arrow). Subsidence of the posterior broken fragment of the baseplate is apparent.

a cutting fracture of the screw inserted in the screw hole of the fractured tray. The remaining part of the screw could not be observed and we decided not to remove the remaining small screw fragment because it was embedded in bone and was unlikely to cause clinical complications. On extraction

of the broken tibial metal tray, the medial aspect of the tibia showed cavitation of the cancellous bone under the medial weight-bearing surface. All metal and debris were removed and the revision prosthesis (LCCK, Zimmer-Biomet) was implanted. Medial augmentation was required to correct the

bony deficiency (Figure 4(d)). There were no postoperative complications, and the patient was ambulating with full weight-bearing on postoperative day 2. Significant pain relief and functional improvement was achieved based on early follow-up examinations (4 months). Remarkably, the MG II prosthesis on the right side was properly aligned, surviving for 17 years after primary surgery (Figure 5).

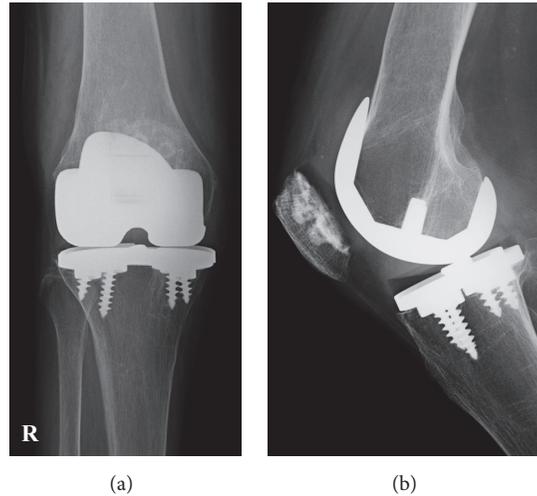
FIGURE 5: Follow-up plain radiograph obtained 17 years after initial surgery of the right-side implants shows normal alignment is maintained, with no evidence of stress shielding or loosening.

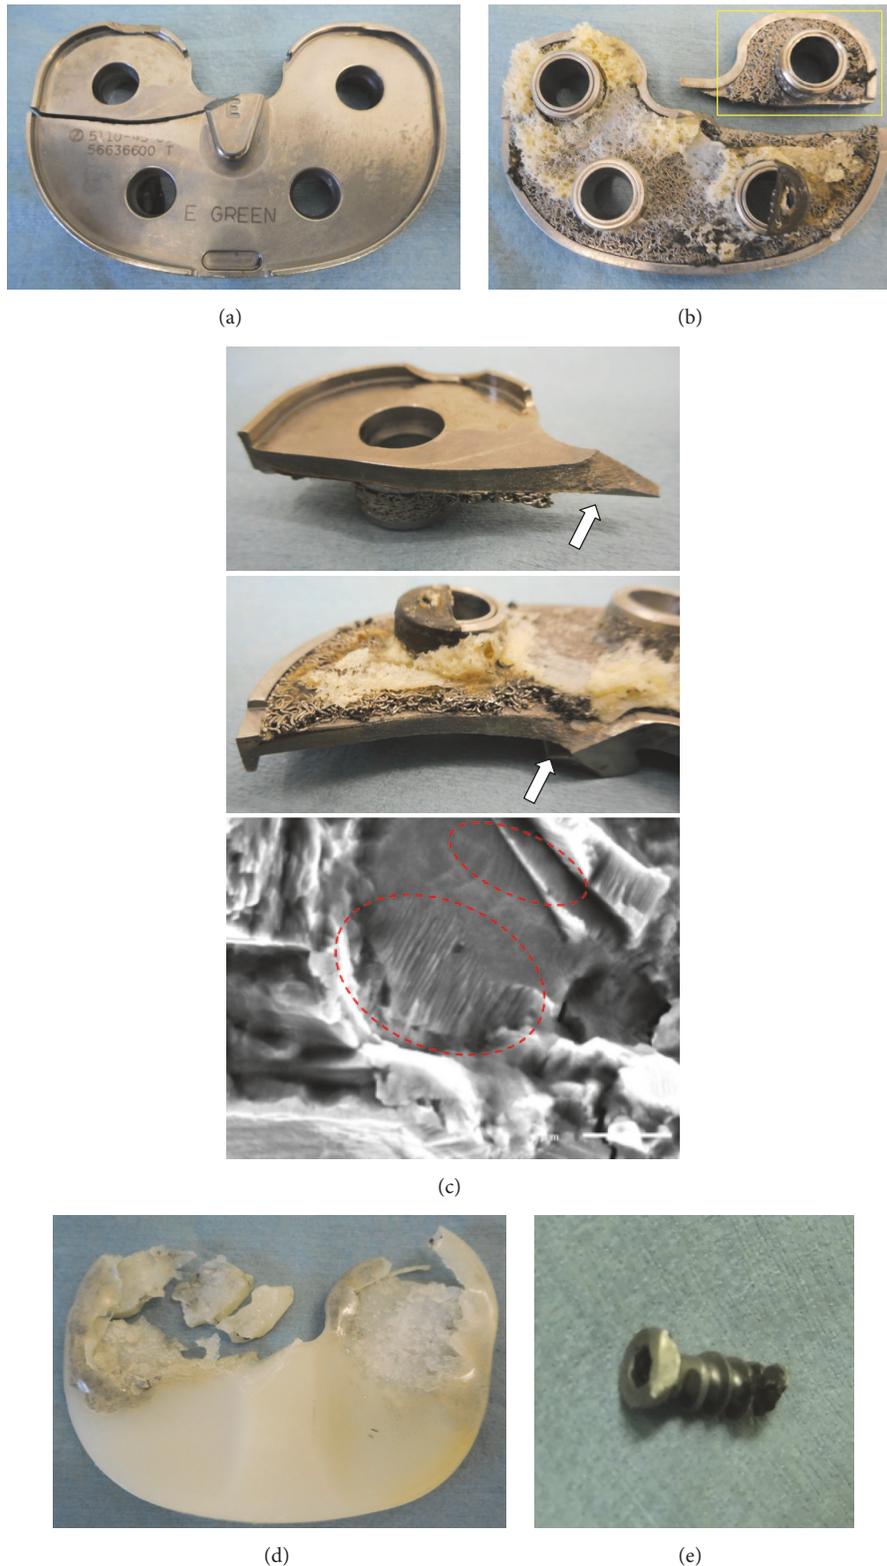
Gross observation of the retrieved broken tibial baseplate revealed that the fracture line extended in a coronal direction from the medial corner to the posterior cruciate ligament (PCL) recess (Figure 6(a)). There was no evidence of bone ingrowth at the undersurface of the posterior fragment of the tibial tray, although bone ingrowth was noted under the tray anterior to the fracture line (Figure 6(b)). The broken surface was complex, instead of showing regular fracture waves. A focal stair-step pattern could be observed on gross examination at the medial corner of the PCL recess, and scanning electron micrography showed fatigue striations at this point (Figure 6(c)). This observation supported the possible development of a fracture line that had started at the medial corner of the PCL recess [6]. The retrieved polyethylene insert revealed that the heavily worn medial site corresponded to the posteromedial breakage area of the tibial baseplate (Figure 6(d)). The retrieved portion of the fractured screw demonstrated the severe load that had been exerted on the posterior fractured baseplate (Figure 6(e)).

FIGURE 6: (a) Gross observation of the retrieved broken tibial baseplate reveals that the fracture line extended in a coronal direction from the medial corner to the posterior cruciate ligament (PCL) recess. (b) Gross observation of the undersurface of the tibial baseplate shows uneven bone attachment surrounding the medial fracture line but even bone attachment at the posterolateral portion. (c) Surface of the break is complex rather than with regular fracture waves. A focal stair-step pattern can be observed grossly at the medial corner of the PCL recess (arrow), indicating a fatigue fracture. Scanning electron micrography shows fatigue striations (circle). (d) Retrieved polyethylene insert has severely worn medial sites that correspond to the posteromedial breakage area of the tibial baseplate. Polyethylene insert is also severely worn at the posterolateral area. (e) Retrieved portion of the fractured screw.

Gross observation of the knee during revision surgery and of the retrieved implants indicated another factor predisposing to the posteromedial coronal-type fracture observed in our case. On the undersurface of tibial baseplate, the fracture line passed through a region of uneven bone attachment. After removal of the fracture tray, we noted bone loss due to osteolysis, consistent with the radiographic appearance. In our case, the tibial baseplate was fixed inadequately due to osteolysis, resulting in cyclic cantilever bending that concentrated stresses at the junction of the supported and unsupported regions. This is a typical failure mechanism reported for tibial tray fractures [5, 15, 18, 19, 21, 22]. Cankaya et al. [18] reported polyethylene wear and osteolysis leading to tibial component fracture. We speculate that the malalignment of implants causes polyethylene wear and osteolysis, resulting in a bone deficit predisposing to this tibial component fracture. A review of 74 cases demonstrated 100% correlation between the site of the fractured tibial baseplate and the region of bone loss [5]. Gross observation of the surface of the fractured baseplate revealed a focal stair-step pattern at the medial corner of the PCL recess, indicating a fatigue fracture; this site was therefore considered to be the starting point of the fracture [15].
