## Case Report

# Fracture of a Femoral Revision Stem following a Technical Failure

*Department of Orthopaedic Surgery, RS Emmental AG, Burgdorf, Switzerland*

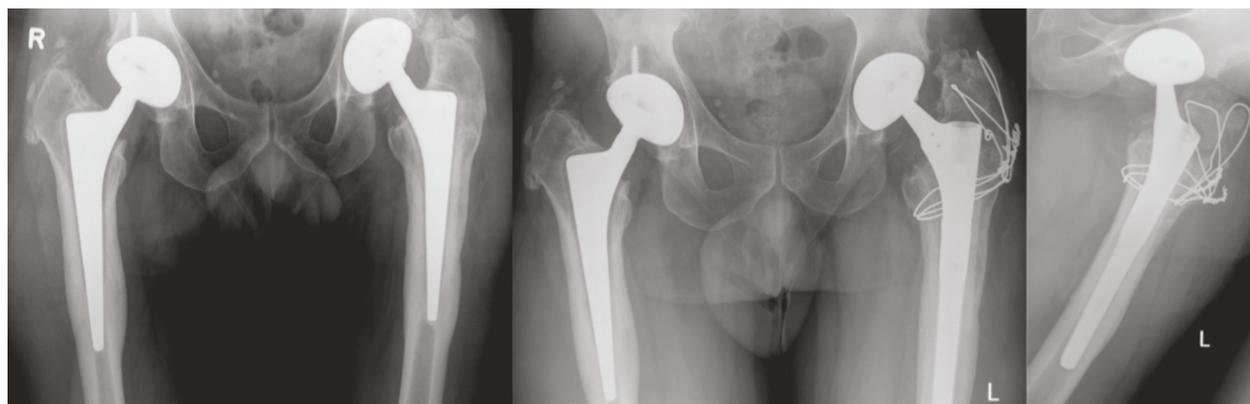
In March 2008, a primary total hip replacement was revised for loosening of the femoral stem in a 48-year-old carpenter (Figure 1). The old lateral incision with an

FIGURE 1: Radiograph a.p. view with loosening of the left femoral stem, radiograph a.p. and axial view of first revision.

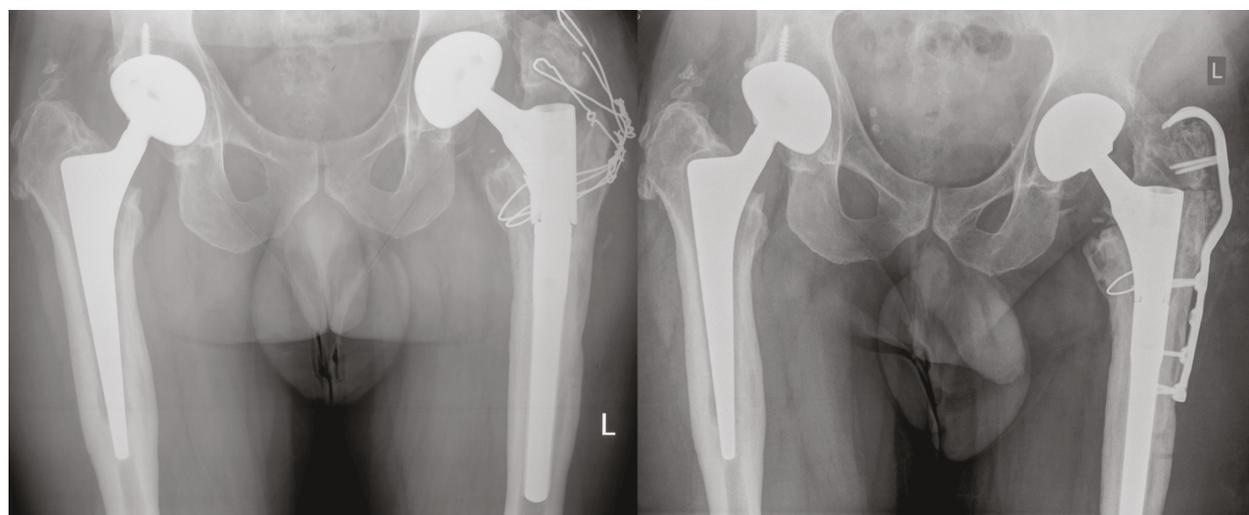
Two and a half years postoperatively, the patient felt a sudden pain while walking. He could only limp and hardly walk. He walked on without consulting a doctor for another 2 months, where after he presented to us. On the radiographs, a fracture in between the 2 modular parts of the stem was seen (Figure 2).

FIGURE 2: Radiograph a.p. view with broken stem and radiograph a.p. view of the second revision.

broken on the medial side. The distal part was well fixed, and there seemed to be no need to change this part. Even the threaded part of the distal stem was intact. However, connection of a new proximal part to the distal part failed, as during the first revision. On further inspection, a small ring was suddenly born from the distal part. It was then discovered to be a part of the proximal trial part (Figure 3). Thereafter, connecting the two parts was easy. The nonunion of the trochanter was debrided and fixed with a hooked plate (proximal conical spout Revitan 75 mm, Biolox Delta Ceramic femoral head 28 mm medium, Trofix Trochanter Fixation plate large head 150 mm) (Figure 2).

In our patient, the fracture did not occur in between the two parts. There was a fracture of the proximal part of the stem following disassociation of the two parts that were never fixed together well. We were lucky to be able to use the distal part of the stem again, as it was still well fixed to the bone. It

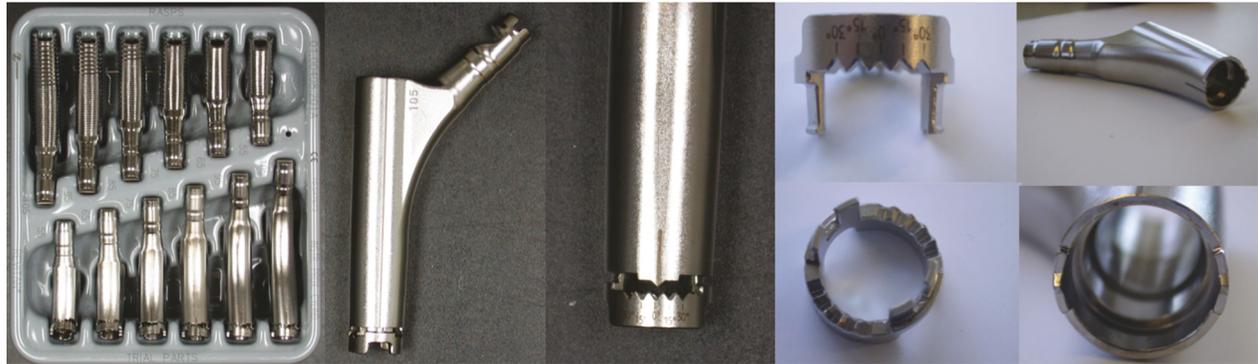
modular shaft, which provides the surgeon many options for restoring leg length, hip offset, and femoral anteversion and therefore good stability [5]. In general, and also with this stem, it is thought that the advantages of the modularity of the stem outweigh its susceptibility to corrosion, fretting, and fatigue fracture [1–4]. Several reports have been published about fractures of a modular femoral stem. Nearly always, the fracture is seen in the middle of the two parts of the stem [1, 2]. Although failure may be due to the morphological construction of the stem, noningrowth of the proximal part of the femur to the proximal part of the stem is thought to be responsible for failure [4]. This is the first report of a fracture of the proximal part of the uncemented Zimmer Revitan revision stem caused by unrecognized loosening of the distal ring of the proximal trial part, which results in a stem fracture and disassociation (Figure 3).

FIGURE 3: Description of the manufacturer's operation manual [5]; small ring, part of the proximal part of the trail stem.

seems to us that this complication is due to the design of the trial prosthesis, although of course the surgeon is always responsible for proper handling of the instruments and trial implants. However, we call into question the necessity this ring on the proximal part, this particular trial part. One should always be sure that this ring is removed before assembling the complete prosthesis in vivo.
