Case Report

Fracture of the Femoral Component Caused by Insufficient Crimping after Modern Unicompartmental Knee Arthroplasty

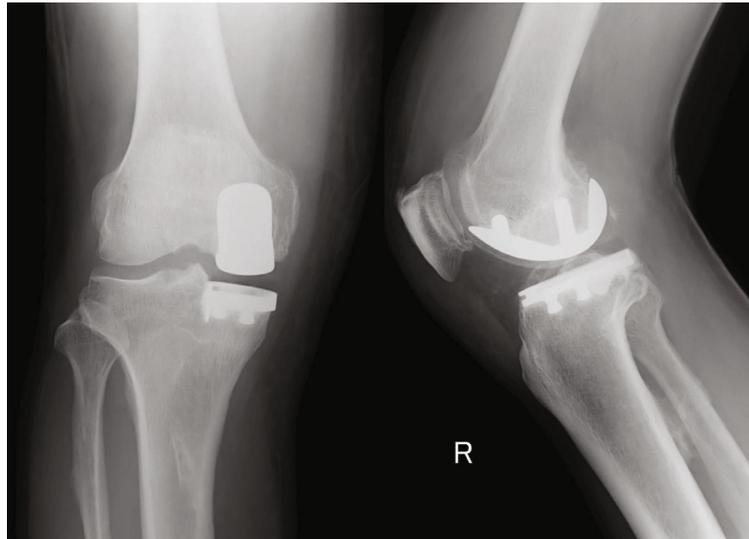
FIGURE 1: Immediate postoperative radiography demonstrating good implant position and alignment.

during the perioperative period. The postoperative knee range of motion was 0° – 140° , and no knee instabilities were noted. No abnormalities and problems with the positioning of the component were noted on the postoperative radiograph (Figure 1).

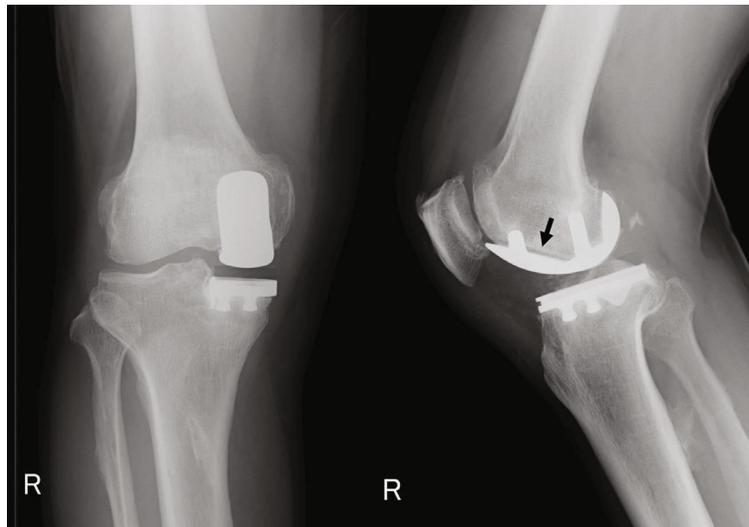
FIGURE 2: Plain radiography demonstrating a radiolucent line around the femoral component at the 1-year follow-up.

At the 1-year postoperative follow-up, the patient reported occasional right knee pain. Radiography revealed a radiolucent line around the femoral component (Figure 2). However, he was followed up by observation alone because he only had occasional mild right knee pain that was relieved by medication.

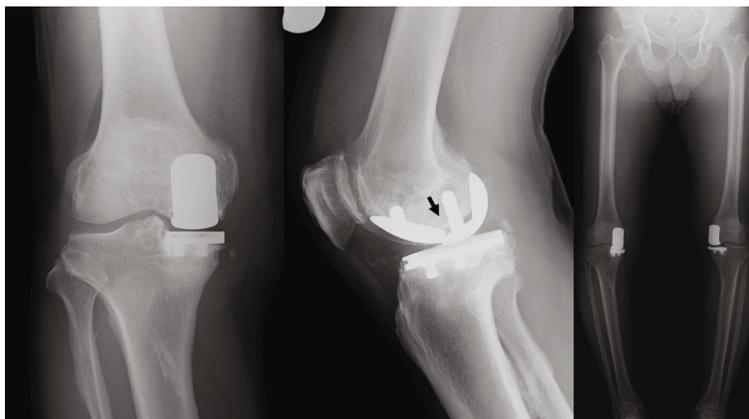
At the 8-year postoperative follow-up, he complained of increasing right knee pain, and radiography revealed fracture of a metallic femoral component, loosening of the femoral component, and marked narrowing of the medial joint space (Figure 3). There were no trauma events postoperatively. On careful analysis of past radiographs, a small crack sign was found in the femoral component, which had been missed at

FIGURE 3: Radiography demonstrating fracture and loosening of the femoral component at the 8-year follow-up. Marked narrowing of the medial joint space is also seen.

In the present case, the fracture site was the boundary between the distal and oblique posterior surfaces of the femoral component, which is the thinnest part of the femoral component. In addition, the metallic fracture site was, to some extent, distant from a peg. This is in contrast to a finding by Manzotti et al. [9] in which fracture of the femoral component occurred adjacent to the peg in old generation UKA implants, such as UC-plus, St George Sled, or Allegretto prosthesis. These authors, along with some other researchers [10, 14], have suggested that older UKA femoral implant designs have a higher risk of breakage and that this risk has reduced with newer UKA designs that incorporate a thicker

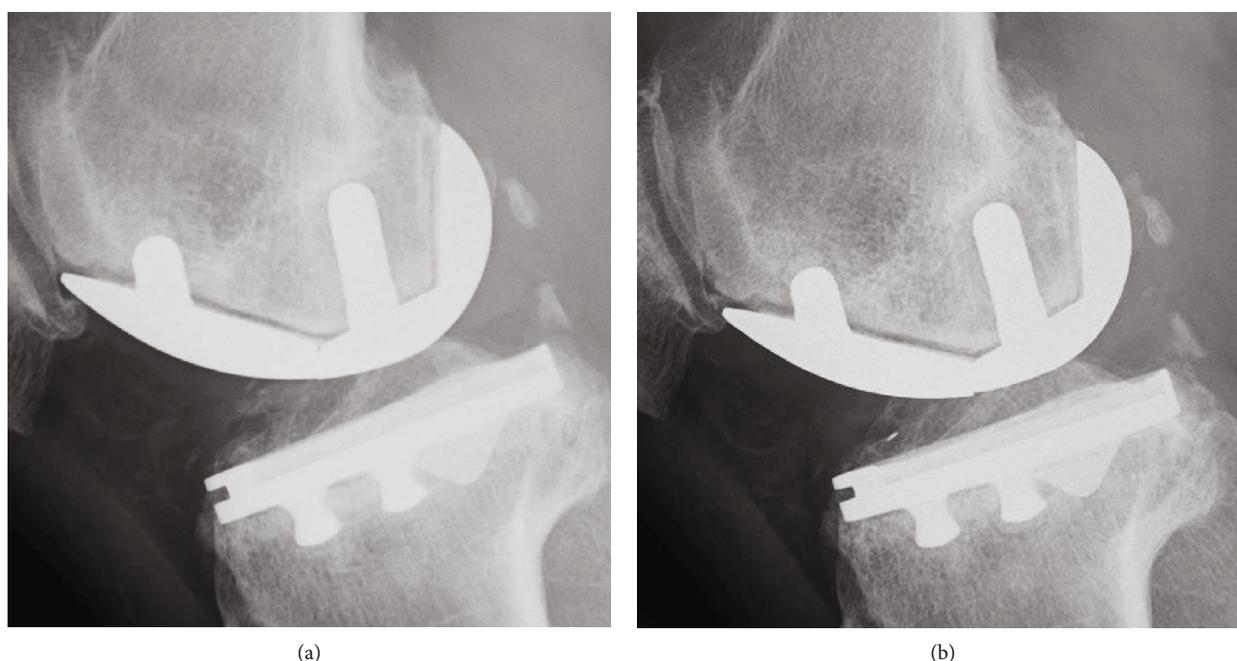
FIGURE 4: A small crack sign is found in the femoral component, which had been missed at the (a) 6- and (b) 7-year postoperative follow-up.

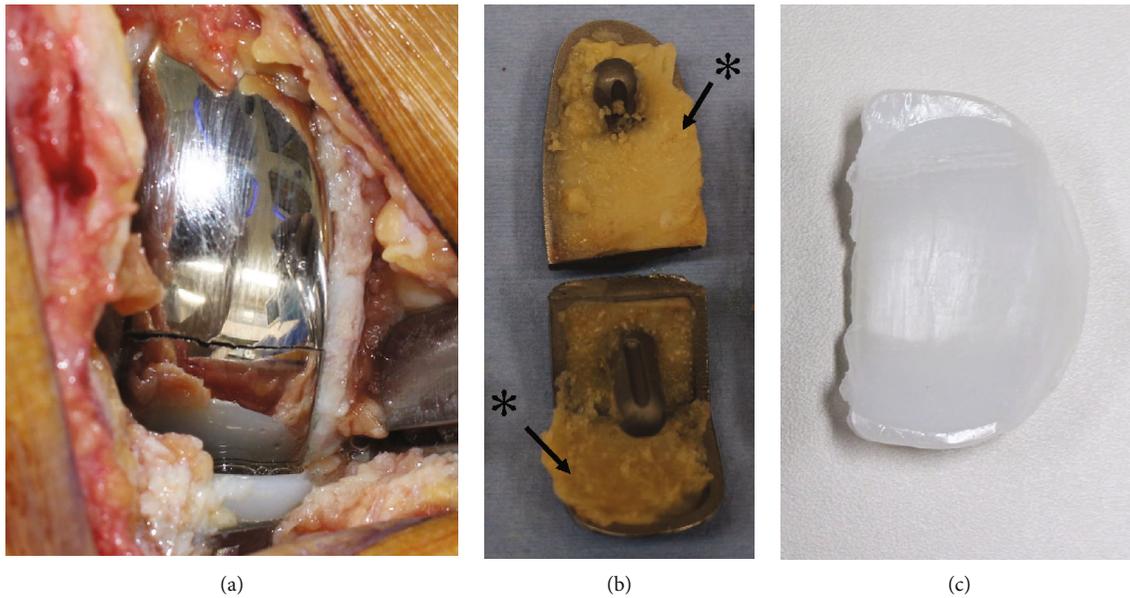
Intraoperatively, a fracture and loosening of the femoral component were observed (Figures 5(a) and 5(b)). There was marked wear of the middle part of the polyethylene insert (Figure 5(c)). However, the tibial component was well-fixed. Clear joint fluid and mild synovitis were detected. There was no sign indicating infection during the surgery, and all culture examinations were negative. The posterior and anterior cruciate ligaments were stable, and there was sufficient bone stock after the removal of the UKA implants.

FIGURE 5: (a) Fracture of the femoral component is noted intraoperatively. (b) Thick cement mantle observed at both lateral sides of the distal surface and at the medial side of the posterior surface (*). (c) Marked wear of the middle part of the polyethylene insert.

prosthesis and/or reinforcement at the fixation pegs. The model used in the present case was a modern UKA implant with a better implant design and improved implant material compared to those of older UKA prostheses; however, it is likely that a fatigue fracture can occur at the weakest part of the femoral component in case of implant loosening. In our case, the removed femoral component revealed a thick cement mantle at the lateral part of the distal surface and the medial part of the posterior surface (Figure 5(b)), indicating that insufficient contact between the femoral component and the cutting bone surface at the initial surgery led to early loosening of the implant. Furthermore, this patient continued with his daily heavy farm work, including carrying 30 kg rice bales. This consequent repetitive overloading on the unstable loosened femoral component might have caused a fatigue metallic fracture. To our knowledge, this is the first case report suggesting that insufficient crimping of the femoral component with cement can cause fracture of a femoral component after modern fixed-bearing UKA.

The present report indicates that implant loosening due to insufficient crimping of the femoral component using cement and excessive loading can cause fracture of a femoral component even with a modern implant with a better design. Thus, a careful procedure is necessary at the time of implantation with cement.

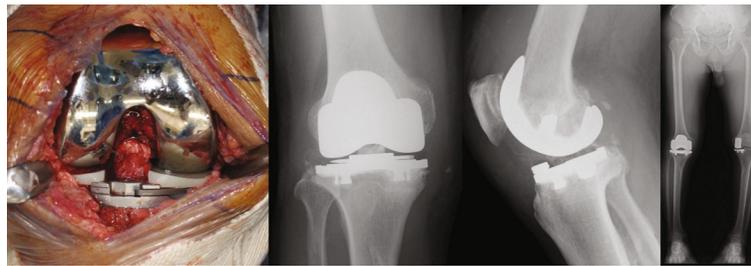
FIGURE 6: Revision surgery using cemented bicruciate-retaining total knee arthroplasty.

Therefore, we performed revision surgery using cemented BCR-TKA (Vanguard XP Total Knee System; Zimmer Biomet, Warsaw, IN, USA) based on the desire to preserve intact cruciate ligaments (Figure 6). No complications were noted after the revision surgery. At the 1-year follow-up after the revision surgery, the patient reported no pain and could walk 10km and return to farm work. His right knee range of motion was 0° – 130° .
