# Multidisciplinary Approach to a Recovery Plan of Historical Buildings

**Luciana Orlando**

*Dipartimento di Ingegneria Civile, Edile e Ambientale, Sapienza Università di Roma, Via Eudossiana 18, 00184 Roma, Italy*

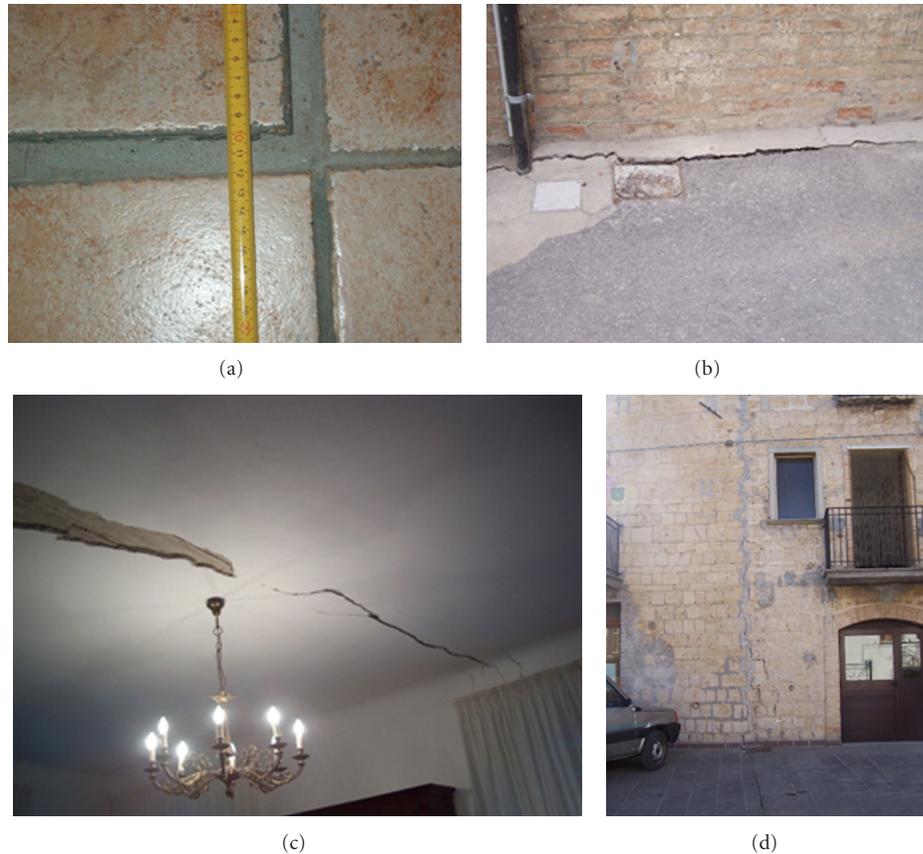
FIGURE 2: Photo images of cracks in the floor (a), road (b), ceiling (c), and building walls (d).

Pattern A (Figure 5(a)) runs parallel to the road, and the cracks are located both inside the buildings and on the road. The main cracks have caused the detachment of the footpath from the buildings (Figure 2(b)). Pattern B (Figure 5(a)) is perpendicular to the A and C patterns and crosses roads and buildings (Figure 2(d)). Pattern C runs almost parallel to A and is nearly perpendicular to B. This pattern was the most difficult to characterise as some of the buildings exhibit heavy damage while the roads are little affected. A careful analysis of the crack locations, and the setting of the area, led us to suppose that stress had induced a viscous deformation of roads that, in this area, are built on embanked materials.

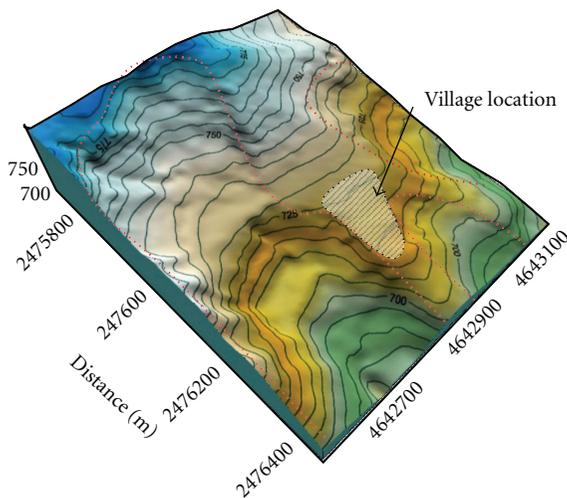
**2.1.1. Geo-Hydro-Morphology.** The village is 690–770 m above sea level, on a slope varying from 2% to 10% (north west-south east) (Figure 4). Large-scale topography shows numerous nicks from landslides that have occurred in the past (dotted lines in the figure); in fact, a landslide in the mid-eighteenth century induced the population to migrate to the present-day village location (750 m above s.l.) from

FIGURE 4: Morphology of the area. Dotted lines outline niches induced by landslides that occurred in the past.

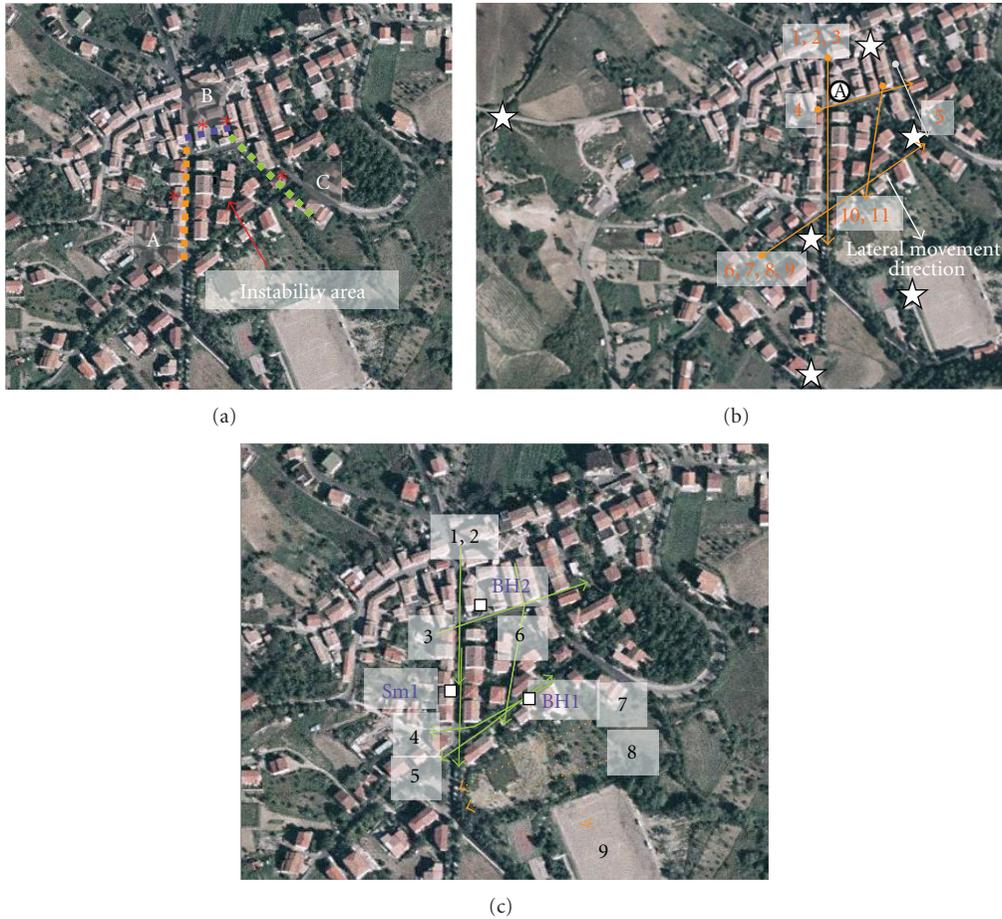
Each pattern, formed by cracks more or less parallel to each other was marked with A, B and C in Figure 5(a).

- (1) Instability induces mainly vertical movement. The maximum value detected at point A (Figure 5(b)) was about 2 cm in six months.
- (2) Only at point A, a significant lateral movement of about 4-5 cm was recorded, its direction is NNW to SSE, more or less parallel to the pattern of cracks A and C patterns (Figure 5(a)).
- (3) The greatest displacements occurred in the summer season.

These results, combined with those obtained from the crack analyses, are consistent with the hypothesis of compaction of the near surface layers, consequent with lowering of the water table during long periods of drought and activation of two pumping points in the most unstable area (crack pattern A).

FIGURE 5: (a) Location of main crack patterns lying more or less normal to each other, the buildings with the greatest damage are marked with stars. (b) White circles and stars indicate location of topographic survey: stars indicate steady points and circles unsteady ones. Orange lines are the location of seismic refraction surveys. (c) Borehole locations are indicated with white squares and electric resistivity tomography with green and orange dot lines.

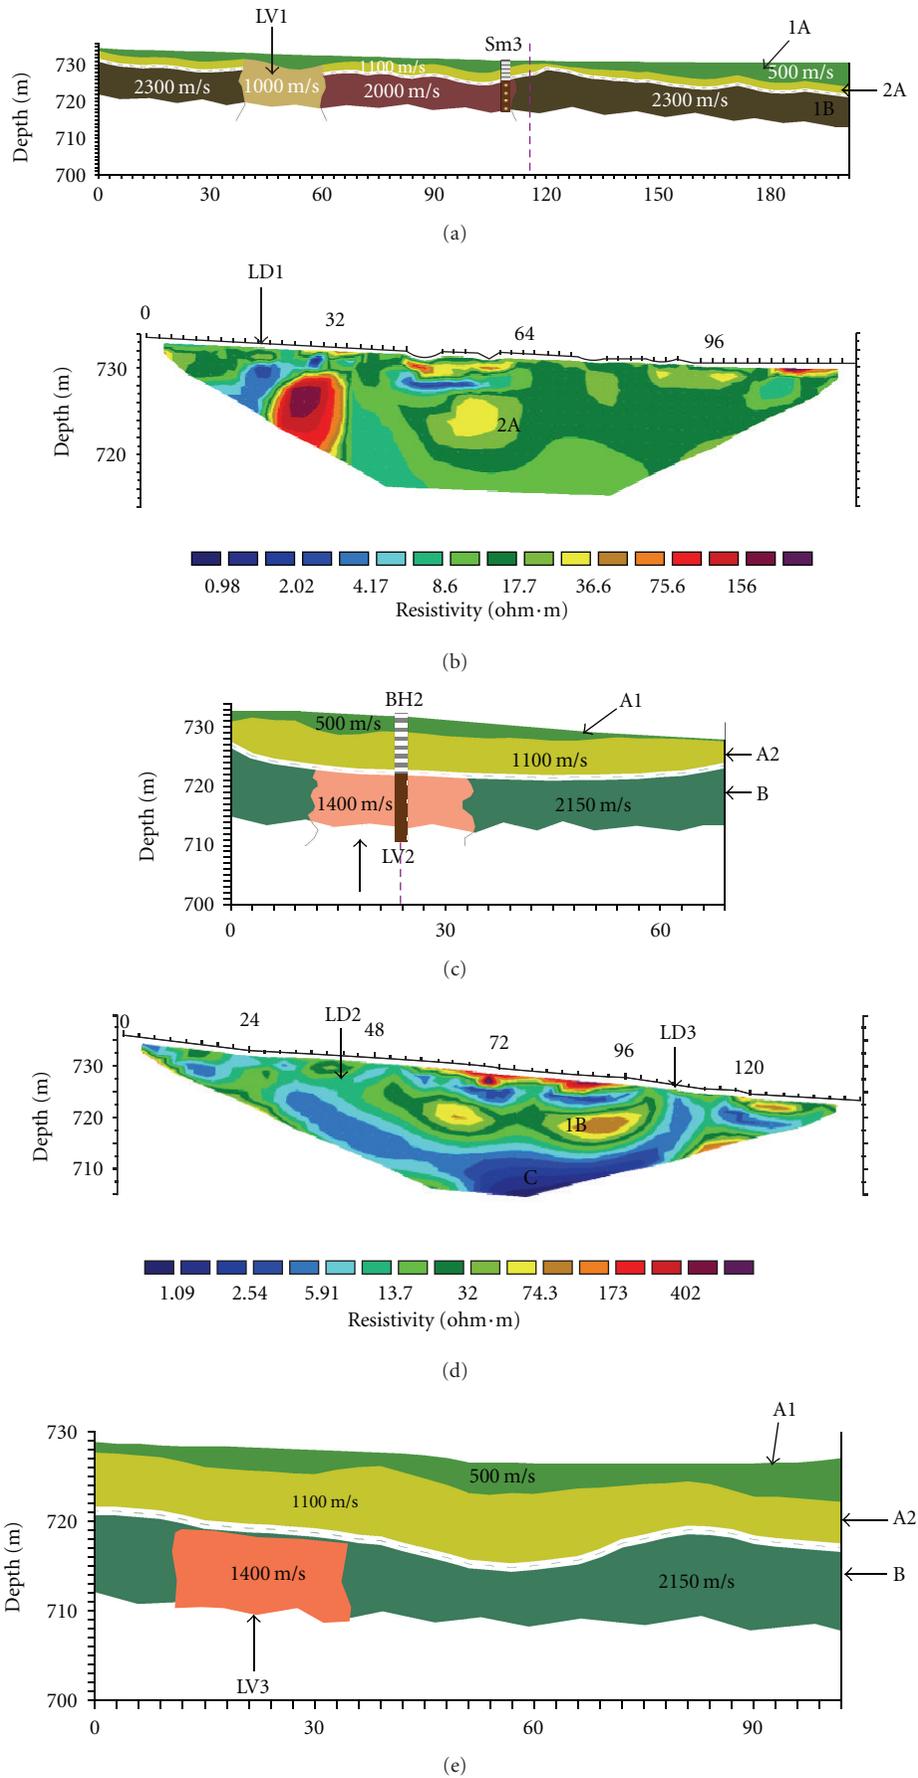
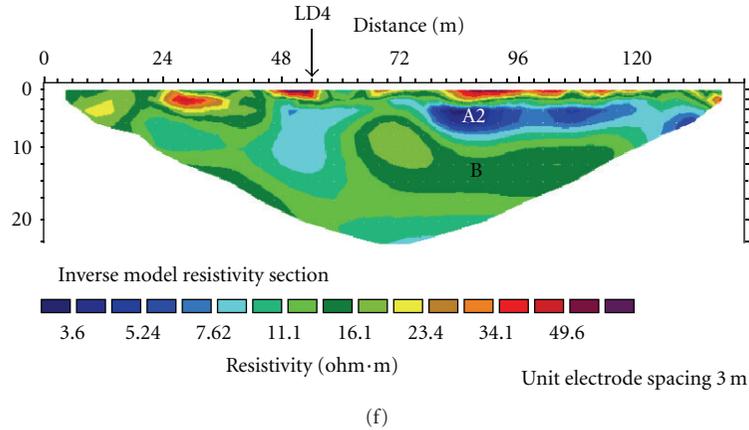
FIGURE 7: Seismic refraction profiles ((a), (c) and (e)) detect three layers, the first two (A1 and A2) related to Unit A and the third to Unit B drilled by boreholes; LV indicates low-velocity zones. Electrical resistivity tomography profiles ((b), (d) and (f)) detect four layers, the first two related to Unit A, the third to Unit B, and the fourth (C) to a non drilled shale layer. LD indicates lateral discontinuity of marl formation. Profile locations appear in Figure 5.

The third layer is characterised by marked lateral changes in P wave velocity, varying between 1000 and 2300 m/s. The main low-velocity zones in Figures 7(a), 7(c), 7(e) and 8(a) are marked with capital letters LV followed by a number. The couple of seismic profiles with crack locations of Figure 5(a) show a good overlap of the low-seismic-velocity zones with patterns of cracks: in detail, pattern B crosses the profile of Figure 7(a) in correspondence with the LV1 zone, pattern C crosses profiles of Figures 7(c) and 7(e) in correspondence with the LV2 and LV3 zones respectively.

is laterally discontinuous and probably dips in the same direction as the topography. From the ERT images, the discontinuous marl layer is merged into a shale formation. The main lateral discontinuities of marl in Figures 7(b), 7(d), 7(f), and 8(b) are marked with capital letters LV (lateral discontinuity) followed by a number. Coupling the marl lateral discontinuities with pattern of cracks, I observed that the crack pattern B crosses the profile 7B in correspondence with discontinuity LD1; the crack pattern C crosses the profiles 8D and F in correspondence with LD2 and LD4.

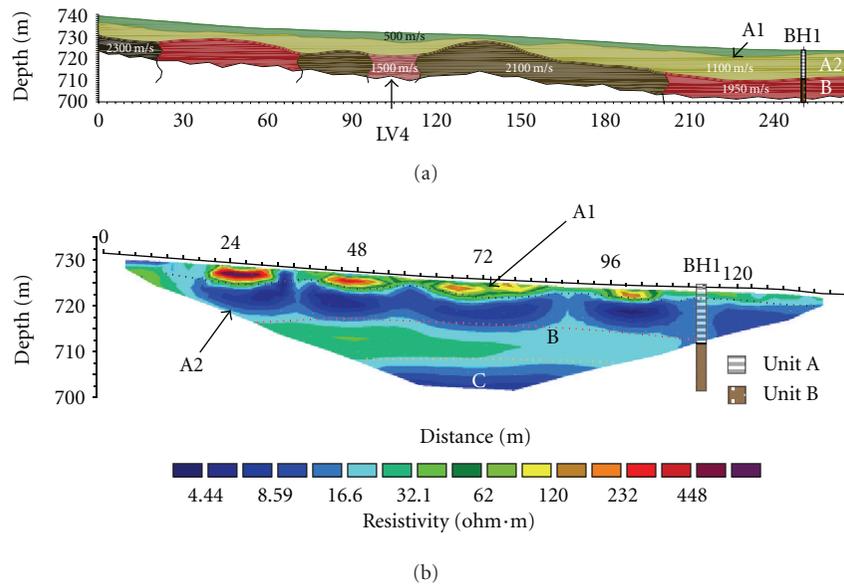
FIGURE 8: (a) Seismic refraction profile detects two layers of Unit A and the top of Unit B; LV indicates a low-velocity zone. (b) Electrical resistivity tomography profile detects Units A and B and a non drilled shale layer. LD indicates lateral discontinuity of marl formation. Profile locations appear in Figure 5.

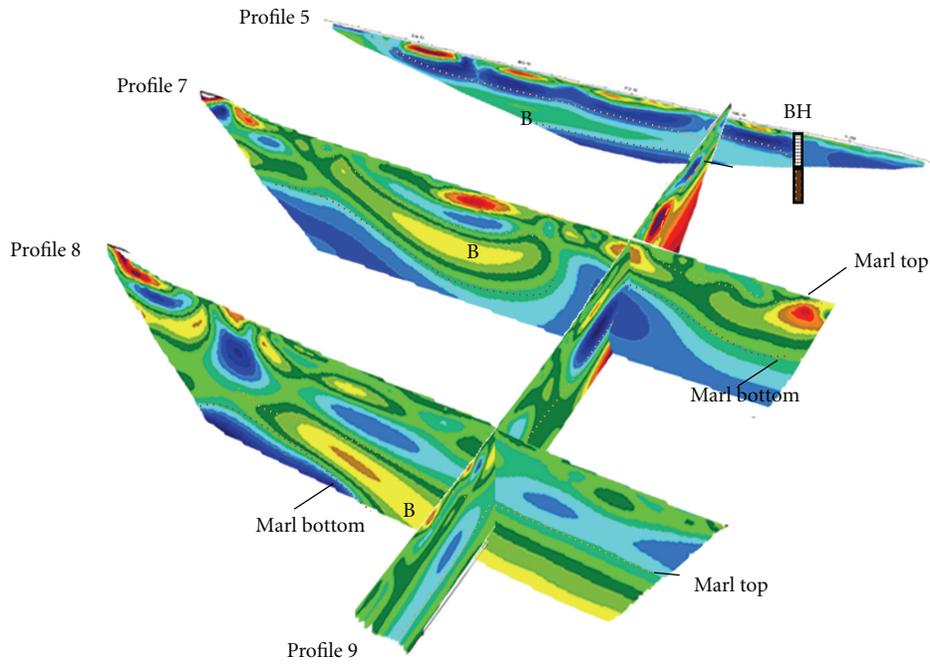
A perspective mapping of the 4 lines (Figure 9) acquired on the sloping area (Figure 5(c)) shows a shallow subsurface with the same features as the urban area. Here the marl

FIGURE 9: Perspective map of ERT profiles located in sloping area. Profile location in Figure 5(c).

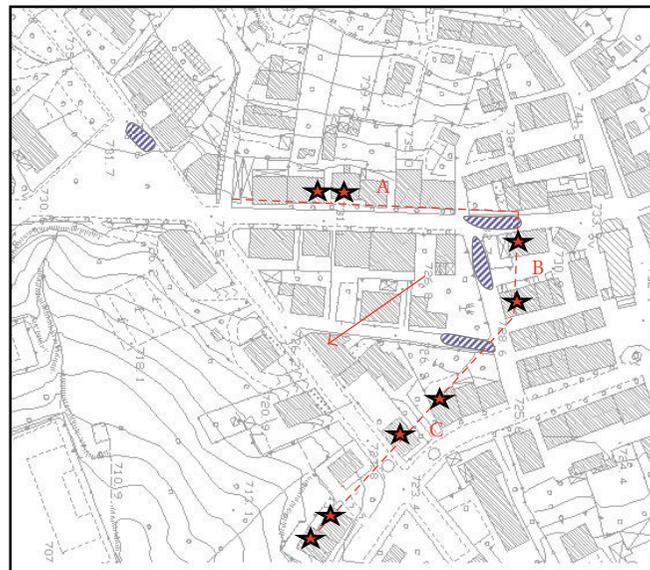
In Figure 10, a synthesis of the data interpretation is shown. The crack survey detected three main patterns of cracks with directions perpendicular to each other. The cracks bound the unstable area. The GPS shows that, in the unstable area, the vertical component of the soil displacement is more prevalent than the horizontal. The direction of the horizontal component is indicated by the arrow in Figure 10. These results agree with the hypothesis that the instability is due to the compacting of near-surface strata caused by the water table drawdown following long periods of drought and the pumping of water in the proximity of two restructured buildings.

Combining the ERT and seismic data I constrained the interpretation of low-velocity zones (LV) detected by seismic reflection asserting that the low-velocities are due to lateral discontinuities of marl. The map location of the main low velocity zones of Figure 10 shows that they are positioned

FIGURE 10: Location of main rupture zones, buildings affected by marked damage, and low-velocity zones detected by seismic refraction. The arrow indicates the main direction of movement in the area and the dashed lines the rupture alignments.

near the crack pattern B. From geophysical investigations, I can infer that the marl layer, although characterized by high seismic velocity (1900–2200 m/s), cannot be regarded as bedrock for planning of environmental recovery of the area because of its lack of lateral continuity. Furthermore, since the lateral discontinuities are located in correspondence of fractures, I can assert that the detachments occurred in the greatest weakness zones of the subsoil.

The joint analysis of the data did not allow me to uniquely identify the cause of instability, because the evidence can be justified both by the reactivation of an old landslide and by the compaction of sediments. In detail, the stratigraphy and morphology could lead to hypothesize that the area has been affected by reactivated landslides, while the topographic survey and the long period of drought that occurred just before the instability problem could lead to hypothesize that the instability was due to the compaction of the near surface sediments. Unfortunately, this problem is inherent in the combined use of direct and indirect methods currently available that allow us to photograph the effects of instability and the soil stratigraphy in a time period that is often too short to understand the phenomena and to reduce the ambiguity in determining the causes of instability in a complex situation. Speculatively, I advance the hypothesis that the urban area was built on an old landslide and that the recent instability that occurred within a period of 5–7 years has been caused by compaction of surface sediments. Despite this, the results obtained from the joint interpretation of direct and indirect surveys, can be considered absolutely necessary for effective restoration planning of the area.
