Pump Damage in the Hanshin Earthquake*

TOSHIYUKI OSADA[†]

*Pump Section, No. 1 Environmental Systems Department, Mitsubishi Heavy Industries, Ltd.,
5-1, Marunouchi 2-Chome, Chiyoda-ku, Tokyo, Japan*

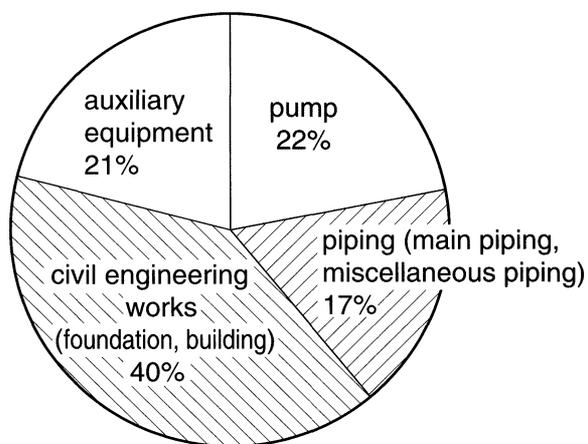
Figure 1 shows the ratio of each of damaged facility components in the above to total number of damage cases in the pump facilities. The number of cases of damage to pumps is small and the ratio is 22%. It is found that most cases occurred in the civil engineering works rather than the pumps themselves.

FIGURE 1 Details of damage to pump facilities. The number of cases of damage to pumps were small, and most cases occurred in the civil engineering works.

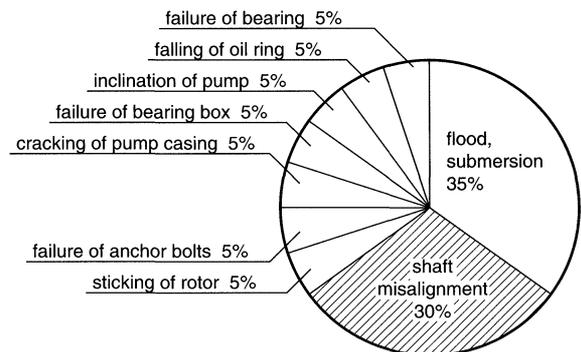
(a) *Pump* As shown in Fig. 2, the types of damage on pumps were mostly flood and submersion of pump and shaft misalignment which corresponds to 65% of the total number of damage. Other types of damage on pumps were

FIGURE 2 Details of damage to pumps. The types of damage on pumps were mostly flood and submersion of pump and shaft misalignment.

sticking of pump rotor, failure of anchor bolts, cracking of pump casing, failure of bearing box, etc. with only one case for each type of damage.

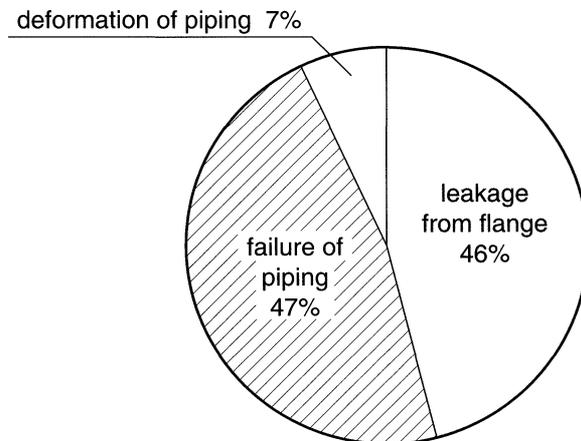
FIGURE 3 Details of damage to piping. The types of damage to the piping were roughly classified into leakage from flange mating surface and failure of piping.

(b) *Piping* As shown in Fig. 3, types of damage to the piping are roughly classified into leakage from flange mating surface and failure of piping. The number of these types corresponds to 93% of the total types of damage.

Most of the flanges that failed are of rigid type coupled to each other with bolts.

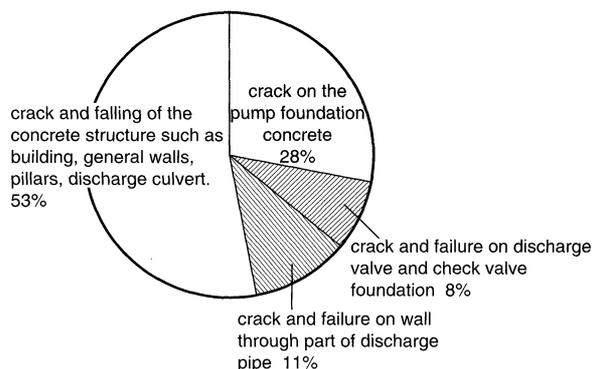
(c) *Civil engineering works* Damage to the civil engineering works as shown in Fig. 4 is due to crack or failure of the pump foundation

FIGURE 4 Details of damage to concrete structures. The types of damage to concrete structures were crack or failure of the pump foundation concrete, wall through part of discharge pipe, and foundations of discharge valves and check valves.

concrete, wall through part of discharge pipe, and foundations of discharge valves and check valves, which are important installation parts for mechanical equipment. These types of damage correspond to 47% of the total.

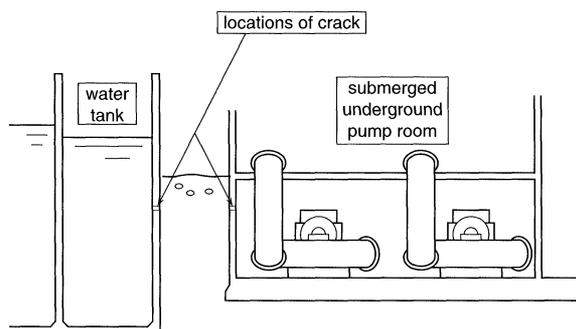
(a) *Flooding and submersion of pump and electrical equipment* Figure 5 shows the layout of a horizontal shaft mixed flow pump (discharge opening diameter 350 mm). Cracks occurred on the concrete walls of the tank and the underground pump room; the pump room was flooded and the pumps and electric equipment were damaged. The flood water went into the bearings, damaging the bearings. Cracking was caused by the dissimilar local displacements of adjacent buildings. As emergency measures, the bearings were washed with oil and the electrical equipment were dried. For preventing recurrence of damage,

FIGURE 5 Pump submersion. The pump room was flooded due to cracks on the concrete walls of the tank and the underground pump room.

it is necessary to integrate the foundation structure and to strengthen the foundation.

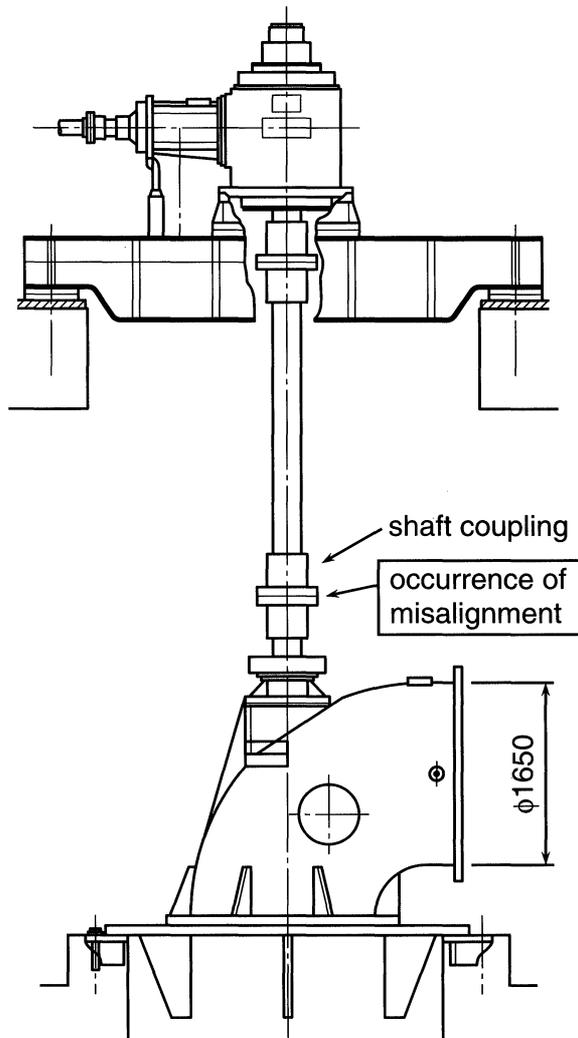
(b) *Shaft misalignment between pump and driving machine* Figure 6 shows a damaged vertical shaft mixed flow pump (discharge opening diameter 1650 mm). The pump and the reduction gear are installed on separate foundations (two-floor type). The axial thrust of the pump shaft is supported by the reduction gear, and the pump and the reduction gear are coupled with a rigid type coupling.

During the inspection of the pump, after the earthquake, it was found that the alignment between the pump shaft and reduction gear shaft deviated in the radial direction, and the deviation exceeded the allowable value for installation and adjustment of the pump and the reduction gear. The cause of misalignment is considered to be slight distortion of the building due to two-floor type foundation. Other abnormalities could not be found, therefore the alignment was readjusted.

FIGURE 6 *Shaft misalignment.* The alignment between the pump shaft and reduction gear shaft deviated in the radial direction because of slight distortion of the building.

To maintain functions of the pump facilities even after earthquakes, adoption of a flexible shaft coupling (laminated sheet type coupling, gear coupling, universal joint, etc.) is recommended so that a larger misalignment can be allowed for. However in this case the axial thrust bearing should be integrated in the pump, resulting in complicated pump design.

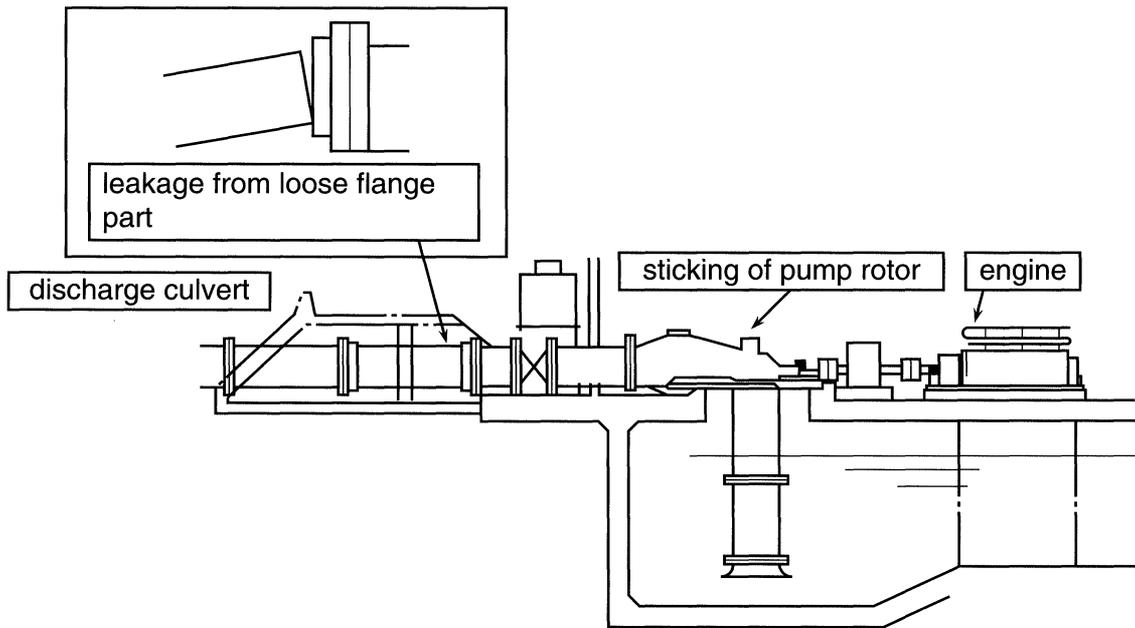
(c) *Pump rotor getting stuck* Figure 7 shows the installation of a horizontal shaft mixed flow

pump (discharge opening diameter 1600 mm). Since excessive external force was applied to the pump due to unequal sinking of delivery culvert, misalignment occurred, resulting in sticking of the pump rotor. In addition there was leakage from the loose flange. To repair the damage, the main parts of the pump rotor were replaced. The leakage from the flange part was stopped by loose stop using jig and by coating, before the pump was reassembled. To prevent recurrence, installa-

FIGURE 7 *Pump rotor getting stuck.* Since excessive external force was applied to the pump due to unequal sinking of delivery culvert, misalignment occurred, resulting in sticking of the pump rotor.

tion of a flexible expansion joint to the piping where foundation strength changes rapidly, adoption of a flexible shaft coupling to the pump and integration of the structure foundations should be considered.

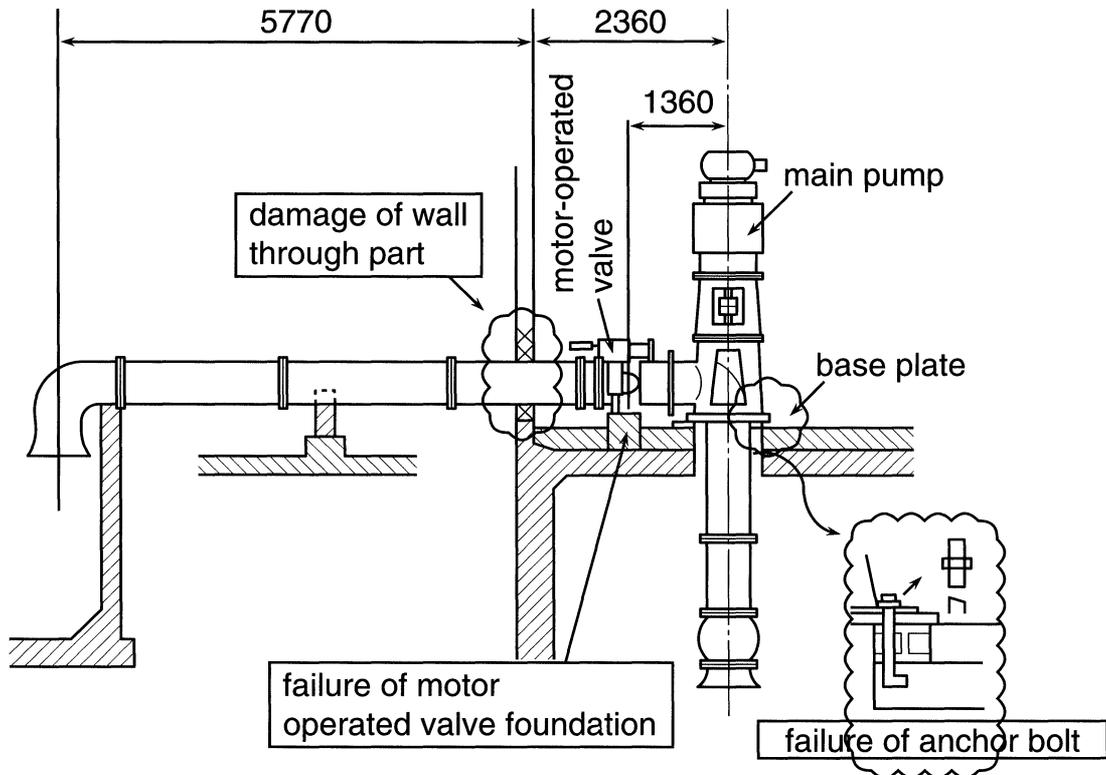
(d) *Anchor bolt failure* Figure 8 shows installation of the vertical shaft mixed flow pump (discharge opening diameter 500 mm). Since a large load from the piping due to unequal sinking of foundation and inertia force in earthquake was applied to the pump, shear fracture of all the pump anchor bolts ($W1 \times 4$) and failure of the motor-operated valve foundation occurred. Photo 1 shows failure of the anchor bolts. The anchor bolts were temporarily fixed as an emergency measure. Thereafter they were completely restored. In order to reduce inertia force and absorb relative displacement of devices owing to unequal sinking of the foundation generated by earthquake, study of installation of a flexible expansion joint to the piping is required.

FIGURE 8 *Anchor bolt failure.* Since a large load from the piping due to unequal sinking of foundation and inertia force was applied to the pump, shear fracture of all the pump anchor bolts ($W1 \times 4$) occurred.

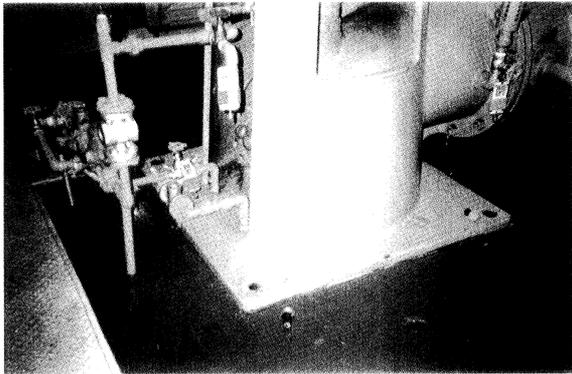
PHOTO 1 *Anchor bolt failure.* Shear fracture of all the pump anchor bolts ($W1 \times 4$) occurred due to excessive piping load.

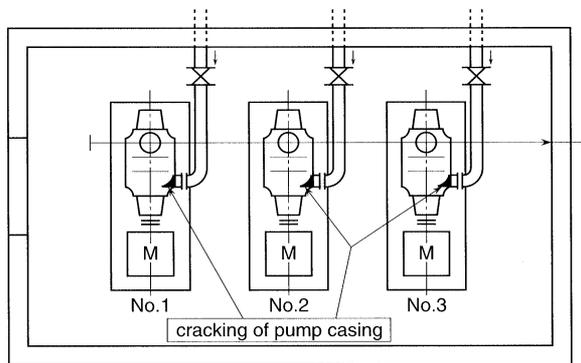
(e) *Suction casing cracking* Figure 9 shows a plan view of the installation of a horizontal shaft centrifugal type pump (discharge opening diameter 100 mm). It is assumed that the inlet pipe and pump casing were pulled apart by excessive piping external force due to unequal sinking of the building, and failure of the pump casing occurred. Failure occurred adjacent to the inlet flange of the pump casing. As correction measures, the casing was replaced and flexible pipe joints were fitted to the suction and discharge pipings.

FIGURE 9 *Suction casing cracking.* The inlet pipe and pump casing were pulled apart by excessive piping external force due to unequal sinking of the building, and failure of the pump casing occurred.

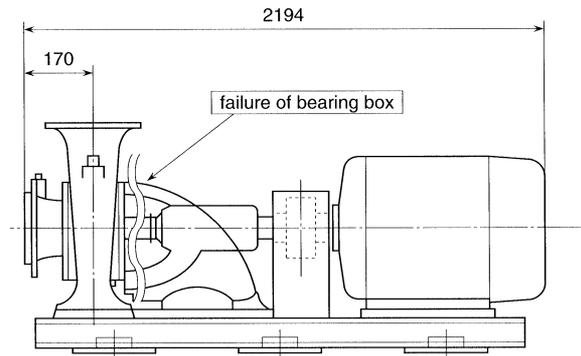
(f) *Bearing box failure* Earth and sand were blown in due to fluidization phenomenon in over a half of the plant area, and rising, fall and cracking of the ground occurred in many places in the vicinity of the wharf of Kobe port. Cracks of the pump foundation occurred and also, as shown in Fig. 10, several horizontal shaft centrifugal type pumps (discharge opening diameter 80 mm) sustained damage such as complete failure in the bracket part of the pump bearing box. The cause of the damage is assumed to be excessive load from the piping and foundation. As a

FIGURE 10 *Bearing box failure.* Several pumps sustained damage such as complete failure in the bracket part of the pump bearing box due to excessive load from the piping and foundation.

measure for this, the complete pumps were replaced with new ones.

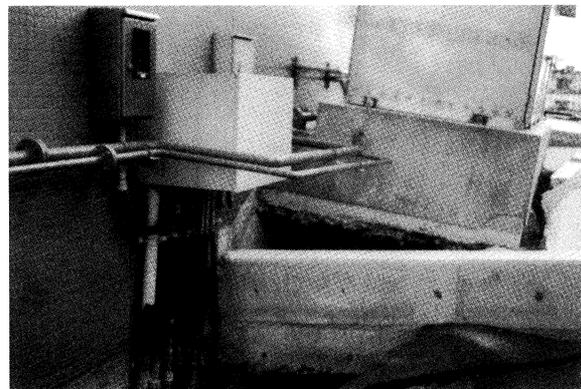
(g) *Inclination of pump* The horizontal shaft gear type oil pump (discharge opening diameter 25mm) was inclined with the pump foundation, as shown in Photo 2, due to unequal sinking of the foundation. This pump was installed outside the building containing the main pumps. It is assumed that the ground sank a lot because the foundation was dug and filled up again and hence the ground was soft. As an emergency measure for this, test operation of the pump was performed after visual inspection. It was confirmed that oil leakage, vibration, noise, etc. were normal. The

PHOTO 2 *Inclination of pump.* Oil pump inclined with pump foundation due to unequal sinking of foundation.

foundation was later reconstructed and the pump was restored completely. The future topic of interest is the integration of the foundation with the main pump building adjacent to the oil pump.

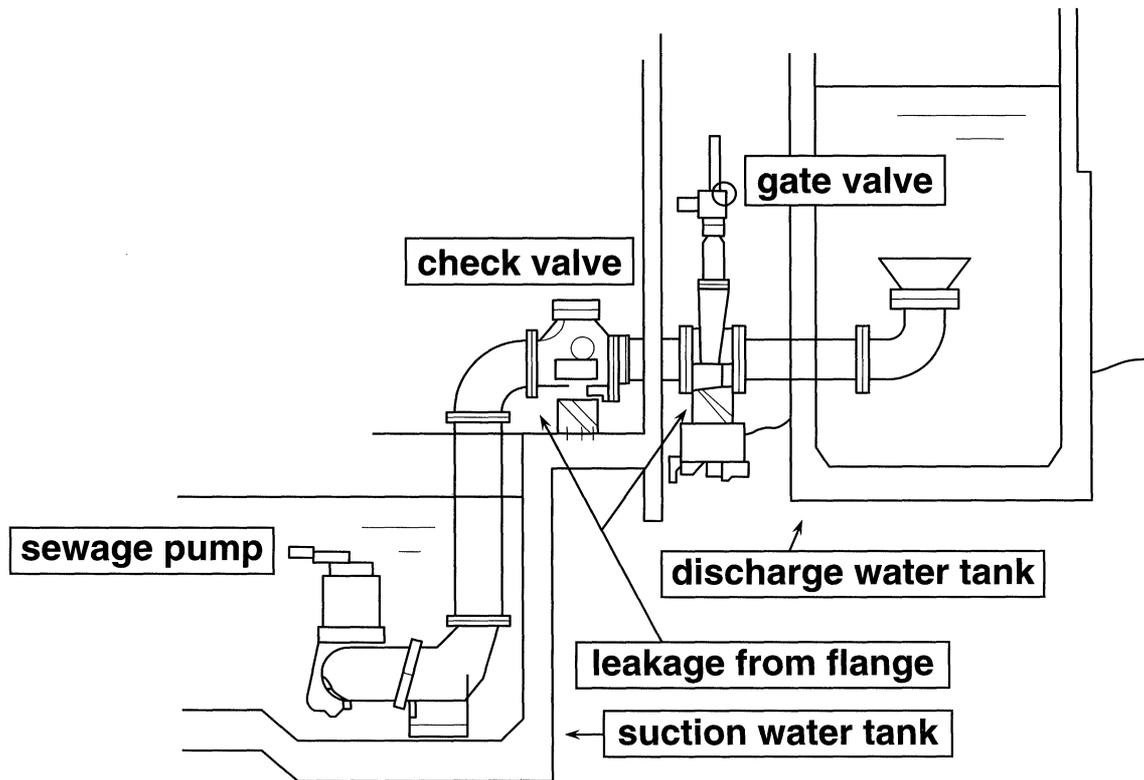
(h) *Leakage from outlet flange* Leakage from the outlet flanges is a typical damage of the piping from the viewpoint of securing pumping function. Figure 11 shows the outlet piping line of a horizontal submerged shaft pump (discharge opening diameter 600 mm). Cracks were found in the foundation concrete due to excessive piping load caused by relative displacement of the foundations of the suction water tank and the discharge water tank. Slippage occurred on the piping flange

FIGURE 11 *Leakage from outlet flange.* Slippage occurred on the piping flange surfaces, caused by relative displacement of the foundations of the suction water tank and the discharge water tank, resulting in leakage.

surfaces, resulting in leakage. As correction measures for this, a flexible expansion joint was inserted and reassembled. To prevent recurrence, it is important to consider installation of a flexible expansion joint in the location where the foundation strength changes rapidly, and integration of the foundations.

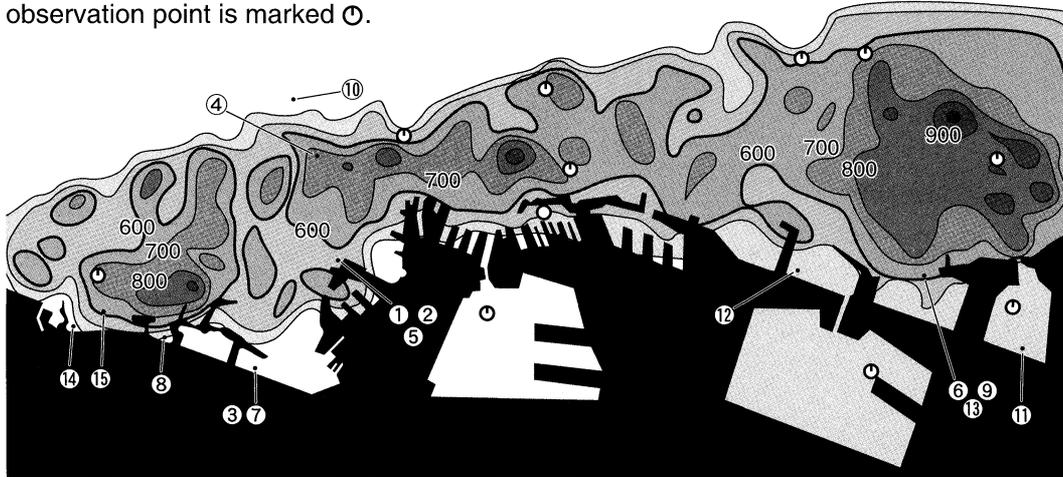
①-⑮ show the locations of damaged pump facilities.
(refer to Table II for correspondence with damage)

For Kobe City, the distribution of the seismic intensity (maximum acceleration) has been estimated by Sato (1996). Table II and Fig. 12 show the relationship between damage (15 cases in total) in Kobe and seismic intensity. No explicit correlation between damage and seismic intensity was apparent. However, seven cases of damage which

account for approximately 50% cases were found in relatively low seismic acceleration below 500 Gal from viewpoint of magnitude of seismic intensity. Most cases occurred in the reclaimed land along the coast. It might be surmised that unequal sinking of the ground occurred, even for relatively low seismic intensity, due to soft ground caused by reclamation, and thus large cases of damage were induced.

FIGURE 12 Estimated maximum acceleration and the location of pump damage. Seven cases of damage which account for approximately 50% cases were found in relatively low seismic acceleration below 500 Gal. Most cases occurred in the reclaimed land along the coast.

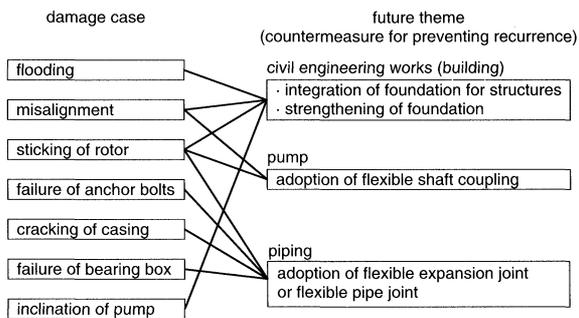
From the viewpoint of improvement of equipment, Fig. 13 shows the future theme of countermeasures for preventing recurrence of pump structure damage described so far. In order to prevent damage of the pump, it can be seen that comprehensive

FIGURE 13 Relationship between damage to pump and countermeasures to prevent it. In order to prevent damage of the pump, comprehensive study not only on the pump itself but also on civil engineering works and piping is required.

study not only on the pump itself but also on civil engineering works (building and foundation) and piping is required. This study should be performed from the design stage.
