Research Article

A Systematic Approach to Identify Sources of Abnormal Interior Noise for a High-Speed Train

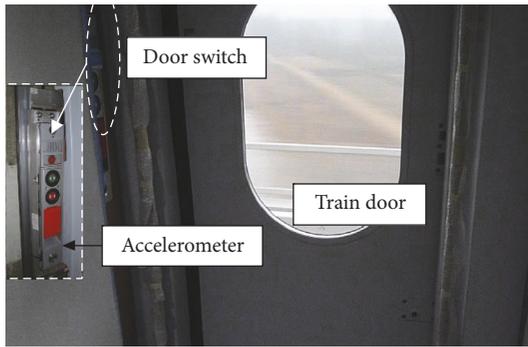
FIGURE 3: Abnormal interior noise generated by the door switch.

For example, (1) abnormal noise is generated by the door switch assembly as indicated in Figures 3 and 4. The noise/vibration is at a single frequency which is related to train speed. The noise is radiated by the structural resonance of the door switch assembly which is in turn excited by the first order of the wheel out-of-round wear at 380 km/h. (2) Abnormal interior noise occurred at the ends of a coach [18] at a single frequency as indicated in Figures 5 and 6. The problematic frequency is related to train speed. The root cause is the sleeper passing of the train at 250 km/h which excites one of the acoustic modes at the coach end through vibrations of the floor and the sidewall. (3) Abnormal interior noise occurred in a driver's cab of a high-speed train as indicated in Figure 7. It is of broadband and the problematic frequencies are independent of train speed. The source is related to the air-conditioning and the generated noise propagates into the interior via airflow in the ducts.

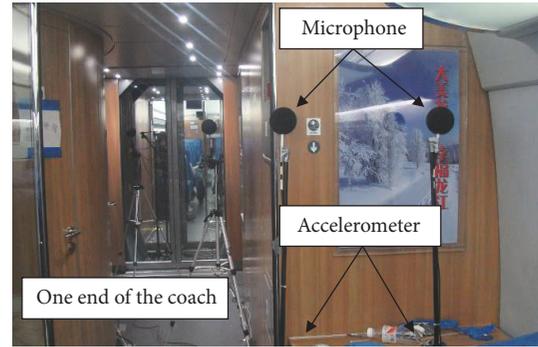
FIGURE 5: Abnormal interior noise at one end of the coach.

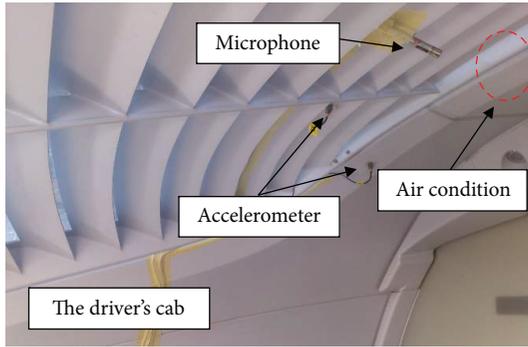
FIGURE 7: Abnormal interior noise in a driver's cab of a high-speed train.

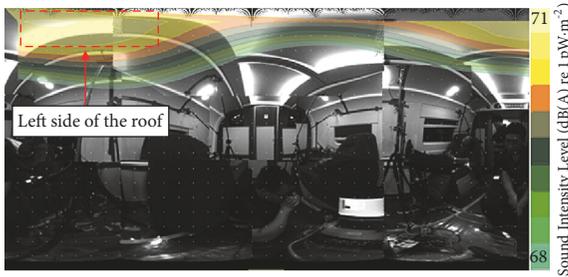
FIGURE 15: Noise source identification result of the VIP cabin in TC08 (125 Hz).

From Figure 15, the noise source in 1/3 octave band centered at 125 Hz in TC08 is mainly located on the left side of the roof. In order to obtain the contribution of each area to the total noise of the receiving point (position of the microphone), the VIP cabin is divided into six areas, which, respectively, correspond to the roof, the left sidewall, the right sidewall, the floor, the front, and rear of the cabin, as shown in Figure 16.

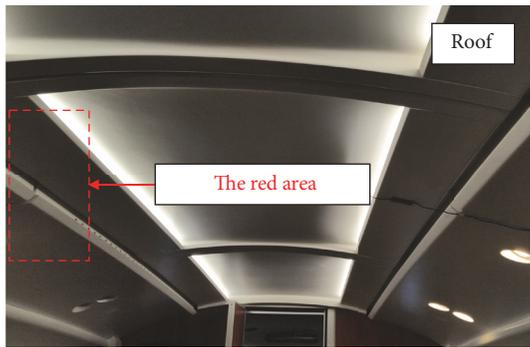
FIGURE 20: Noise source location on the roof of TC08.

Up to this point, it can be concluded that the noise issue in TC08 is attributed to an area (the red area) which is located on the roof of the cabin. A photo of the red area is shown in Figure 20. However, there are a number of possibilities: (1) that the area produces noise by too strong vibration and radiation of a panel and that vibration is caused by structure-borne transmission or resonance; (2) that the area produces noise by too strong vibration and radiation of a

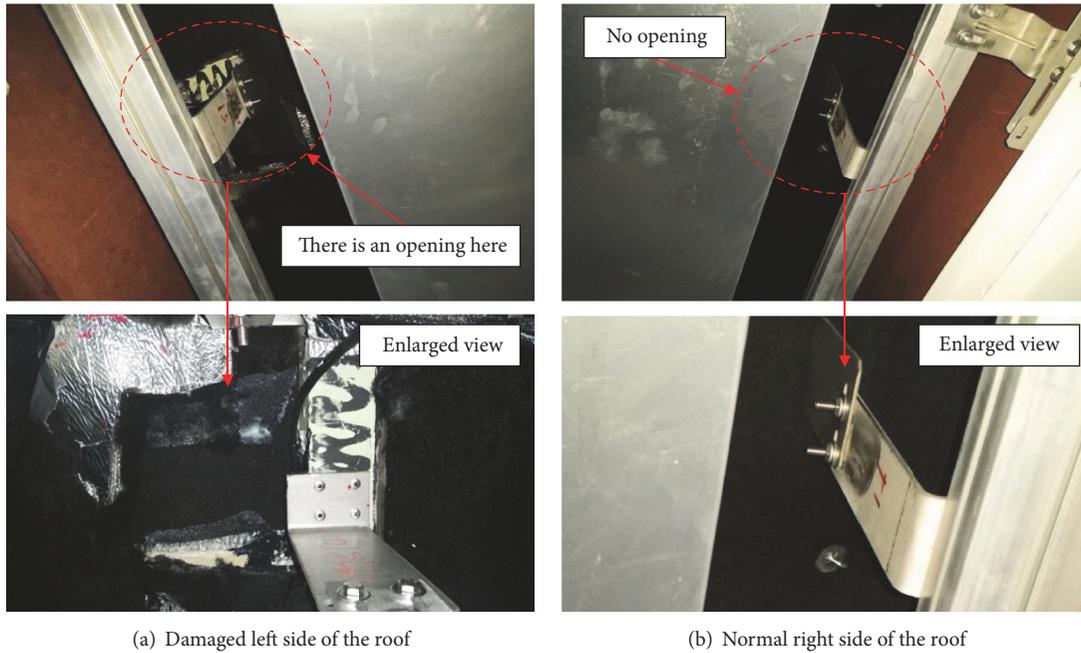
FIGURE 27: Inner roof structure of the VIP cabin in TC08.

It can be seen from Figure 27(a) that, on the left side of the roof, there is an opening of 300 cm² for running cables,

and such an opening is not present on the right-hand side (Figure 27(b)). The opening should have been blocked using sound insulation material to prevent sound propagation through the opening into the cabin. It is this defeat that allows external noise to enter the cabin, especially for the wheel/rail noise and vibration caused by the sleepers passing of the train.

(a) Damaged left side of the roof

(b) Normal right side of the roof

3.6. Correction Measures and Effects. The opening is now mended so that it becomes normal as the right-hand side shown in Figure 27(b). After mending the damaged roof of TC08, the field test is carried out again to check the effect of the correction. Figure 28 shows the measured noise results of the two VIP cabins at 250 km/h.

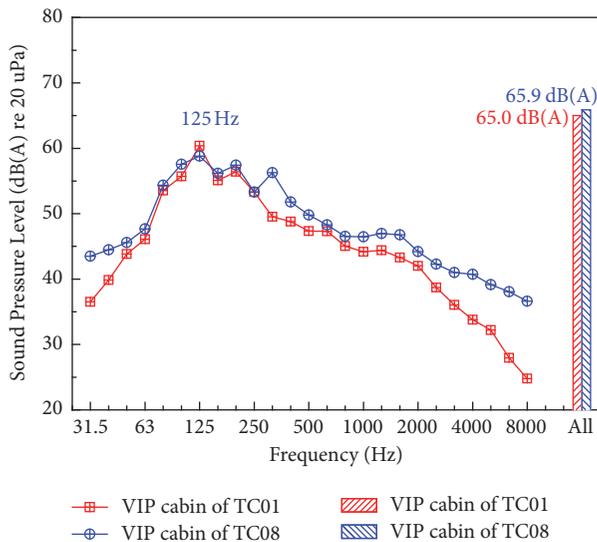
FIGURE 28: Noise test results in the two VIP cabins after the roof mending.

From Figure 28, the overall SPL in TC08 is 65.9 dB(A), while that in TC01 is 65.0 dB(A). The difference in overall

level is now less than 1 dB(A). The difference between the peak values at 125 Hz is even much smaller. However, it can be seen from Figure 28 that across all the 1/3 octave bands, TC01 is quieter than TC08, although these two VIP cabins are constructed based on the same design and production process. From Figure 11 it is also seen that, apart from the problematic frequency bands, TC01 is quieter than TC08. These observations can be explained partly by variations between products of the same design and partly by measurement uncertainty. A measurement system analysis (MSA) may be required to quantify relative contributions.
