# Physicochemical and Vibration Analysis of Christmas Tree Four-Way Flange Failure under Fracturing Process

When a wellhead gas production tree in a certain oilfield block fracturing completed 12 layers and 22 layers and then the bottom-up discharge operation was performed, the Wellhead four-way suddenly suffered erosion failure. This is the seventh failure of this operation. In order to obtain the cause of failure, the chemical analysis, hardness testing, tensile property testing, and finite element structural dynamic analysis are used to analyze the failure of the cross connection. The results of physical and chemical analysis show that the chemical composition, hardness, and tensile properties of the failed parts meet the requirements of the standard, not the problem of the material of the work piece. Due to the high-frequency vibration generated by the three-phase fluid in the pipeline during the discharge process, different types of vibration and deformation of the four-way valve and the valve body occur. The dimensions of the on-site structural parts were measured, and the bolt sizes were found to be different. A finite element model was established based on the measured dat

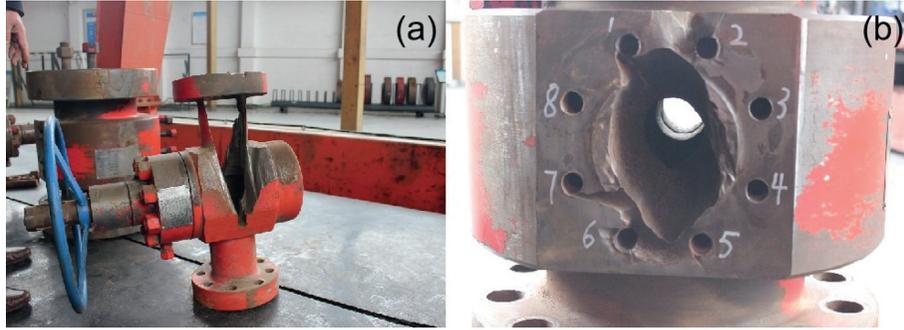
installation of the gas production tree. No. 2 valve and No. 3 valve connected to the big cross during the injection are both open. Figure 2(a) is the failure morphology of No. 3 valve body, and Figure 2(b) is the failure morphology of the joint between the cross and No. 3 valve, and the serial numbers 1–8 are marked on the bolt positions. During the fracturing process, the pressure sand, backflow fluid, natural gas, etc. in the pipeline form a three-phase flow. When the three-phase flow is discharged from the four-way through No. 3 valve, the vibration of different frequencies occurs in the valve body. Vibration causes leakage at the joint between the tree and No. 3 valve, eventually resulting in erosion failure. From Figure 2, it can be observed that there are obvious erosion marks on the failed tee and the valve. As shown in Figure 3, bolts and nuts at the flange joint of the four-way flange are found to have inconsistent bolt sizes after field measurement. The bolts have been replaced. The bolts on the four-way bolts are labeled B7 (left); bolts labeled 2, 3, and 4 are labeled HD B7 (center); bolts labeled 5 and 6 are labeled LL B7 (right). Specific specifications are shown in Table 1 below.

FIGURE 2: (a) Failure morphology of No. 3 valve body; (b) failure morphology of the joint between the cross and No. 3 valve.

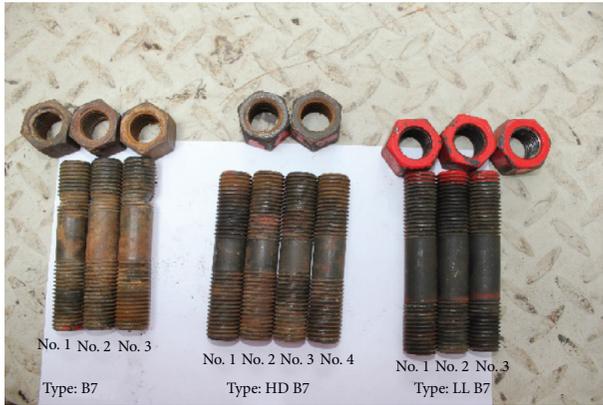
FIGURE 3: Bolts at flange connections.

nominal stress cross-sectional area of the bolt (the nominal diameter of the thread), and the nominal stress cross-sectional area of the M22 bolt is  $303 \text{ mm}^2$ . The pretightening force of the bolt is calculated to be about  $150000\text{--}200000 \text{ N}$ . Three different types of bolts were used on the site. Due to the different pretension forces applied to bolts of different lengths, the stress and deformation of the bolts and structures were analyzed under multiple loads.

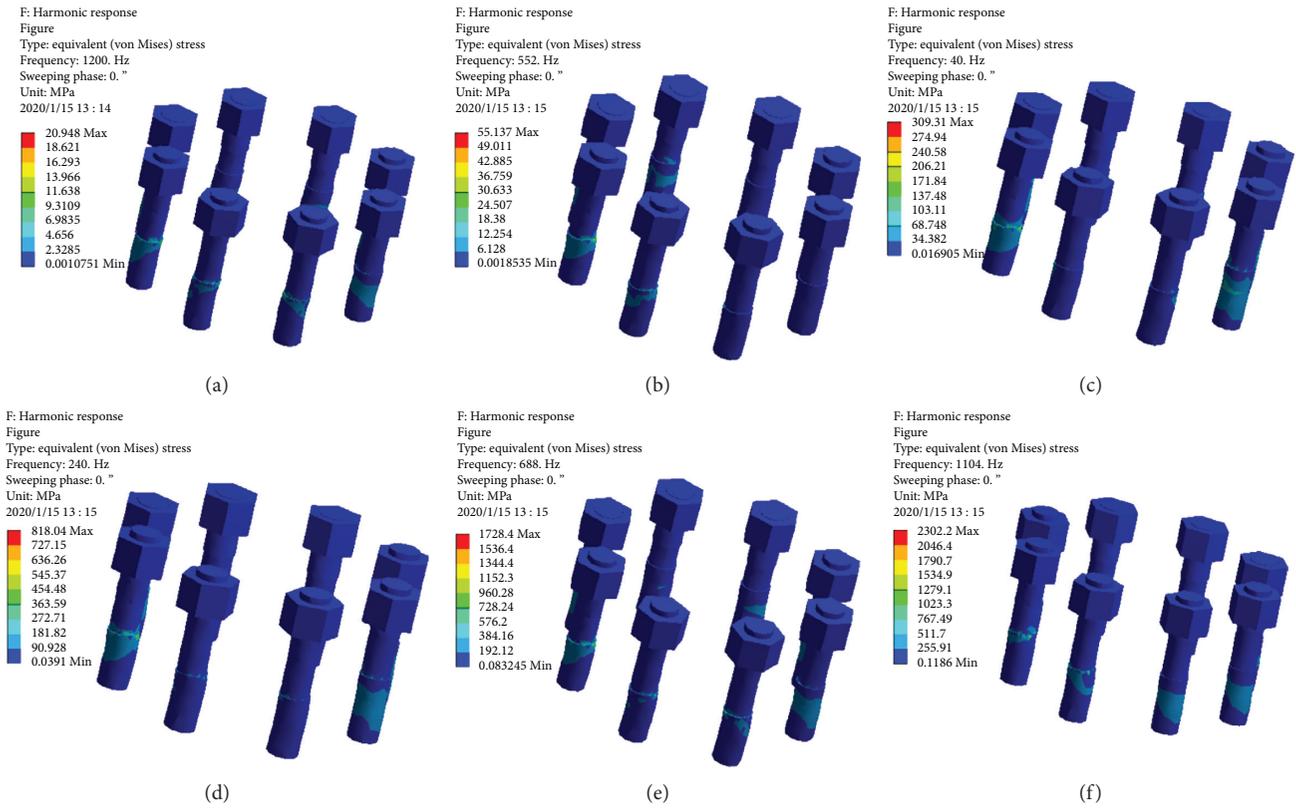
specified frequency (or frequency range). The deformation is restricted to zero, and the force of the valve body is 10 kN in the vertically upward direction (calculated based on the contact area of the fluid pressure with the hole in the valve body). Figure 5 is the stress cloud diagram of the bolt at different frequencies. When the frequency of the three-phase flow is 40 Hz, 240 Hz, 552 Hz, 688 Hz, and 1104 Hz, the three-phase flow in the bolt and the valve body will resonate. As can be seen from the figure, the three-phase fluid and structure did not resonate at a frequency of 1200 Hz, and the stress of the bolt was 20.948 MPa. When the resonance occurred, the stress of the bolt was gradually increased. When the frequency was 1104 Hz, the bolt was subjected to the maximum stress. It reaches 2302.2 MPa, far exceeding its yield limit. Figure 6 shows the stress spectrum response curves of No. 1–8 bolts. These parts will produce different magnitudes of stress in the frequency range of 0–1200 Hz. No. 1 bolt is the most stressed, followed by No. 5 and No. 6 bolts. As shown in Figure 7, the spectral response curves of the deformation amount of No.

FIGURE 5: Stress cloud diagrams of bolts at different frequencies: (a) 1200 Hz; (b) 552 Hz; (c) 40 Hz; (d) 240 Hz; (e) 688 Hz; (f) 1104 Hz.

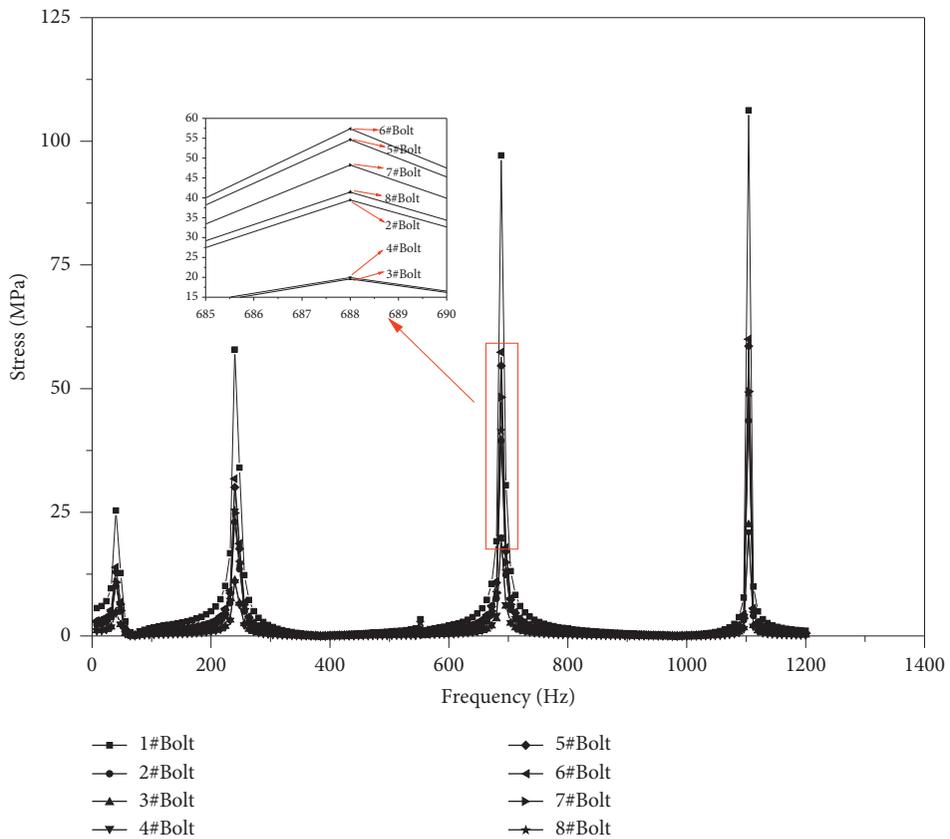
FIGURE 6: Bolt stress spectrum response curve.

- (3) According to the harmonic response curves of Figures 6 and 7 above, it is found that the bolt will be subjected to different magnitudes of stress in the frequency range of 0–1200 Hz to produce different degrees of vibration. The maximum stress on the bolt is close to 110 MPa, and the vibration of the bolt. The maximum deformation reaches 0.1 mm.

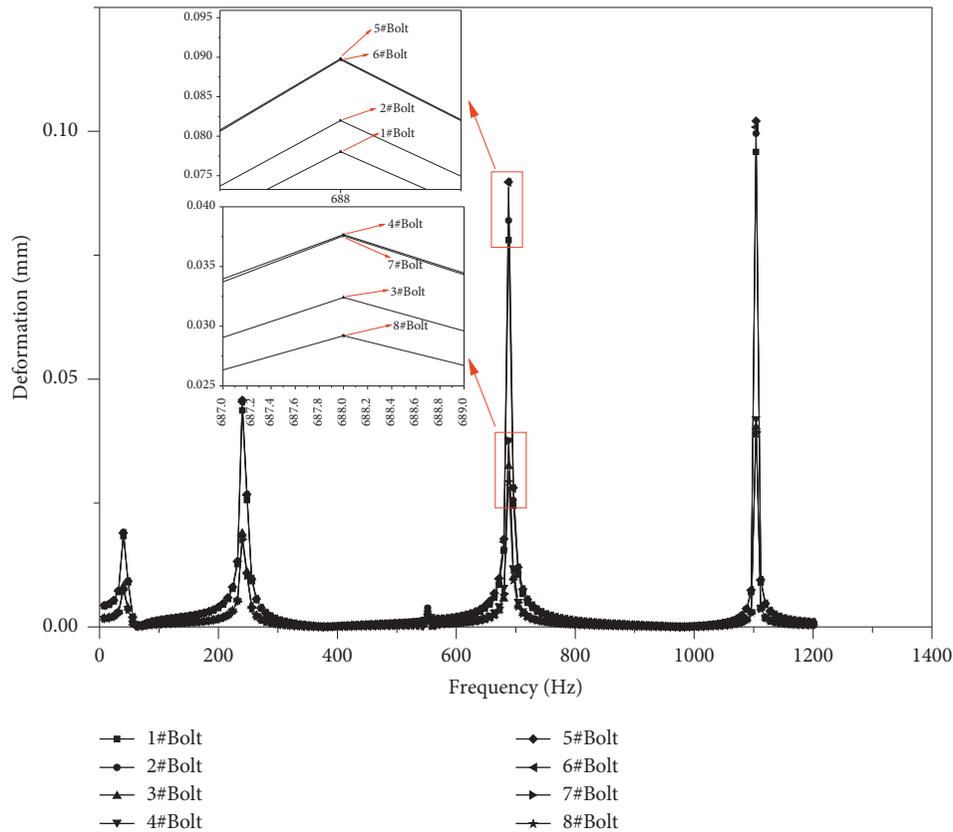
FIGURE 7: Spectrum response curve of bolt deformation.

1–8 bolts are, respectively, found from the spectral response curves of the deformation amount of bolts. The upper and lower ends of the cross, that is, No. 1, No. 2, No. 5, and No. 6 bolts have a deformation amount greater than 0.08 mm; the left and right ends of the cross, No. 4, No. 7, No. 3, and No. 8 bolts have a small deformation and deformation The volume is about 0.03 mm. The amount of bolt deformation is connected to the cross, and the failure situation at the place coincides. At the same time, there are five peaks in the entire spectral response curve of the deformation. When the frequency of the three-phase flow in the valve is 40 Hz, 240 Hz, 552 Hz, 688 Hz, and 1104 Hz, the three-phase flow and four-way valve will resonate and cause the vibration to increase. The four-way valve structure is stimulated by the regular vibration, and No. 1, No. 2, No. 5, and No. 6 nuts are most excited by vibration and have the largest amount of deformation. At the same time, the three-phase flow in the valve and the valve body will cause resonance to cause vibration. Because this part is easy to relax, the nut will be reversed due to vibration, eventually the bolt will loosen and fall off, and the wellhead cross and No. 3 valve will have erosion failure.

- (4) When the gas extraction tree is performing the spraying operation, the three-phase fluid will generate high-frequency vibration in the pipeline, which will cause the valve body to vibrate up and down. Due to the size of the bolt at the junction of the wellhead cross and No. 3 valve, the length is different, the load on the bolt is in an unbalanced state, and the nut is buckled, which causes leakage at the flange connection. Eventually, the wellhead cross and No. 3 valve have erosion failure.
- (5) It is recommended to regularly use an electronic torque wrench to detect the pretightening force of each bolt to prevent vibration and failure due to inconsistent pretightening force of the bolts.
