An Autopsy of Nanofiltration Membrane Used for Landfill Leachate Treatment

Komurcuoda leachate treatment plant, Istanbul, which consists of membrane bioreactor (MBR) and nanofiltration (NF) system, faced rapid flux decline in membranes after 3-year successful operation. To compensate rapid flux decline in membranes, the fouled membranes were renewed but replacement of the membranes did not solve the problem. To find the reasons and make a comprehensive analysis, membrane autopsy was performed. Visual and physical inspection of the modules and some instrumental analysis were conducted for membrane autopsy. Membranes were found severely fouled with organic and inorganic foulants. Main foulant was iron which was deposited on surface. The main reason was found to be the changing of aerator type of MBR. When surface aerators were exchanged with bottom diffusers which led to increasing of dissolved oxygen (DO) level of the basin, iron particles were oxidized and they converted into particulate insoluble form. It was thought that probably this insoluble form of the iron particles was the main cause of decreased membrane performance. After the diagnosis, a new pretreatment alternative inc

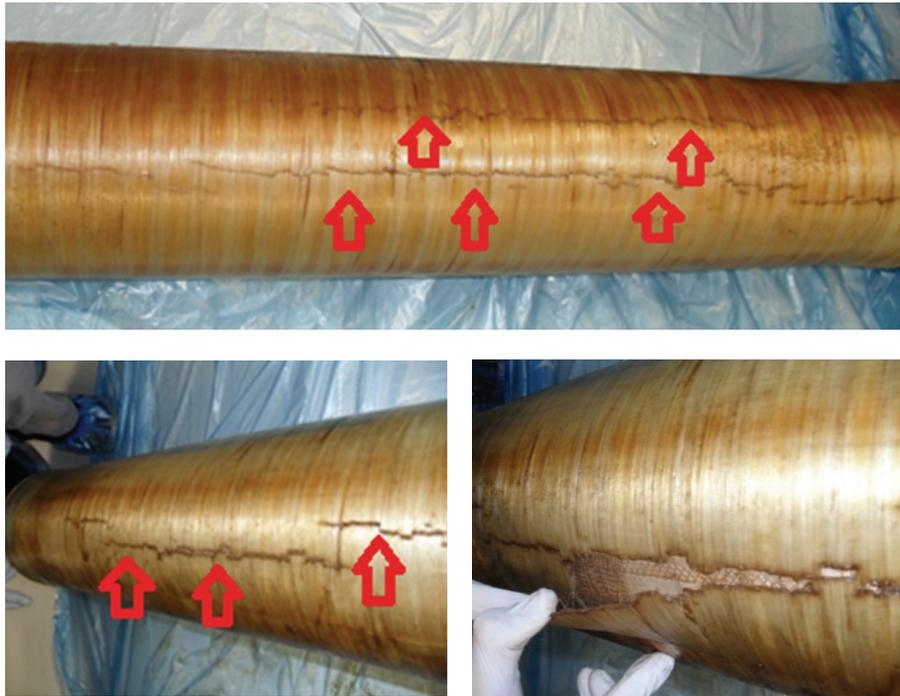
3.1. Physical Inspection. Antitelescoping devices, junction points, and gaskets on the module were intact; however, module outer shell had cracks on it longitudinally as can be seen in Figure 2. This may be related to the high pressure drop between the entrance and exit. Pressure drop originated from fouling may be converted to axial pressure by the module.

This axial pressure may be caused by the longitudinal cracks on the module [16]. These cracks led to deterioration of membrane unity and stability. Because of that, membrane sheets can be damaged or flow can be decreased.

FIGURE 2: Cracked module shells due to high pressure drop (arrows indicate cracks).

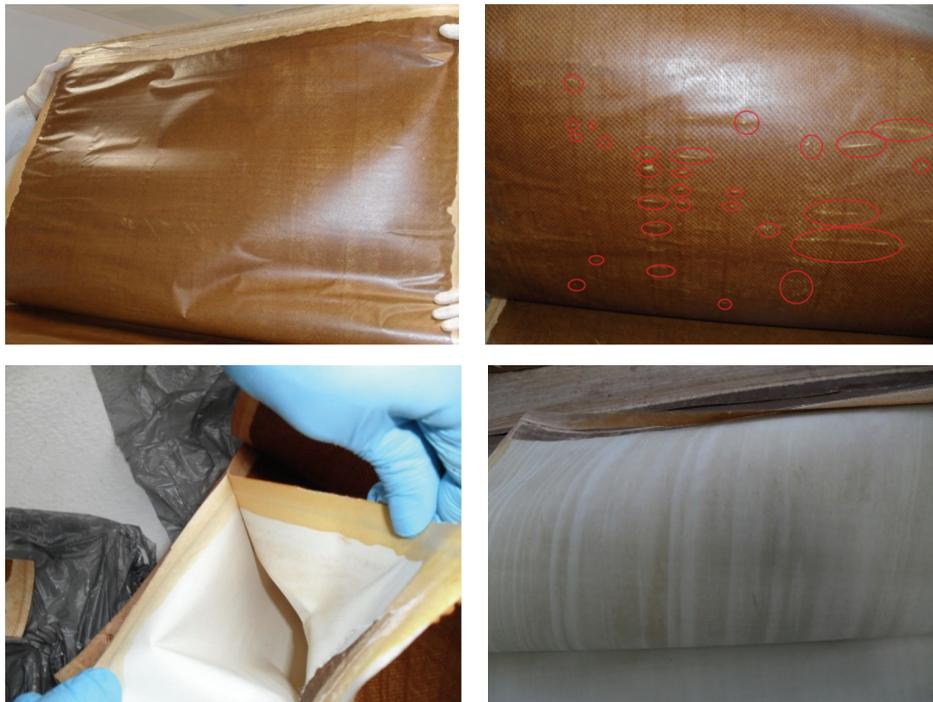
After removing of module outer shell, a brownish colored film layer was observed on each membrane sheet. This was the proof of iron fouling and biofouling (Figure 3). After the inspection of each membrane sheet, the defects on the membranes were detected as can be seen in Figure 3. These defects can be due to the combined effects of cracked shell and high pressure which led to unity and stability losses. Since module was no longer intact, applied pressure may have forced spacers to press the membrane surface. Because of that membrane surface and active layer may be deteriorated. Permeate spacers were discarded from the membrane module for observational analyses. It was seen that permeate spacers had also a brownish colored film layer which may result from damage taken (Figure 3).

FIGURE 3: Membrane leaves and permeate spacer images taken during physical inspection (circles indicate surface damage).

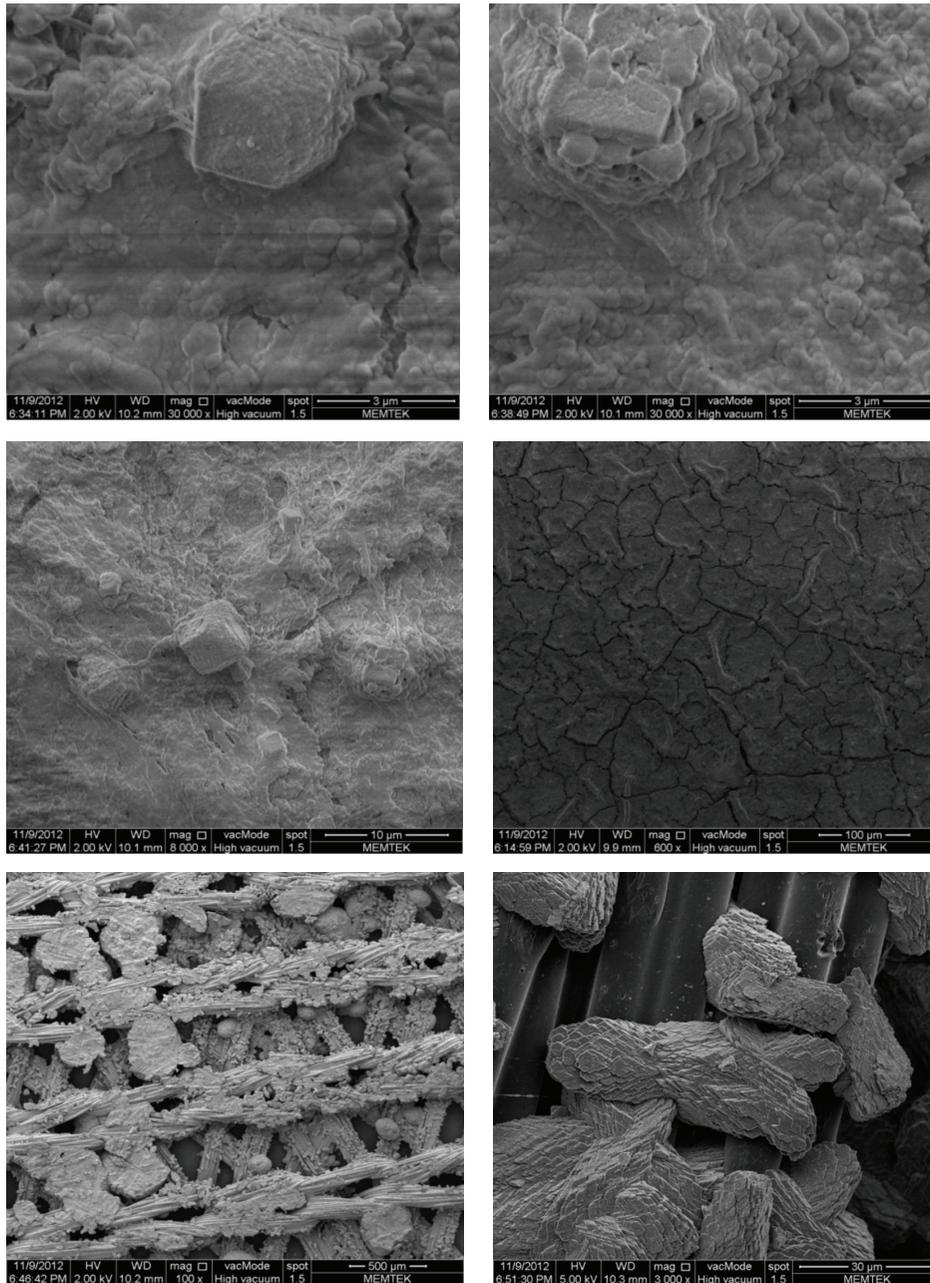
3.2. SEM/EDS Analysis. As seen in Figure 4, significant amount of organic matters was deposited on the membrane surface and a biofilm layer can be clearly seen on the membrane surface. Moreover, scaling formation that resulted from inorganic deposits was observed and it was predicted as calcium carbonate (CaCO_3) scaling based upon the shape of scaling. Chemical washing effectiveness can be affected by this inorganic scalant entrapped within organic layer.

Additionally, SEM analysis of the permeate spacer was conducted. Unexpectedly, significant amount of inorganic scales was found also on permeate spacers. EDS analysis proved that scaling arised from calcium carbonate as well.

FIGURE 4: SEM analysis of membranes and spacer.

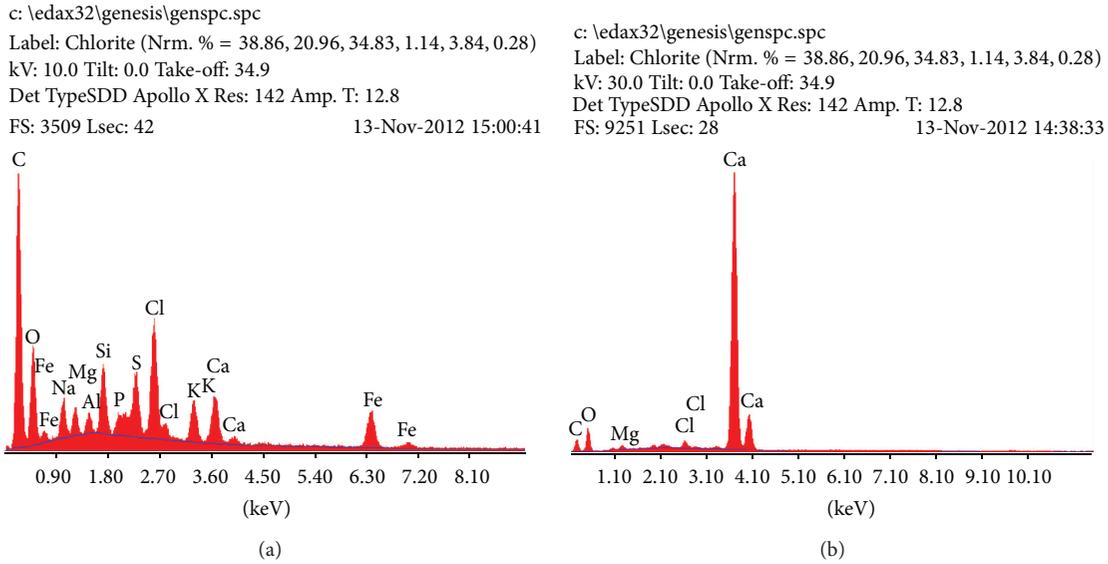
Major foulants found in the membrane and spacer's deposit layer were calcium, chlorine, silicium, magnesium, iron, and sodium according to EDS analysis (Figure 5).

FIGURE 5: EDS spectrums of membrane (a) and spacer (b) surfaces.

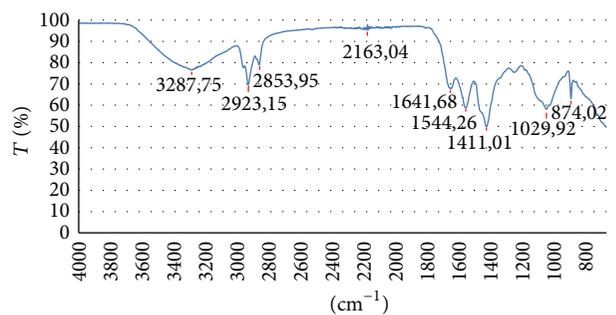
FT-IR spectra of the fouled membrane surfaces were given in Figure 6. Broad absorption peak between 3200 and 3400 cm⁻¹ indicated the presence of polysaccharides as foulants [17]. The peaks around 1640 and 1540 cm⁻¹ showed amide I and amide II bonds which show protein presence

FIGURE 6: ATR-FTIR spectra of fouled membrane surface.

[18]. The peaks around 1030 cm⁻¹ belonged to the C-O bonds which can be an indicator of carbohydrates. FT-IR results validated biofilm layer existence on the membrane surface.

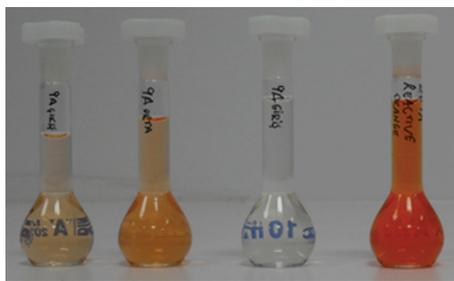
FIGURE 7: Feed dye solutions (right) and permeates collected using membranes taken from three different parts from membrane.

Dye rejection tests were conducted by using 10 mg/L reactive orange dye solution. Three random membrane samples were used in finor dye rejection test. This test aimed to find whether membranes are capable of removing color or not. Therefore, the rate of color removal was not studied in details. After dye filtration, color existed within permeates which indicated poor color rejection. Color existence in permeate can be associated with the damaged active layer on membrane surface. Different permeates obtained during dye filtration were presented in Figure 7.

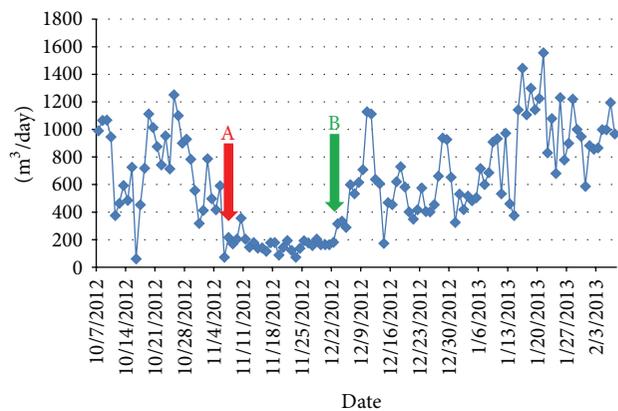
3.5. Problem Diagnosis and Strategies for Increasing Treatment Efficiency. Membrane autopsy revealed that exchanging surface aerators with bottom diffusers increased the oxygen concentration in tank. Increased oxygen amount increased ferric iron formation (insoluble form). Particulate iron caused rapid fouling of the membranes. Also particulate iron may enhance the oxidation of thin film composite (TFC) surface. Loss in the rejection performance of the membranes may occur due to TFC layer oxidation. When membrane rapidly fouled, pressure dropped so permeate amount decreased. Plant operators increased the pressure applied to compensate the permeate rate. However, pressure increase damaged outer shell of membrane module.

FIGURE 8: Flow rate graphic of NF membrane plant (A: when problem started and B: when problem solved).

One of the strategies suggested for increasing the treatment efficiency was the usage of more effective antiscalant against iron. Antiscalant specifications were given in Table 4. In the treatment plant, Vitec 3000 was used as scalant. Suggested antiscalant was Vitec 400, which is more effective for iron and silica scaling.

Performance losses and performance enhancements of the treatment can be clearly seen in Figure 8. In Figure 8, point “A” indicated starting point of the problem whereas point “B” indicated the point where the problem was solved. After the membrane autopsy, and proper problem diagnosis, treatment plant capacity increased.
