## Research Article

# An Experimental Study of Thermal Fatigue on ASTM A 213 Grade T-23 Steel Tube

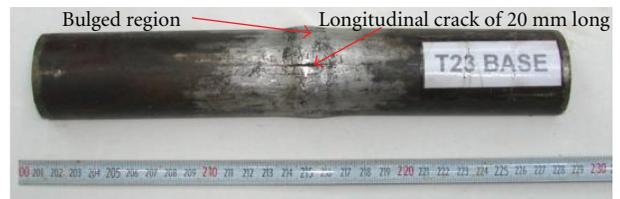
**3.1.1. Visual Inspection in Failed Base Tube.** The macrograph of the failed base tube is shown in Figure 18. From Figure 18, it is observed that many surface cracks are obtained in the base tube subjected to thermal fatigue after 120 cycles. A 20 mm long longitudinal crack is visually identified in the failed base tube at the heated zone. The tube is bulged in the heating zone due to localised heating. The failed tube is then subjected to liquid penetrant test to identify the small surface cracks.

FIGURE 18: Visual inspection of failed base specimen after subjected to thermal fatigue.

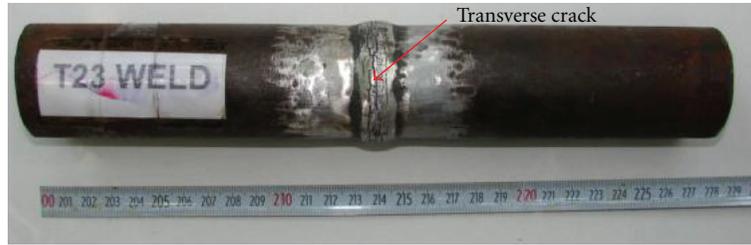
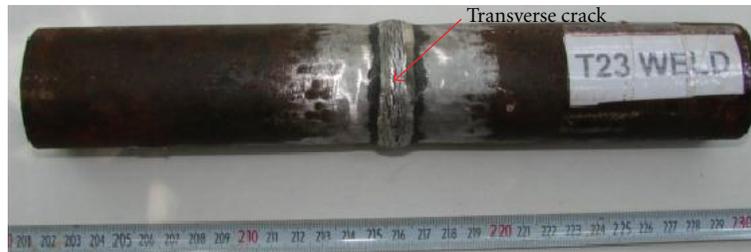
**3.1.2. Visual Inspection in Failed Weld Tube.** The macrograph of the failed weld tube is shown in Figures 19(a) and 19(b). From Figures 19(a) and 19(b), it is observed that many surface cracks are present in the base tube subjected to thermal fatigue after 80 cycles.

Transverse cracks of 80 mm long are visually identified in the failed weld tube at the heated zone.

FIGURE 19: Visual inspection of failed weld specimen after subjected to thermal fatigue.

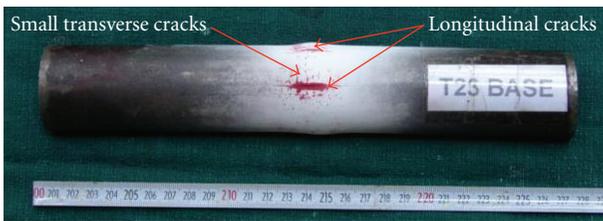
**3.2.1. Liquid Penetrant Test on Failed Base Tube.** The macrograph of the failed base specimen subjected to liquid penetrant test is shown in Figure 20 and it clearly shows that many longitudinal cracks are found in the heated zone and from the longitudinal crack, small transverse cracks are also identified, which were not seen in the visual examination.

FIGURE 20: Liquid penetrant examination of failed base specimen.

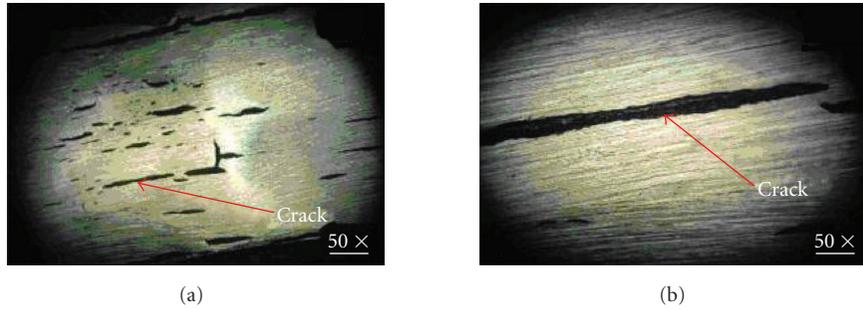
FIGURE 23: Surface crack obtained in the failed base tube.

3.4.1. *Macrostudy on the Failed Base Tube.* Figure 23(a) shows the magnified view of the surface crack obtained in the failed base tube subjected to thermal fatigue and it is clearly identified that many longitudinal cracks are found in the heated zone, and from the longitudinal crack small transverse cracks are also developed. Figure 23(b) shows the magnified view of the single longitudinal crack obtained in the failed base tube.

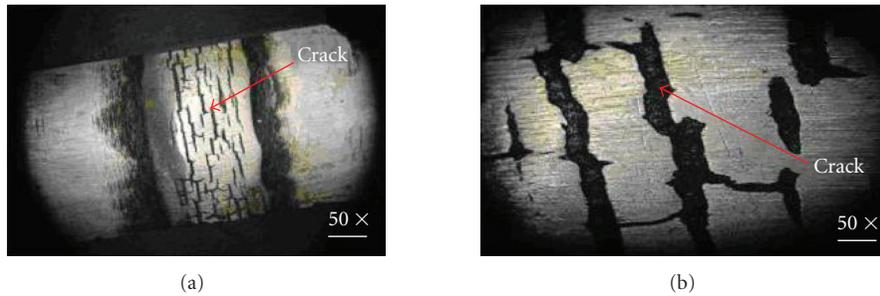
FIGURE 24: Surface crack obtained in the failed weld tube.

3.4.2. *Macrostudy on the Failed Weld Tube.* Figure 24(a) shows the magnified view of the surface crack obtained in the failed weld tube subjected to thermal fatigue and it is clearly identified that many transverse cracks are found in the weld joint, and from the transverse crack small longitudinal cracks are also developed. Figure 24(b) shows the magnified view of the surface crack obtained in the failed weld tube.

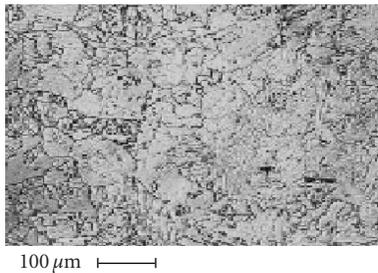
FIGURE 25: Microstructure of the failed base in defect free region.

(1) *Study on the Defect Free Surfaces on the Failed Base Tube.* The microstructures of defect-free surfaces of the failed base tube are shown in Figure 25.

Figure 25 shows the optical microstructure of failed base tube taken in the defect free surface. The microstructure of T23 failed base tube shows that the grains are little coarse and irregular in shape. The failed thermal fatigued base tube shows similar microstructure as observed in the base tube before being subjected to thermal fatigue. This reveals that during thermal fatigue there is no phase transformation taking place in the base tube subjected to thermal fatigue.

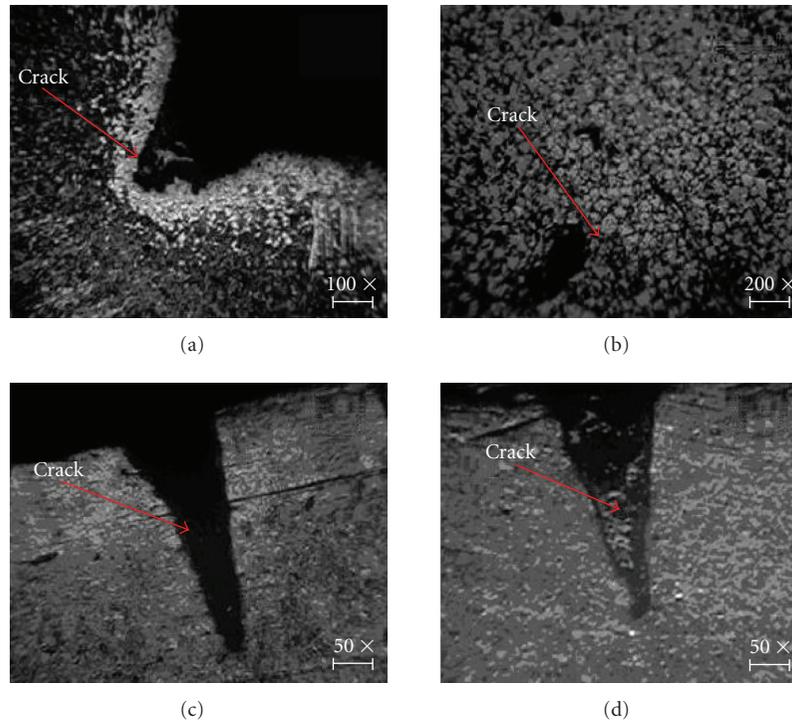
FIGURE 26: Cracks identified in the failed base tube.

(2) *Study on the Defect Surfaces on the Failed Base Tube.* Through the optical microscope, the defect surfaces in the T23 base tube are identified and presented in Figures 26(a)–26(d). From the Figures 26(a)–26(d) it is clearly identified that large number of cracks are present in the failed base tube. The cracks have developed from the heating surface (outer surface) of the tube and propagate towards the inner surface. Cracks are observed in the failed base tube have a close resemblance with cracks observed in the failed tubes [6]. In Figure 26(a), mild decarburization to the depth of one grain is observed. The obtained cracks in the failed base tubes show blunt tip cracks as shown in Figure 26. This crack shows typical characteristics of thermal fatigue failure.

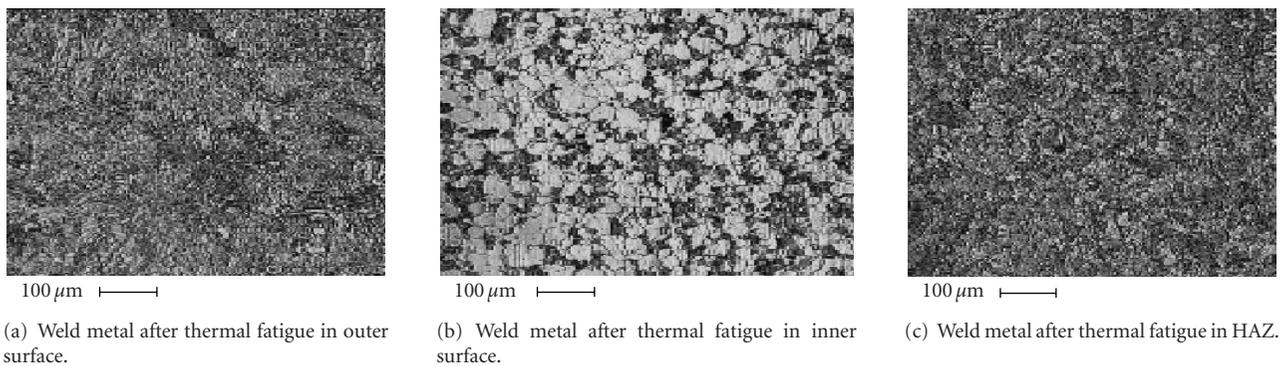
FIGURE 27: Microstructure of weld region in defect free areas of the failed weld tube.

(1) *Study on the Defect Free Surfaces on the Weld Tube.* The microstructures of defect-free surfaces of the failed weld tube are shown in Figures 27(a) and 27(c). The microstructures of the weld are taken on the outer surface, HAZ, and inner surface of the tube as shown in Figures 27(a) and 27(b). When compared to the grains observed in inner surface of the tube, the outer surface and HAZ shows very finer grains. This difference is due to the application of the heat from the outer surface of the tube to the inner surface. Formation of martensite is more as observed in the failed welded tubes when compared to the base tubes.

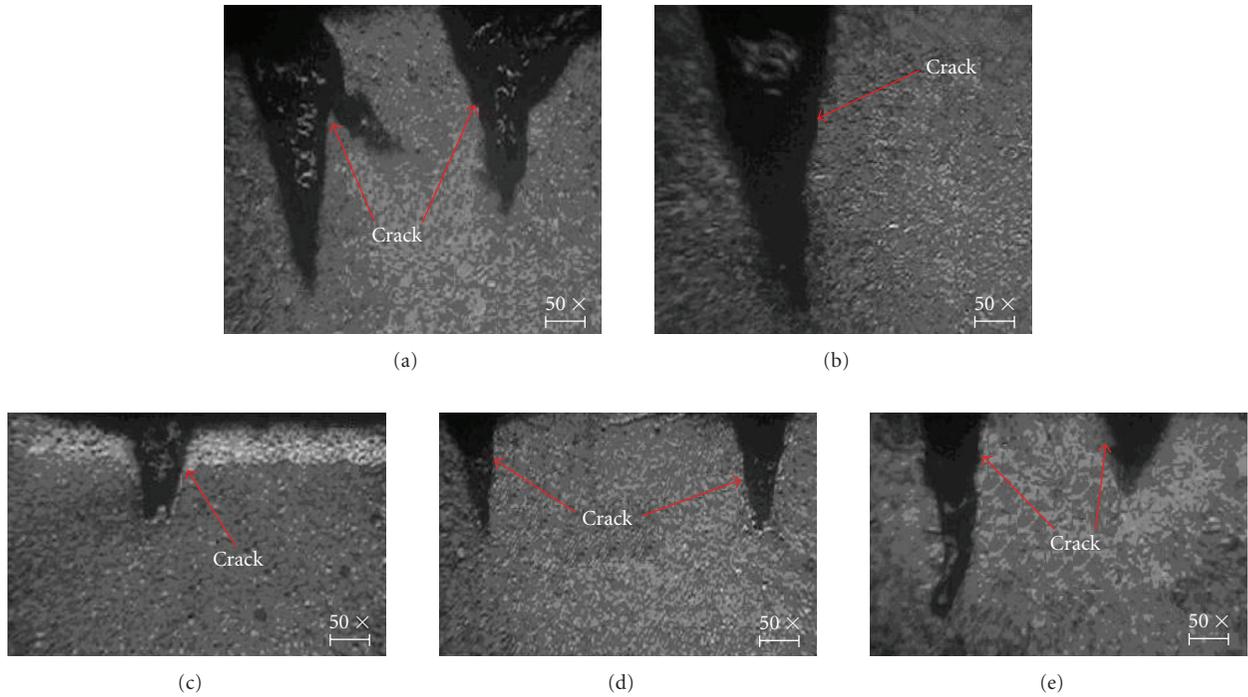
(2) *Study on the Defect Surfaces on the Weld Tube.* Through the microstructures, the defect surfaces in the weld tube is identified and presented in Figures 28(a)–28(e). From Figures 28(a)–28(e), it is clearly identified that large number of cracks are present in the failed weld tube. The cracks are developed from the heating surface (outer surface) of

FIGURE 28: Cracks identified in the failed weld tube.

the tube and propagate towards the inner surface. Cracks observed in the weld tube which had a close resemblance with cracks observed in the failed tubes as reported in [6]. The obtained cracks in the failed base tubes show that blend tip cracks and parallel cracks are also observed as shown in Figure 28. This crack shows typical characteristics of thermal fatigue failure.

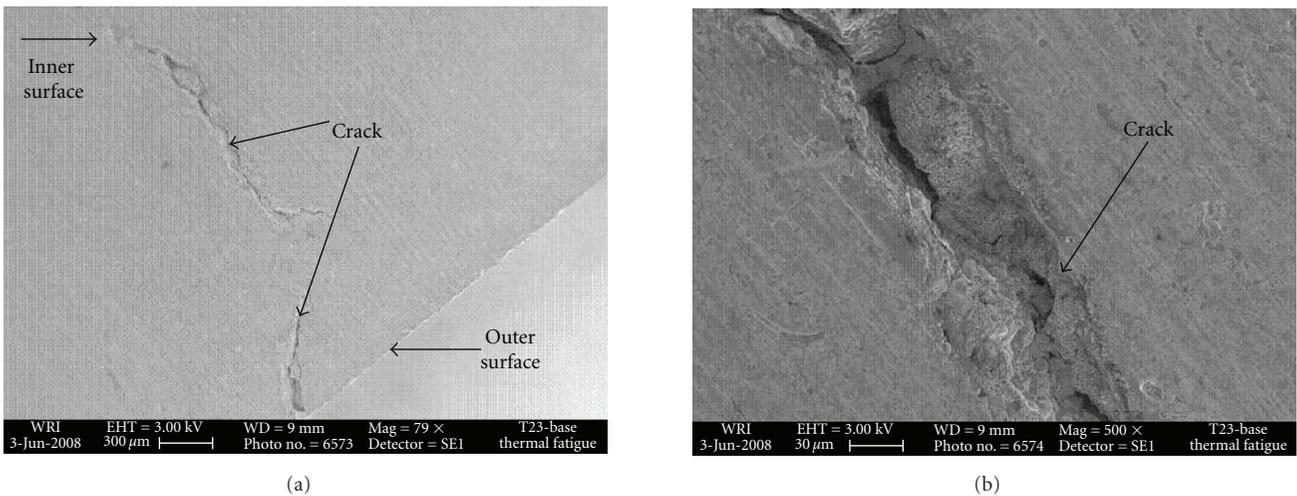
FIGURE 29: Crack propagation in the failed base tube.

3.6.1. Defect Surface on Failed Base Tube. The cracks observed in the SEM photography of the failed base tube are shown in Figures 29(a) and 29(b). From Figures 29(a) and 29(b), the cracks are developed from the outer surface of the tube and propagate towards the inner surface. Similarly it travels through or across the circumference of tube heated region. When it is compared to the cracks obtained in the failed weld tube, the width and depth of the cracks are less as shown in Figures 29(a) and 29(b). The cracks have been opened and examined as shown in Figures 30(a) and 30(b). They revealed smooth-oxidized crack surfaces. From Figure 31, Mosaic-like crack formation is observed when it is magnified. From Figures 29(a) and 29(b) it is clearly

identified that the initial position of the crack width is high, when it propagates towards the inner surface, the crack growth rate increases due to the temperature difference and rate of cooling. Due to these reasons, cracks are developed.

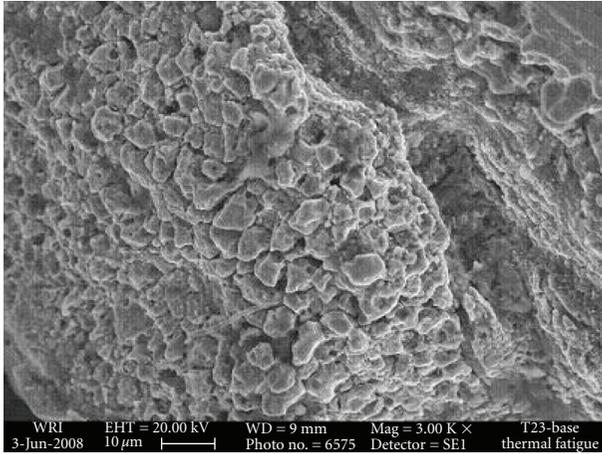
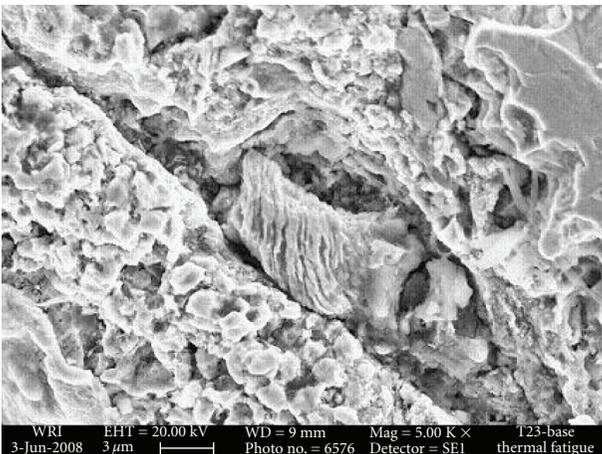
FIGURE 30: Smooth-oxidized crack surfaces.

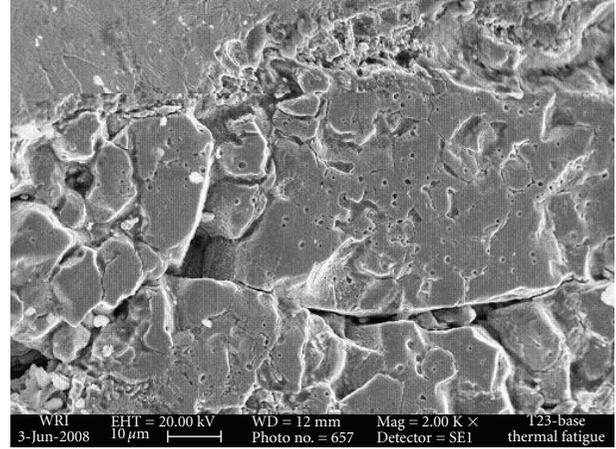
FIGURE 31: Mosaic-like crack formation.

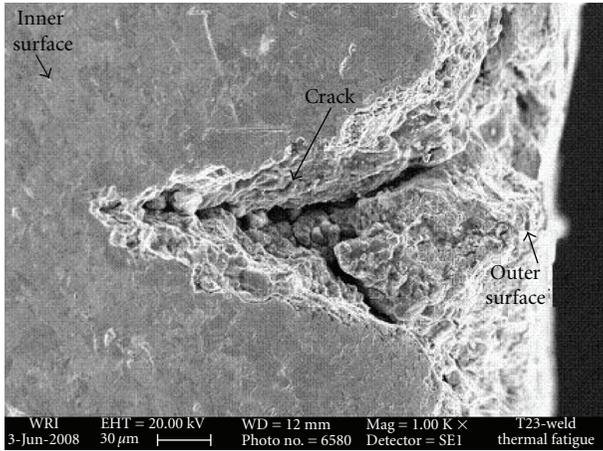
**3.6.2. Defect Surface on Failed Weld Tube.** Figure 32 shows the microstructure taken in an unaffected region of the failed weld tube. The defects present in the failed weld tube are shown in Figures 33(a) and 33(b). From Figure 33, the cracks are developed from the outer surface of the tube and propagate towards the inner surface. Similarly, it travels in the circumference of the tube-heated region. When compared to the base crack, the size of the crack obtained in the weld is large. Mosaic-like crack formation is observed when it is magnified as shown in Figures 34(a) and 34(b) which is a typical thermal fatigue crack. From Figures 33(a) and 33(b), the initial crack width is large, when it moves towards the inner surface, the crack growth rate increases due to the temperature difference and rate of cooling. Due to these reasons, cracks are developed.

FIGURE 33: Crack propagation in the failed-welded tube.

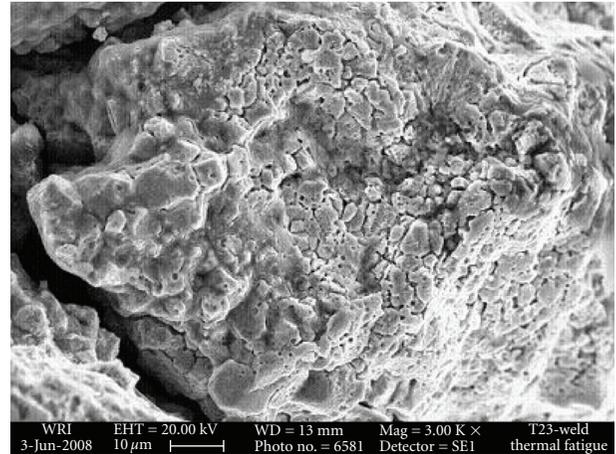
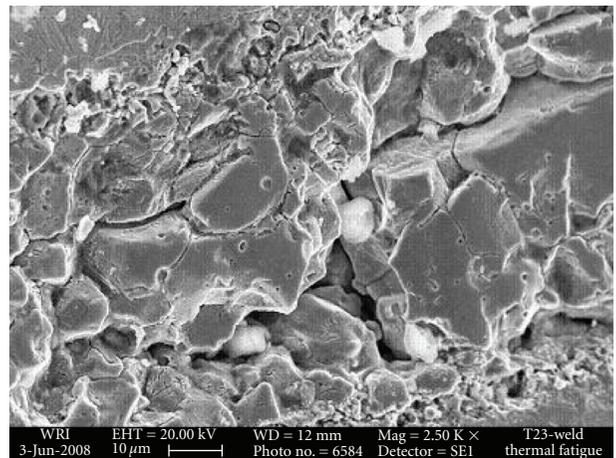
FIGURE 34: Smooth oxidized crack surfaces and Mosaic-like crack formation.

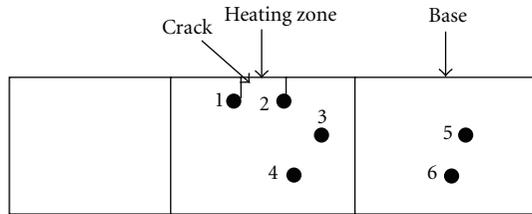
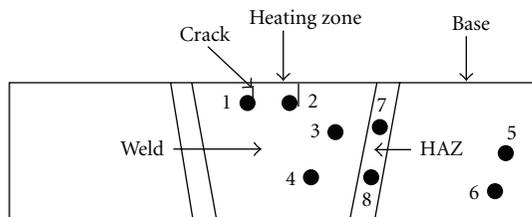
**3.7. Hardness.** Vickers's hardness measurements are taken on the base and welded tube, before subjected to thermal fatigue and after failure occurs. The hardness location taken in the base and welded specimen is shown in Figures 35 and 36. The load applied is 10 kg and the hardness values taken in the base and welded specimen are tabulated in Tables 3 and 4.

From Tables 3 and 4, the hardness value is much higher nearer in the cracked zone. Due to the higher hardness, the initiated cracks due to the thermal fatigue can propagate towards the circumferential areas and through the thickness of the tube. The hardness value of the weld near the crack zone is nearly closer, due to repeated heating and cooling.
