Review Article

Geotechnical Distinction of Landslides Induced by Near-Field Earthquakes in Niigata, Japan

Hirofumi Toyota and Susumu Takada

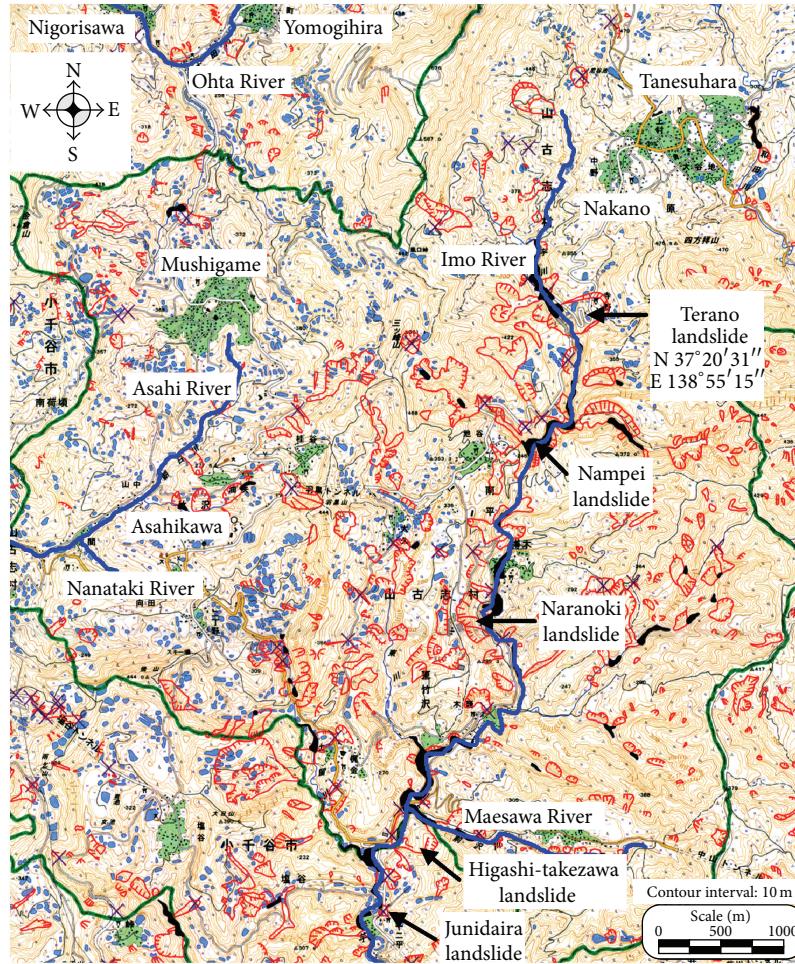
3.1.1. Old Landslides. “Tanesuhara,” “Mushigame,” and “Asahikawa” in Yamakoshi area have been described as representative designated landslide areas. Figure 3 presents a landslide map of those areas during the Mid-Niigata Earthquake provided by the Geospatial Information Authority of Japan (GSI). River-clogging landslides along the Imo River during the earthquake are the “Terano,” “Nampei,” “Naranoki,” “Higashi-takezawa,” and “Junidaira” landslides from upstream (Figure 3). Among those landslides, Terano and Higashi-takezawa were large-scale landslides, which required urgent countermeasures against river clogging.

FIGURE 3: Disaster map around Yamakoshi area during Mid-Niigata Earthquake (provided by GSI).

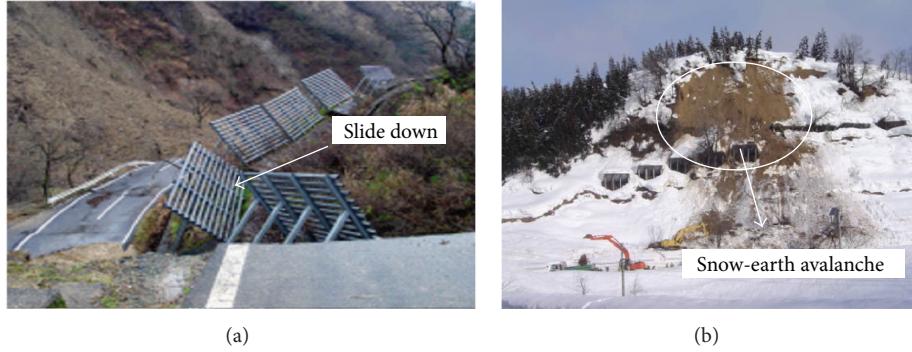
Snow avalanches occurred more frequently than year than in a normal winter. Some slopes were not covered with deep snow because a small snow slide occurred at all snowfalls. However, frequent patrols were conducted, preventing heavy damage. The risk of avalanche was reduced by the removal of unstable snow, construction of snow walls, and road closures during the winter. A new type of avalanche, where snow fell together with surface soil stripped from the damaged slope, was observed in Tokamachi City (Figure 1) as shown in Figure 11(b). An avalanche of this type, called a “snow-earth mixture avalanche,” is regarded as a compound natural disaster, causing extensive damage to residences and roads [21].

FIGURE 11: (a) Damage to snow avalanche fence; (b) snow-earth avalanche [21].

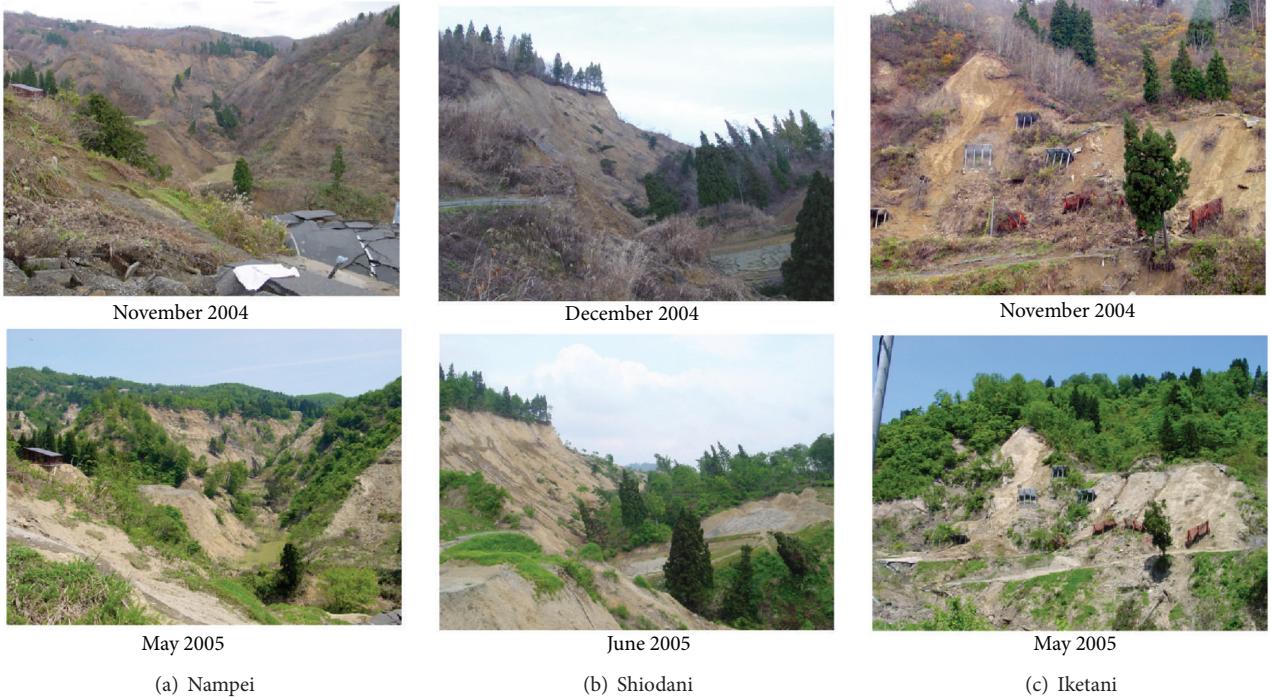
FIGURE 12: Slope failures: upper row, before winter, and lower row, after snow-melting season.

movement occurred during the snow-melting season. These sliding masses induced by the Mid-Niigata Earthquake were therefore stable except for erosion from rain and snow melting. Situations of slope failures can be compared for those before winter and after the snow-melting season in Figure 12. There is no apparent difference between the photographs.

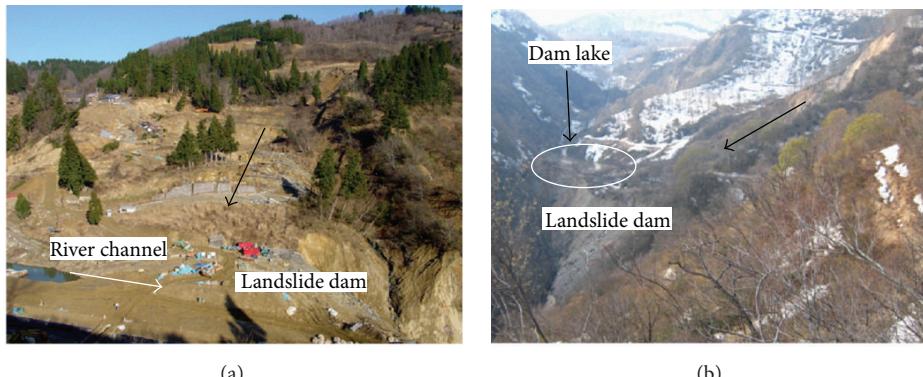
FIGURE 13: Typical river-clogging landslides that occurred (a) during the Mid-Niigata Earthquake and (b) during the Northern Nagano Earthquake.

which is different from the tertiary mudstone of the Chuetsu area (Figure 2). Examples of slope failures are exhibited in Figure 13. Figure 13(a) shows a river-clogging landslide at Yamakoshi area during the Mid-Niigata Earthquake. The weak soft deposit moved down and closed the Imo River channel. Figure 13(b) presents river-clogging landslides at Sakae Village during the Northern Nagano Earthquake. Apparently, the weathered part of a steep cliff fell and clogged a narrow valley. Then the dammed lake was created by the moving mass. However, the tertiary mudstone is distributed in Tokamachi and Tsunan areas (Figures 1 and 2) where strong seismic motion was recorded during the earthquake. Therefore, the second considered reason is that groundwater level might not be high during the Northern Nagano Earthquake compared with that of the Mid-Niigata Earthquake, as shown in Figure 9(a). From Figure 10, it is inferred that the ground water level remained low immediately before snow melting during the Northern Nagano Earthquake. Although snow remained deeper than 2 m in mountainous areas, few snow avalanches were triggered by the earthquake. Accumulated snow is apparently quite stable against earthquakes during this season (March). Consequently, the relations between the epicentre, the geography including geology, and groundwater level are extremely important factors to discuss to assess the risk of landslide damage.
