Research Article

Construction Practices Contributing to Rising Damp in Kumasi Metropolitan and Ejisu Municipal Assemblies in Ghana

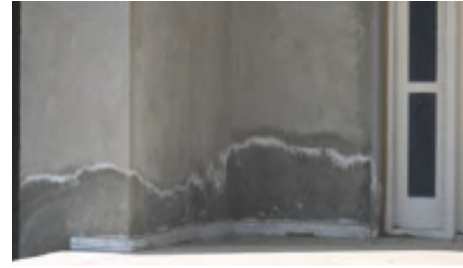
FIGURE 1: Tidal mark on wall in Kumasi.

2.2. The Effects of Rising Damp. The World Health Organization publications on “Damp and Mould” (WHO, 2009) indicated that, in Europe, between 10 and 50% of the indoor environment, where people live, work, and play, are damp as a result of humid conditions [9]. Humid walls create coldness, which require more heating energy leading to increase in energy bills. This buttresses the need to consider thermal conductivity materials of various types in relation to dampness. The rate of evaporation on the external wall is related to the nature of wall surfaces, climate, orientation, and location [24]. As moisture evaporates from both sides of the wall, more water is drawn from the ground and a continuous upward flow of water occurs. The upward movement of water causes stains on internal walls, crumbling of plastered surface, paint peel off, and leaving a musty smell. On the external walls, signs of rising damp can usually be seen at the base of the masonry walls, where crumbling plaster and peeling paint are evidence. Severely affected masonry exhibits extensive decay, and powdery salt residue can clearly be seen at the base of the wall resulting into efflorescence, tide mark, mould, and fungi [25]. Dampness in walls of buildings lead to physical, biological, or chemical deterioration of building materials. The presents of damp also affect the quality of air in relation to human health and comfort. According to the WHO (2009), some occupants of damp rooms are at risk of experiencing health problems such as respiratory infections, allergic rhinitis, and asthma [10]. Damp also affect the structural integrity of timber products, walls, and thermal insulation in buildings [26]. Figures 1 and 2 show tidal mark and growth of mould and fungi effects, respectively.

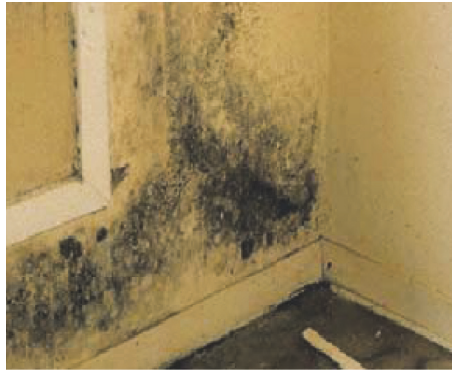
FIGURE 2: Moulds on walls in Ejisu.

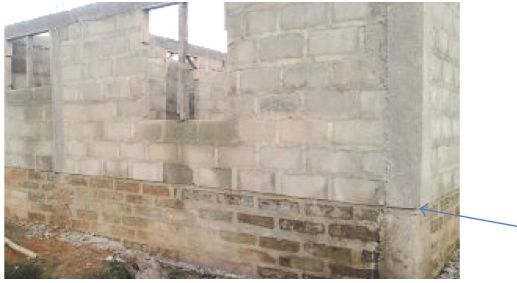
4.2.1. Failure to Use Damp-Proof Material. The straight method of building construction, where sandcrete block wall starts from foundation to superstructure lintel without floor bed concrete and damp-proof materials, was in practice. All the new building sites visited were identified with these poor construction practices. These practices promote speedy capillary action causing rising damp in most buildings. As shown in Figure 3, the arrow shows the boundary between the foundation and superstructure masonry block where there is no floor concrete bed and no damp-proof material. These practices were mostly found at private construction sites.

FIGURE 3: Building without floor concrete bed.

Consultants, and site supervisors should ensure that damp-proof materials are always part of their specifications and also indicate how it should be used. Artisans should be educated on the right application of damp-proof materials and their functions. Construction of block work from foundation to superstructure lintel, without ground floor bed concrete, should not be accepted by consultants.

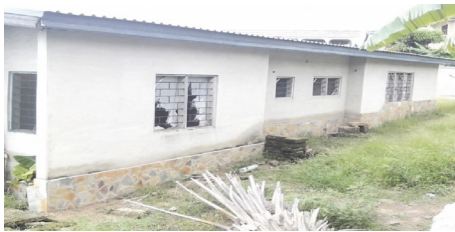
4.2.2. Cladding on Wall Surface. Buildings experiencing rising damp were cladded with the use of wall tiles, marble stones, and tyrolean finish as shown in Figure 4. The study revealed that these methods were ineffective due to the continual capillary action through the pores of the block wall

from the foundation [30]. The finish losses bonding and rising damp reappeared above as shown in Figure 4.

FIGURE 4: Rising damp above marble stone.

The study recommend that all plumbing fittings and fixtures should be tested to detect leakages, making them good before finish works commence. Also, the use of tyrolean, terrazzo, and tilling is not effective and efficient measures of remedying rising damp, undersetting and saw slotting are the most recommended methods. Proper placement of damp-proof materials in all foundation works for new buildings construction should be strictly enforced by consultants irrespective of the type of soil or geographical location.

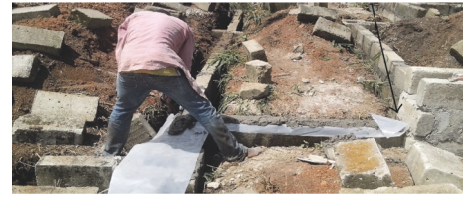
4.2.3. Artisans' Lack of Appreciation of the Use of Damp-Proof Materials. The study observed that most of the artisans at the private building sites visited did not understand the concept and the application of damp-proof materials. It was revealed that the artisan handled the material (polythene) arbitrarily without due recognition, leading to holes, inadequate lapping, and discontinuation of the damp-proof material as shown in Figure 5 by the arrow. At some sites the material was wrongly placed. These acts by artisans make the provision of material ineffective.

FIGURE 5: Placing of damp-proof material in foundation.

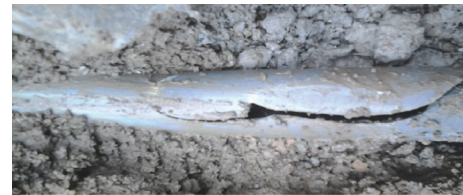
4.2.4. Nontesting of Plumbing Service Pipe. Rising damp was identified in buildings particularly where service pipes had busted and leaked under paved compound and were not detected on time. These were prevalent in new completed buildings where testing of an entire plumbing installation was not done before ground paving, as shown in Figure 6. Lack of regular monitoring and maintenance of plumbing works was identified as one of the causes of rising damp in buildings.

FIGURE 6: A burst PVC pipe beneath paved compound of a house.

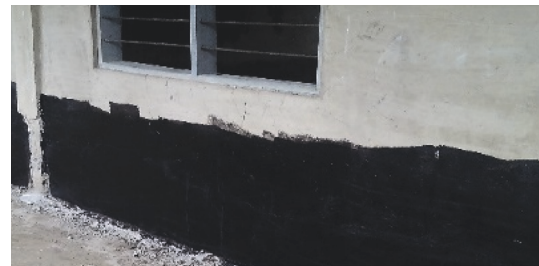
4.2.5. Application of Bitumen. The application of water-based bitumen compound to wall with rising damp crinkled and flaked off due to moist within wall as shown in Figure 7. The moist in wall caused loss of adhesion of the bitumen compound on the wall surface.

FIGURE 7: Bitumen applied before painting.
