Shear Stress Analysis and Crack Prevention Measures for a Concrete-Face Rockfill Dam, Advanced Construction of a First-Stage Face Slab, and a First-Stage Face Slab in Advanced Reservoir Water Storage

Kongzhong Hu, Jiankang Chen

College of Water Resource & Hydropower, Sichuan University, Chengdu 610065, Sichuan, China

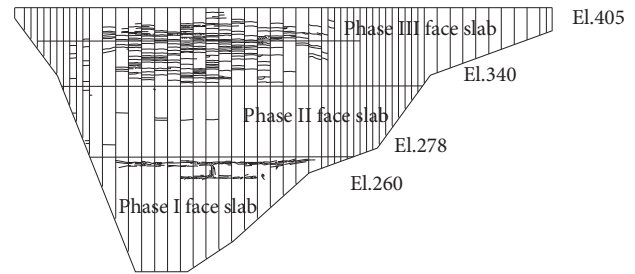
The concrete slab has a flexible, thin plate structure [16]. The internal reinforcement of the first-stage slab is equipped with a single layer of steel mesh along the middle layer, such as that of Buxi Power Station. In addition, the outer edge within the slab is provided with double steel mesh, like that of the Shuibuya Power Station. The analysis of structural stress characteristics reveals that double-layer reinforcement is more advantageous than single-layer reinforcement in structural shearing resistance [17]. However, it is not absolutely perfect. Figure 1 shows the on-site drawing of the Shuibuya slab crack. Figure 2 displays the on-site photo of the slab penetrating the crack for Buxi Power Station. The figure indicates that because Buxi Power Station is equipped with single-layer steel mesh, its shearing resistance is weak. Thus, the first-stage slab presents a large extent of shearing failure. The slab is brittle, bulging, and broken into large pieces, and the steel rebar undergoes distortion and deformation. Although Shuibuya shows no large-scale shearing failure, the cracks in the upper and lower layer also appear in the relatively concentrated region, and the cracks display an “I” shape [18].

FIGURE 1: Sketch of the slab crack distribution at Shuibuya Power Station.

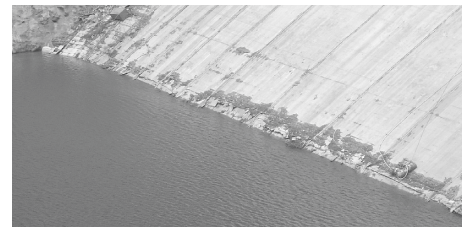
FIGURE 2: Image of slab cracks at Buxi Power Station.

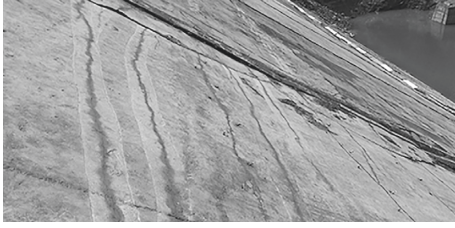
4.1. Slab Fracturing. When phase I of the face construction was completed, inspection of slab fractures in February 2011 resulted in identification of 46 fractures in the concrete face. All were horizontal fractures. Six fractures were 0.15 mm or greater in width, and 2 fractures were 0.2 mm or greater in width. During the phase II face impoundment, 12 microfractures were discovered. When the dam impoundment reached 3297.5 m in elevation, 5 microfractures were discovered between elevations of 3297.5 m and 3300 m. Because the fractures were small, they were repaired with HK-G epoxy grouting material and PUA-75 polyurea elastic coating and surface sealing material.

FIGURE 5: Horizontal fractures in the concrete-face slab.

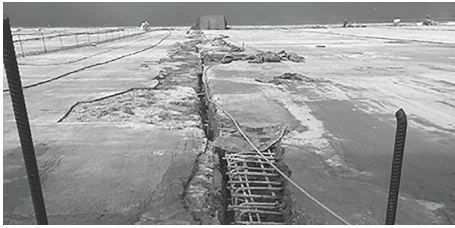
FIGURE 6: Extrusional deformation along the slab joints.

The dam at the Buxi Power Plant is an irregular, deep U-shaped structure whose left bank is steep and whose right bank is a distinct staircase terrace. Due to this configuration, the rockfill body on both sides tends to develop extrusional deformation toward the river's center. Therefore, deformation along slab joints is normal. Analysis of images of the deformation suggests that the total deformation is within a reasonable range. However, the horizontal fracturing and extrusional joint deformation were insufficient to cause the sudden increase in seepage after August 2012. Analysis results suggest either significant failure elsewhere or significant seepage within the dam body. Analysis of horizontal stress and vertical stress at 3255 m shows that, by approximately July 2012, the concrete face experienced a significant, abrupt change, and that time point exactly coincides with the reservoir impoundment in phase II, stage II.

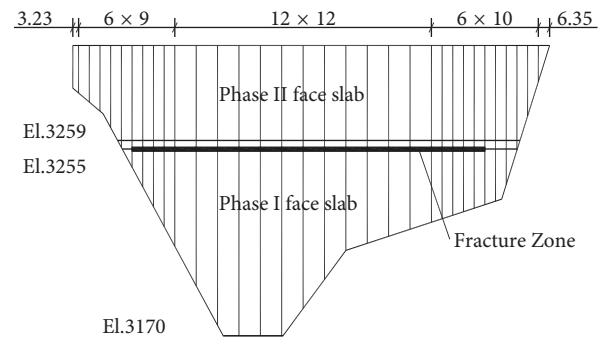
In April 2014, the reservoir was lowered. When the water level dropped below the elevation of the temporary construction joint between phases I and II, severe deformation of the concrete face at the river centerline was observed near the temporary construction joint with phase I. Bulging of the concrete created large blocks representing brittle failure, and rebar was exposed and developed contortional deformation. This fracturing had a widespread effect. Except for face 28 on the left and faces 4, 5, and 6 on the right displaying no marked fracturing, fracturing almost penetrated the

temporary construction joints between the other concrete faces of phases I and II. Analysis suggests that the main cause of the sudden increase in seepage measured at the weir after August 2012 was that water flowed downstream through this seepage channel in the dam body.

FIGURE 12: Location of slab fracturing in the phase I portion.

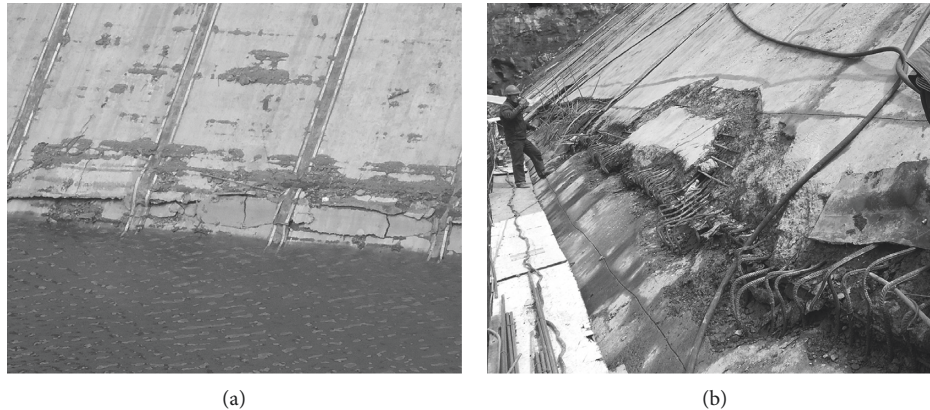
Analysis of the concrete face stress monitoring data and photographs suggests that the fracture deformation of the face near the temporary construction joint in the phase I portion was likely caused by a specific mechanism. It appears that the reservoir water level during phase I was high and that stress within the concrete face was substantial. Before the placement of concrete in phase II, the interior stress in the phase I face had not dissipated sufficiently. As the water level rose in phase II, this stress generated significant shear stress near the temporary construction joints between phases I and II, which finally led to shear stress failure in the concrete face.

FIGURE 13: Local failure of the face in the phase I portion.

- (1) By comparing concrete slab cracks of Buxi Power Station with those of Shuibuya Power Station, in the case of advance slab construction and reservoir water storage, the first-stage concrete slab should be equipped with double-layer steel mesh to strengthen shear stress resistance.

- (2) Calculation reveals that if a large shear stress value is obtained, appropriate shear reinforcement steel rebar should still be arranged to increase the shear deformation resistant ability and reduce the probability of crack occurrence on the face slab.

- (3) Prior to concrete pouring of the late-stage face slab, the reservoir water should be lowered to a certain level to allow the internal stress of the slab to be moderated and unleashed, thereby reducing the internal stress intensity of the first-stage face slab and the stress change during late-stage reservoir water storage.

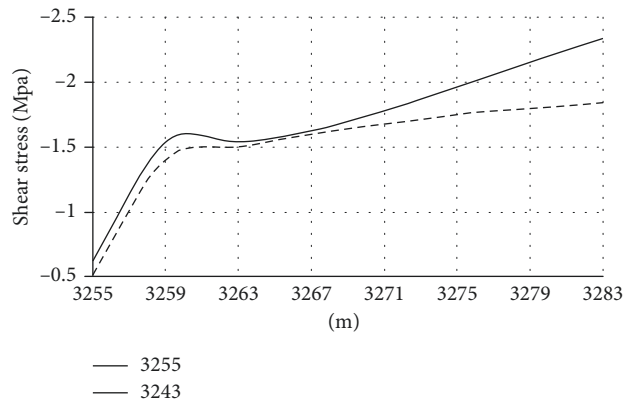
Figure 20 shows that the two horizontal shear stress values tend to increase as the reservoir water level rises. However, the increase in shear stress at an elevation of 3255 m is faster than at 3243 m; that is, its shear stress will reach the ultimate shear strength value first and cause shear cracks, resulting in cracks on the concrete slab.

According to our analysis, stress transfer during upper dam filling and water pressure from a high reservoir water level are the primary causes of greater shear stress at 3255 m of elevation in sectioned construction and water storage (the water level of first-stage water storage is at 3255 m, which is only approximately 4 m lower than that of the first- and second-stage temporary construction seams). Some stress has been generated within the first-stage concrete slab. Since the reservoir water level was not lowered in the second-stage slab construction, the stress of the first-stage slab has not been effectively reduced or eliminated; therefore, the internal stress of the first-stage slab has changed considerably as the water level of the second-stage water storage rises, and the shear stress value at 3255 m gradually increases. When the reservoir water level rises to a certain height, the strengthened shear stress causes shear failure at 3255 m. The first-stage slab of Buxi Power Station is a single-layer steel reinforcement that has weak shear stress resistance. When the first-stage slab undergoes shear failure, due to the release of internal stress, the shear stress strength of the following layer is weakened, and second horizontal cracks such as those of Shuibuya will not occur. The moment that shear failure occurs under stress, the steel mesh located in the middle of the slab causes a large, brittle fracture of concrete through stress distribution.

FIGURE 20: Diagram of maximum shear stress corresponding to change in the water level in two horizontal shear stress regions of the first-stage slab.
