Rethinking the Water Leak Incident of Tunnel LUO09 to Prepare for a Challenging Future

Wen-Chieh Cheng

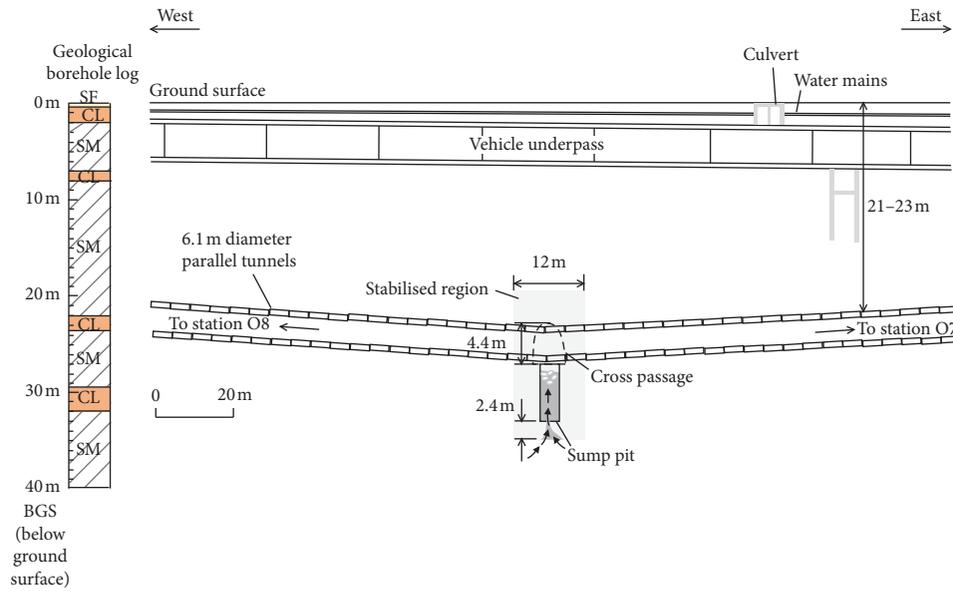
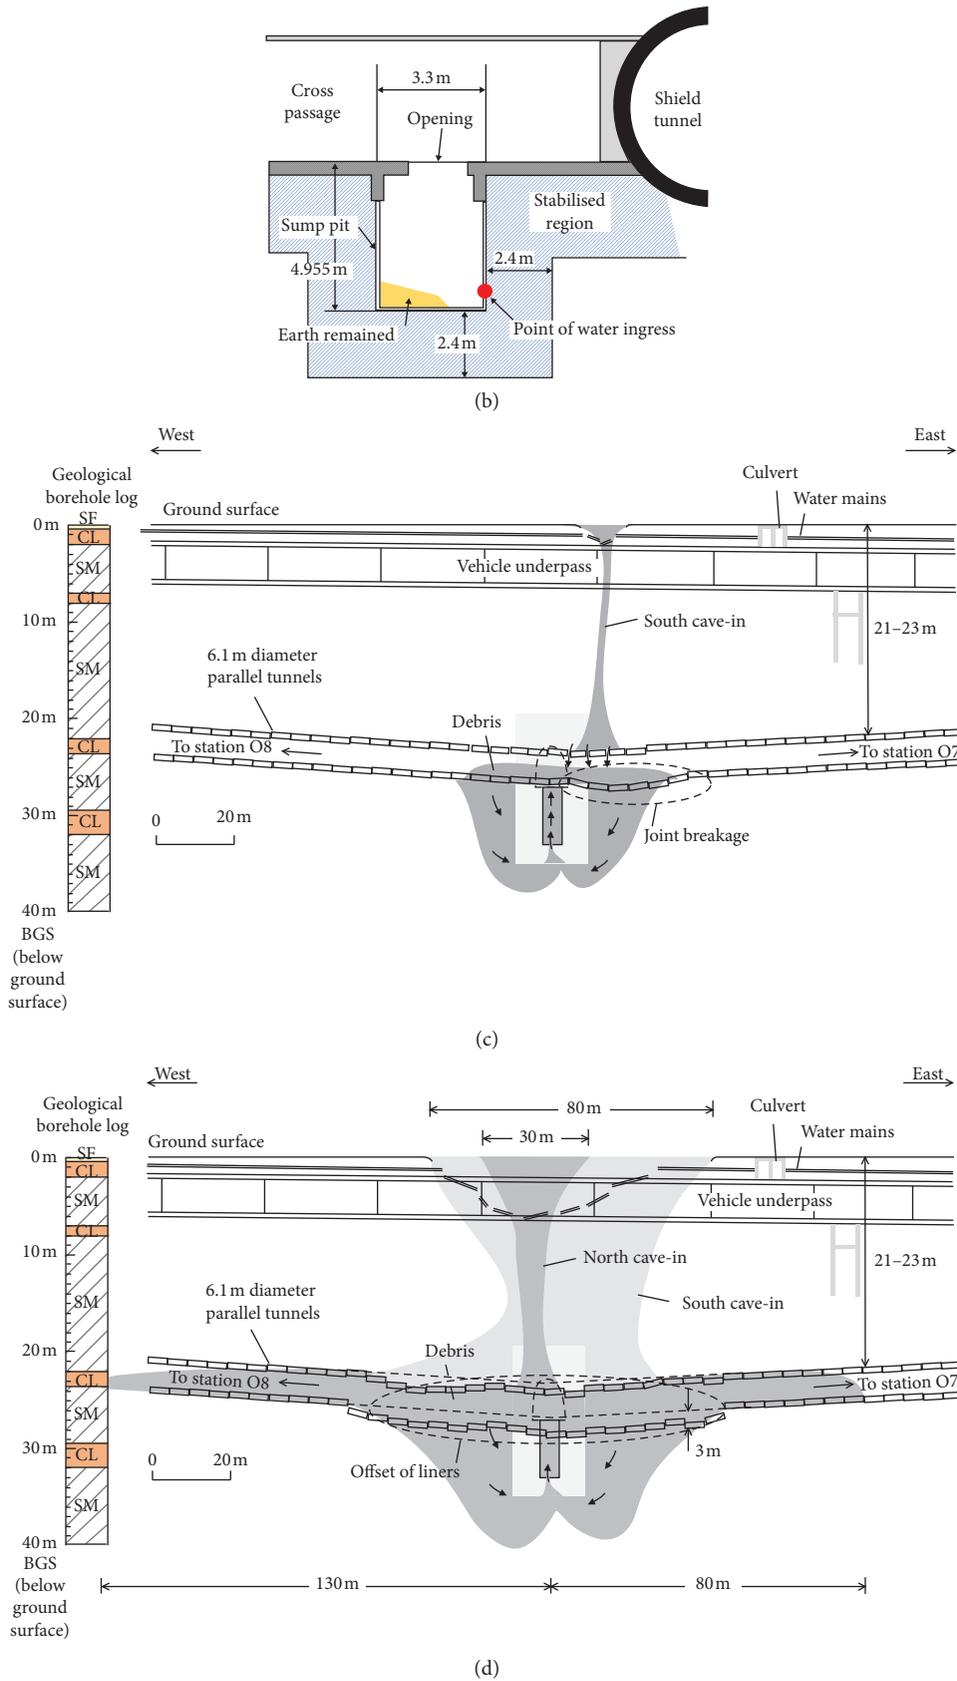
2.2. Incident, Associated Damage, and Remedial Measure. It was noticed that an outburst of mud water occurred while excavating to near the bottom of the sump pit (Figure 2(a)). Authorities immediately responded to the water ingress event by dumping sand bags and quick-set cement but in vain. Men at work soon heard sounds of breaks at liner joints of the tunnel on the south side, with water leaked into the tunnel from the ripped liner joints. The water also carried away fine particles, and the tunnel due to this reason lost contact with the ground leading to stepwise surface settlement in the longitudinal direction. More soil, while the settled cone expanded upwards, fell by slipping along the vertical wall of the vehicle underpass and passing through the ripped liner joints into the tunnel. Not only serious ground loss but also two undermined water mains transferred the soil into more flowable debris, causing a large surface cave-in on the south side (Figures 2(c) and 3(a)).

The ground loss also caused the tunnel on the north side to sink, accompanied by the offsets of the liners (Figure 3(b)). The soil fell into the tunnel mainly from the liner offset at the junction between the tunnel and the cross passage, leading to another surface cave-in (Figures 2(d) and 3(a)). To summarise, the amount of earth and quick-set cement dumped to fill the surface cave-ins was estimated to

FIGURE 2: Scenario for progressing the water leak incident: (a) water leak (SF: backfill; SM = silty sand; CL: low plasticity clay), (b) illustration of the shortest path for groundwater seepage, (c) formation of the surface cave-in on the south side, and (d) formation of the surface cave-in on the north side (SF: backfill; SM = silty sand; CL: low plasticity clay).

3.1. Triggering Mechanism. The piping phenomenon was responsible for initiating the water leak incident, with reference to the testimony of workmen. Notwithstanding that, the initiation of piping was conceived variously. The existing vehicle underpass, in fact, led to some difficulties in installing the jet-grout columns exactly in the plumb. Thus, the overlapping of jet-grout columns was estimated to be less than the design value of 60 cm, and some seepage-prone weak zones were thus developed. On the other hand, as the groundwater level was at 5–6 m depths below the ground surface, the head difference between the groundwater level and the 34 m depth where the piping initiated was 29 m. The length of the shortest path for groundwater seepage was from the bottom of the soilcrete body to the point of water ingress, that is, 2.4 m (Figure 2(b)). This came out with the hydraulic gradient i being equal to about 12.1 ($i = 29 \text{ m}/2.4 \text{ m} = 12.1$). The critical hydraulic gradient i_{cr} for triggering piping within gap-graded sand-gravel mixture could be as low as 0.2–0.3 as compared to $i_{cr} = 0.9$ –1.0 for clean sands [26]. In spite that this might not be true for the Kaohsiung soil with the finer particle-size range, the soil particles could easily be detached or washed away as subjected to such a high hydraulic gradient of 12.1. It is evident that the seepage-prone weak zones allowed the water to flow through the jet-grout columns and into the sump pit and that this high hydraulic gradient made the water inflow even greater. The combined effects of high hydraulic gradient and existence of seepage-prone weak zones were deemed as the main cause to initiate the water leak incident.

- (2) The hydraulic pressure at the point of water ingress was estimated to be about 300 kPa. The length of shortest path for groundwater seepage was from the bottom of the soilcrete body to the point of water ingress, that is, 2.4 m, corresponding to the hydraulic gradient of 12.1.

- (3) The existing vehicle underpass led to some difficulties in installing the jet-grout columns exactly in the plumb, and some seepage-prone weak zones were thus developed. The seepage-prone weak zones allowed the water to flow through the jet-grout columns into the sump pit, and such high hydraulic gradient made the water inflow even greater. The combined effects were deemed as the main cause initiating the water leak incident.

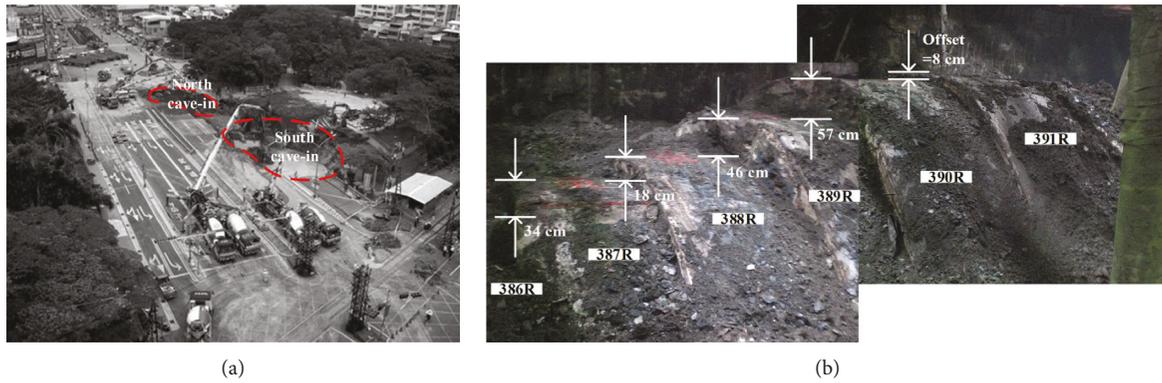
FIGURE 3: Photos taken from the water leak incident: (a) two surface cave-ins and (b) offsets of tunnel liners.

- (1) The piping was responsible for initiating the water leak incident. Dumping sand bags and quick-set cement failed to ease the water leak. Mud water carried away fine particles in the ground and together flowed into the tunnels through the ripped liner joints leading to serious ground loss. Such ground loss caused two surface cave-ins. The surface cave-ins not only impeded traffic but also caused damages to adjacent properties.

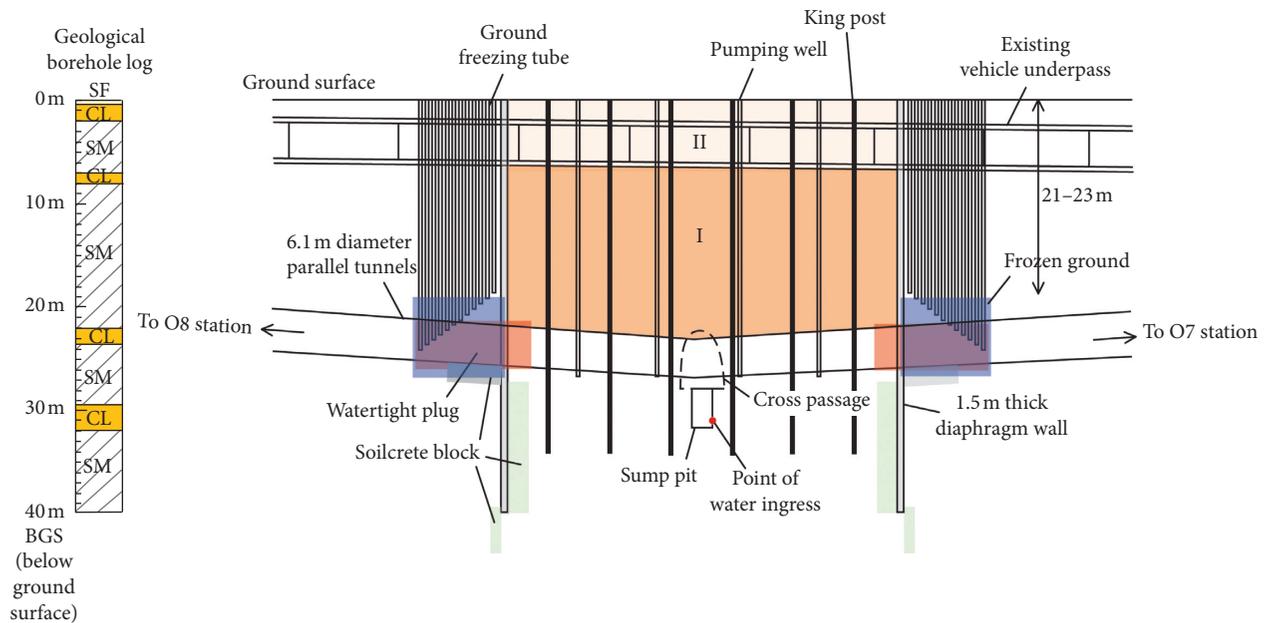
FIGURE 4: Schematic illustration for progressing the rehabilitation. Note: Soil in Regions I and II to be removed in the rehabilitation and then backfilled to the surface upon completion of the tunnel liners erection and new vehicle underpass installation. Note: soil in Regions I and II to be removed in the rehabilitation and then backfilled to the surface upon completion of the tunnel liners erection and new vehicle underpass installation. SF: backfill; SM = silty sand; CL: low plasticity clay.

be as much as 12,000 m³, whereas the water inflow, resulting from the two undermined water mains, was approximately 2,000 m³. Then, a 2-year rehabilitation was carried out to resume the traffic and its activities are detailed as follows (Figure 4):

- (i) Two watertight plugs within the tunnels at some distance from the point of water ingress were to secure the watertight effectiveness with additional jet-grout blocks
- (ii) Porewater within the surrounding soil was frozen using the ground freezing method
- (iii) Diaphragm walls of 1.5 m in thickness to retain the excavation-induced lateral loads were constructed at the depth of 60 m
- (iv) Dewatering wells screened at the bottom of the tunnels were constructed to secure the excavation face dry
- (v) The removal of the undermined vehicle underpass was conducted upon completion of Region “II” excavation
- (vi) New tunnel liners were erected following completion of Region “I” excavation
- (vii) Controlled low-strength materials (CLSM) was backfilled to the bottom of new vehicle underpass allowing for new vehicle underpass installation
- (viii) CLSM was backfilled to the surface

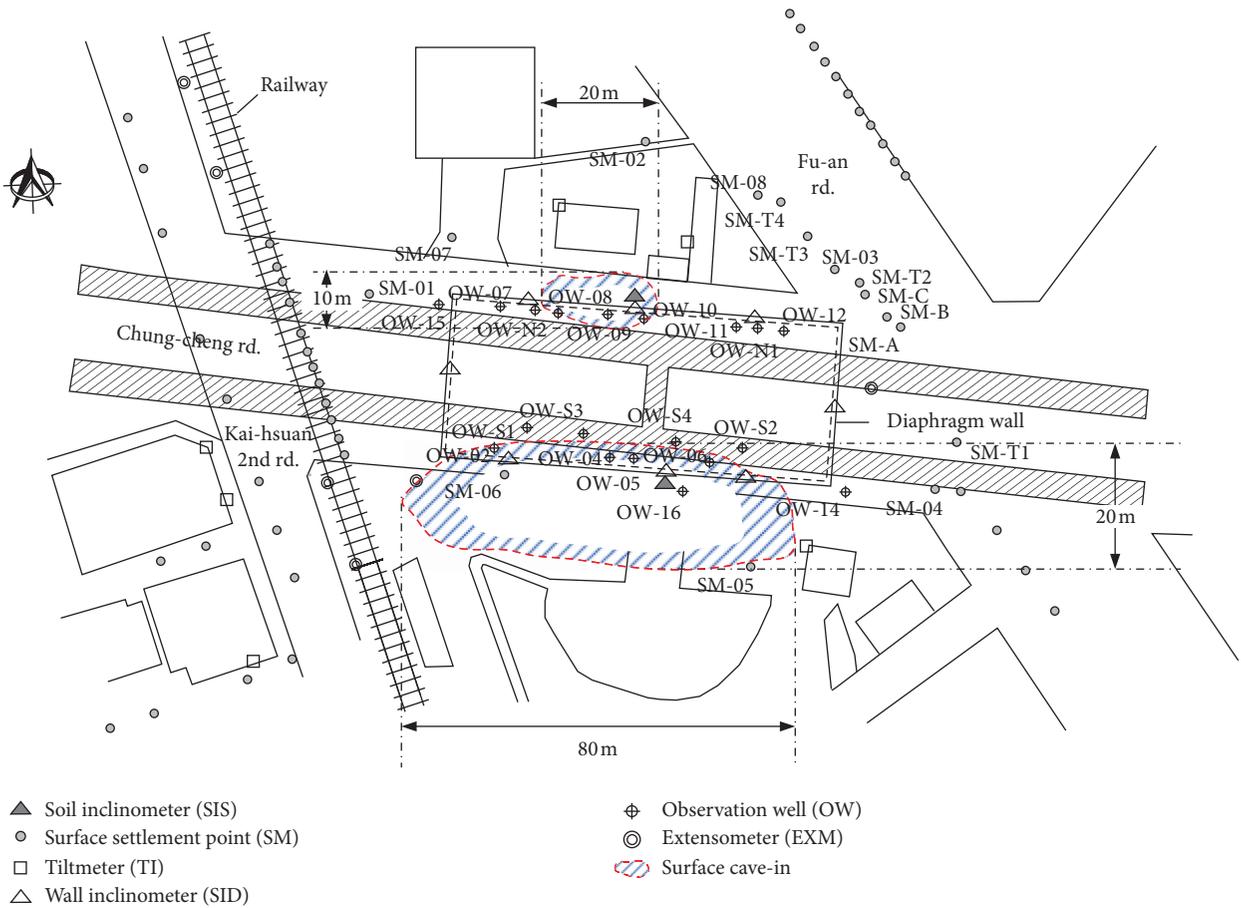
2.3. Field Instrumentation Data. Such serious ground loss caused two surface cave-ins to be developed on the south and north sides, respectively. The tunnel on the south side and the vehicle underpass due to loss of the contact with surrounding ground significantly settled 2.7 m and 1 m, respectively. The tunnel on the north side showed a relatively small settlement of 0.16 m. Additionally, the adjacent railway also measured some settlements and track relative displacements. As discussed, the diaphragm walls with the frozen ground and soilcrete blocks aimed to secure the watertight effectiveness while progressing the rehabilitation. The rehabilitation including the removal of undermined vehicle underpass and the erection of new tunnel liners as well as the installation of new vehicle underpass was performed when the water inside the walls was drained using the pumping wells and when the earth inside was removed. Therefore, the proposed layout of monitoring instruments (Figure 5) intended not only to observe the groundwater level and surface settlement variations while progressing the rehabilitation but to assess the associated environmental impacts.

FIGURE 5: Layout of monitoring instruments and locations of surface cave-ins.

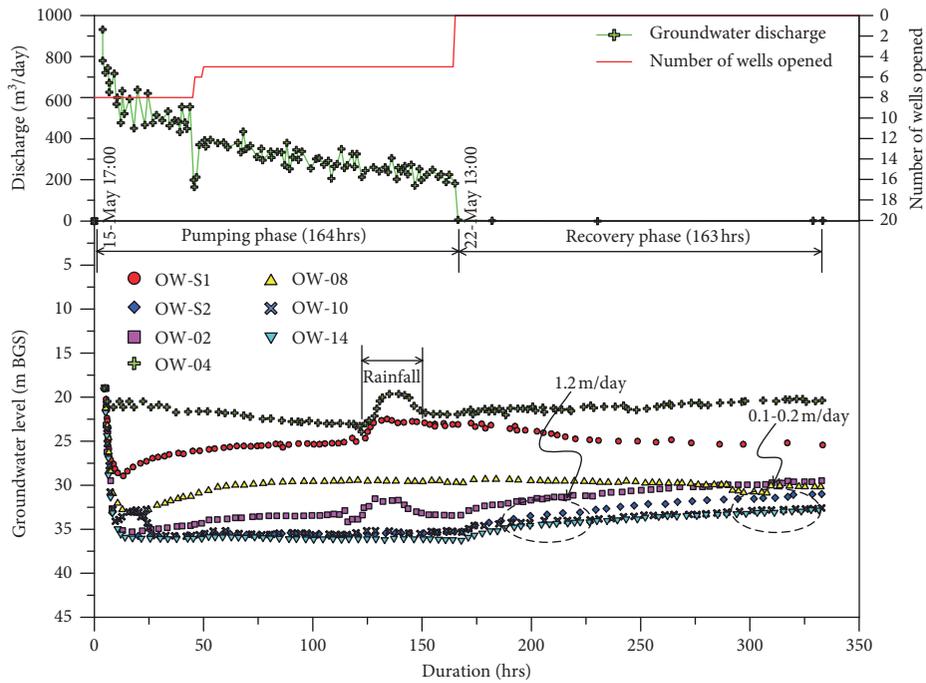
instruments used in the test. It can be seen from Figure 6 that the groundwater levels in the observation wells OW-S1, OW-S2, OW-04, and OW-10 declined sharply to the 33–35 m depths in the very beginning of the pumping phase and maintained almost constant until the end of the pumping phase. A similar tendency, but with smaller variation, was observed from the observation wells OW-02 and OW-08. There was a sudden increase in the groundwater levels right before the completion of the pumping phase, most likely because of the recharge effect resulting from a rainfall. The recovery rates of the observation wells OW-S1, OW-S2, OW-04, and OW-10 gradually declined from 1.2 m/day in the beginning of the recovery phase to 0.1–0.2 m/day in the end of the recovery phase. Except the duration of rainfall, the groundwater level in the observation well OW-14 remained almost constant, indicating that the group-well pumping

appeared to have negligible influence on the groundwater level outside the diaphragm walls, which also indicated good watertight effectiveness.

FIGURE 6: Variations of groundwater levels for verification of watertight effectiveness.

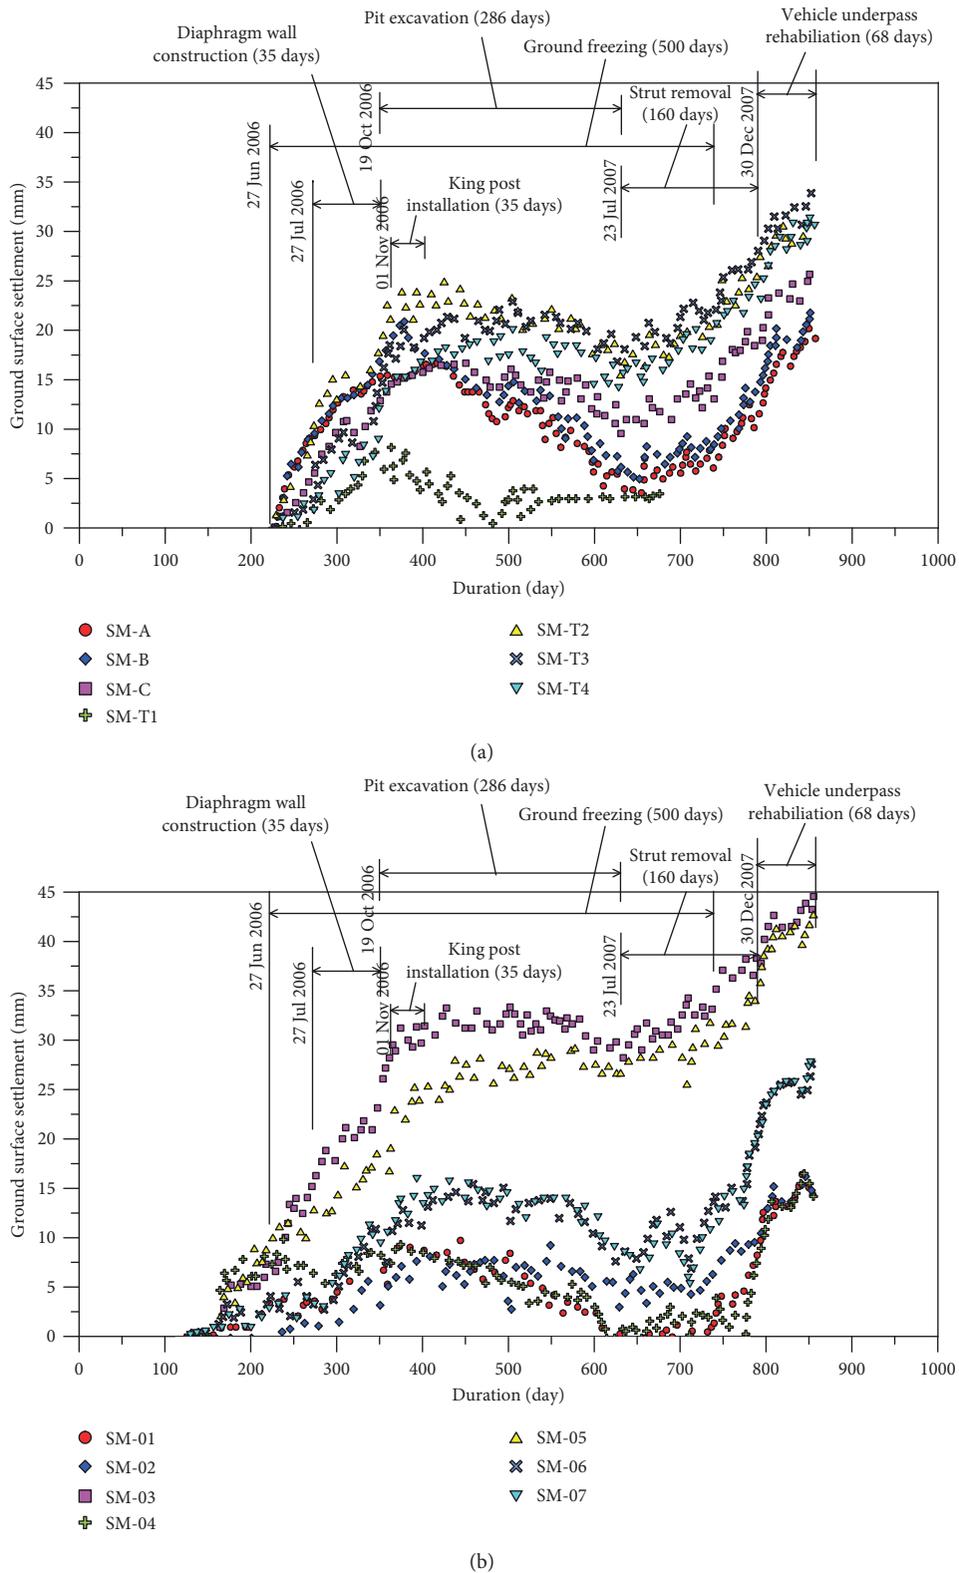
Figure 7 shows the variations of the ground surface settlements while progressing the rehabilitation. The surface settlement point SM-T1 measured the smallest settlement, compared with the surface settlement points SM-T2, SM-T3, SM-T4, SM-A, SM-B, and SM-C. Similarly, the surface settlement points SM-01, SM-02, SM-04, SM-06, and SM-07 measured the relatively small settlements, compared with the surface settlement points SM-03 and SM-05. This phenomenon is due to the fact that the indicated surface settlement points were all close to the short side of excavation pit and the diaphragm walls of the short side due to its larger bending stiffness than those of the long side exhibited smaller lateral deflection and surface settlements. Despite

the unignorable contribution from the effects of the diaphragm wall construction and the strut removal to the ground surface settlements, the associated increases were typically 4.8–9.4 mm and 5.5–7.5 mm, respectively, for SM-A to C and SM-T1 to T4 and 1–13 mm and 8.2–13.1 mm, respectively, for SM-01 to 07. While the pit excavation appeared to have minimal influence on the ground surface settlements, it is worth to mention that when the ground was unfrozen prior to the installation of new vehicle underpass, the ground surface settlements increased very quickly, especially for SM-01 to SM-07. Despite the increases in the surface settlement, the surface settlements then soon reached a steady state condition.

FIGURE 7: Variations of ground surface displacements for progressing the rehabilitation: (a) SM-A to C and SM-T1 to T4 and (b) SM-01 to 07.
