# Analysis of the Residual Deformation of Yingxian Wood Pagoda

Cumulative damage and residual deformation of structural components of Yingxian Wood Pagoda over its existence have caused widespread concern. Because Yingxian Wood Pagoda is a very complex ancient wooden structure, previous studies on single-storey and multistorey ancient structures are not very applicable. In this study, the deformation to the pagoda at the components, storey, and overall structure levels was monitored considering residual deformation, component cracking, and component connection conditions. The effects of different factors were preliminarily identified, including the structural weight, external impacts such as earthquakes and artillery shells, differences in moisture content according to sunlight exposure, and the prevailing wind direction. The study findings are useful in diagnosing the health and causes of deformation of unique buildings such as this in order to develop effective repair and restoration measures.

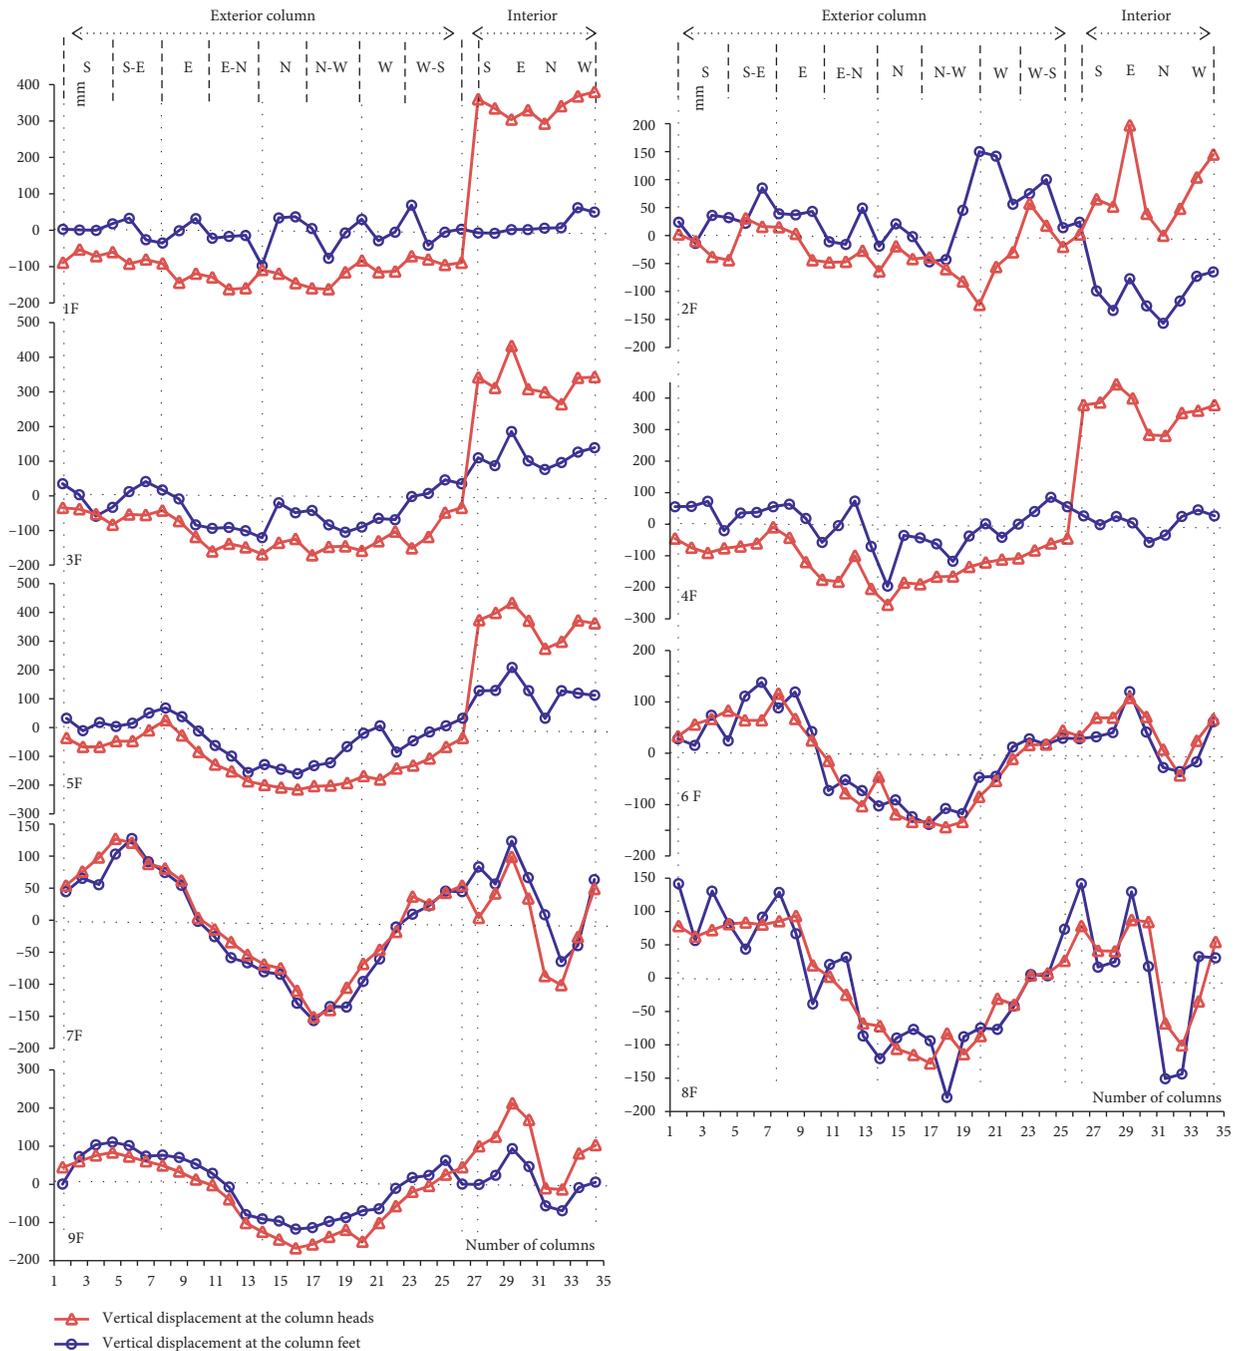
Figure 5 shows the difference between the vertical position of each column head (or column foot) and the average vertical position of all the column heads (or column feet) of each floor. The column head of each floor essentially changed as the position of the column foot. The position of the column heads on the first to fifth floors and ninth floor generally had a greater difference than the column feet mainly because of the length error of the column itself and inconsistent tilting. The elevations of the heads of the inner columns on the first, third, fourth, and fifth floors were significantly higher than the other columns of the corresponding floor, which is based on the requirements of the architectural and structural functions during the design and construction. Moreover, compared to the foot of the outer columns, the elevations of the inner columns on the third and fifth floors generally increased because their vertical structure was stacked by several beams (Figure 6). In contrast, the outer columns had some *Dou* (Figure 6) between the beams, which led to different compressive deformations because of their diverse levels of vertical bearing stiffness. Under huge pressure, the inner columns on the second floor

FIGURE 5: Vertical displacement at the column feet and heads.

Note that the columns on the north side and adjacent sides on each floor of the pagoda showed greater settlement than those on the other sides (Figure 5). This is because the north and adjacent sides of the pagoda were less exposed to sunlight; thus, their components experienced greater humidity. This

cumulatively increased the compressive deformations of the components on these sides, which generated a trend of vertical deformations. For the inner columns, C26, C27, C30, and C31 of each floor carried high vertical loads; therefore, their vertical deformations were also greater. C30 and C31 had greater vertical deformations than C26 and C27, which was mainly due to discrepancy in the water content.

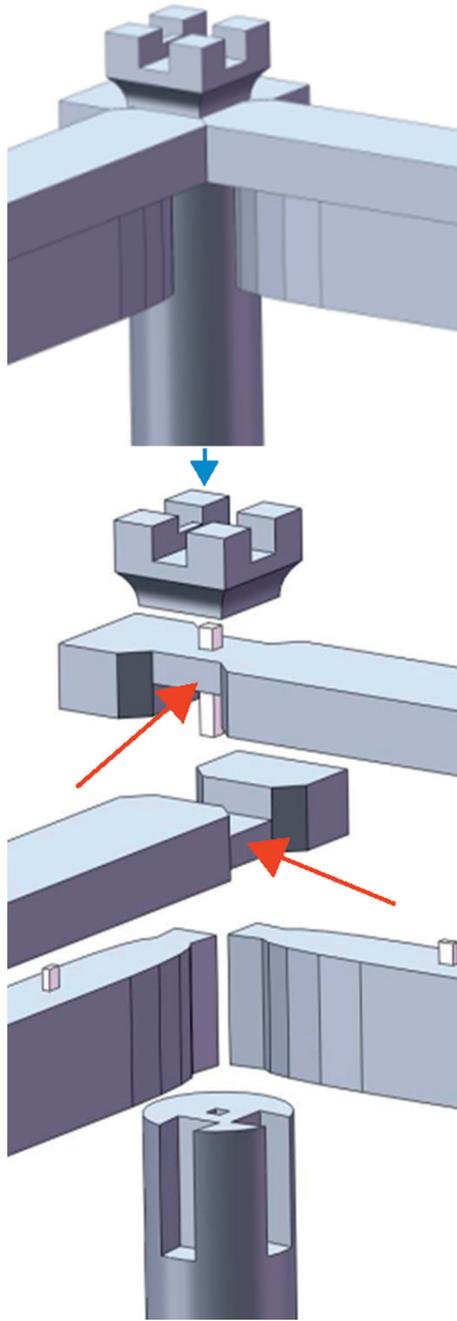
The beam end sections, *Gong* roots, and *Dou* brackets were compressed perpendicular to the grain, whereas the columns were compressed parallel to the grain. The residual vertical deformation of the beam directly connected to the column head (Figure 7) was very obvious because it was concentrated by the column head and *Lu-Dou* bottom. The average residual vertical deformations of such beam ends were measured to be 70, 19, 56, 13, 41, 16, 28, 16, and 22 mm from the first to ninth floors, respectively, and the measured average residual vertical deformations of the other members of the column head subject to horizontal compression perpendicular to the grain were 130, 32, 130, 28, 41, 19, 25, 17, and 17 mm, respectively. The values were markedly higher on the first and third floors than on the other floors because of serious damage. Columns under pressure,

FIGURE 7: Connection of the beam-column frame. The red arrows indicate the weak parts of this frame.

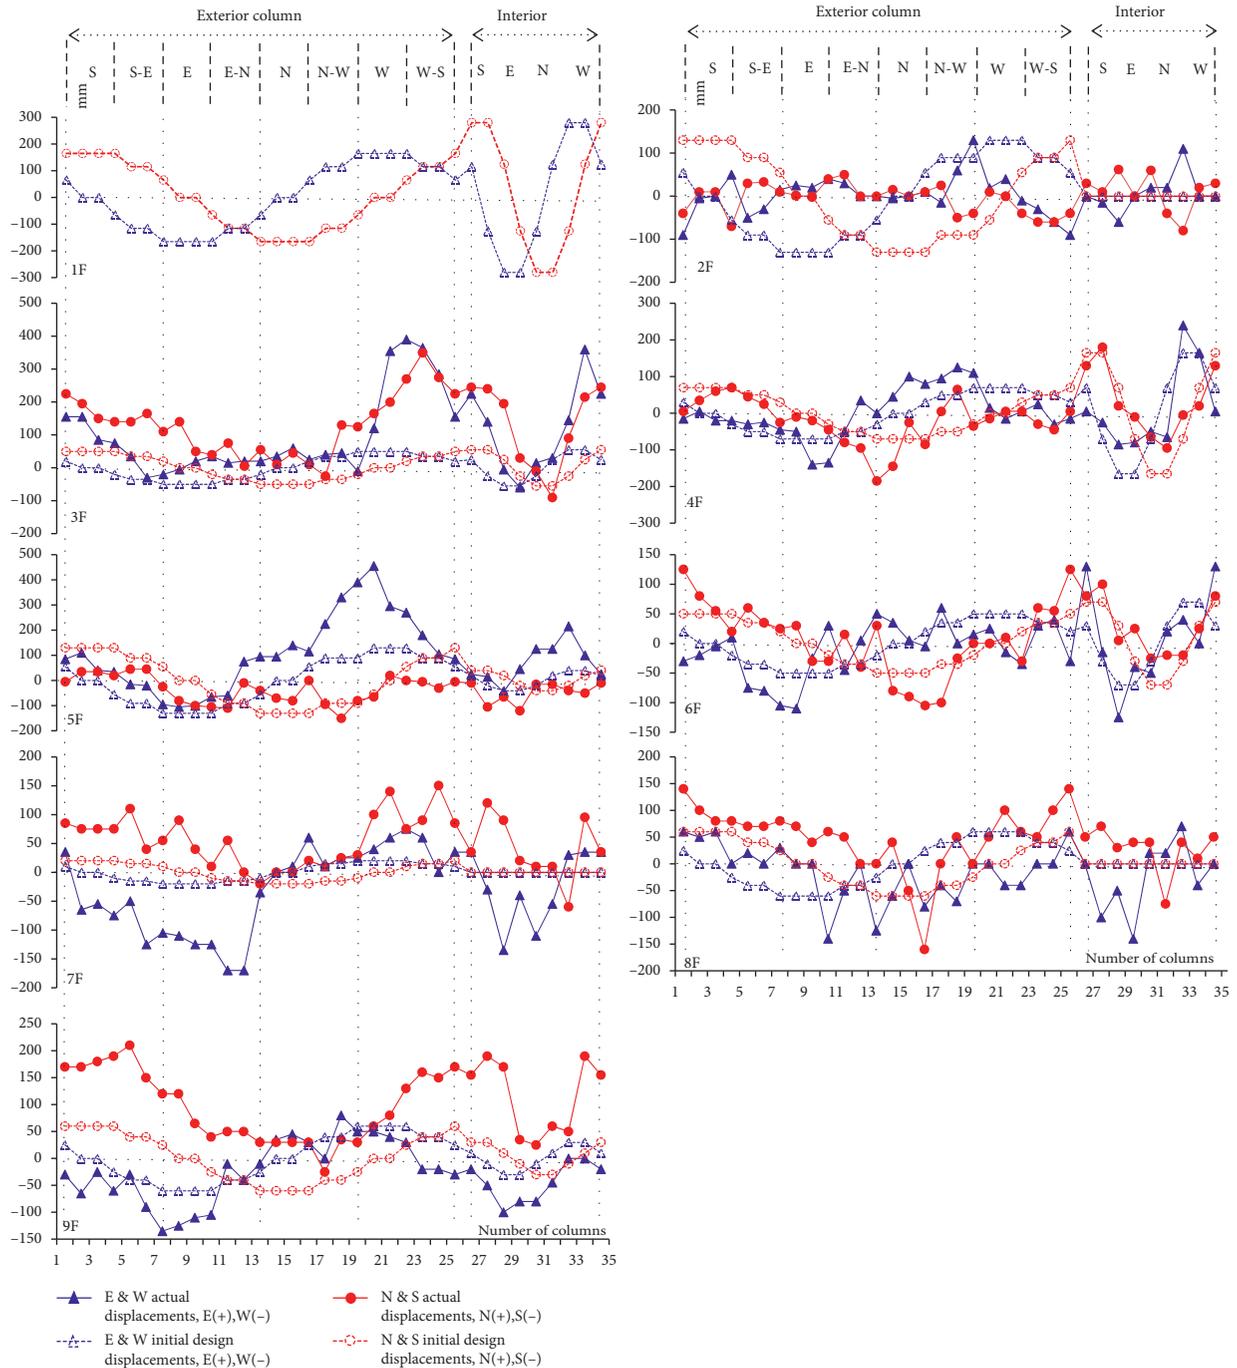
Compared to the initial design, the columns on each floor had disparate degrees of inclination (Figure 8). Specifically, most columns on the third floor were inclined to the northeast; 3C22, 3C23, and 3C33 were inclined more than 300 mm to the east, and 3C23 and 3C24 were inclined more than 300 mm to the north. 4C9–4C19 and 4C32 on the fourth floor were tilted to the east, whereas the other columns inclined less than the initial design. All columns on the fifth floor were inclined to the east; 5C18–5C20 and 5C32 were inclined more than 300 mm, and 5C24 was inclined approximately 499 mm. Columns 6C1 and 6C14–6C17 on the sixth floor showed increasing inclination in the north-south direction. For the seventh floor, all columns on the north and south sides were inclined to the north, and the columns on the south, southeast, east, and northwest sides were inclined to the west. All columns on the eighth floor were inclined to the north, whereas most columns were inclined in the east-west direction less than the initial design.

For the ninth floor, all columns were inclined to the north, and the columns on the south, southeast, east, and northeast sides were obviously inclined to the west.

The columns on the west and southwest sides of the third floor and the west and northwest sides of the fifth floor were heavily inclined because of artillery shells from wars in 1926 and 1948 and showed bullet marks. Accidental shelling actually produced large deformations in local areas, which increased the residual deformation of the corresponding floor. The continuous effect of wind for nearly 1000 years and the long-term difference in water

FIGURE 8: Horizontal displacements at the column heads.

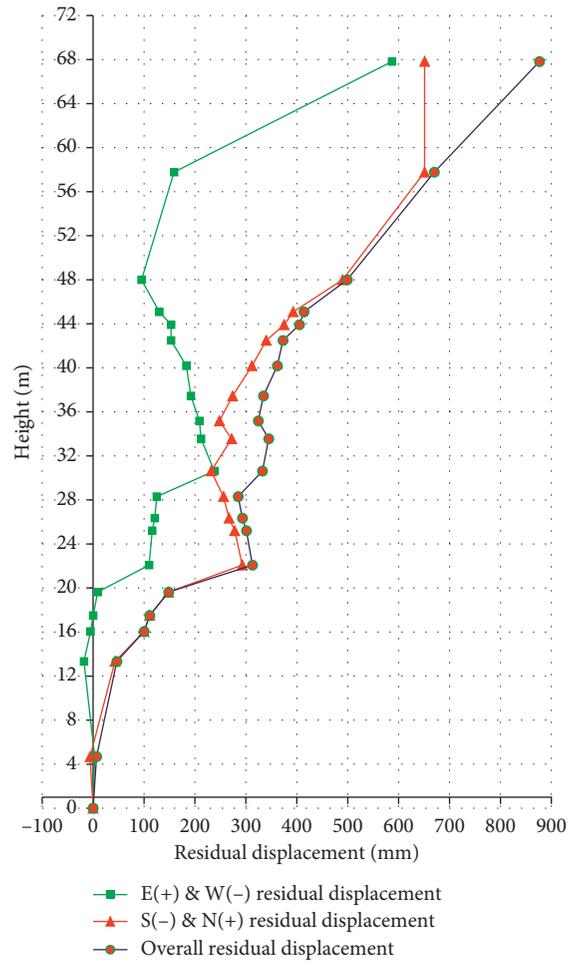
*2.2.2. Residual Horizontal Deformation of the Overall Structure.* Figure 9 illustrates the residual horizontal deformation at the centre of each structural layer (column layer formed from the column feet to the heads, and beam-bracket layer formed from the top of the stud beam to the top of the bracket) of the pagoda relative to the horizontal central projection of the regular octagonal stone base at the bottom of the platform. This was obtained by combining the deformations in the east-west and north-south directions. The horizontal offset for the first floor was averaged from the data of the eight corner columns of the outer circle that could be measured.

Each structural layer had different inclination directions and degrees, but the overall structure was inclined in the northeast direction. Within the height ranges of 0–22.18, 22.18–28.16, 28.16–31.00, 31.00–47.57, and >47.57 m, the structure was inclined in the northeast, southeast, northeast, northwest, and northeast directions, respectively. As mentioned earlier, the prevailing wind in Yingxian County is in the northwest direction, and the components were subject to long-term effects from slight differences in water content. This is the main reason the whole pagoda was inclined to the northeast. Note that the severe inclinations of column layers (19.32–22.18 m and 28.18–31.00 m) affected by artillery shells were the main hidden risk to the pagoda's safety. Some scholars have tested and analysed the dynamic characteristics of the pagoda and pointed out that the third and fifth floors mainly vibrated in the second and third modes, which is another major reason for the increased residual deformation [13]. The serious tilting of the iron *Tacha* to the east was because of the rotation of its base around the horizontal axis.

The horizontal displacement angle from the top of the foundation stone to the top of the lotus throne (4.4–57.67 m) of the overall structure was  $1/80$ . The horizontal displacement (177 mm) angle of the column layer (19.32–22.18 m) exceeded  $1/16$ , and the ratio of the average column radius (302 mm) to the height of the structural layer was  $1/9.4$ . The horizontal displacement (116 mm) angle of the column layer (28.18–31.00 m) exceeded  $1/25$ , and the ratio of the average column radius (288 mm) to the height of the structural layer was  $1/9.9$ . Xie et al. [19] set the

FIGURE 9: Residual horizontal deformation at the centre of each structural level relative to the central projection of the foundation.

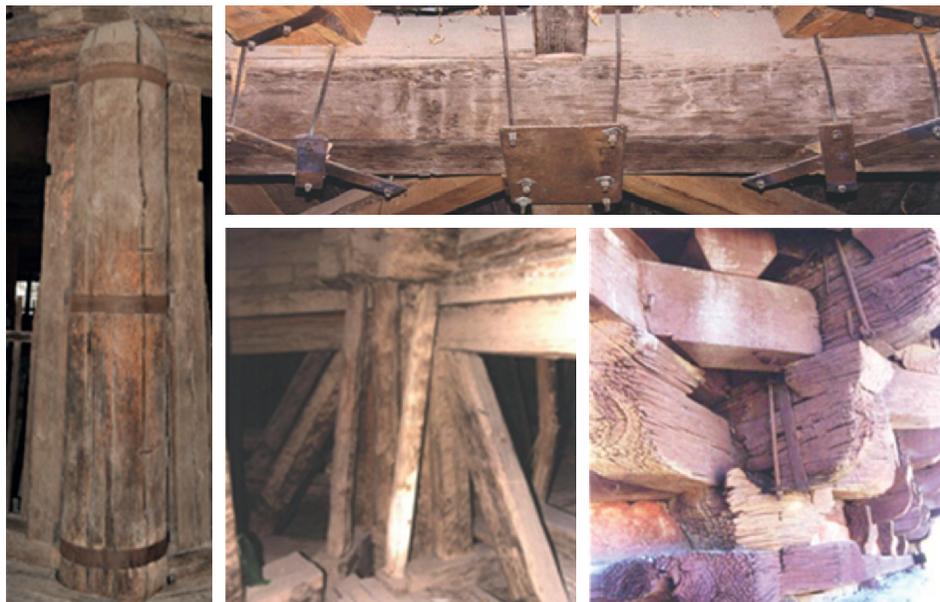
According to the historical records, Yingxian Wood Pagoda has been repaired six times, in 1191, 1320, 1508, 1722, 1866, and 1928–1935 CE. Most of the repairs involved partial reinforcement of a single component in the traditional manner (Figure 10). However, owing to the weight of the pagoda itself and its complex structure and components,

FIGURE 10: Partial reinforcement conducted on different components of Yingxian Wood Pagoda over the years, such as columns, beams, and *Dou-Gong* brackets.

a suitable repair method. To reduce the lateral displacement of the wooden tower, auxiliary columns were added except for the ninth floor. The experts attempted to reduce the severely inclined third and fifth column structural layers by adding auxiliary components, but no consensus was reached; hence, further analysis and research are currently underway.
