Assessment of Fractures in Excavation Damaged Zone around Roadways of an Iron Mine Using Optical Televiewer Detecting Method

School of Resources and Civil Engineering, Northeastern University, Shenyang 110000, Liaoning Province, China

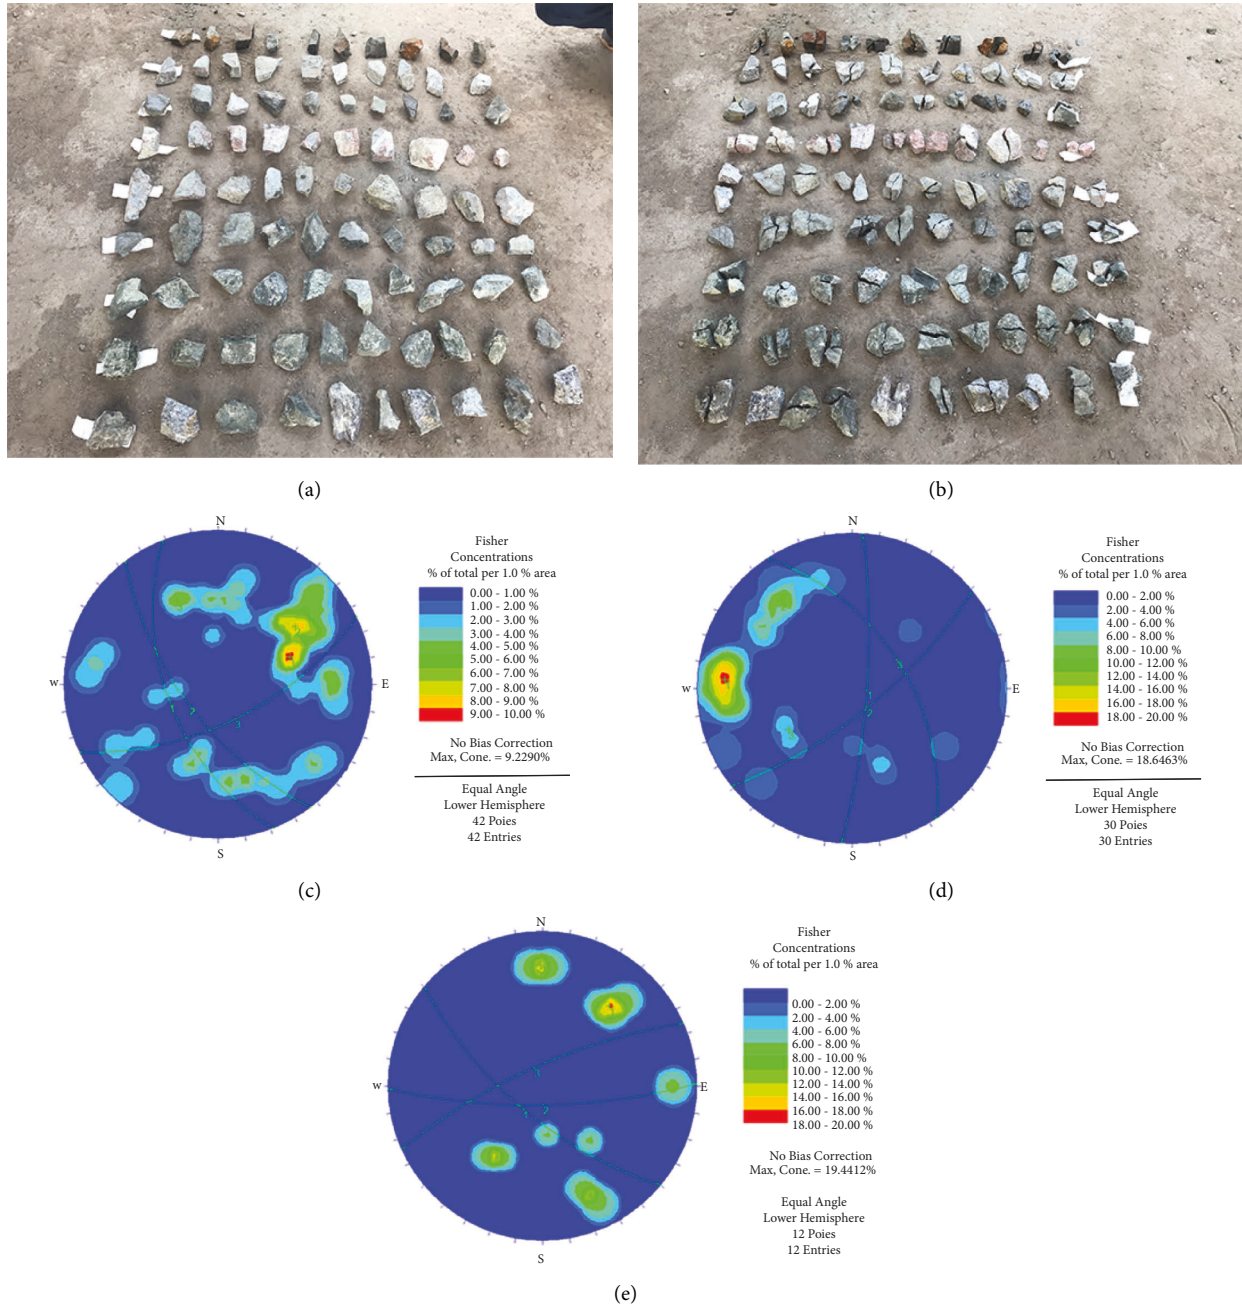
FIGURE 3: Rock mass quality classification test. (a) Point load test sample, (b) sample after test, (c) pole contour map of Xiaoxingshan footwall, (d) pole contour map of Daxingshan orebody, and (e) pole contour map of 3[#] mining area hanging wall.

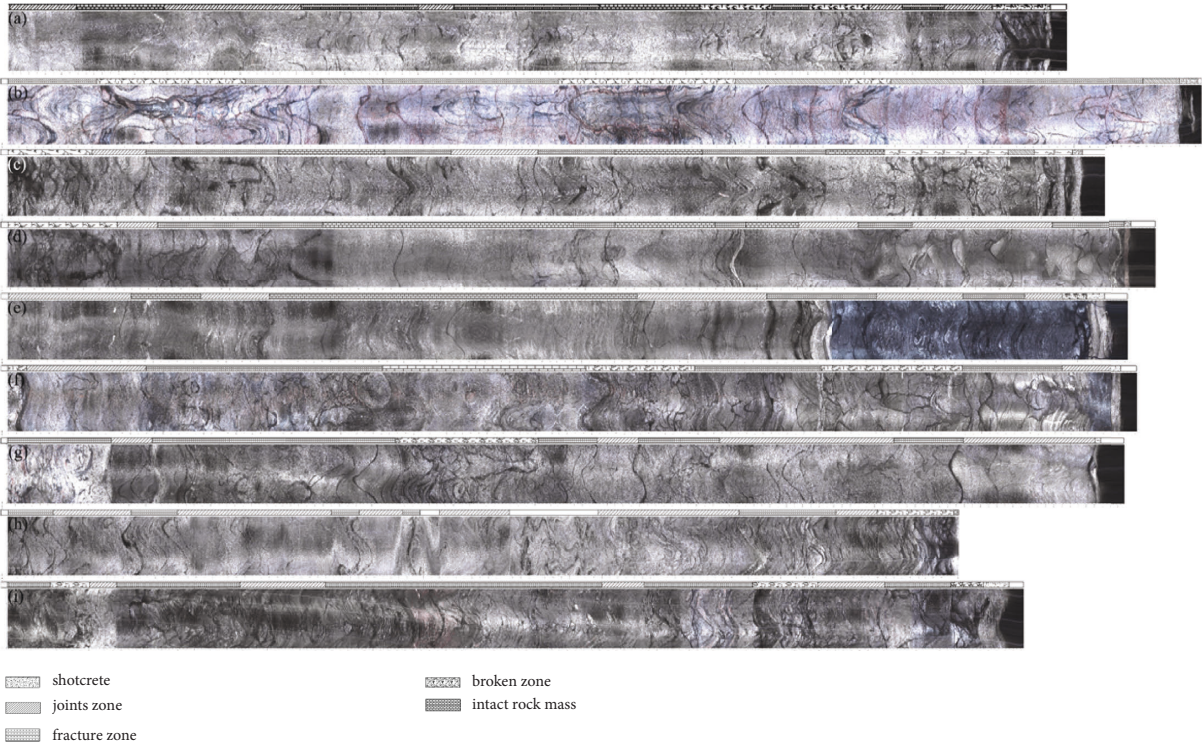
complete, which is mainly the joint zone and fracture zone, and only a small part of the rock mass is broken. Hole No. 4 is relatively broken at both ends of the hole, above 2.4 m and below 9.9 m, and the middle part has more intact rock mass, although there are also broken zones. Hole No. 9 was severely damaged above 4.7 m, and there were many joints and cracks below 10.6 m, but they were basically not damaged. The central part of the rock mass was very intact. Hole No. 10 has a large area of broken zone and fracture zone below 10.2 m, and the rock above 10.2 m is relatively intact with some joints. Hole No. 11 has more broken zone and fracture zone from the overall perspective, but above 2.8 m and below 14.1 m both ends are relatively intact. Hole No. 13 is mainly broken zone and fracture zone above 7.9 m, and there is an

ore-rock interface at 1.85 m. It is relatively complete below 7.9 m, with many joint zones and a few fracture zones. There are some broken zones and fracture zones at hole No. 16 above 3.2 m and below 10.1 m, with more joints and fissures in the middle, and some of the images are distorted and unrecognizable. Hole No. 17 is relatively fractured overall; some are broken, and there is no intact rock mass.

FIGURE 9: Image of IV grade surrounding rock of a vertical hole (a) Hole No. 1. (b) Hole No. 2. (c) Hole No. 4. (d) Hole No. 9. (e) Hole No. 10. (f) Hole No. 11. (g) Hole No. 13. (h) Hole No. 16. (i) Hole No. 17.

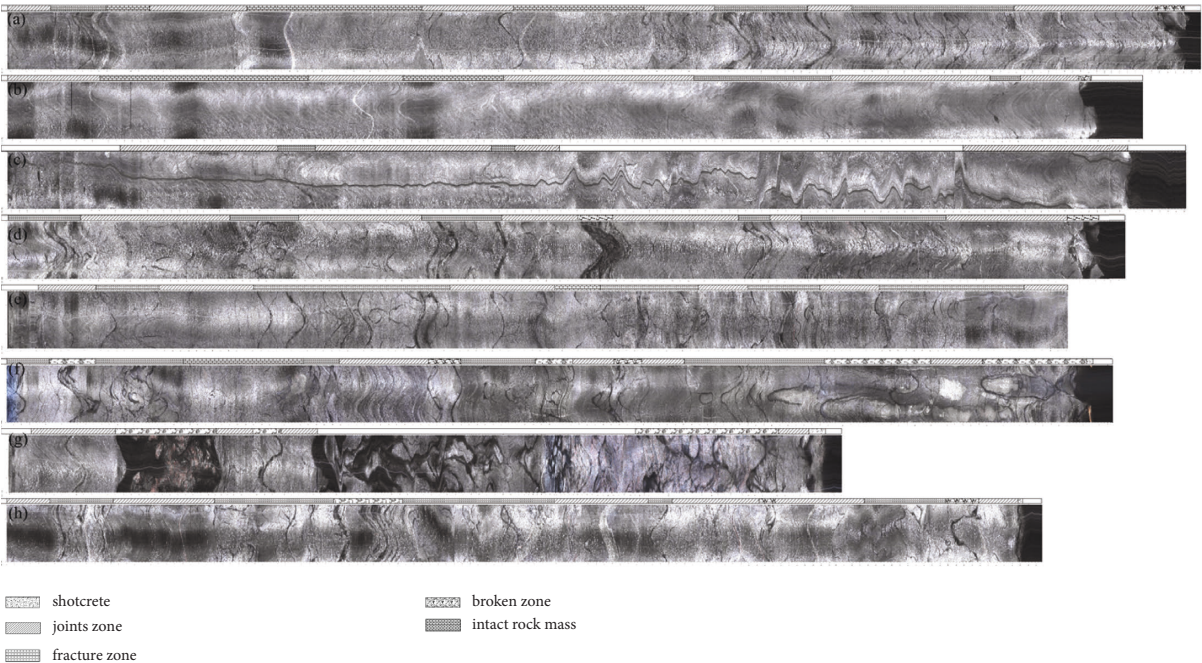
Among the 8 vertical boreholes of II and III grade surrounding rocks, most of hole No. 3 is intact rock mass and joint zone, with more fracture zone below 9.4 m and a broken zone between 15 and -15.3 m. Hole No. 5 is II grade surrounding rock, with intact rock mass and joint zone accounting for the vast majority, a small part of fracture zone and a broken zone of 0.16 m at the lower end. Hole No. 6 is II

FIGURE 10: Image of II and III grade surrounding rock of vertical hole. (a) Hole No. 3. (b) Hole No. 5. (c) Hole No. 6. (d) Hole No. 7. (e) Hole No. 8. (f) Hole No. 12. (g) Hole No. 14. (h) Hole No. 15.

grade surrounding rock. the image of 7.2–12.2 m is distorted and unrecognizable. The rest of the rock mass is almost joint zone, which is relatively intact. The middle and both ends of hole No. 7 are fractured, and the damage is severe at 8–8.4 m in the middle and 14.1–14.5 m in the lower part. The upper

part of hole No. 8 is relatively intact, the middle part is relatively fractured at 2.2–4.5 m and 6.5–9.2 m, and there are a few cracks in the lower part. Hole No. 12 is very fractured or even broken below 9.2 m, and a intact rock mass, joint zone, and broken zone appear alternately in the middle and

upper part. The image above 1.8 m of hole No. 14 is compressed, and 5.6–10.7 m is distorted and cannot be recognized. In other parts, the upper part is mostly a joint zone with a large cavity in the middle, and the lower part is granite, which is seriously broken. In hole No. 15, the fracture zone and joint zone appeared alternately, occasionally partially broken, but the rock mass was intact overall.

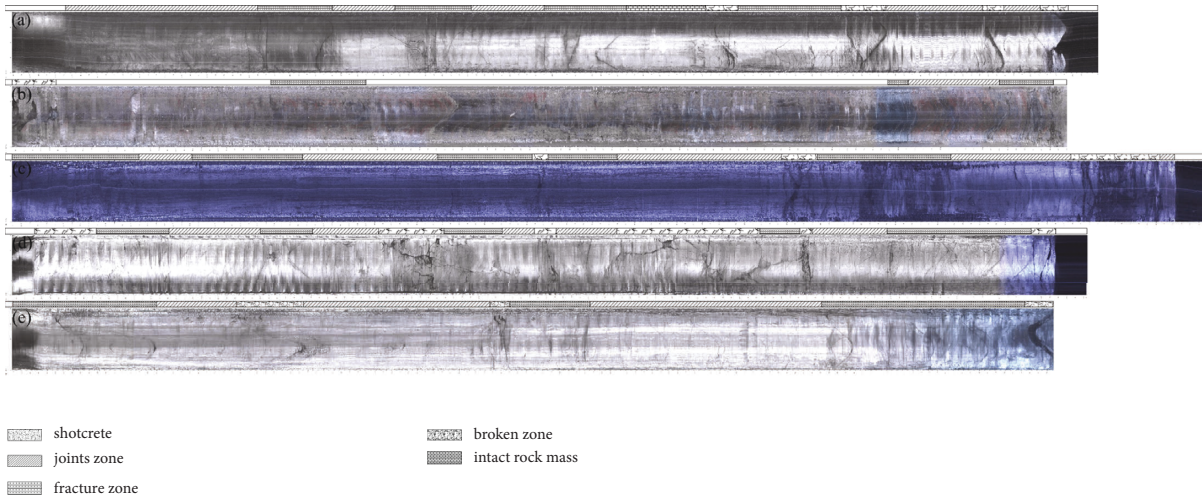
FIGURE 11: Image of horizontal hole. (a) Hole No. 13. (b) Hole No. 20. (c) Hole No. 21. (d) Hole No. 22. (e) Hole No. 23.

Among the five horizontal boreholes, only hole No. 22 is II grade surrounding rock and the other four holes are IV grade surrounding rock. On the whole, hole No. 19 shows the joint zone and fracture zone alternately, and there is a small part of the broken zone at 4.6 m to the right. Because there is silt at the bottom of hole No. 20, most images are not easy to identify, and the rock mass at both ends of the hole is

relatively fractured and broken. The broken of hole No. 21 is obvious, especially to the right of 5.1 m. There are a large number of broken zone and fracture zone, and large cavities appear in the rock mass. Although hole 22 is II grade surrounding rock, there is a broken zone in the middle and at both ends of the rock mass, but the rock mass is relatively intact except for the broken zone. The right side of 10.5 m and 6.6–7.3 m in the middle of hole No. 23 are relatively fractured, while other parts of the rock mass are relatively intact.
