Finite Element and Vulnerability Analyses of a Building Failure due to Landslide in Kaithakunda, Kerala, India

Rajkumar Andrewwinner¹ and Sembulichampalayam Sennimalai Chandrasekaran

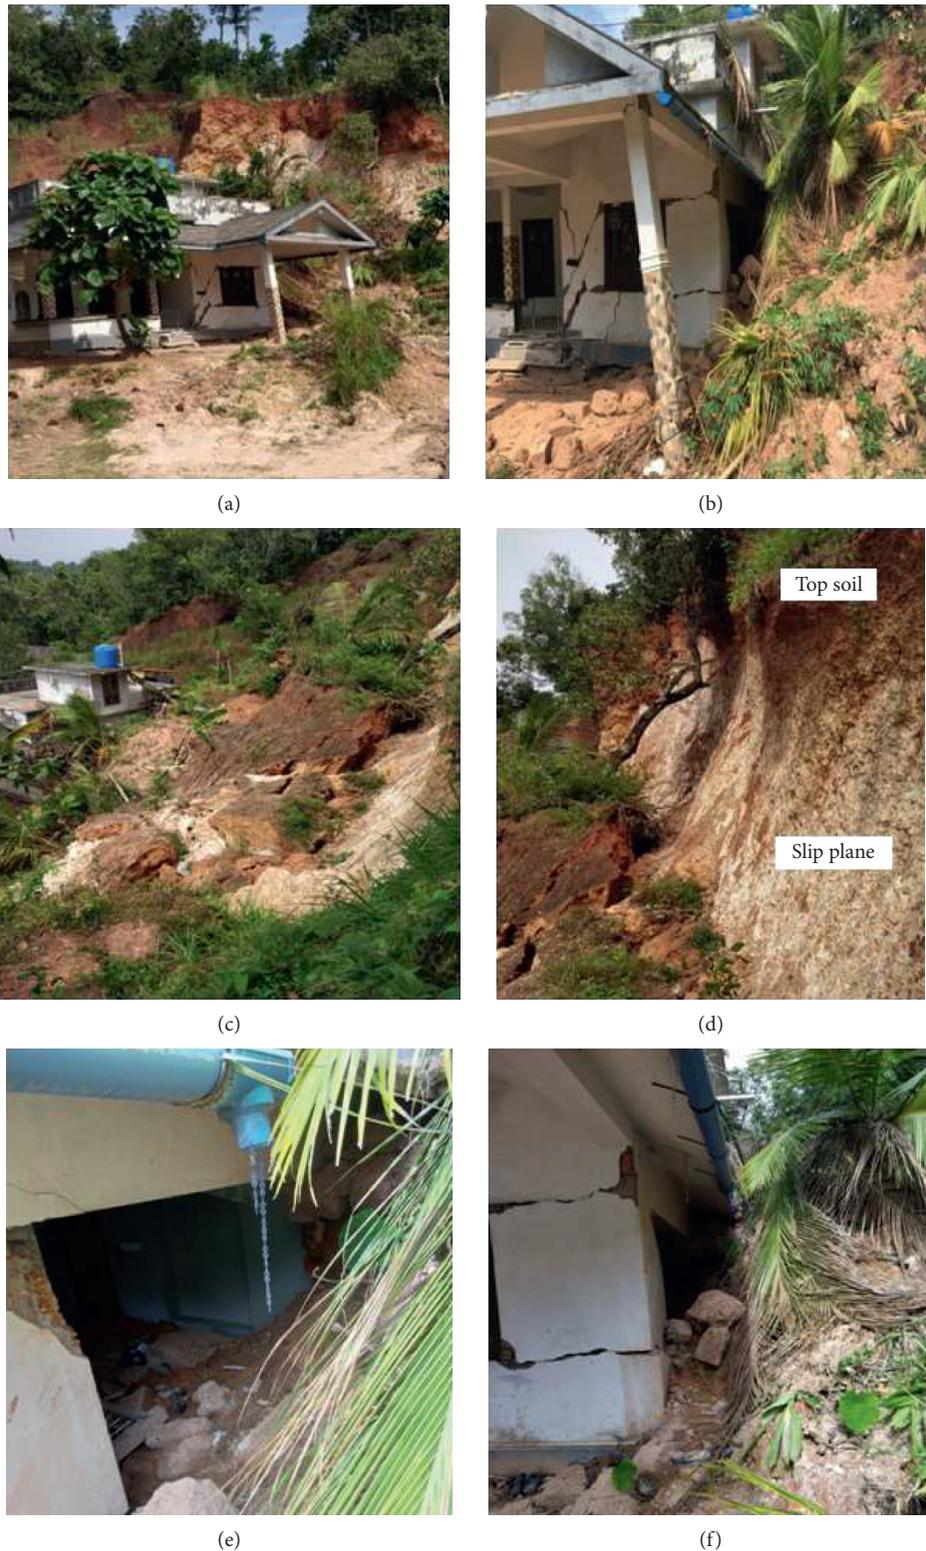
columns to support the front porch of the building. Figure 2(b) shows the tilting of the column in the portico of the building and wide cracks in the building. As can be observed from Figure 3(b), the building was constructed after cutting the original slope vertically for about 11.5 m. No stabilization measure was adopted for the vertical cut. The building was located 3 m from the vertical cut. The vertical cut of the slope extended up to 20 m in width. At the top of the cut, another building applied the surcharge load on the vertical cut. The main reason for the occurrence of the slide is the heavy rainfall experienced in the area. The rainfall occurred in two stages, with the 1st stage of very light rainfall between June and July 2018. The second stage of rainfall occurred from August 1 to August 14. The third stage consists of very heavy rainfall during and August 15–16, 2018.

FIGURE 2: View of building failure. (a) View of the damaged house with vertical cut. (b) Elevation of damaged building. (c) Sliding part of the failed cut. (d) View of vertical cut failure. (e) Detailed view of the damaged portion. (f) Outside view of the damaged portion.

water pressure (Figure 15(d)) of 35 kN/m², which is accompanied by a decrease in effective stress of 25 kN/m². This reduction in the effective stress of the slope results in its failure (Figure 13(a)). The displacement of the soil is found to be 4.1 m from the top of the vertical cut (Figures 14(a) and 14(b)) and hence the displaced soil from the vertical cut caused the building to fail as observed from Figures 2(e) and 2(f).

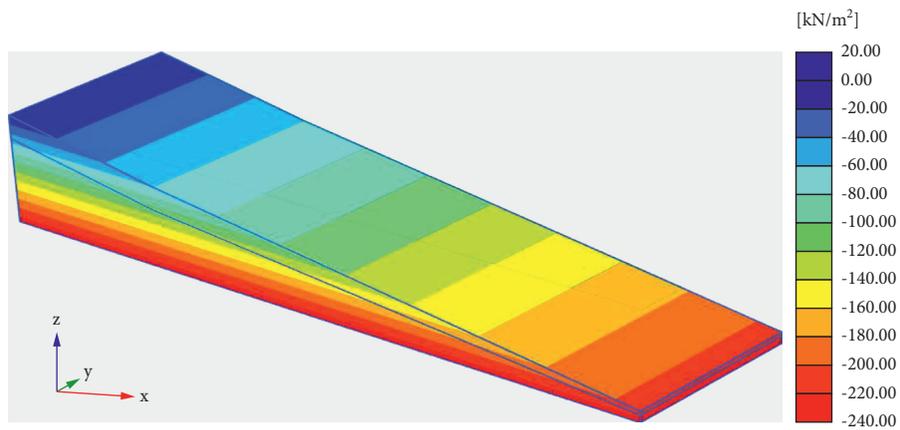
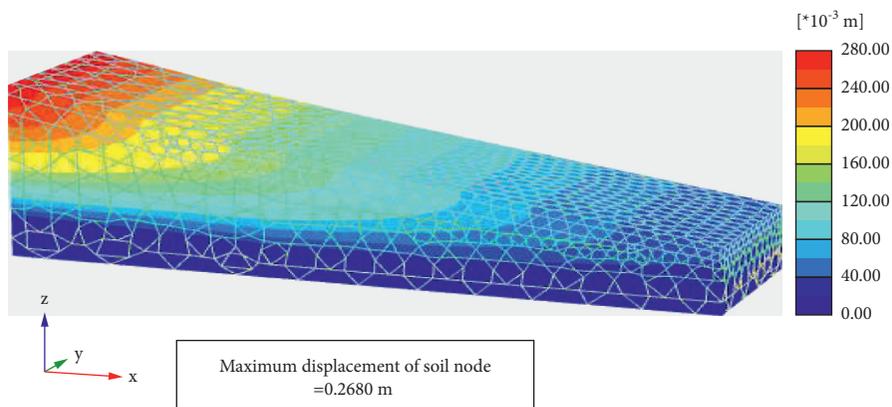
stage, there was no significant displacement. The pore water pressure and the displacement of the original slope at the end of the second stage are shown in Figures 12(a) and 12(b), respectively. The pore pressure, as observed in Figure 12(a), indicates that the matric suction of the soil is more and hence negligible displacement in the slope, as shown in Figure 12(b) [69]. This indicates the stability of the original slope.

Steady state pore pressures p_{steady} (Pressure = negative) (Time 76.00 day)
 Maximum value = 0.000 kN/m² (Element 1 at Node 4282)
 Minimum value = 231.1 kN/m² (Element 5489 at Node 5378)

Maximum displacement of soil node
 =0.2680 m

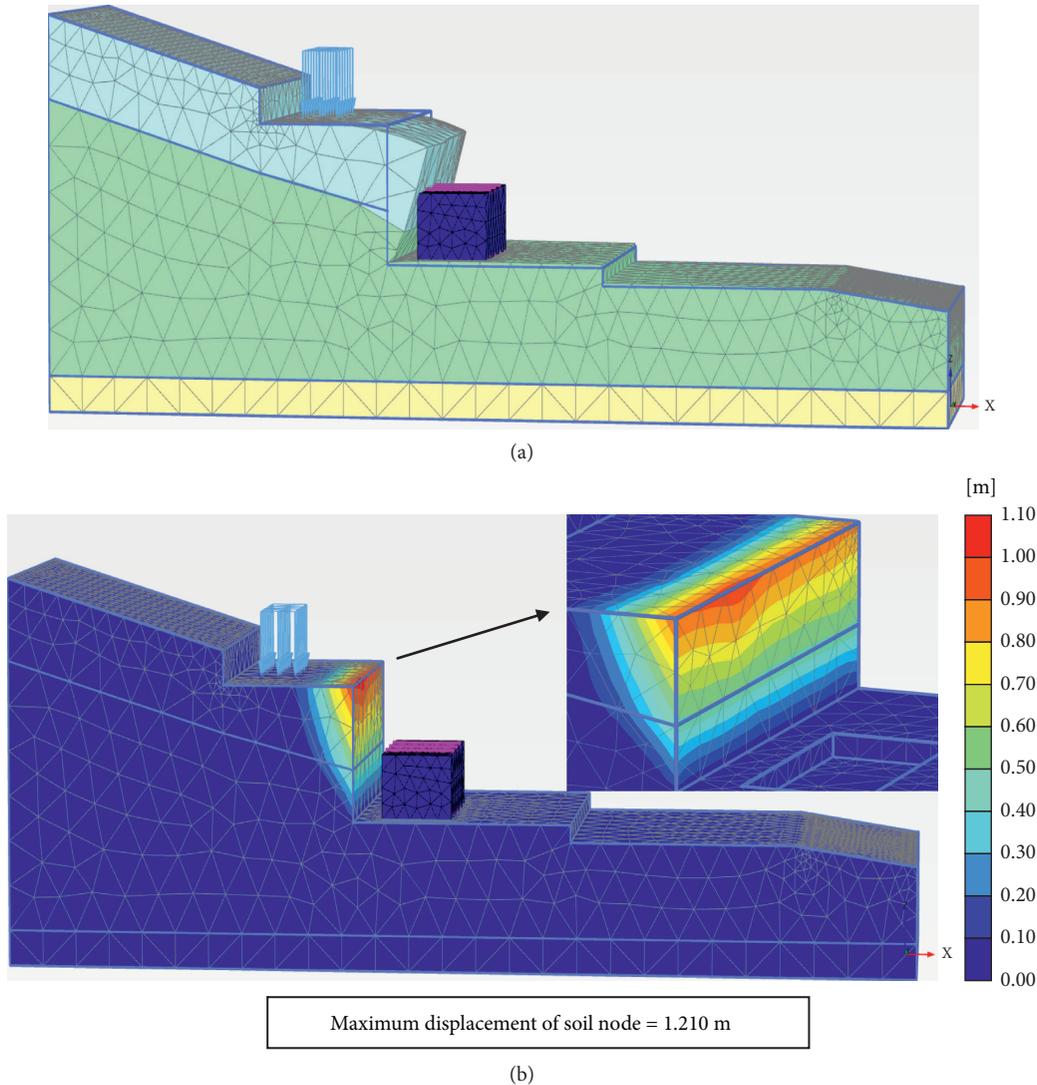
7.2.2. Results of Vertical Cut Analysis. The details of the beam and plate elements are given in Table 2. The deformed mesh is shown in Figure 13(a). The deformed mesh indicates the caving of the vertical cut. The shape of the deformed mesh indicates the failure of the vertical cut. The displacement profile of the slope (Figure 13(b)) indicates that the maximum displacement occurred at the top of the vertical cut. It depicts the slip surface of failure as observed

FIGURE 13: View of vertical cut failure. (a) Deformed mesh. (b) Displacement profile for vertical cut.

from the field (Figure 2(c)) and indicates the displacement of the soil node as 1.20 m.

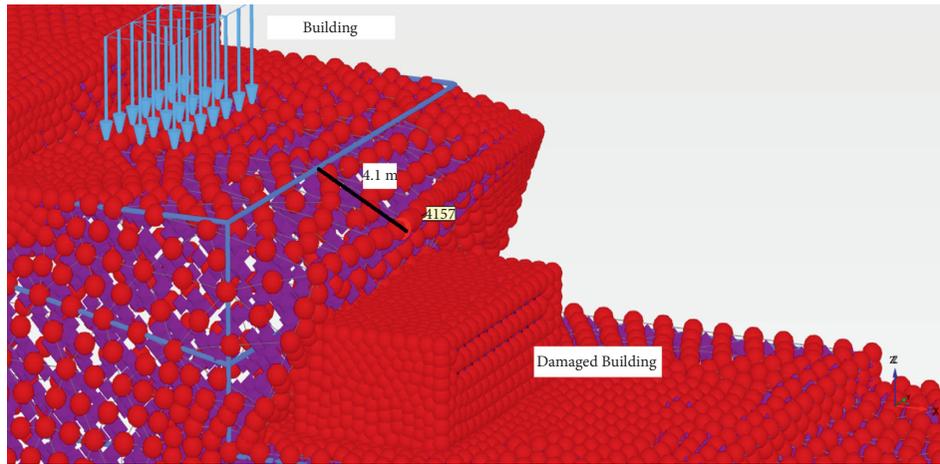
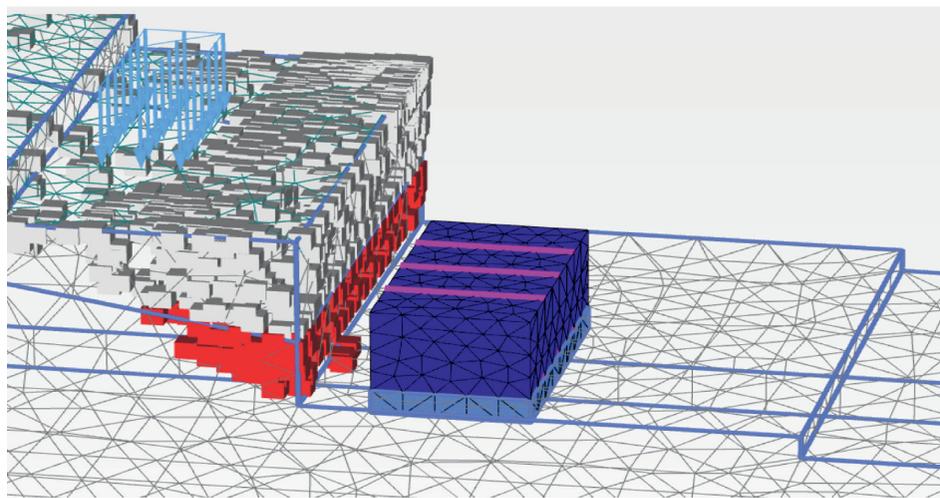
Figure 14(a) shows the maximum displaced nodal position of the model. The calculation is carried out with infiltration analysis and the maximum value of the displaced soil node is found to be 1.210 m at the position of the node (40, 9.737, -8.9), as shown in Figure 14(a). The figure shows that the maximum displacement of the soil from its original position before deformation is 4.1 m. The rotation of the soil node is found to be 4.667 degrees. As the distance between the vertical cut and the building is 3 m (Figure 3(b)), the

displacement of soil, flow pattern, and plastic points of soil observed from Figures 13(a), 13(b) and 14(a) and 14(b), the sliding soil reaches the building, which caused tilting and severe damage of the building (Figures 2(e) and 2(f)) and hence the building wall is deformed to a distance of 45 cm from its original position, which is visible from Figure 2(d). Figure 14(b) shows the plastic points of the model slope with the failure points occurring at the toe of the cut and it progresses to the topsoil layer. The tension cut-off point refers to the movement of the soil due to the failure. The red cube indicates the development of failure stress in the failure

FIGURE 14: Detailed view of (a) maximum displaced node (node no. 4157) and (b) plastic points in the model.

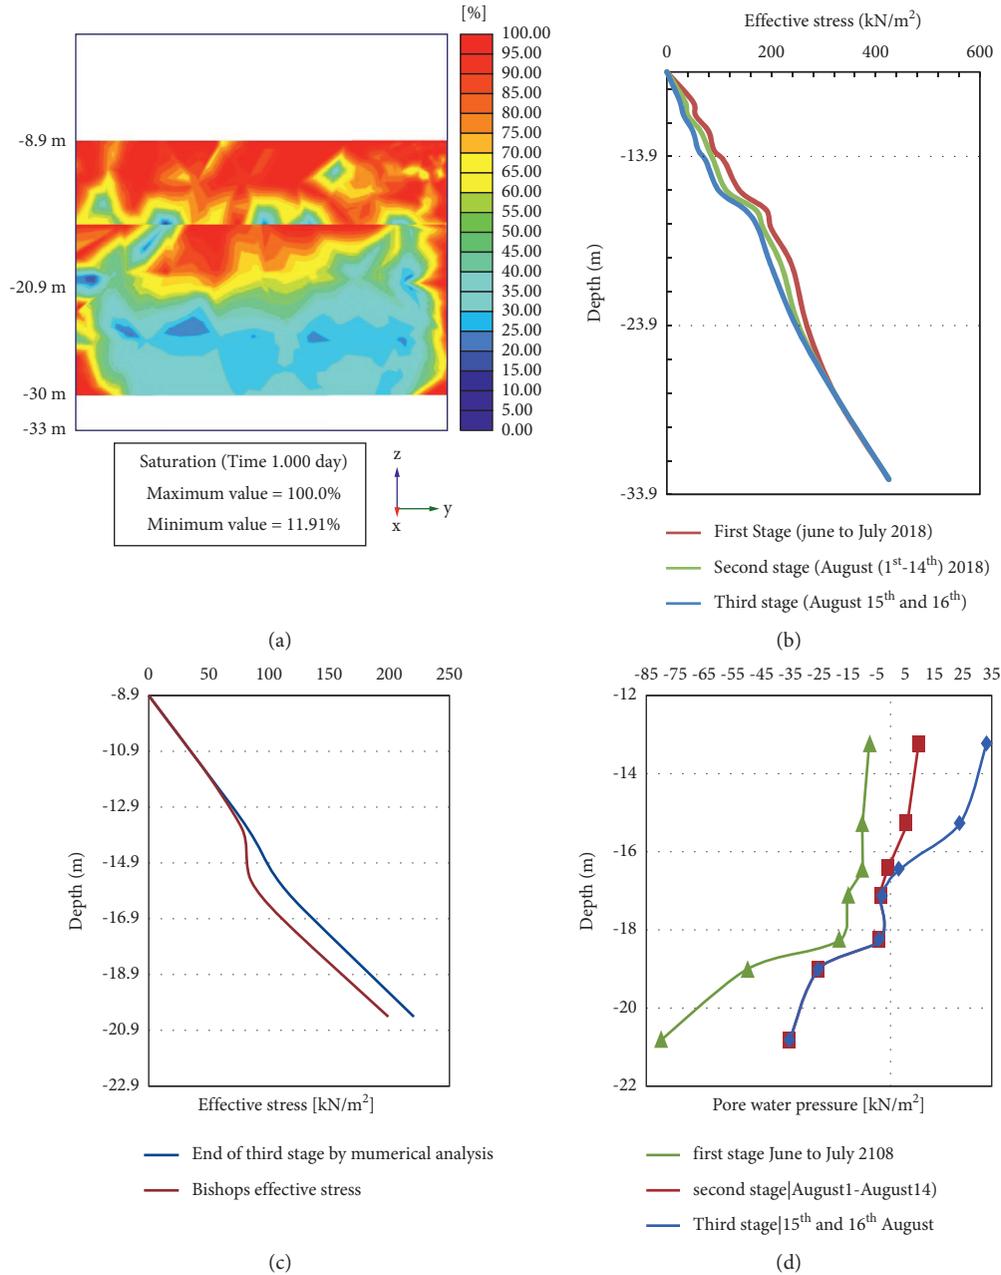
FIGURE 15: Results of numerical analysis. (a) Saturation level of the soil cross section at $x = 39.55$ m and $Z = 8.9$ m at vertical cut. (b) Effective stress at various stages. (c) Effective stress validated with the analytical method from PLAXIS 3D. (d) Pore water pressure of the soil at various stages.

The slope is stable at the end of the first stage of rainfall (Figure 15(d)) and this is due to the increase in matric suction in the soil. This is well supported by the increase in the effective strength of soil (Figure 15(b)). During the second stage of rainfall, the slope gets saturated and thereby, the pore water pressure increases. The increase in pore water pressure causes the effective stress to be reduced. The third stage causes the slope to be saturated (saturation up to 80%) for a depth of 8 m from the ground surface of the vertical cut. This causes the soil to develop an intense increase in pore

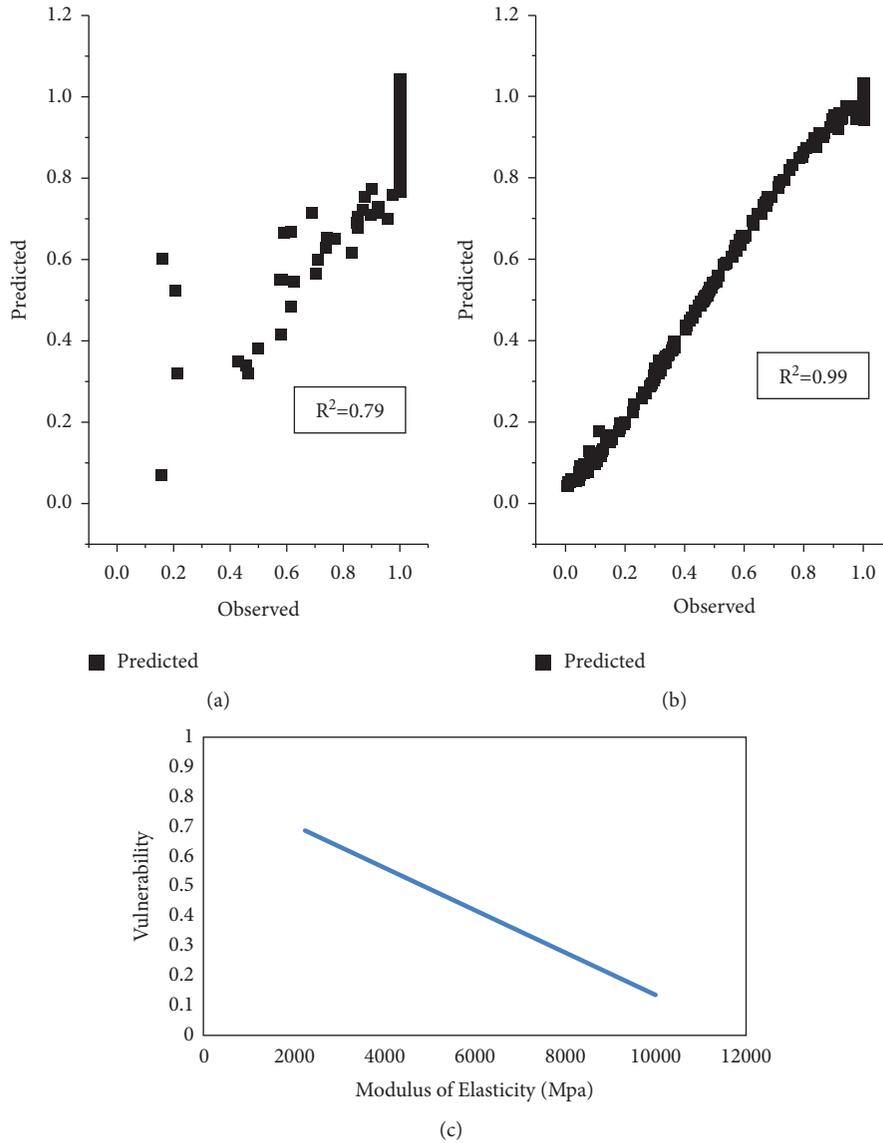
FIGURE 16: SVM model. (a, b) Performance of testing dataset of $E = 2,250$ MPa and $10,000$ MPa. (c) Variation of the vulnerability of the building for modulus of elasticity.

accuracy of 0.93 in training and 0.79 in testing (Figures 16(a) and 16(b)). The testing data is less than the training data, which shows that the SVM model does not overfit the model and helps in attaining valuable predictions [57]. The input parameters such as the lateral Earth thrust and the angle of inclination of the building are calculated from the finite element analysis. The length and the width of the building are set as 15 m and 10 m for the analysis. The elastic modulus of the building is set for the masonry building parameters. Table 3 shows the parameters used for the model. The tests were carried out to find the performance of the building when they have different heights and elastic modulus of the building.

building is 300 kN/m². The value of vulnerability reduces from 0.7 to 0.3 and the building resistance is increased to 20%. This is the case observed in this study for an inclination value of 0.01. This study shows that proper guidelines are to be framed, designed and the construction of the building should be according to the codal provisions.
