Review Article

Liquefaction Incidents of Mineral Cargoes on Board Bulk Carriers

Michael C. Munro and Abbas Mohajerani

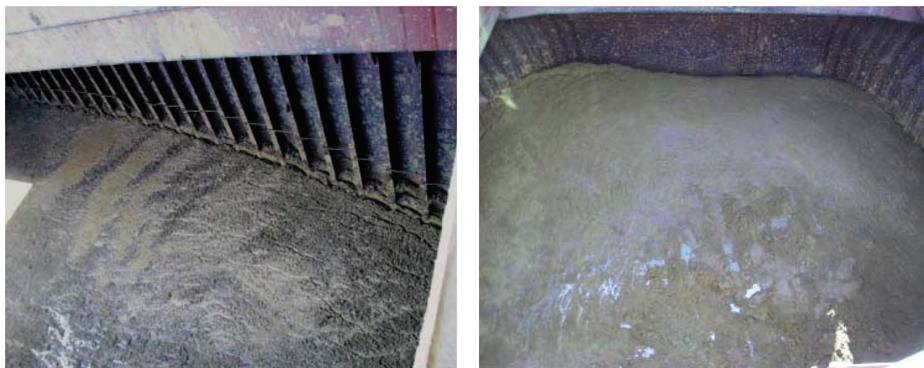
A little before 2200 the Padang Hawk suddenly developed a 15-degree list to port. After reducing speed and altering the course to bring the wind and sea onto the port quarter, crew were sent to check the hatches and the state of the main deck. After noting that nothing was out of place, the crew opened access hatches to each of the holds. They found that the cargo of nickel ore in all the holds, except hold number 5, had settled and shifted to port. The cargo in the first three holds appeared to be semiliquid, "like melted ice cream," as one of the crew described it. Two images of the nickel ore in hold number 1 of the Padang Hawk can be seen in Figure 5 [25].

FIGURE 5: Images of the nickel ore in hold number 1 of the Padang Hawk [25].

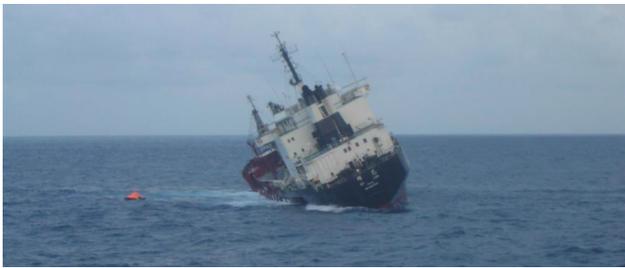
- (2) After investigating the probable causes of the accident, it is believed to be the liquefaction of the fluorspar cargo inside holds numbers 1 and 3. The flow state of the fluorspar cargo might have caused the vessel to list, capsize, and sink.

FIGURE 8: Hui Long listing severely to port after suspected liquefaction of the cargo of Fluorspar [29].

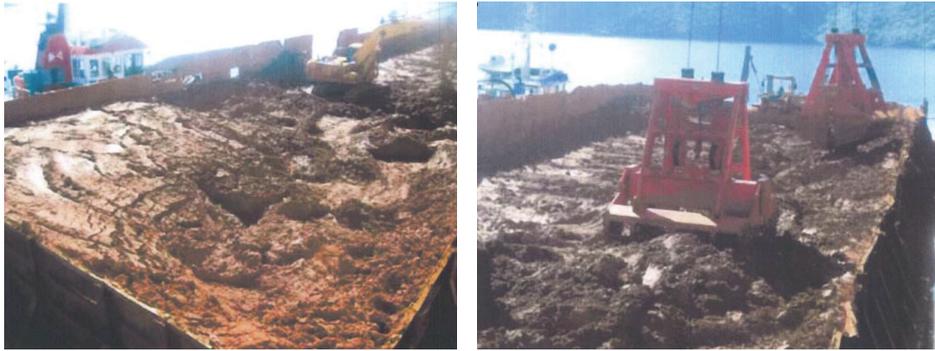
During loading, the Master was unsatisfied with the condition of the nickel ore cargo that was being brought to the vessel by the barges. On 2 November, a “note of protest” was prepared and within stated, “We find the cargo in [the 12th barge] is very wet and contains plenty of water. In view of the above fact, I, the Master of the MV ‘Nasco Diamond’, regret to submit this notice in advance to reject to receive this cargo, the ship, owner is not responsible for any loss.” [26]. Photographs were taken at this time and can be seen in Figure 15. The “note of protest” was more or less ignored as the cargo was allowed to be loaded being wet [26].

FIGURE 15: Photographs submitted to the head office by the Master of the condition of the nickel ore cargo at the time of loading at Kolonodale, Indonesia [26].

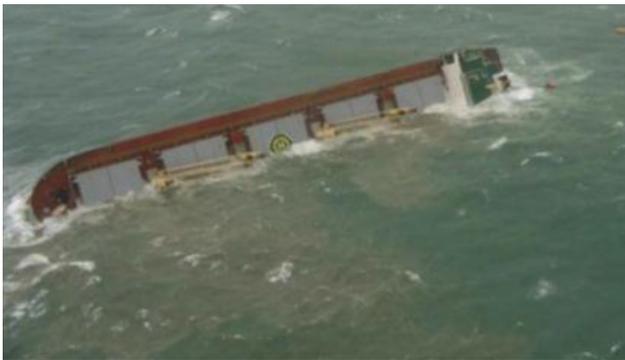
FIGURE 21: View from rescue helicopter as the Trans Summer listed 45 degrees to port [30].

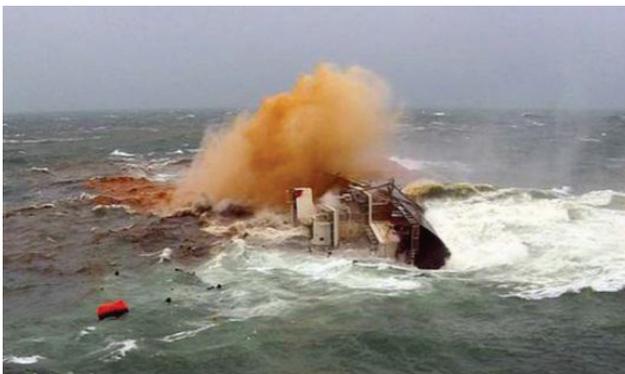
FIGURE 22: View from rescue helicopter as the Trans Summer listed 90 degrees to port [30].

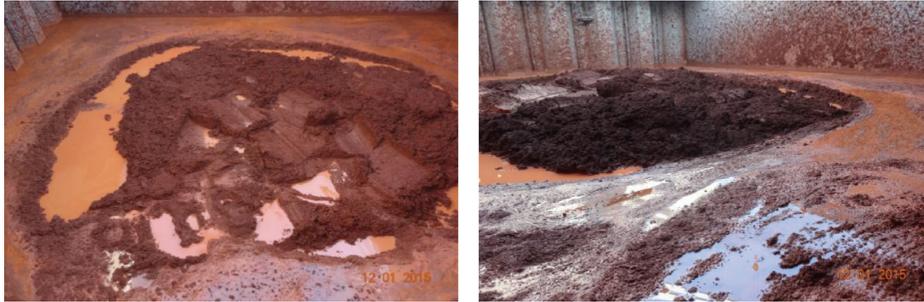
FIGURE 28: View of bauxite cargo in hold number 4 of the Orchid Island after voyage from Kuantan, Malaysia, to Qingdao, China [28].

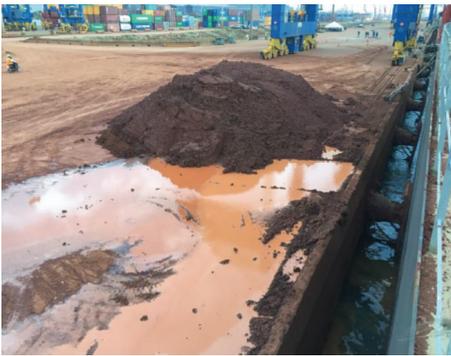
measures to protect the cargo on shore from further rain were not effective in preventing further wetting. The absence of an independent inspection resulted in the cargo being loaded without its physical properties and moisture content being verified against the parameters of the IMSBC Code schedule or the cargo declaration form.

FIGURE 29: Bauxite cargo quayside exposed to the elements. Photo taken from the Medi Okinawa at Port of Kuantan, Malaysia [28].
