## Research Article

# Analysis of Instability Mechanism and Induced Cause of Urban Pavement in Xining City, China

Received 26 November 2021; Revised 13 December 2021; Accepted 24 January 2022; Published 8 February 2022

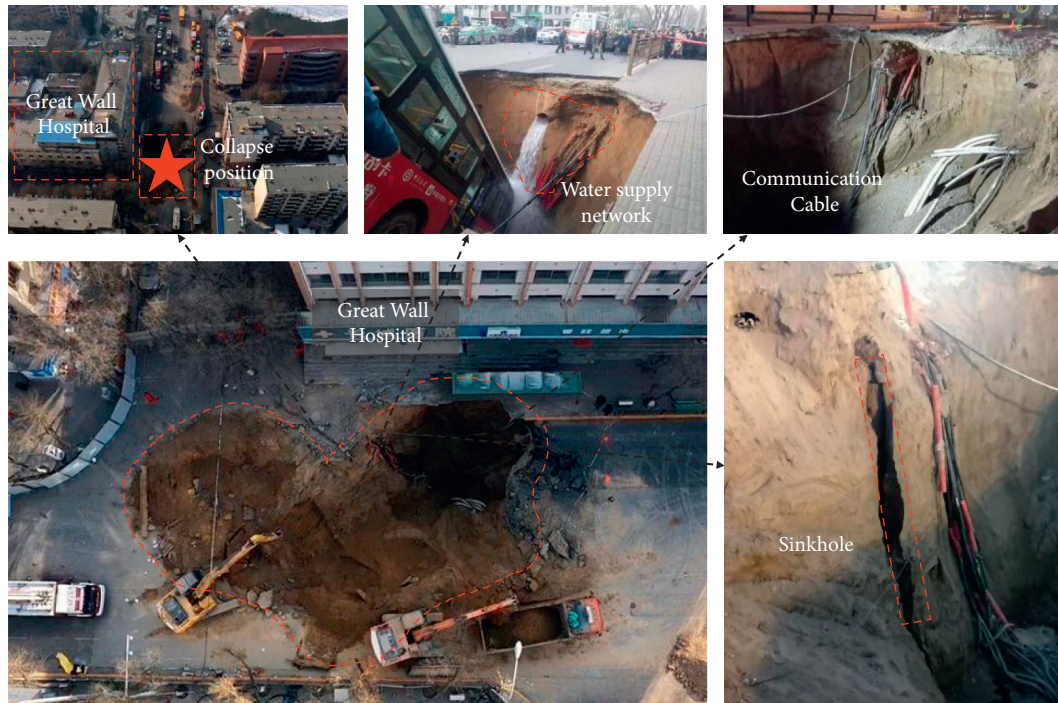
FIGURE 2: Collapse area situation.

According to the public meteorological data, there is no obvious precipitation process from December 2019 to the afternoon of January 13, 2020. The surface pavement in the surface area is covered by asphalt concrete, and the permeability is poor. Therefore, the formation of collapse pit can exclude the influence of groundwater and surface water. According to the on-site infiltration and collapse inspection, the water supply pipe which was wrongly broken on the east side of the pit wall had a buried depth about 1.5 m, a diameter of 50 cm, and a wall thickness of 0.6 cm. The material is cast iron. A water drop hole with a diameter about 0.8 m and a depth about 7 meters is formed at the lower part.

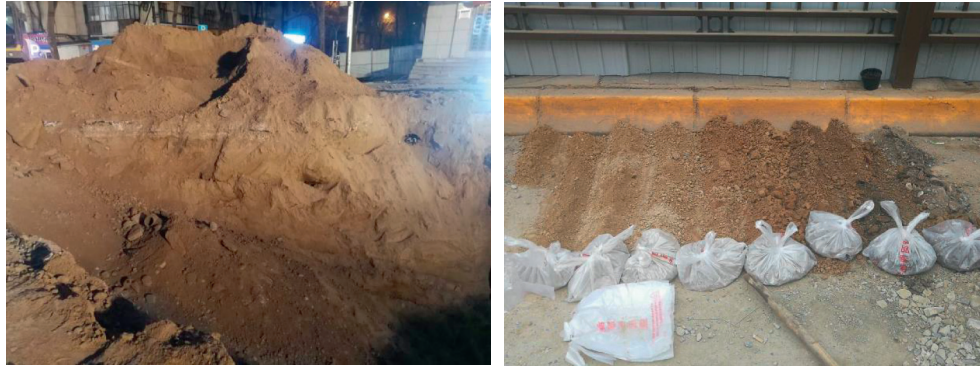
3.2.2. *Basic Geological Conditions.* The geotechnical experiment is carried out on the soil samples obtained from the site, as shown in Figure 6. The physical and mechanical properties of collapsible loess-like soil and noncollapsible

Due to the different thickness and compaction degree of the fill under the asphalt concrete cover, there is a certain degree of uneven settlement. The collapsible loess soil is the main stratum in the collapse area, with loose structure, vertical joints, macropores, and strong water sensitivity. The loess soil is collapsible, with medium to strong collapsibility, and the collapsibility grade is grade II to grade III. It is easy to dissolve the soluble salt when it is wet with water, and the particulate matter is easy to lose and the strength is reduced. This kind of stratum is the basic geological condition of road collapse.

FIGURE 6: Selection of field soil samples.

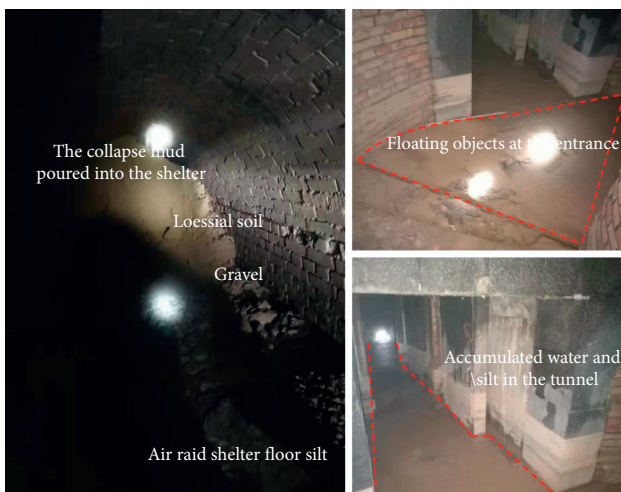
The cave body is filled with collapsing loess-like soil and gravel, and the bottom of the cave is silted. The underlying underground air raid shelter is a precast arch structure with rubble wall. Figure 7 shows the whole picture of the air raid

FIGURE 7: Full view of air raid shelter below after collapse.

shelter after collapse. The water depth is about 1.3 m and the silt thickness is about 0.5 m.

The seepage of the top plate of the air raid shelter reduces the bearing capacity of the subgrade and provides the

migration channel and storage space for the water and soil loss of the pavement before and after the collapse. The air raid shelter provided space conditions for the road collapse.

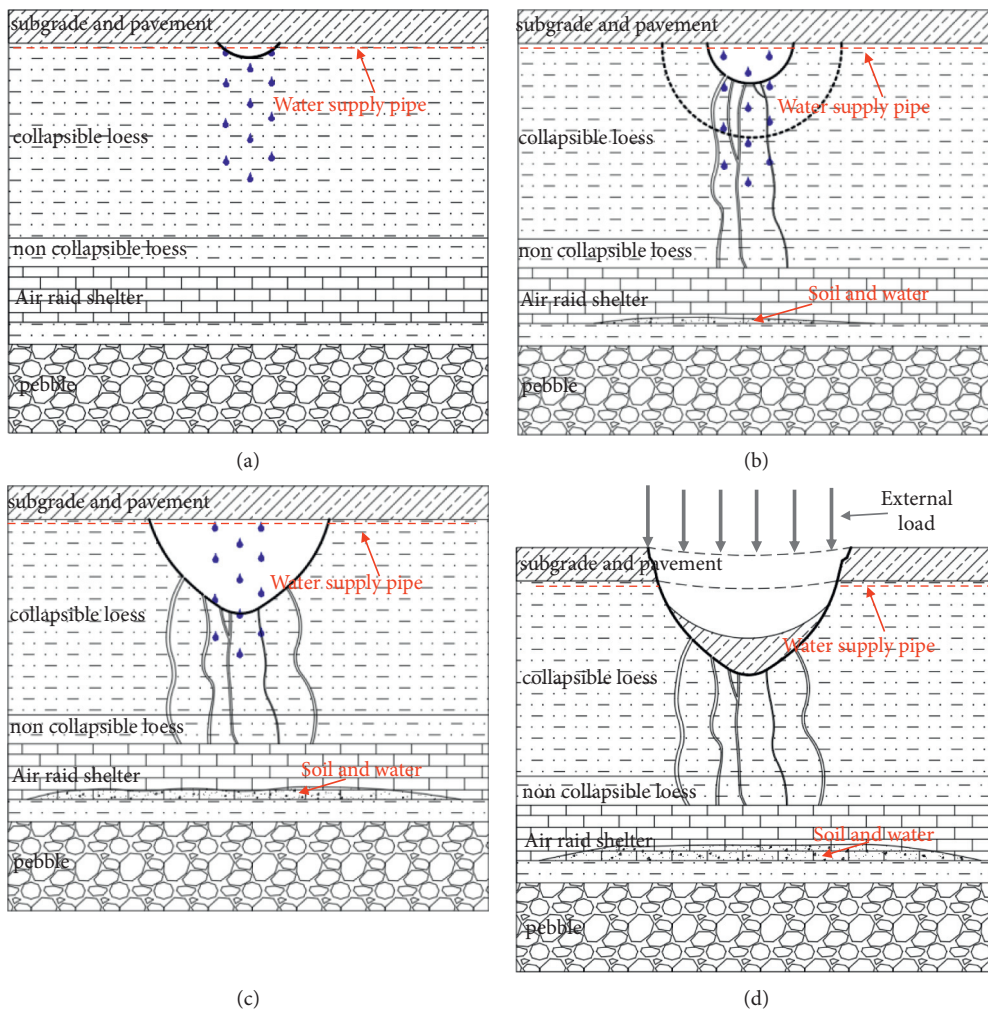
**3.3.3. Void Formation Mechanism Analysis.** Urban road collapse is sudden, but the formation of underground cavity has experienced the development process of water supply pipe leakage, underground soil penetration and cavity formation, critical state of collapse area, road collapse, and so on, as shown in Figure 12.

FIGURE 12: Formation and collapse process of underground cavity. (a) Leakage. (b) Development. (c) Through. (d) Collapse.

**3.3.5. Penetration of Underground Soil and Formation of Cavities.** On the one hand, the long-term water leakage will accelerate the corrosion of the water supply pipe, thus speeding up the water leakage in the water supply pipe. On the other hand, the fine particles in the soil are taken away and flow into the air raid shelter under the action of water, forming “underground passages” at the initial stage, which connect and expand with each other, eventually leading to the formation of underground cavities. At the same time, because of the collapsibility of the loess in this area, the collapsibility effect will occur when it meets with water, which will also cause the uneven settlement of the soil at the leakage and accelerate the formation of underground cavities.

**3.3.6. Critical State of Collapse Zone.** With the formation, transfixion, and expansion of underground cavity, coarse particles in soil exist in the form of skeleton, and soil structure also changes to some extent. However, soil can still maintain a critical stable state through its skeleton effect and stress adjustment. When this stable state is disturbed by external factors, it is easy to lose stability.

**3.3.7. Road Collapse.** The collapse area is in a critical state, forming “Asphalt Pavement Bridge.” When the bus and other external loads act on the pavement, the external load reaches and exceeds the ultimate bearing capacity of the subgrade, and the pavement collapses suddenly.

- (4) It is suggested that Xining City should adopt various means as soon as possible to carry out exploration and safety risk assessment on various underground pipe networks and air raid shelters of urban roads and do a good job in the daily operation, maintenance, management, monitoring, and early warning of underground pipe networks to avoid similar incidents in Xining area. At the same time, it should also sound an alarm to the whole country and strengthen the planning, development, and utilization, comprehensive management, and underground
