# Fatigue Failure Analysis of a Gear in Automobile Engine Coolant Pump

Gear is a reliable part of power transmission. This article presents a metallurgical failure analysis of a failed gear used in automobile engine coolant pumps. In gear, the soft microstructure of pearlite and ferrite is witnessed in metallographic analysis. Significant wear is perceived in gear teeth, and significant deformation is observed in the keyway. The crack initiated from the corner radius of the keyway and propagated towards to the root of the teeth, which is evidence of the failure due to fatigue. Recommendations are given to improve the fatigue strength of gear.

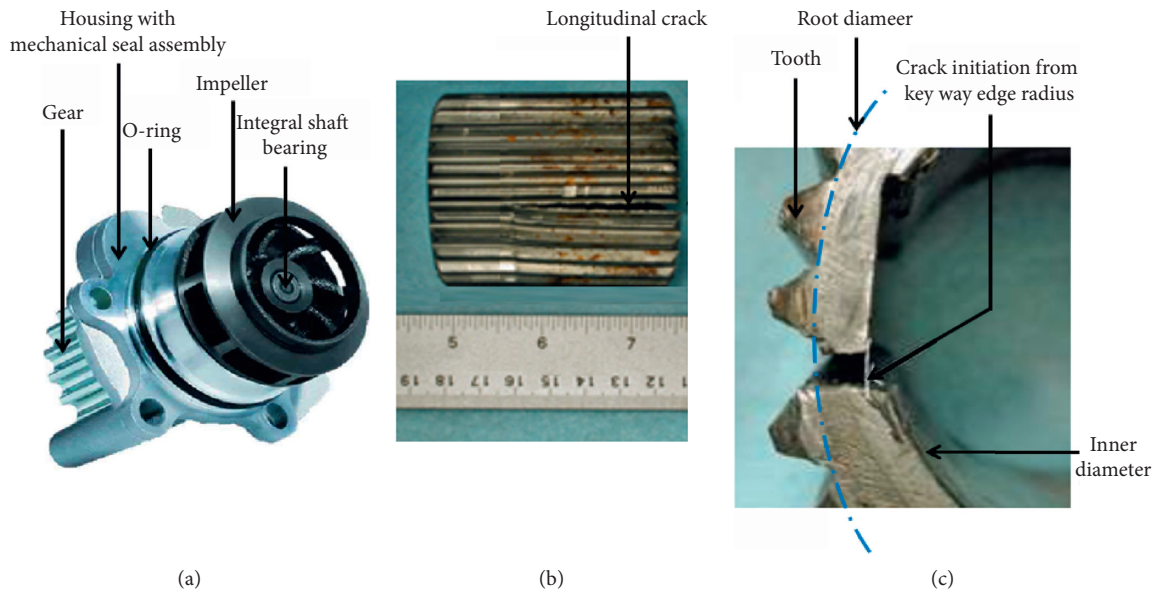
**2.1. Visual Examination.** Failed gear has a keyway in the inner diameter and a gear tooth profile in the outer diameter, as shown in Figure 1(c). The gear had failed in a longitudinal mode lengthwise, as shown in Figure 1(b). The longitudinal mode crack occurs up to 65% of the length, and significant wear is perceived in the gear profile [15, 19, 20]. The crack initiated from the corner radius of the keyway and propagated towards the root diameter of the gear.

FIGURE 1: (a) Parts of an engine coolant pump, (b) Crack geometry of the failed gear, (c) Crack initiation.

- (1) Keyway edge radius to be increased to reduce stress concentrations in the area of fatigue crack origin.
- (2) Based on tensile test validation in samples, by the case hardening process, 59% of tensile strength was improved.
- (3) The case hardening process followed by quenching and tempering could confidently increase the wear resistance and the fatigue strength of the gear.

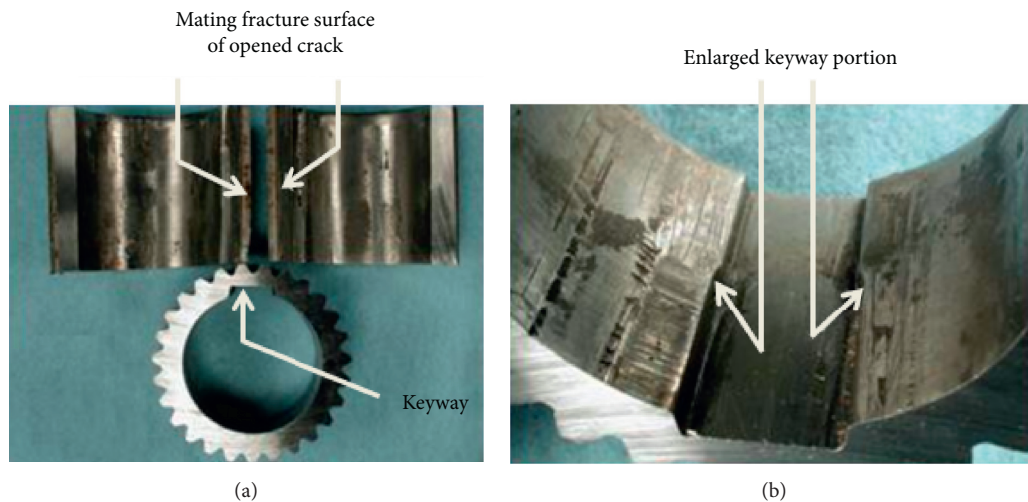
The gear is cut in a cross-sectional view where the longitudinal mode is ended and cross-sectional keyway of the remaining portion, is shown in Figure 2(a). A close-up view of the remaining part, as shown in Figure 2(b), confirms the enlarged keyway portion. The deep deformation of the keyway is due to the heavy load during application.

FIGURE 2: (a) Overview of longitudinal mode crack surface and the cross-sectional view of keyway at the nonfailed portion. (b) Enlarged keyway portion of gear.

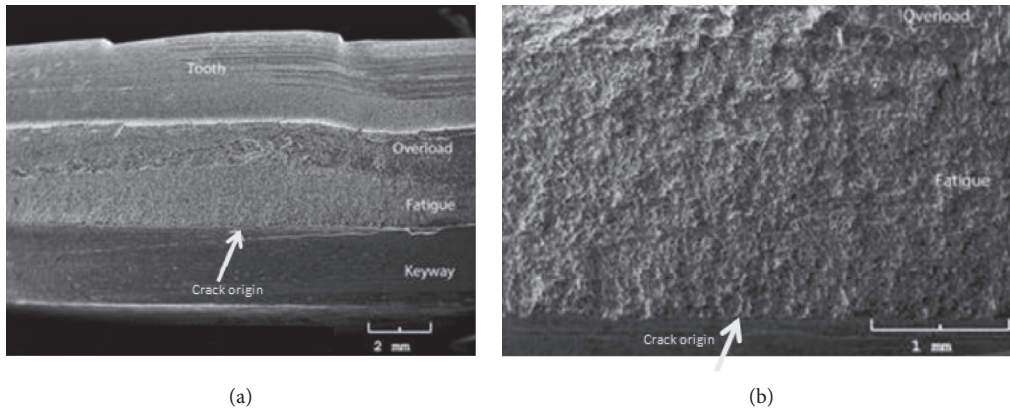
**2.4. Scanning Electron Microscopy Analysis.** The entirely fractured surfaces are washed by using acetone and diluted HCL. The crack initiated from the keyway edge and propagated towards the root diameter of the gear tooth. The low magnification SEM image (Figure 3(a)) indicates that the top area is the tooth surface and bottom area is the keyway surface. In between the tooth and keyway surface, the crack origin, fatigue propagation zone, and overload zone are presented. Fatigue propagated zone stand up before the overload zone. Figure 3(b) shows the increased magnification SEM view of the fracture surface at the crack origin.

FIGURE 3: (a) SEM image of the fractured surface (magnification: 10x). (b) SEM micrograph showing the crack origin, fatigue zone, and overload zone of the fracture surface (magnification: 40x).

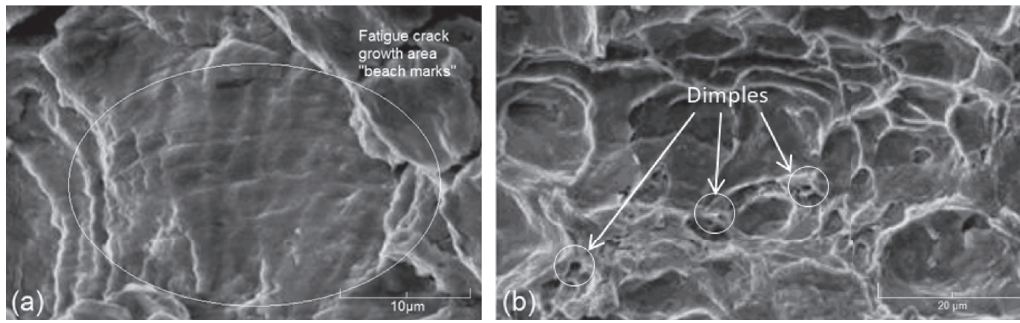
The high magnification shows the fracture origin exposed fatigue striations (beach marks) in Figure 4(a), and the beach marks are concentric rings in a fatigue region which resembles wave marks on a beach. The crack progression is caused by changes in working load and environment. The overload high magnification SEM view in Figure 4(b) revealed a dimpled feature. The dimpled features occurred due to the creation and coalescence of microvoids sideways to the fracture mode. This confirms the ductile overload fracture.

FIGURE 4: (a) SEM micrograph showing the fatigue (magnification: 4000x). (b) SEM micrograph showing the dimpled surface feature (magnification: 2000x).

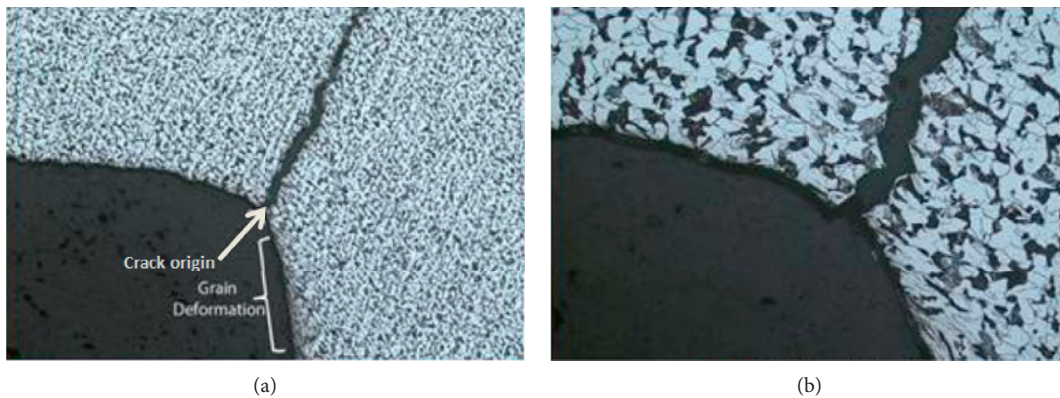
**2.5. Metallography.** In optical microscopic observation, a minor crack is observed at the corner radius of the keyway shown in Figure 5(a). A considerable grain deformation was also observed in the keyway radius. The fatigue crack initiated from the keyway edge radius and propagated towards the root of the teeth. In the microstructure of the core, soft pearlite and ferrite are perceived, as shown in Figure 5(b). It is confirmed that gear is not heat-treated [29–32].

FIGURE 5: (a) Optical microscopic view showing the crack origin at the corner radius of keyway (magnification: 50x). (b) Microstructure shows the soft pearlite and ferrite in the core (magnification: 200x).

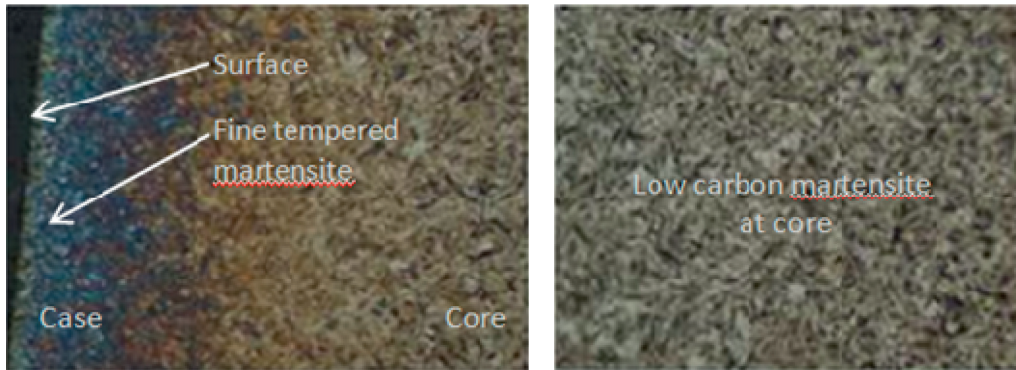
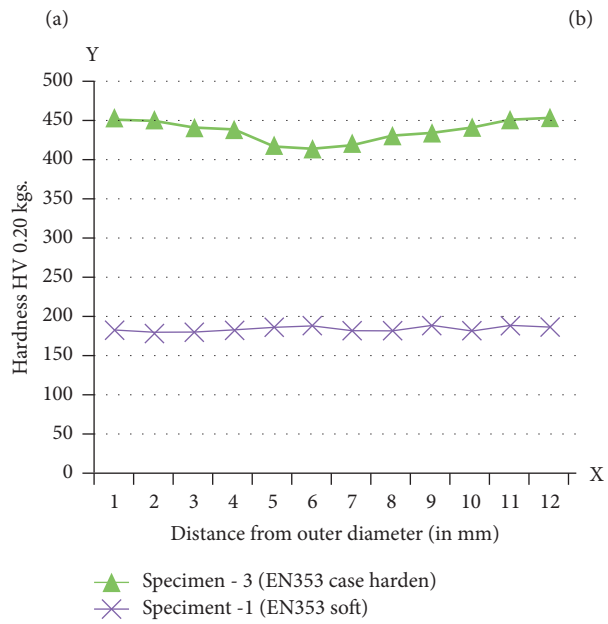
microstructure of the specimen is analysed using a Leica DMC2900 microscope. Microstructure is carried out on a metallographically polished specimen 3. Fine-tempered martensite microstructure in the case surface is presented in Figure 7(a), and low carbon martensite microstructure in the core is revealed in Figure 7(b). Readings of hardness are taken in a 15 N:15 kgf superficial rock well. The surface hardness of specimen 3 is 48.5 HR15 N. The case depth of the outer diameter is 0.35 mm. Core hardness is found to be 415 HV @ 0.20 kgs, as shown in the microhardness traverse

survey graph in Figure 7(c). The hardness of the soft specimen 1 is in the range of 180 to 190 HV at 0.20 kgs. (88 to 90 HRB). Rockwell B is shown in the microhardness traverse survey graph in Figure 7(c).

FIGURE 7: (a) Specimen 3 microstructure shows the finely tempered martensite in the case. (b) Specimen 3 microstructure reveals low carbon martensite in the core. (c) Microhardness traverse survey graph.

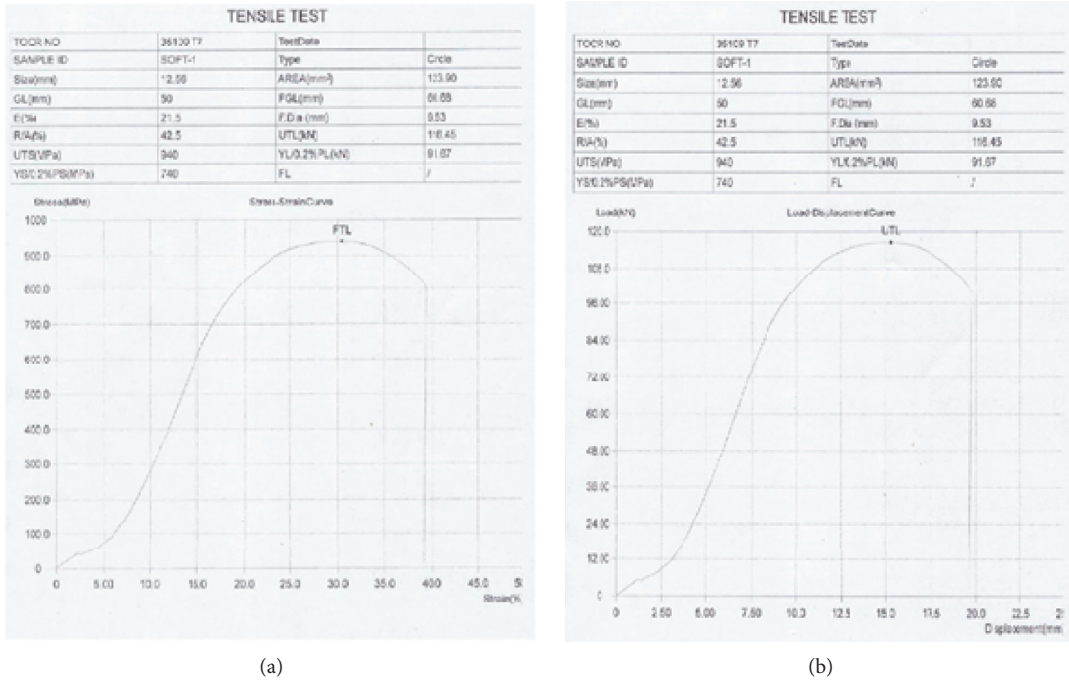
Soft specimen 2 and case-hardened specimen 4 are tested. The stress-strain curve and load-displacement curve of the soft specimen are shown in Figure 8(a) and

FIGURE 8: (a) Stress-strain curve of soft specimen 2. (b) Load-displacement curve of soft specimen 2.

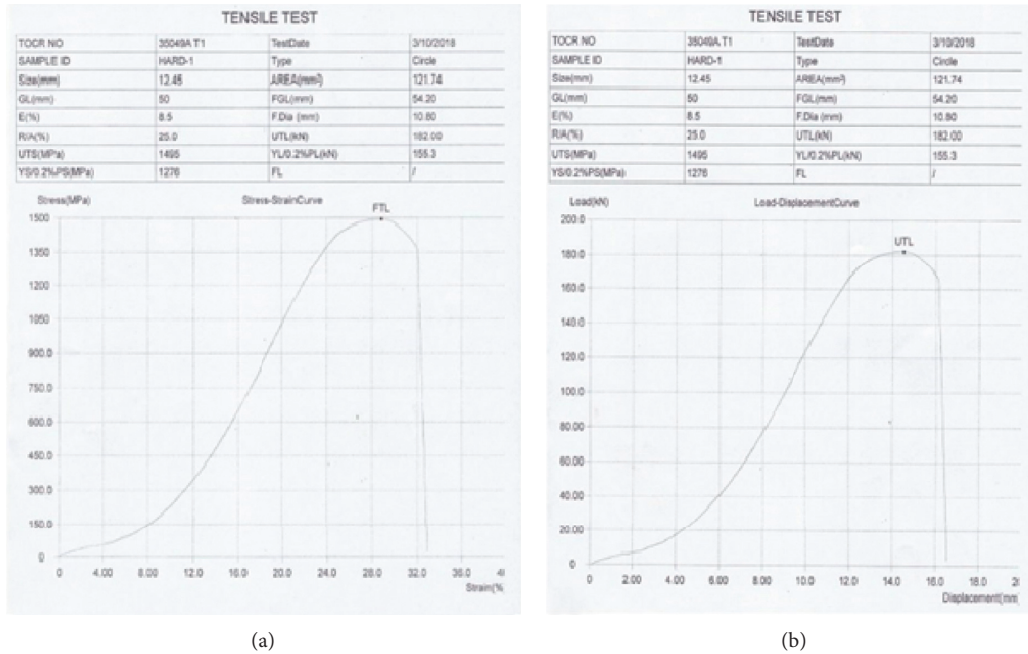
Figure 8(b), respectively. The stress-strain curve and load-displacement curve of the hardened specimen are shown in Figure 9(a) and Figure 9(b), respectively. The ultimate tensile stress (UTS) of soft specimen 2 is 940 MPa, whereas hardened specimen 4 is 1495 MPa. Hence, 59% of the ultimate tensile stress (UTS) is higher in hardened specimen 4.

FIGURE 9: (a) Stress-strain curve of hardened specimen 4, (b) Load-displacement curve of hardened specimen 4.
