FAILURE MECHANISMS IN SOLID ELECTROLYTIC CAPACITORS

J. BRETTLE and N. F. JACKSON

The Allen Clark Research Centre, The Plessey Co. Ltd., Caswell, Towcester, Northants, England

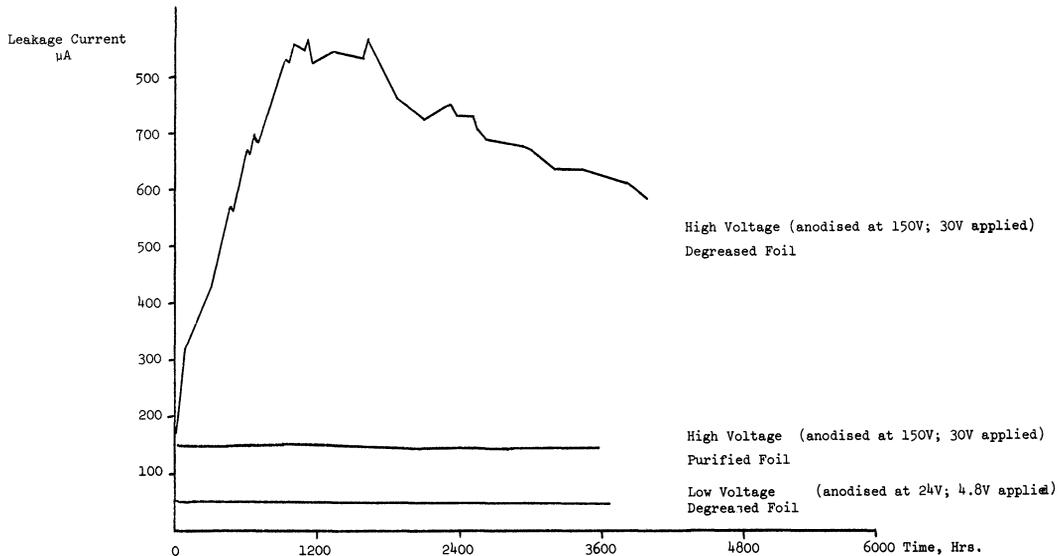
Foils anodised under the conditions described in the preceding section were made up into capacitors and tested at 125°C. Units anodised at 150 V were initially tested at 40 V; because of rapid failures, this was reduced to 30 V. Units anodised at 24 V were tested at 4.8 V, i.e. at the same field strength ($\sim 1.25 \times 10^8 \text{ V/m}$) as the higher voltage units at the reduced level. Figure 1 shows the form of the leakage current/time plot for the three types of capacitor. It can be seen that low voltage capacitors and capacitors using purified foil have low and constant leakage currents, whereas high voltage capacitors exhibited a sharply rising leakage current which peaked early in the life test and slowly declines thereafter. In addition to the normal high leakage currents, current surges often occurred in this type of capacitor which could blow 100 mA safety fuses placed in series with each capacitor. The capacitor often recovered on replacement of the fuse, but the latter was sometimes blown again at a later date.

FIGURE 1 Leakage current vs time for solid tantalum capacitors (125°C)

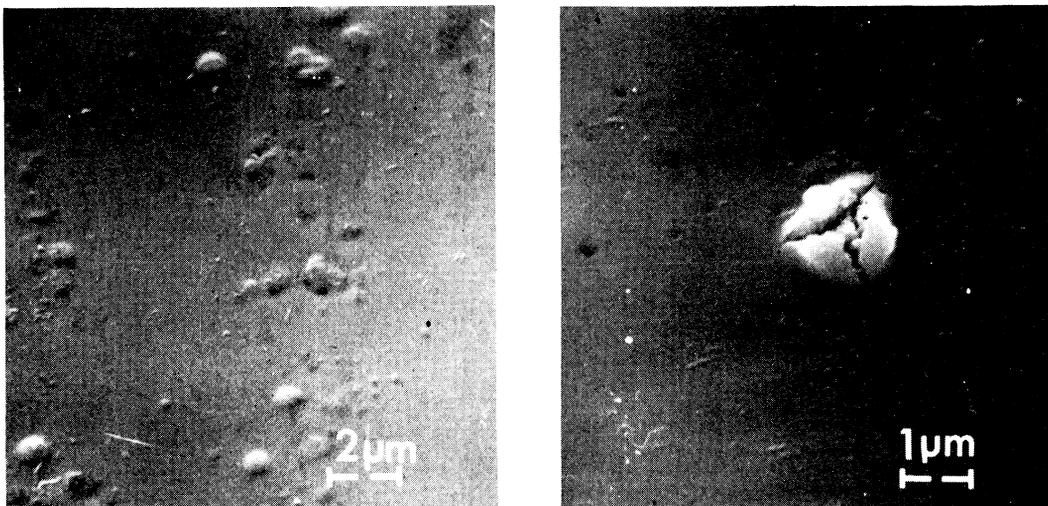
a) Before Life Test Figure 2(a) shows the general structure of the oxide. Defects in the film lie in lines along the rolling direction of the foil suggesting that they are initiated from damage induced by rolling or impurities introduced by the rolls. The defects are of three main types: bumps, cracked bumps and pits.³

Figure 2(b) shows a cracked bump in more detail.

The structure is $\sim 1.5 \mu\text{m}$ across and consists of a pyramidal growth of crystalline oxide cracking open the amorphous oxide to produce a characteristic three branched crack.

FIGURE 2 Structure of 150 V film prepared on degreased tantalum foil: (a) general structure, (b) cracked bump.

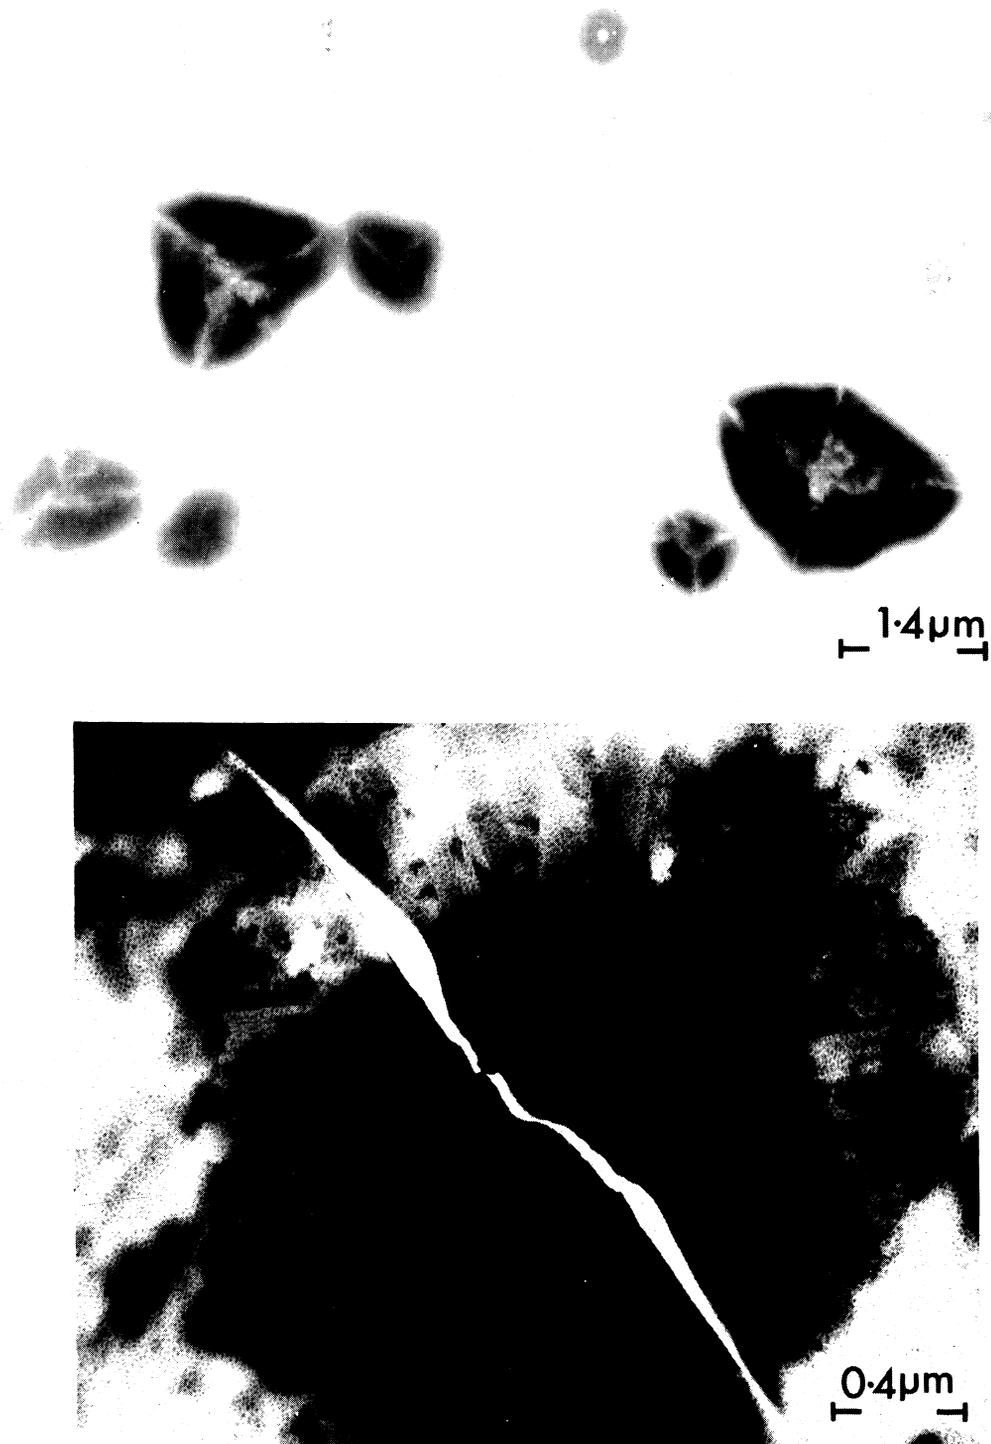
FIGURE 3 Structure of 150 V film prepared on degreased tantalum foil:
(a) transmission micrograph
(b) after argon beam thinning, (the white line across the micrograph is an artefact produced by the film rupturing).

To examine the structures below bumps and cracked bumps argon beam thinning of the stripped oxide film was attempted. A thinned bump is shown in Figure 3(b). The centre of the bump is still dark due to thickness contrast but a fringe of crystalline oxide showing diffraction contrast can be seen.

Selected area electron diffraction shows the crystalline oxide to be $\beta\text{-Ta}_2\text{O}_5$

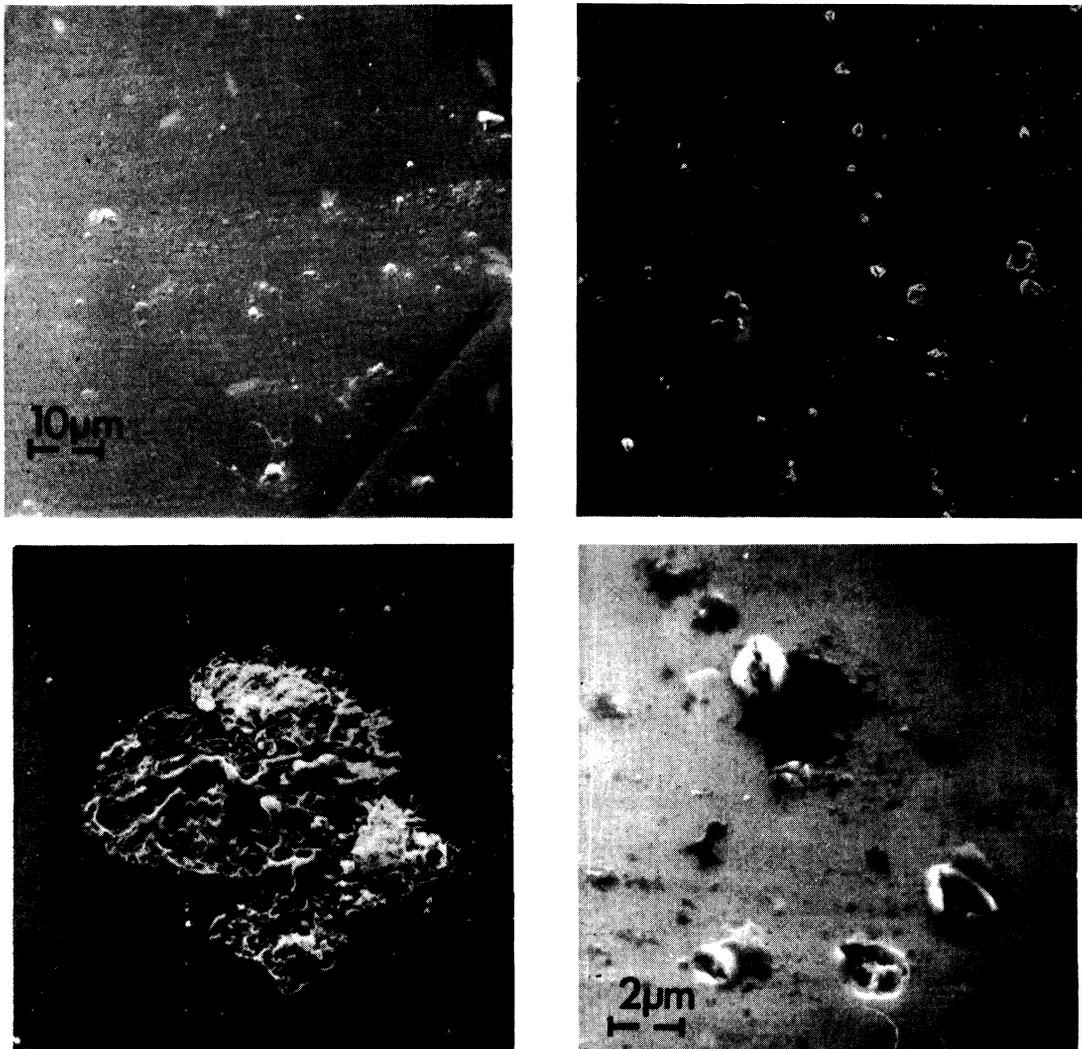
FIGURE 4 Structure of 150 V film prepared on degreased tantalum foil: (a) before life test, (b) after life test (1000 hours), (c) large breakdown site, (d) after extended life test (9000 hours).

b) **After Life Test** Standard, high voltage capacitors which had been on life test for several thousand hours and which were therefore showing large leakage currents were removed from life test, the manganese dioxide removed with $\text{HNO}_3/\text{H}_2\text{O}_2$ reagent and the anodic oxide re-examined using the microscopical methods described earlier. On stripping film for transmission electron microscopy it was immediately obvious that the film was very much more fragile than the untested film. The reason for this was apparent on examination: many large cracked bump sites were present after testing, the centre of the defect often being lost, so leaving a hole in the film. All stages of defect growth could be seen, in contrast to untested film where either uncracked bumps or bumps in a late stage of crack development were more usual.

doubled on life testing. A much larger change, 1–2 order of magnitude, was seen in the number of uncracked bumps. Generally these bumps were larger, more distinct and more difficult to distinguish from the cracked bumps in the lifetested case than in the untested case; a less strict definition of what was taken as a cracked site would have produced a much larger ratio than the doubling reported above. In addition to the defect sites much larger failure sites (Figure 4(c)) were observed. The probable sequence of events is that bumps grow in size during life test and finally crack open; a number of these cracked sites then suffer electrical breakdown resulting in the structure shown.

Capacitors which had been on test for much longer periods were also examined. These had suffered a slow gradual decline in leakage current from the early high value. Figure 4(d) shows a typical area of oxide film in such a unit; it appears that the cracked bump sites had become damaged. All stages of damage could be seen, from the lip of the site being partly broken away, through the "cap" of the site being removed exposing the underlying crystal to the crystal being removed. It appears possible, therefore, that the

decrease in leakage current later in the life test may be due to conducting crystallisation sites mechanically detaching from either the manganese oxide or the tantalum, thus lowering the current.

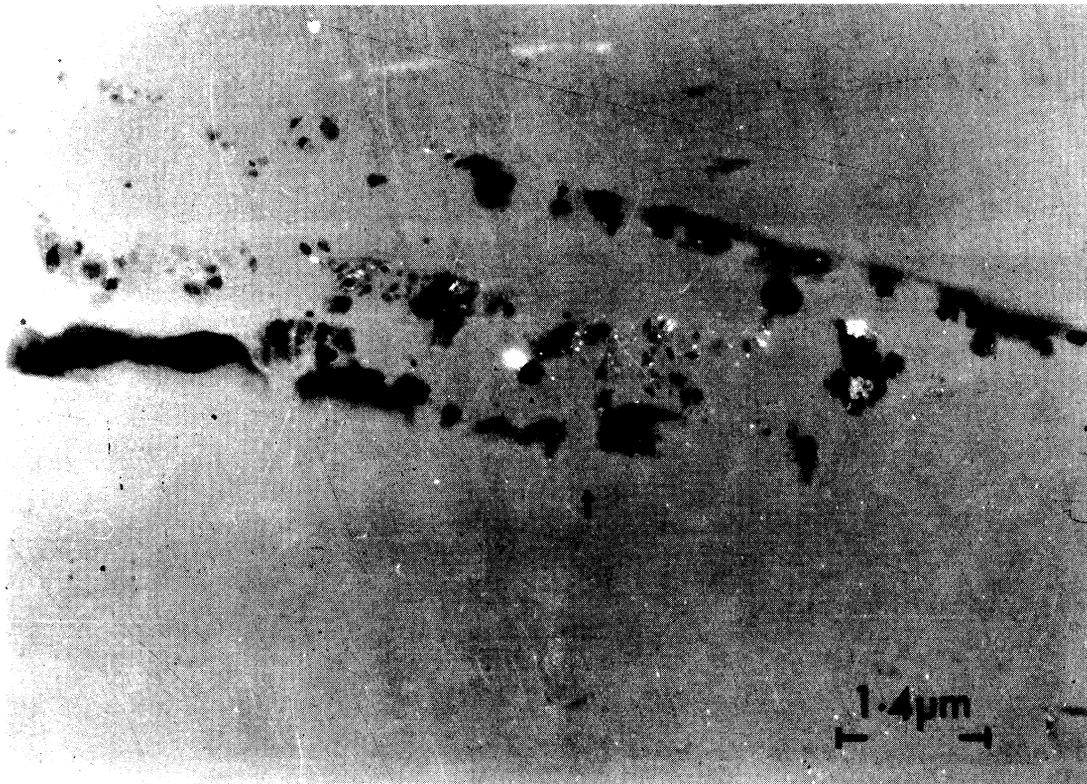
FIGURE 5 Structure of 24 V film prepared on degreased tantalum foil.

3.3.2 Low voltage capacitors In contrast to the high voltage oxide, no differences in structure were apparent between films examined before and after life test.

Scanning electron microscopy showed that none of the pit, bump or cracked bump features previously observed could now be seen. However because the film had consumed such a thin layer of tantalum during anodisation (~ 20 nm)⁶ the original surface of the tantalum was effectively replicated resulting in a rough looking oxide. The close replication of the surface allowed the extraction of surface impurities by the oxide (Figure 5). The dark areas are tantalum metal retained in the folds of the rough oxide, the bright particles being crystalline impurities shown up by the dark field conditions employed in the electron microscope. It has proved difficult to analyse these particles sufficiently well by selected area diffraction

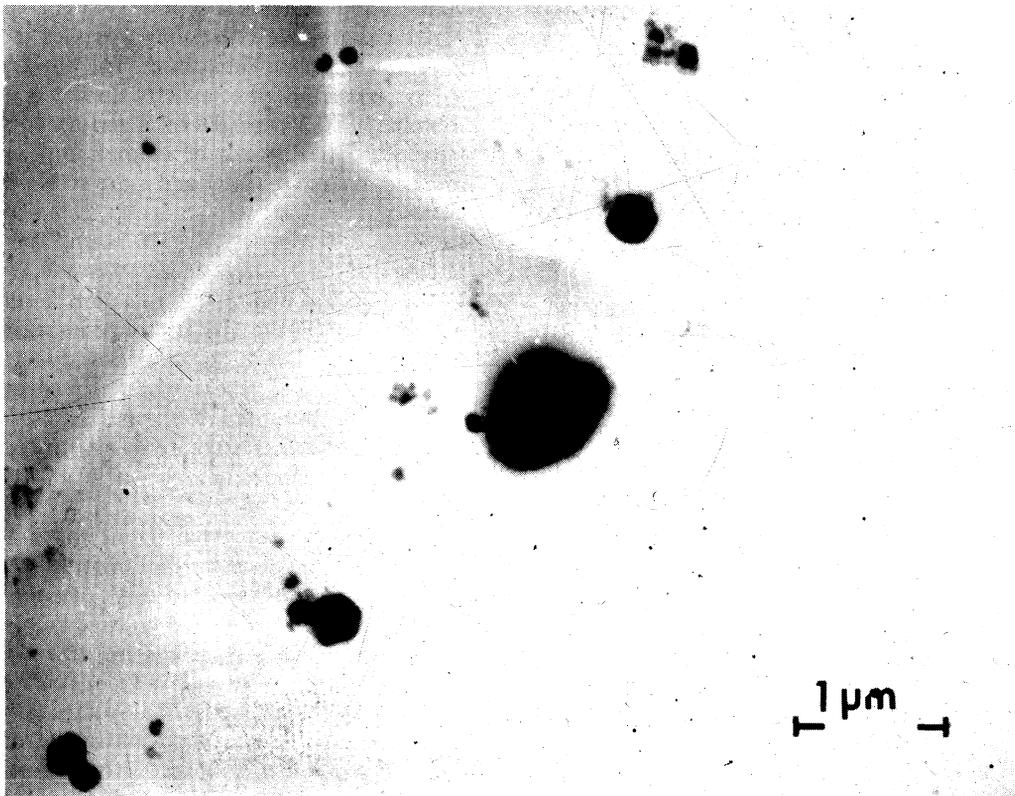
3.3.3 Oxide formed on specially purified tantalum As with the low voltage oxide, life testing had no effect upon the structure. On examination the oxide was found to be smooth and largely defect free. An occasional line of impurities could be discerned following a prior grain boundary in the underlying metal and crystallisation sites were present at a few of these impurities (Figure 6). It can be seen therefore that a purification treatment greatly inhibits the occurrence of defects in the anodic oxide by reducing the number of initiating impurities. Although the starting foil was of 99.99% purity spark mass spectrometry has shown that most impurity elements have concentrations 1–2 orders of magnitude higher at the

FIGURE 6 Structure of 150 V film prepared on purified tantalum foil.

surface than the bulk. Therefore nominally 99.99% pure material may have only a 99% pure surface layer.

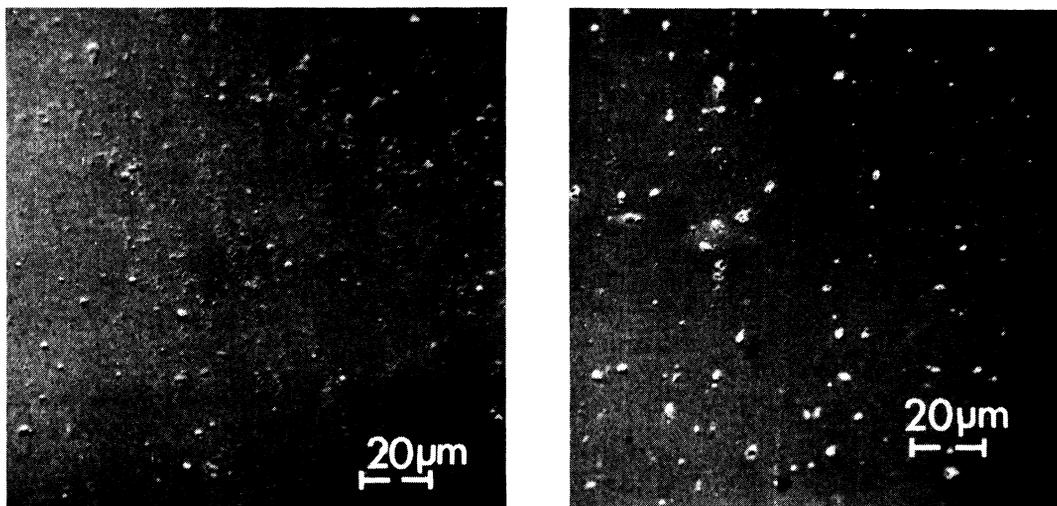
A four terminal power supply was adapted with a 1 k Ω series resistor to provide up to 20 mA without voltage drop to the capacitor terminals; from 20 mA to 50 mA the capacitor terminal voltage fell linearly from 30 to 0 V. In this way variations in applied voltage due to variations in steady state leakage current could be avoided while maintaining the ability of the circuit impedance to inhibit large current surges. A series of standard capacitors with voltages applied from this power supply were compared with a series with voltages applied from low impedance lead-acid batteries. The power supply voltage was adjusted to exactly the battery voltage (nominally 30 V) and the tests performed simultaneously. The addition of a circuit impedance resulted in a much lower and more stable leakage current which increased gradually from about 20 μ A to 45 μ A over a period of 1300 hours. The morphology of the oxide surface before and after life test is shown in Figure 7. With a high circuit impedance, bumps in the film, although increasing in number during life test as in the low circuit impedance case, do not generally crack, in contrast to the observations reported in Section 3.3.1. A further important feature was the initial absence of large electrical discharge sites, only one of these being found.

It appears that an added circuit impedance not only prevents the development of large electrical discharge sites but also the growth of uncracked bumps into somewhat larger cracked bumps. The smoothness of the leakage current/time plot in the low impedance case suggests a gradual increase in the number of "leaky" cracked bump sites rather than the sudden appearance of the occasional large electrical discharge site. To investigate the mechanism of the circuit impedance effect more closely some order of magnitude calculations were performed to see

FIGURE 7 Structure of 150 V film prepared on degreased tantalum foil after life testing: (a) high impedance circuit (b) low impedance circuit

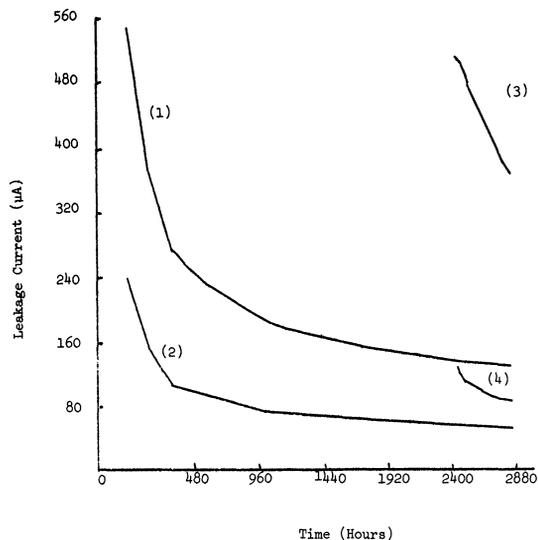
Capacitors were life tested at 125°C with 30 V d.c. applied. Initial leakage currents were similar to the tantalum units but subsequent behaviour was markedly different. In general the leakage current decreased with time up to ~ 1000 hours and then remained essentially constant for test periods up to 9000 hours. The initial decrease in current was found not to be a "drying-out" effect, dependant upon temperatures alone. This was established by storing capacitors at 125°C for 2,500 hours prior to applying the voltage. As shown in Figure 8, the leakage currents decreased in the same way as the control capacitors. It was also observed that if the applied voltage was interrupted for a short period of time when the leakage-current had fallen to the steady value, a significantly lower current was apparent on reconnection. However, a gradual recovery to the steady value occurred over a time period of several tens of hours.

FIGURE 8 Leakage current vs time for solid aluminium capacitors on test at 125°C with 30 V applied. Nos. 1 and 2, testing voltage applied immediately specimens had reached temperature. Nos. 3 and 4 testing voltage applied after 2400 hours at temperature.

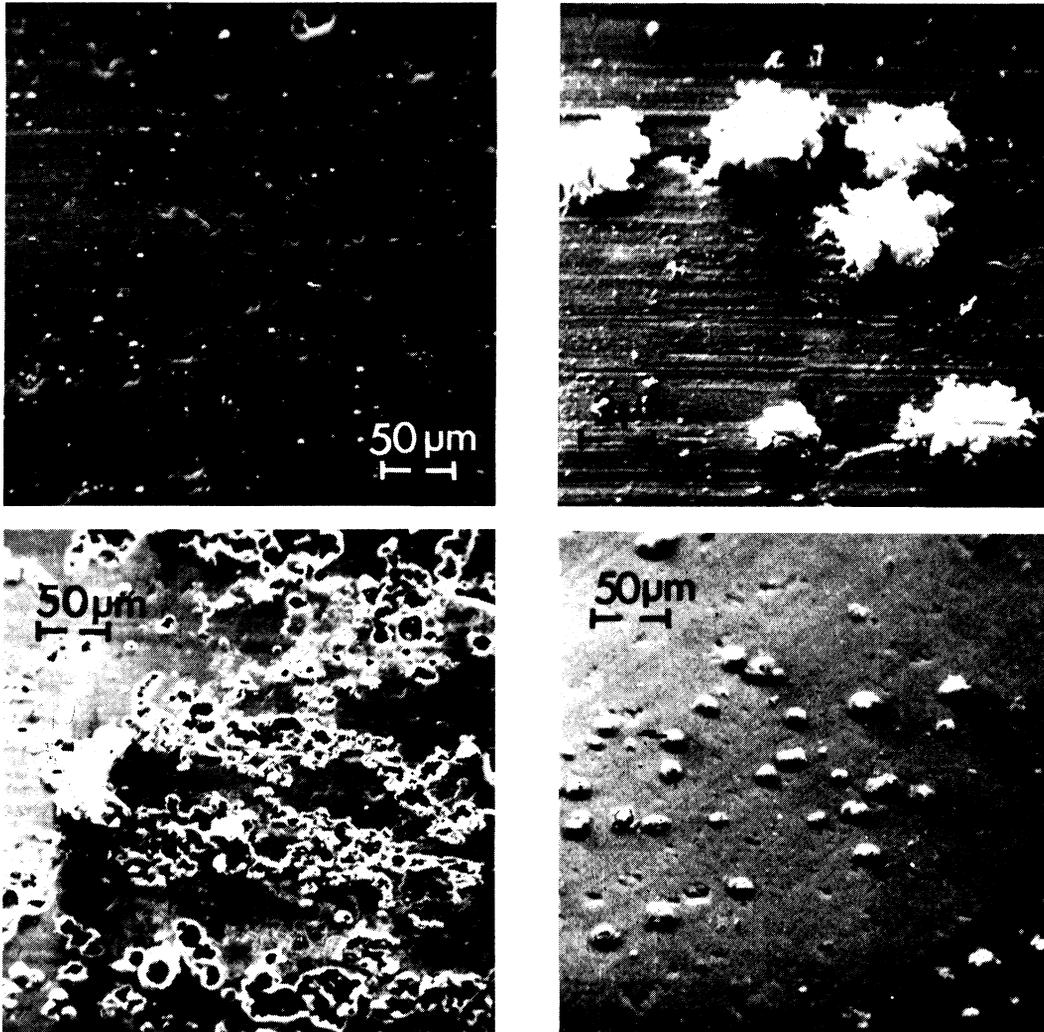
Examination of the anodised foil revealed the presence of nodules of non-coherent oxide distributed randomly over the surface (Figure 9(a) and (b).) The nodules were in the region of $1 \mu\text{m}$ to $3 \mu\text{m}$ in diameter and had a population density of $\sim 3 \times 10^6 \text{ cm}^{-2}$. Electron probe microanalysis indicated a high concentration of iron at the nodular sites. After processing and immediately prior to life testing, the surface showed signs of severe corrosion, a particularly bad area containing massive damage being shown in Figure 9(c). After life testing, many of the less damaged sites had become plugged with new oxide growth (Figure 9(d)).

Studies of the changes occurring during processing of the capacitor indicated that little attack was apparent until after the first pyrolysis/reform. It appeared that pyrolysis initiated damage to the oxide layer and these sites then underwent dissolution during the reform process. The nature of the damage to the oxide caused by the pyrolysis could not be established. For example, X-ray diffraction failed to detect the presence of any hydrated oxide, e.g. Boehmite, and there was no apparent correlation with surface impurities. However, examination after pyrolysis revealed a corrosion pattern characteristic of the warp and weft structure of the fibreglass spacer

FIGURE 9 Structure of aluminium oxide: (a) & (b) after anodisation, (c) after final reform showing a severely corroded area, (d) after life testing.

and indicated that damage to the anodic oxide was largely confined to those areas where the spacer was in close contact with the surface. This was probably because the decomposition products of pyrolysis, largely oxides of nitrogen and water, could not readily escape from these regions. It was observed that the 'dry' leakage current was always much lower than the 'wet', suggesting that much of the reform effect was due to electrical isolation of the damaged sites rather than a reanodisation of the base aluminium.
