# Damage Characteristics and Mechanism of a Strong Water Inrush Disaster at the Wangjialing Coal Mine, Shanxi Province, China

A serious groundwater inrush occurred at the Wangjialing coal mine on March 28, 2010. Great effort from all over the country was taken during the postaccident rescue. However, triggered by accumulated water in the upper abandoned tunnels and goafs of a nearby closed individually owned coal mine, it caused great damage, including 38 deaths and direct economic losses of over 49 million yuan. The inrush water was from the abandoned tunnels and goafs, which were filled subsequently by groundwater from the sandstone aquifer in the roof of the coal seam. The passage formed in the west roof of the heading face of the air return tunnel in the 20101 first mining face. Unidentified distribution and water-filled degree of the abandoned tunnels and goafs are critical bases for the accident. That important regulations for abundant groundwater exploration and release were not carried out thoroughly was another fatal cause leading to the accident. The poor awareness of water hazard controlling also contributed to the accident to a large extent.

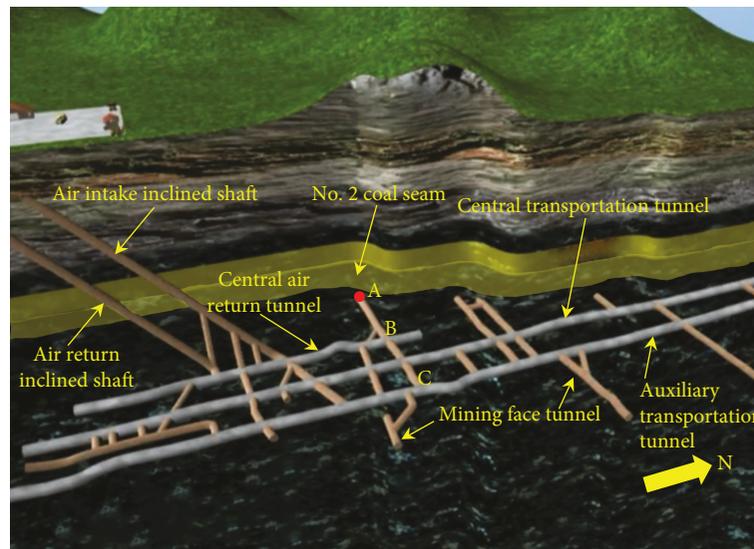
FIGURE 4: Distribution of tunnels at the Diezigou mining area.

The precise location of the water inrush, point A in Figure 4, was located on the roof of the heading face of the air return tunnel, line AC in Figure 4, 20101 first mining face. The height of the tunnel was 3.7 m and its width was 5.6 m. The tunnel began to be constructed on October 1, 2009, and its length reached 797.8 m at 8 a.m. on March 28, 2010, i.e., line AC in Figure 4. The tunnel began to descend slightly from point B to point A as shown in Figure 4. Structural cables or bolts with meshes supported the tunnel. Detecting groundwater near the tunneling face in advance by applying geophysical techniques including direct current electric method and Rayleigh wave method accompanied the

At 13:15, a stream with a depth of about 0.2 m flowed out continuously at point B from point A as shown in Figure 4, where the central air return tunnel and the air return tunnel in the 20101 first mining face intersected. What is more, the coal dust concentration in the air return tunnel was increasing dramatically. At 13:40, all underground workers were asked to escape and go up. However, the workers in the air return tunnel were out of touch by wire telephone. At about 14:10, the AB segment, as shown in Figure 4, of the air return tunnel was flooded wholly. At 16:40, the estimated elevation of the accumulated water reached 579 m a.s.l. and kept rising. At 10 a.m. on March 29, the measured elevation of the accumulated underground water reached 583 m a.s.l.

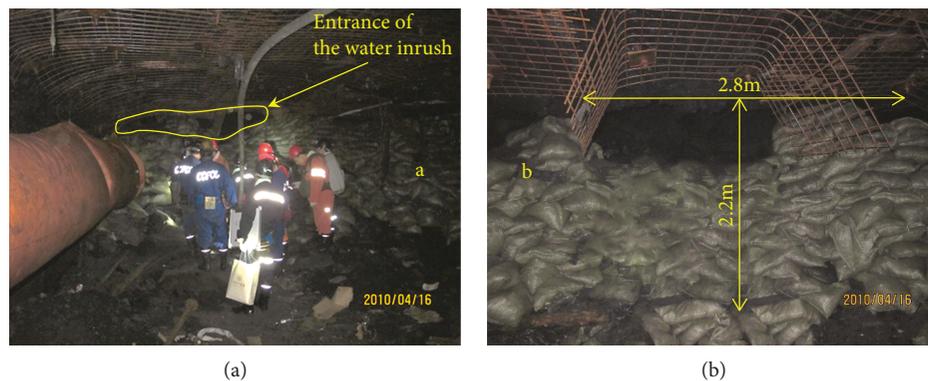
FIGURE 5: Location of the inrush water passage.

According to the site reconnaissance, as shown in Figure 5(a), the precise location of the inrush water passage, point A in Figure 4, was located in the roof of the heading face of the air return tunnel, line AC in Figure 4, in the 20101 first mining face. Based on site measurement, the elevation of the tunnel floor near the heading face was 549.2 m a.s.l. The elevation of the tunnel roof here was 553.0 m a.s.l. The maximum width of the inrush water passage was 6.3 m and the maximum height was 2.2 m.

The inrush water passage was almost a rectangle with a length of 2.8 m and height of 2.2 m as shown in Figure 5(b). The accumulated groundwater rushed into the tunnel under construction through the middle part of the rectangle intensively.

**7.2. Inrush Water Passage.** The inrush water passage formed in the west roof of the heading face of the air return tunnel in the 20101 first mining face as shown in Figure 6. With the tunnel's driving, as shown in Figure 7, when the width of the coal wall between the heading face and the proximal wall

of the No.1 abandoned tunnel decreased to 0.8 m, the thin wall, where it had been damaged by the accumulated goaf water before the accident and its effective waterproof thickness was less than 0.8 m, was eventually broken by the high-pressure inrush water accumulated previously in the abandoned tunnels and goafs of the individually closed coal mine. In the following time, a great amount of the accumulated water flooded the tunnels of the Wangjialing coal mine to 583 m a.s.l. and caused great damage.

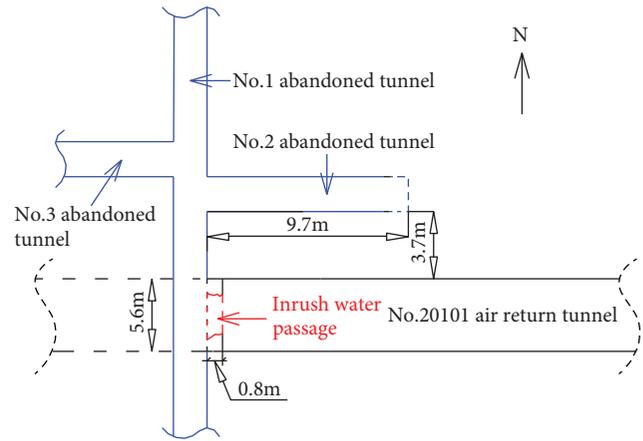
FIGURE 6: Plane location of the inrush water passage.

As shown in Figure 6, the distance between the heading face of the air return tunnel in the 20101 first mining face at the Wangjialing coal mine and east wall of the No.1 abandoned tunnel of the individually owned closed coal mine was 0.8 m. As shown in Figure 7, the distance between the floor of the No.1 abandoned tunnel and the roof of the air return tunnel was 0.8 m, too. Due to strong washout of the accumulated water, obvious damage, including cavings in the roof and pits in the floor, appeared near the water passage in the No.1 abandoned tunnel. A new enlarged cross section with a width of 4.6 m and height of 4.6 m formed. However, the abandoned tunnel here had been almost filled up by coal mud and caving rocks. As shown in Figure 8, obvious roof caving with a height of about 2.2 m near the water passage in the abandoned tunnel formed. The No.1 abandoned tunnel was constructed along the roof of the No.2 coal seam and supported by horizontal timber beams and vertical timber posts as shown in Figure 9. The original height of the tunnel was 2.2 m and the width was 3.5 m. The tunnel descended towards north and the slope angle was about 3 degrees. As shown in Figure 10, much water still accumulated. The tunnel ascended south and the slope angle was about 10 degrees. As shown in Figure 11, the tunnel towards south was empty. Additionally, there existed other two abandoned tunnels. As shown in Figure 6, one was the No.2 abandoned tunnel and the other was the No.3 abandoned tunnel. The distance between the south wall of the No.2 tunnel and north wall of the air return tunnel was 3.7 m. The detected length of the No.2 tunnel was about 9.7 m as shown in Figure 12. The No.3 tunnel was supported by timber as shown in Figure 13. Cross-section sizes of these two tunnels were almost equal. Widths were both 2.4 m and heights were both 2.2 m.

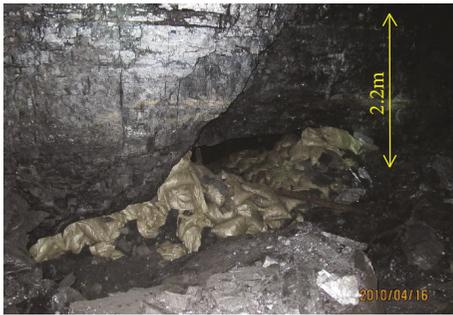
FIGURE 8: Roof caving in the No.1 abandoned tunnel.

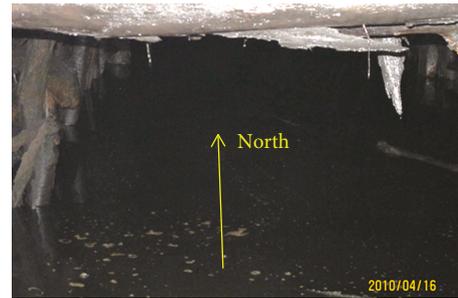
FIGURE 10: The accumulated water in the No.1 abandoned tunnel.

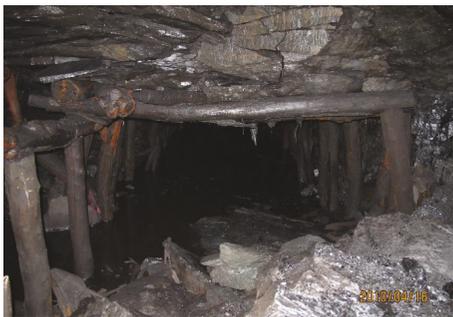
FIGURE 9: Timber support in the No.1 abandoned tunnel.

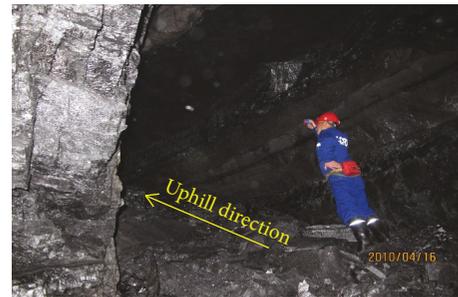
FIGURE 11: Uphill direction in the No.1 abandoned tunnel.
