Deformation Process and Mechanism Analyses of a Rock Slope Based on Long-Term Monitoring at the Pubugou Hydropower Station, China

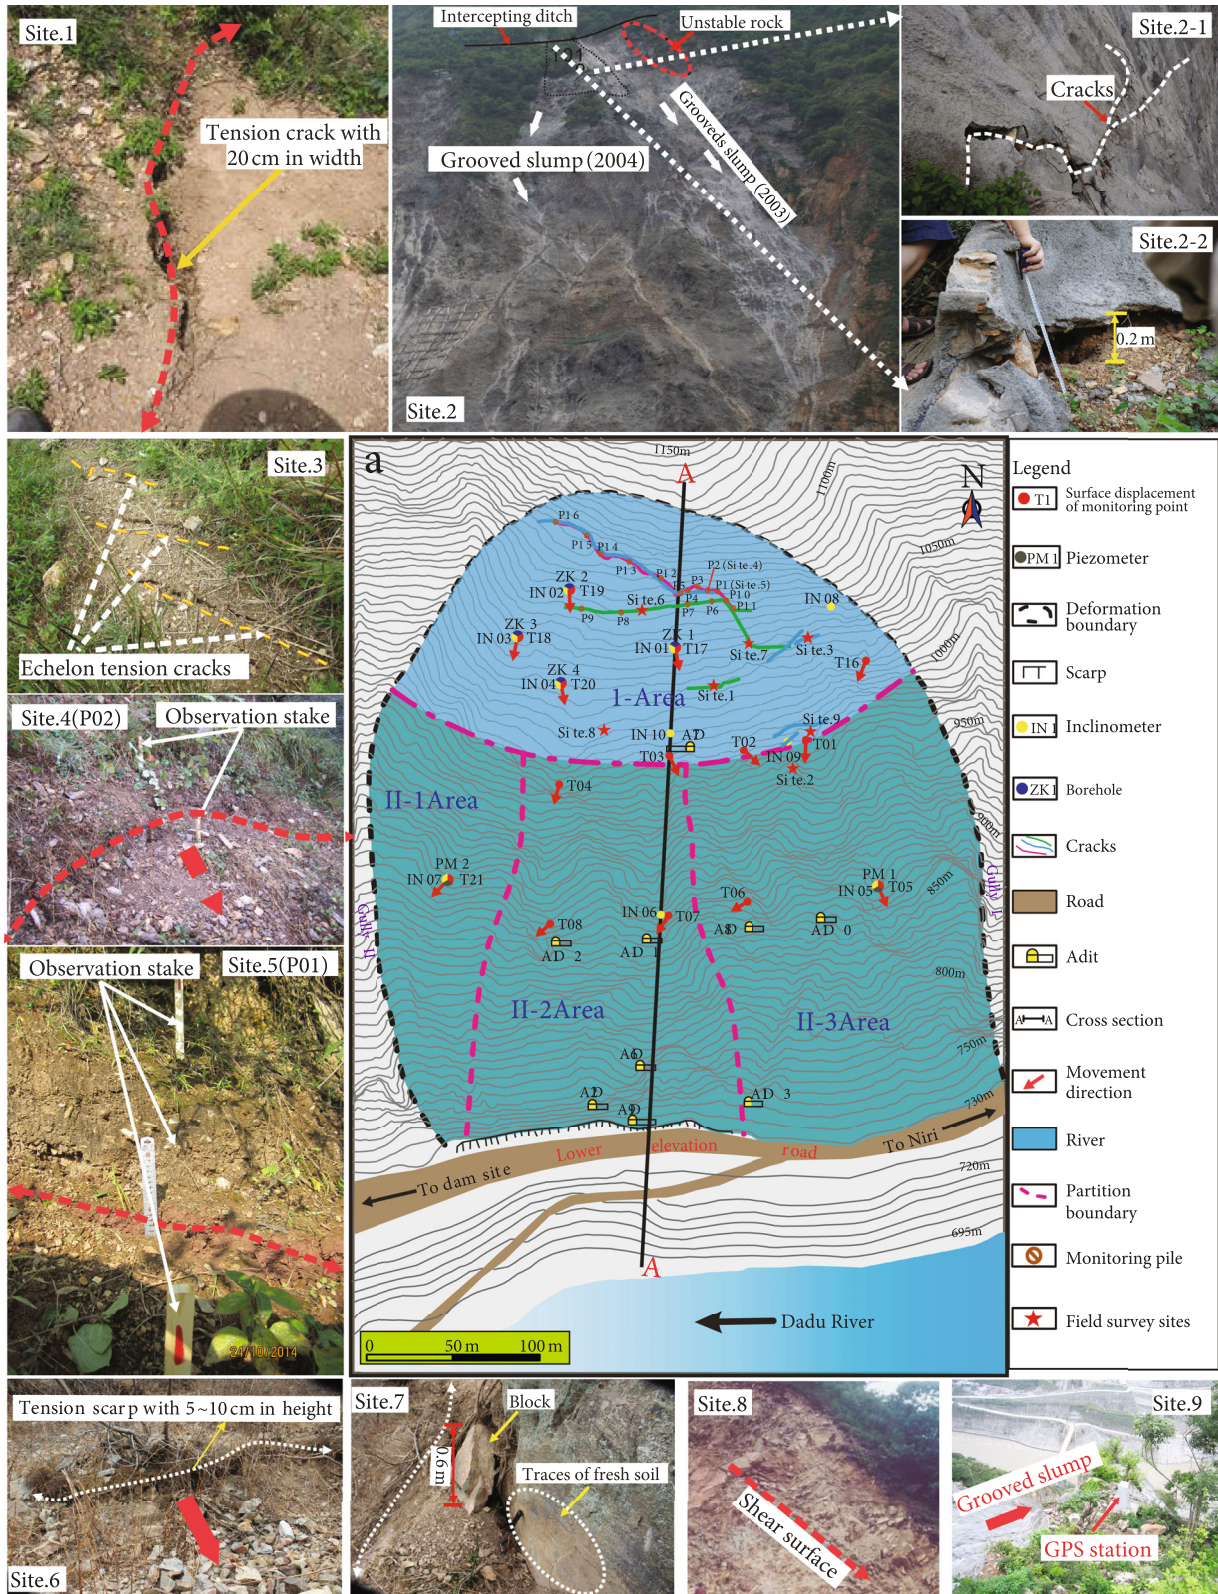
FIGURE 2: Topographic map of the PBGRS, monitoring locations and survey points; Site.1: tensile cracks, the strike is $N29^{\circ}E$, total length is nearly 150 m, and the pull-out width is generally 0.5-2 cm, of which the largest pull-out width is 10 cm; Site.2: the grooved slumps and cracks; Site.3: echelon tension cracks; Site.4: the cracks of P02; Site.5: the cracks of P05; Site.6: the strike is near SN , sinking 5-10 cm; Site.7: the strike is $N29^{\circ}E$, the depth is 1.0 m-1.2 m, and fresh yellow attached soil can be seen on the bedrock wall; Site.8: characteristics of the shear surface along a slope; Site.9: the grooved slumps and GPS monitoring point No.T2.

approximately 50 m³ and injured several workers. Several tensile cracks were observed in the collapse grooves formed in 2003 and 2004 (Site.2-1 in Figure 2). The dislocation cracks with an opening width of approximately 20 cm of drainage ditches (Site.2-2 in Figure 2).

On October 19, 2014, the local inspectors observed that fresh tension cracks (Site.3, Site.4, and Site.5 in Figure 2) appeared on the road to T15, and the width increased from 10 cm to 15 cm in the next two days. Since October 23, 16 groups of wooden piles have been buried on both sides of the edge crack to monitor the change trend of crack width. The typical P02 (Site.4 in Figure 2) and P05 crack change trends are shown in Figure 3, within 18 days of observation; the crack width at P05 increased from 20 cm to 28.2 cm (Figure 7).

In March 2015, several fresh tensile cracks are observed at around 1055 ma.s.l (Site.6 and Site.7 in Figure 2) with an opening width of approximately 5 cm-15 cm and length exceeding 100 m, and the averaged strike nearby SN. An arc-shaped crack develops at 1010 to 1040 ma.s.l and extends

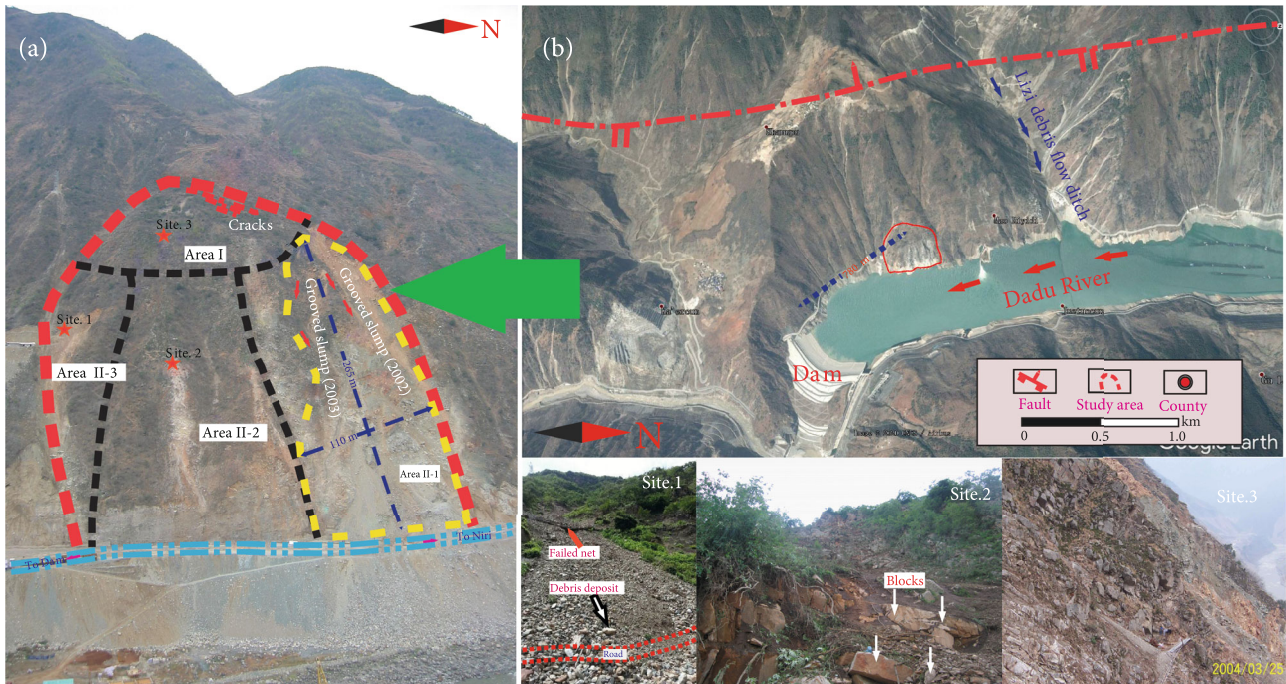
FIGURE 3: Field observations of the PBGRS: (a) overview of the PBGRS; (b) relative position of the fault and PBGRS; Site.1: slippery debris blocking the road at gully II; Site.2: small-scale collapse; Site.3: fractured and highly permeable rock mass.

The earliest deformation history of the PBRGS dates back to February 2003. Several very small-scale collapse sites in area II-1 have been observed (Figure 3(a)), induced by excavation during the construction of a road, and it did not attract much attention. Subsequently, in May 2003, a heavy rainfall induced a collapse with more than 1000 m³. The retrogressive disintegrations failed towards the upslope and formed the first collapse groove (Site.2 in Figure 2). The depth of the collapse groove is about 12 m. By the end of 2004, the range of instability had expanded, and a second collapse groove had

During the construction of the reinforcement measures in 2008, a small-scale collapse occurred at 974.5 ma.s.l (lower monitoring pile T04) in area II-2 (Site.2 in Figure 3). Due to the scraping of the lower deposits, a total volume is

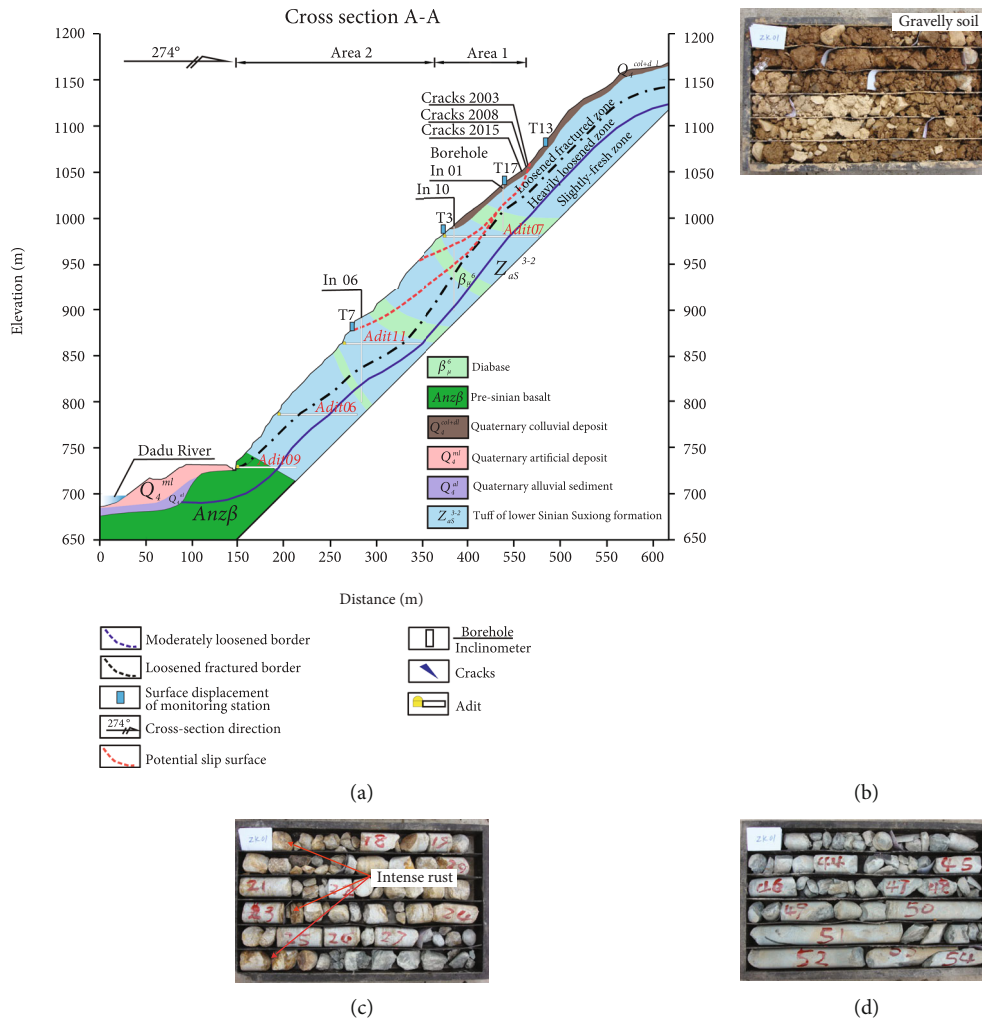
FIGURE 5: (a) Engineering geological profile of the PBGRS; (b) photo of gravelly soil; (c) intense rusty short columnar core of loosened fractured zone; (d) intact core of heavily loosened zone.

3.3. Geological Drilling and Rock Mass Properties. The bedrock exposed in the region is the rhyolite tuffs of the Suxiong Formation in the Sinian and the shallow metamorphic basalts in the pre-Sinian. During the long renovation process, these rocks have been altered by river incision and a series of tectonic events (such as the Yanshan movement and Himalaya orogeny), thus creating very complex structures [45, 46]. According to the lithostratigraphy and structure of the PBRGS which were obtained by drill holes and site investigations, the slope's rock mass has been extensively fractured. The degree of fracturing and jointing increases toward the ground surface, resulting in an increasingly loosened rock mass (Table 2, and detailed core description of DH 01). As shown schematically in the cross-section (Figure 5(a)), except for gravel soil a few meters thick below the surface (Figure 5(b)), the loosened fractured zone extends to a depth of about 20-60 m, and the heavily loosened zone extension depth is approximately 65-90 m. Drilling lithology samples indicate that the drill core sample of the loosened fractured zone is fragmental with a short column, and the crack surface is severely rusty (Figure 5(c)). In contrast, that of the heavily loosened zone is relatively intact (Figure 5(d)). The borehole sampling's core fracture angle indicates that steep dip cracks (inside or outside the steep slope) are absolutely dominant, and rock debris fills with the gaps reflects the mutual displacement between the blocks. In addition, the extended depth of the loosened fractured zone is thick at high

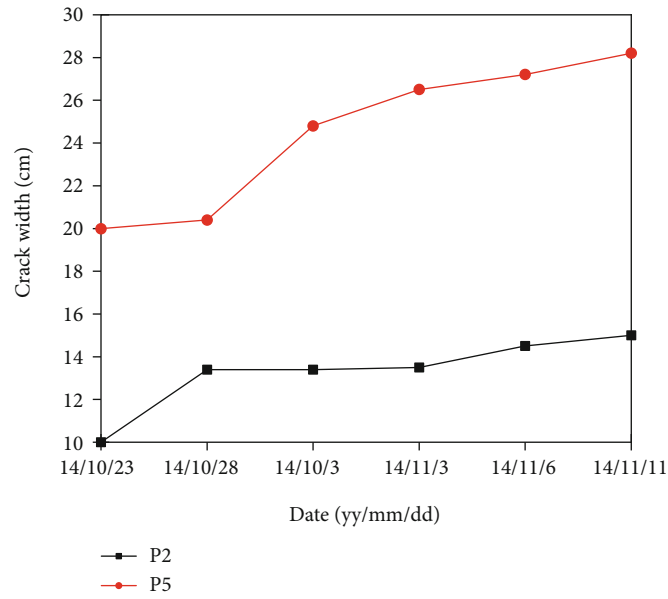
FIGURE 7: Crack width changes with time.

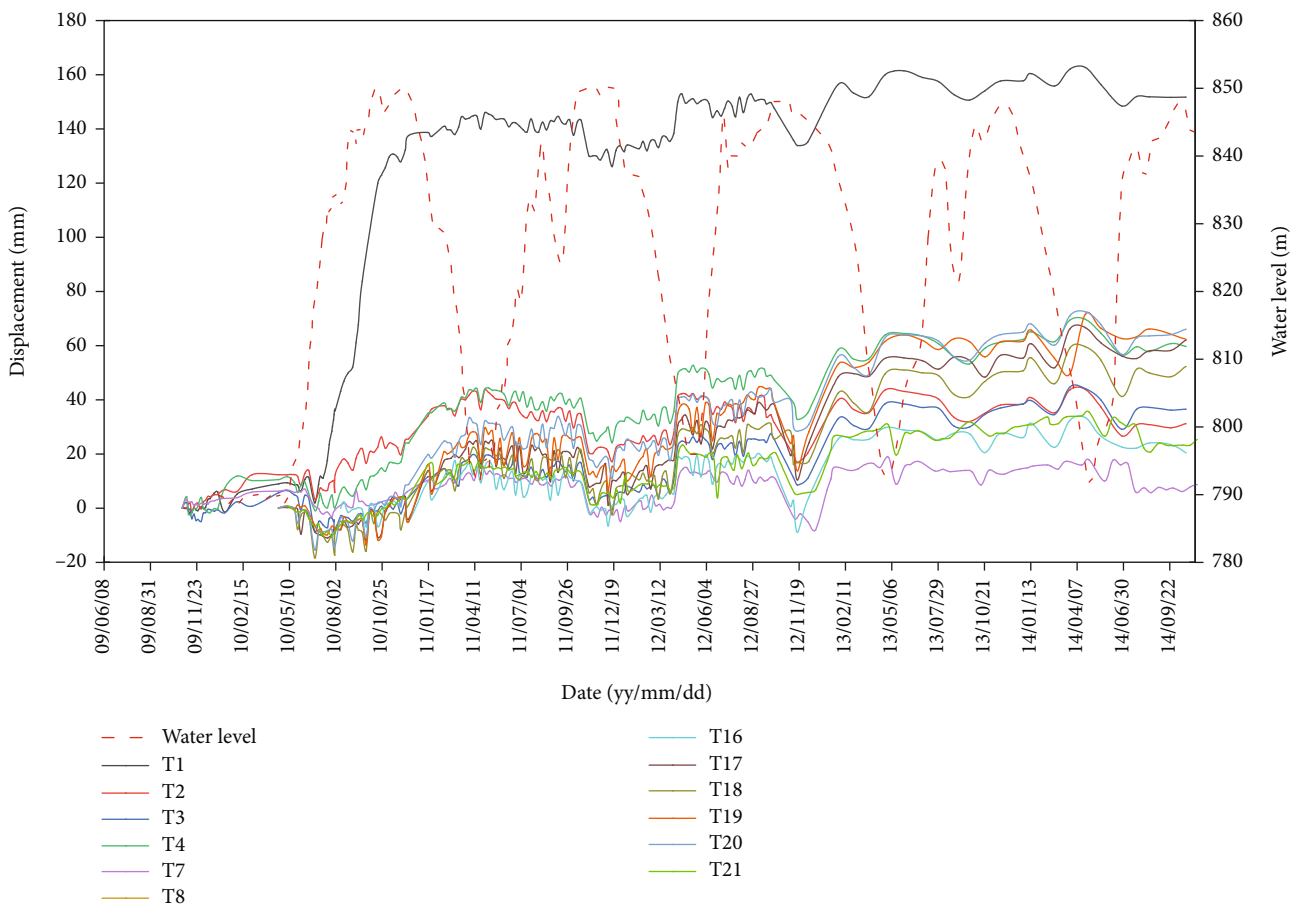
FIGURE 8: The surface movement monitoring and reservoir water level result.

5.1. Relative Surface Displacements. The first emergency mitigation was completed in September 2009. During the next four years monitoring period, the results of 12 surface displacement monitoring and reservoir water level changes are plotted in Figure 8. We can see that

- (1) The cumulative displacement and average displacement velocities increased faster when the first impoundment was accomplished from 780 to 850 ma.s.l (Figure 9). Over the next 4 years, cumulative displacement increases slowly yearly. The cumulative displacement and average displacement velocities of T01 (approximately 980 ma.s.l) are much larger than other points, and their values are 152 mm (Figure 8),

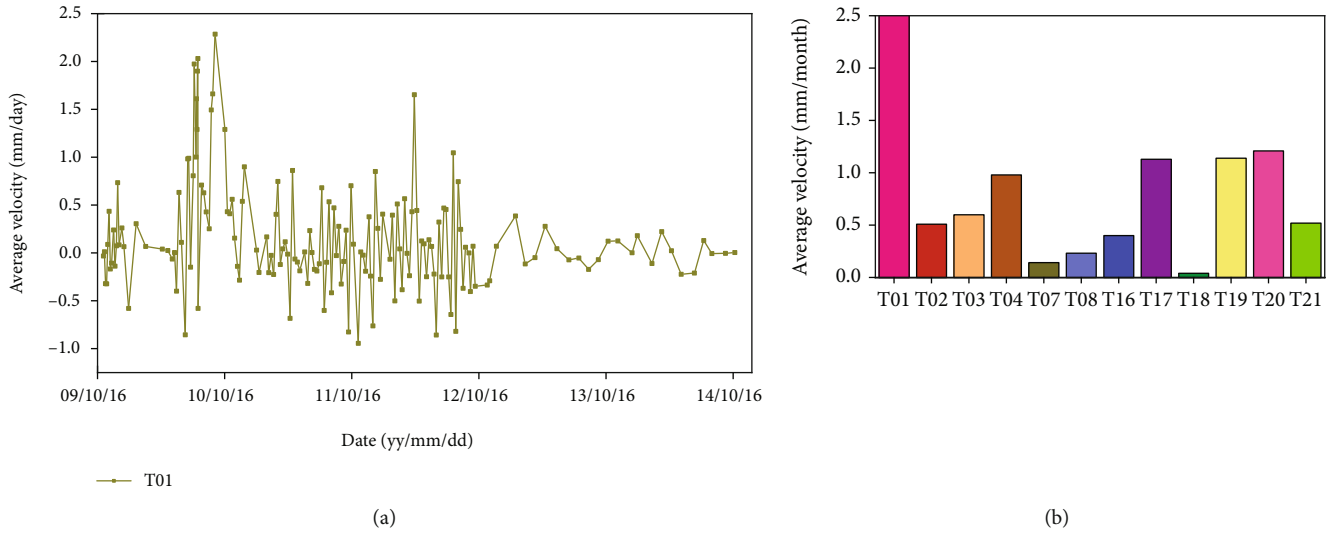
FIGURE 9: Comparison of average displacement velocities from GPS monitoring: (a) daily average velocities of T01; (b) monthly average velocities.

2.5 mm/month (Figure 9(b)), and 2.3 mm/day (Figure 9(a)), respectively, and T01 is located in the collapse groove formed in 2003 and 2004, respectively. This further suggests that area II-1 is relatively unstable. Besides, the slope at T01 monitoring point is steep, and the surface layer mainly consists of eluvium and slope deposits, which is also the reason for the large displacement of T01. The overall monitoring data show that the cumulative displacement and average monthly and daily displacement velocities (Figure 8) vary gently, verifying the reinforced mitigation’s effectiveness to decrease the deformation of the PBGRS

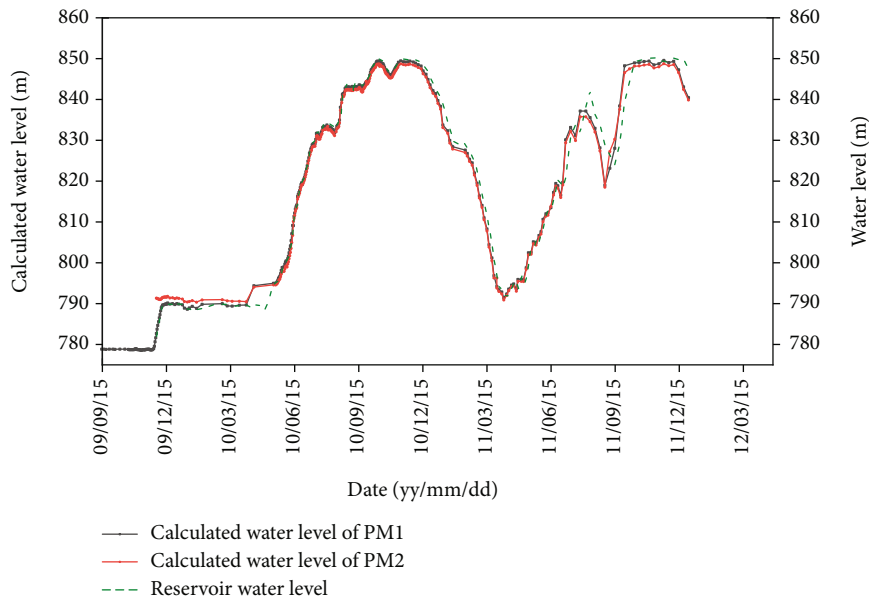
FIGURE 10: Comparison of calculated water level of piezometers and the reservoir levels.

- (2) The reservoir water level has a minor effect on surface displacement. This law can be explained by piezometers and reservoir water level results (Figure 10). The calculated water level (the sum of the pressure head and the buried elevation) of the two piezometers is almost the same as the reservoir water level. There is no head loss and lag, which proves loosened fractured rock mass and high permeability, and this rock mass structure is like a leaky bucket full of mesh

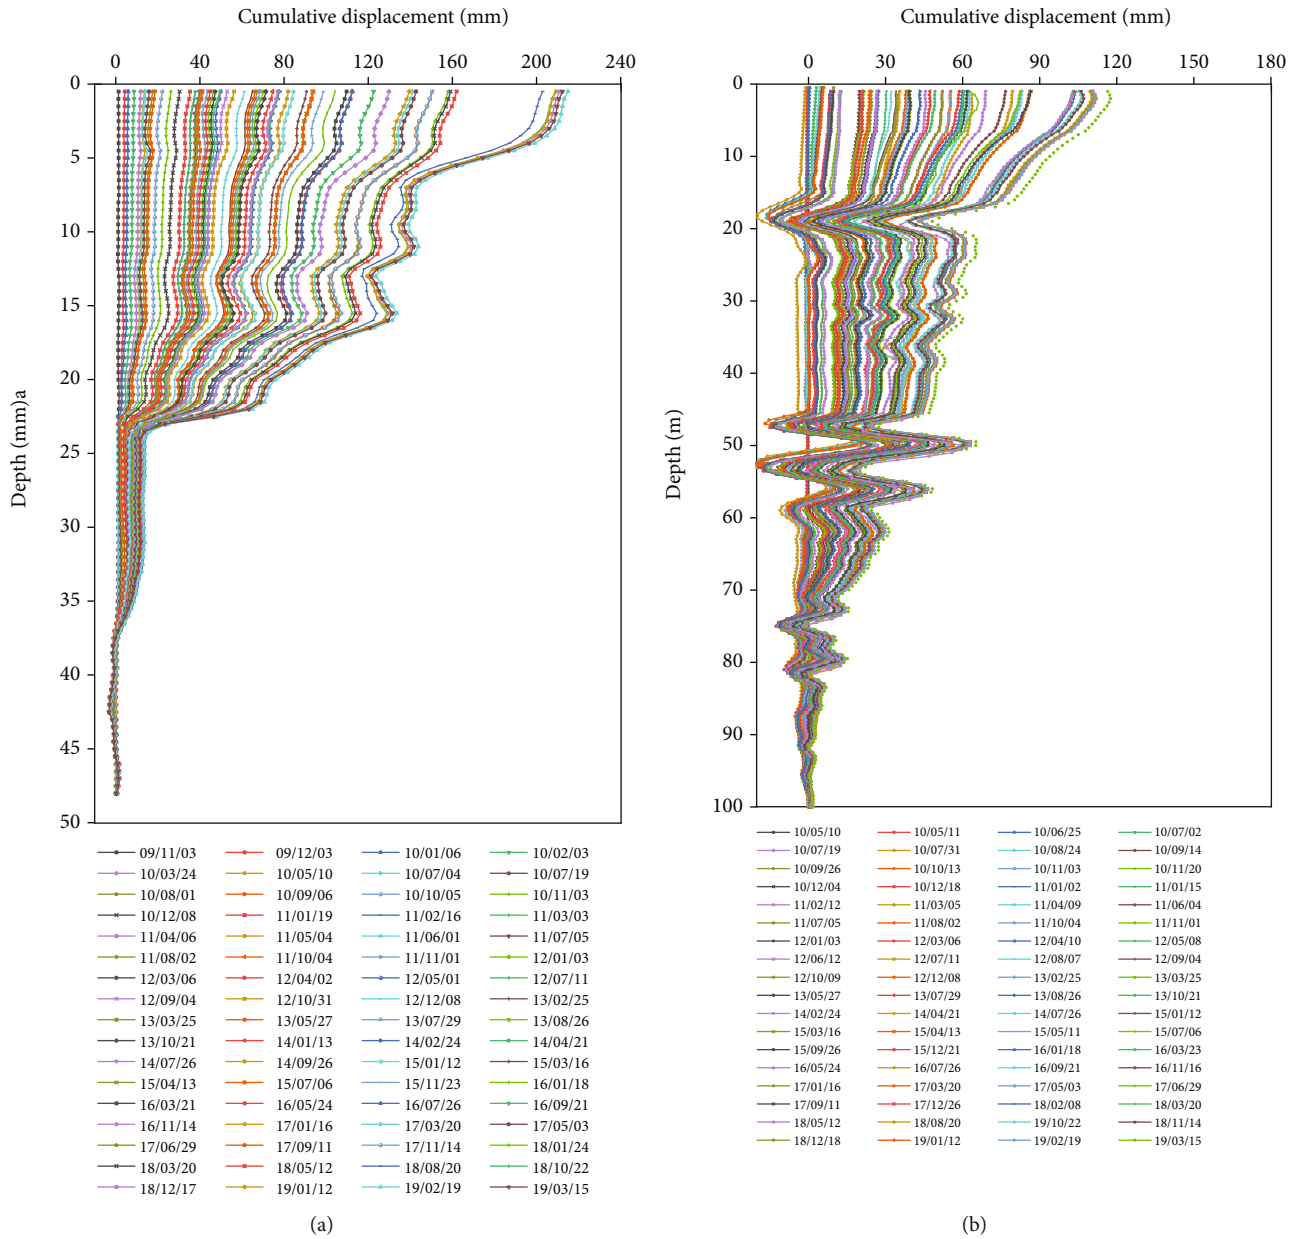
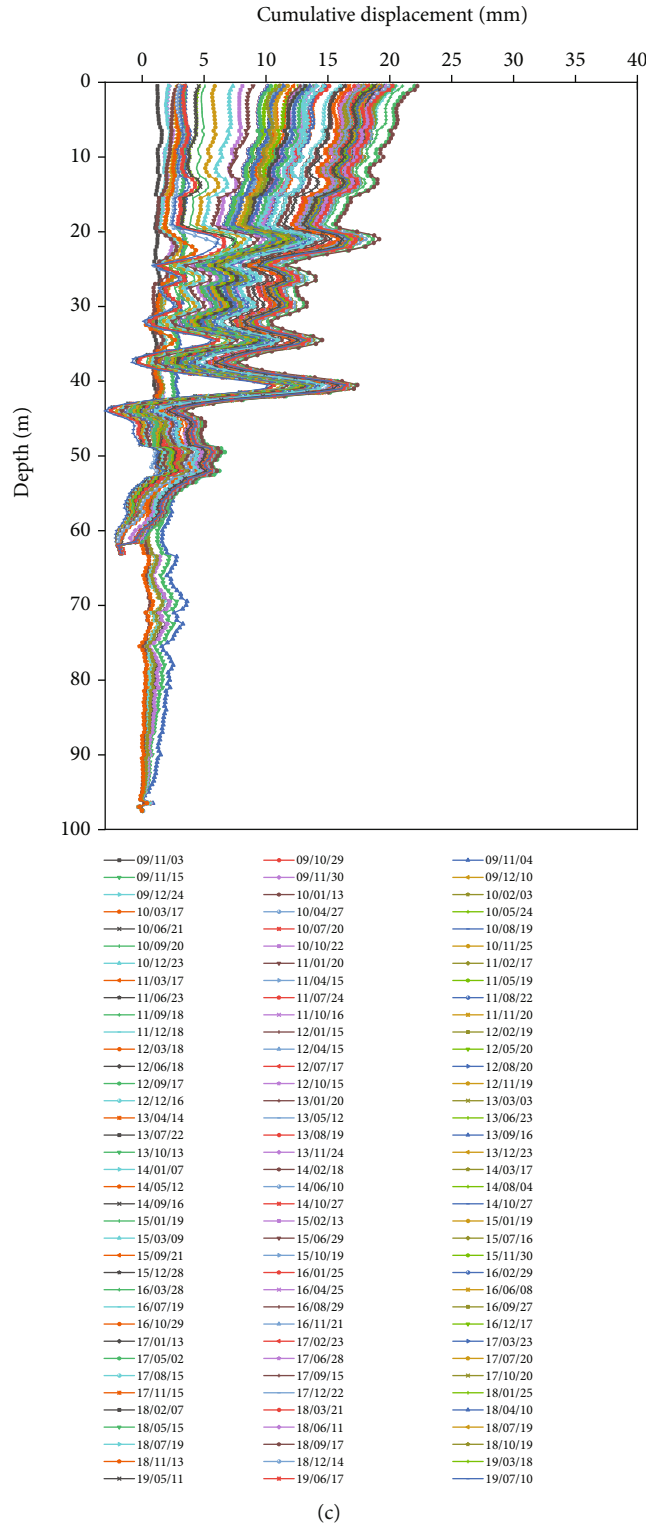
FIGURE 11: Monitoring curves of three inclinometers located at the cross-section A-A: (a) In01; (b) In10; (c) In06.

5.2. Inclinometer and Piezometer Measurements. The shear surface location can be obtained from an interpretation of inclinometric measurements [49–52]. The detailed data from 10 inclinometer monitors are shown in Figure 11, and Figure 2 shows the layout of inclinometers (A-A profiles in Figure 5(a)). According to the time-series deformation data, the subsurface movement was progressive over a continuous monitoring period of ten years. The cumulative displacement decreased towards the downslope, and the cumulative displacement at In06 is only 22 mm (Figure 11(c)). For inclinometers In01, the shear surface is located at 22 m, which

coincides with the DH 01. Notably, monitoring data from In10 indicates that the cumulative displacements at different depths were not uniform. There are at least 3 apparent shear surfaces at different depths, and the thickness of each surface is limited. A sawtooth-shaped cumulative displacement curve was observed at 40–60 m, indicating that the rock mass in this area is loosened, and the relative dislocation is obvious. Besides, the shear surface at 22 m depth forms a continuous failure surface with the In01, and this result can be represented by the red line in Figure 2. Monitoring data from In06 show that the shear surface was located at a depth of approximately 40 m below the ground surface. Notably, relative dislocation can be clearly observed in the depth range of 20–40 m, although these data values have some fluctuations. In view of the In01 (Figure 11(a)), In10 (Figure 11(b)), and In06 (Figure 11(c)) monitoring results, the cumulative displacement at the top of the inclinometers is 210 mm, 119 mm, and 22 mm, respectively, indicating the zone in which In06 is located serves as a locked segment. The complete continuous failure surface is not formed in the A-A cross-section. Because the average displacement velocity of the In01 inclinometer was slow before July 2012, from May 2014 to August 2014, the average displacement velocity increased to 5 mm/month. Then, it decreased to 1.2 mm/month in the next year. The most recent increase occurred from June 2018 to July 2018, and the cumulative displacement values increased from 167 mm to 202 mm.

The stability of the rock mass in area II-2 is most noting. To better understand the failure mechanism, inclinometer measurements may provide some evidence. According to Figure 11, the intermittent deformation trend indicates that the loosened fractured zone went through three stages: (1) sliding and compression cracking, (2) compaction due to the antislip effect of the locked segment, and (3) sliding and compression cracks again. After multiple cycles, a continuous shear surface is finally formed, and the destruction finally occurred; the free surface formed by the failure of the area II-

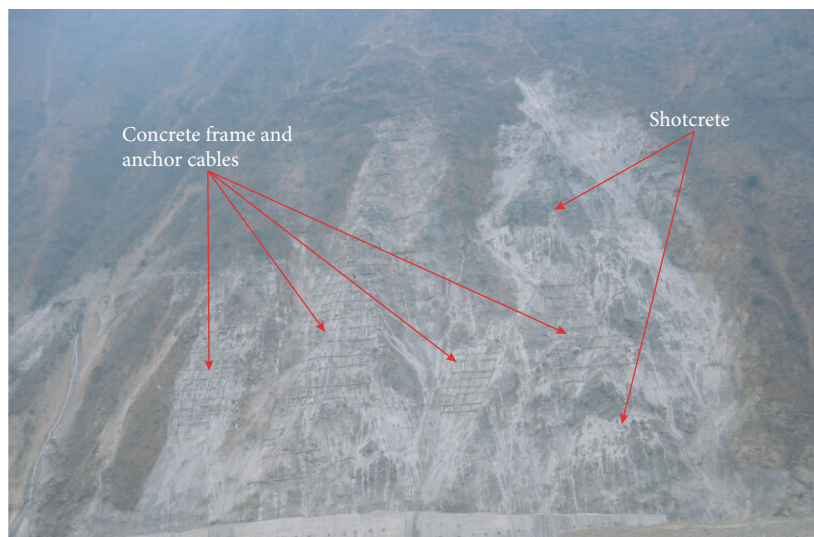
FIGURE 12: Reinforcement solution under construction as of 2015.

6.2.1. Mitigation Measures. Based on extensive field surveys and continuous monitoring results, the leading engineering reinforcement measures, including concrete frame combined with anchor cables, large area concrete shotcrete, and intercepting ditch, were applied to stabilize the PBGRS (Figure 12). The premise of these reinforcement measures is to remove loose deposits on the surface. The total length of the anchor cable is between 45 and 70 m. The single anchor cable ($10 \times \varnothing 15.2$ unbonded steel stranded wire) is designed to have an anchoring force of 1500 kN, with a standard area and density of 140 mm^2 and 1101 kg/km , respectively. The tensile strength is 1860 MPa, the elastic modulus is $1.95 \times 10^5 \text{ MPa}$, and the anchor hole diameter is 140 mm. The emergency mitigation plan was divided into two phases: The first

stage is mainly aimed at the water level fluctuation zone with 780–850 ma.s.l. To obtain maximum antisliding force, the anchoring angle of the anchor cables is tilted up 5°, which the engineering audit was completed in October 2009. Based on ensuring the loosened fractured zone's stability, in the second stage treatment, the anchoring angle is inclined downward 15°. As of September 2015, 912 anchor cables have been implemented, and 1020 anchor cables have not been completed.

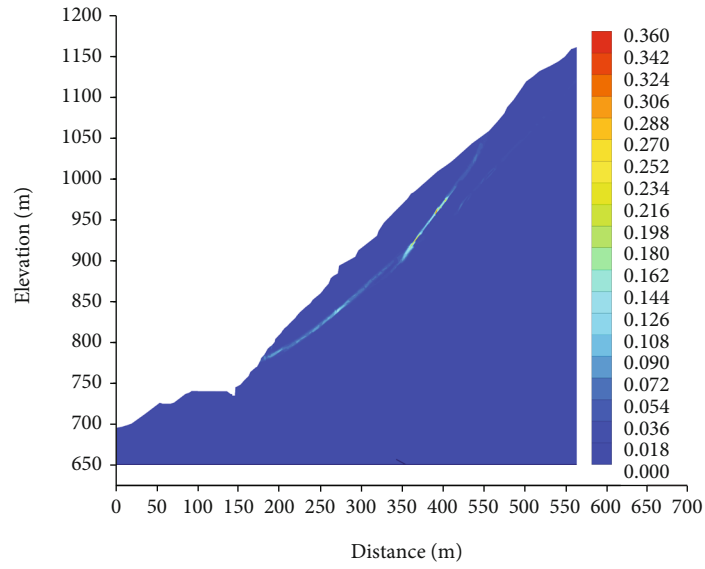
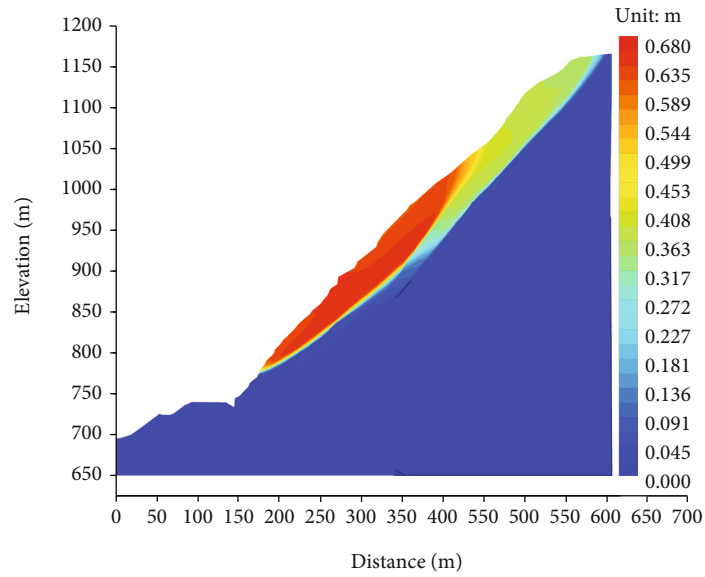
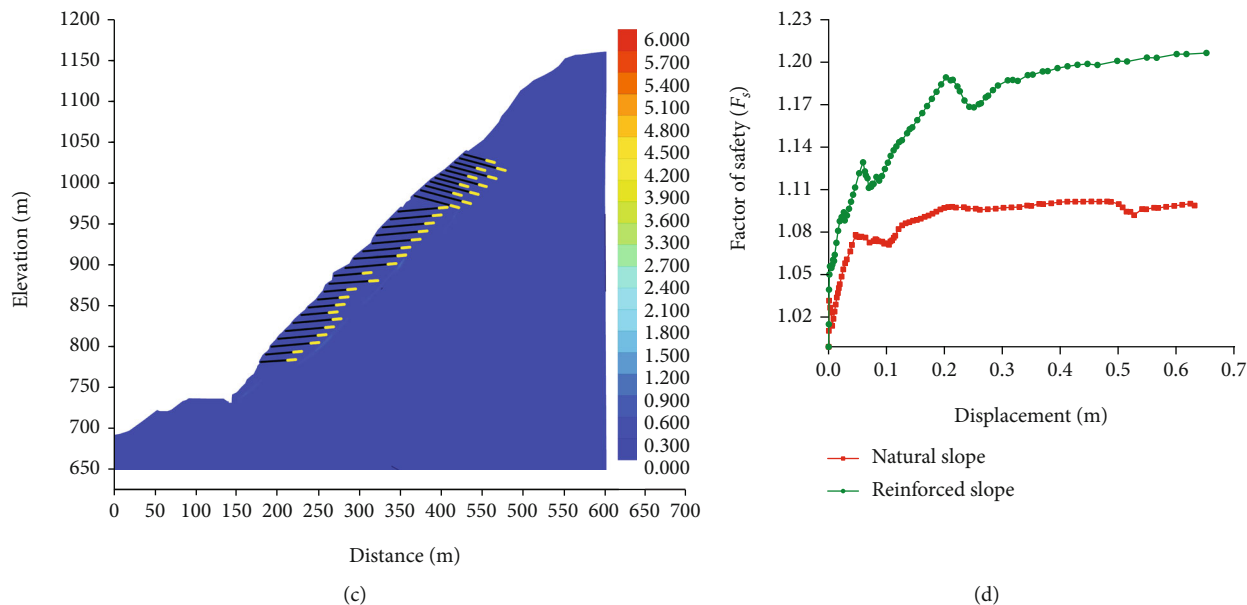
FIGURE 13: Numerical calculation results: (a, b) potential failure surface and the total displacement before the implementation of engineering measures; (c) potential shear surface reinforced by concrete frame combined with anchor cables; (d) factor of safety with pre- and postreinforcement measures.

6.2.3. Analysis Results. Figures 13(a) and 13(b) show the calculation results without reinforcement measures. As expected, the predicted failure surface mainly occurs at the bottom of the loosened fractured zone (780–1050 ma.s.l). Above the 950 ma.s.l, a discrete shear surface appears at the bottom of the heavily loosened zone. From the numerical simulation results, we can predict if the PBGRS does not take reinforcement measures, and with continuous dislocation deformation. Finally, the loosened fractured zone was completely cut-off to form a huge slide body and a new head scarp. After adopting the concrete frame combined with anchor cables, the FEM results are shown in Figure 13(c). The continuous shear surface in a loosened fractured zone was effectively blocked. The most dangerous shear surface moves around the anchor cables to the bottom of the heavily loosened zone but only forms the partially discrete shear surface, so anchor cables also improve the stability of the heavily loosened zone. By comparing pre- and postreinforcement measures of concrete frames and ground anchors, safety increased from 1.09 to 1.21 (Figure 13(d)), which basically meets the 2012 Professional Standards of the People's Republic of China.

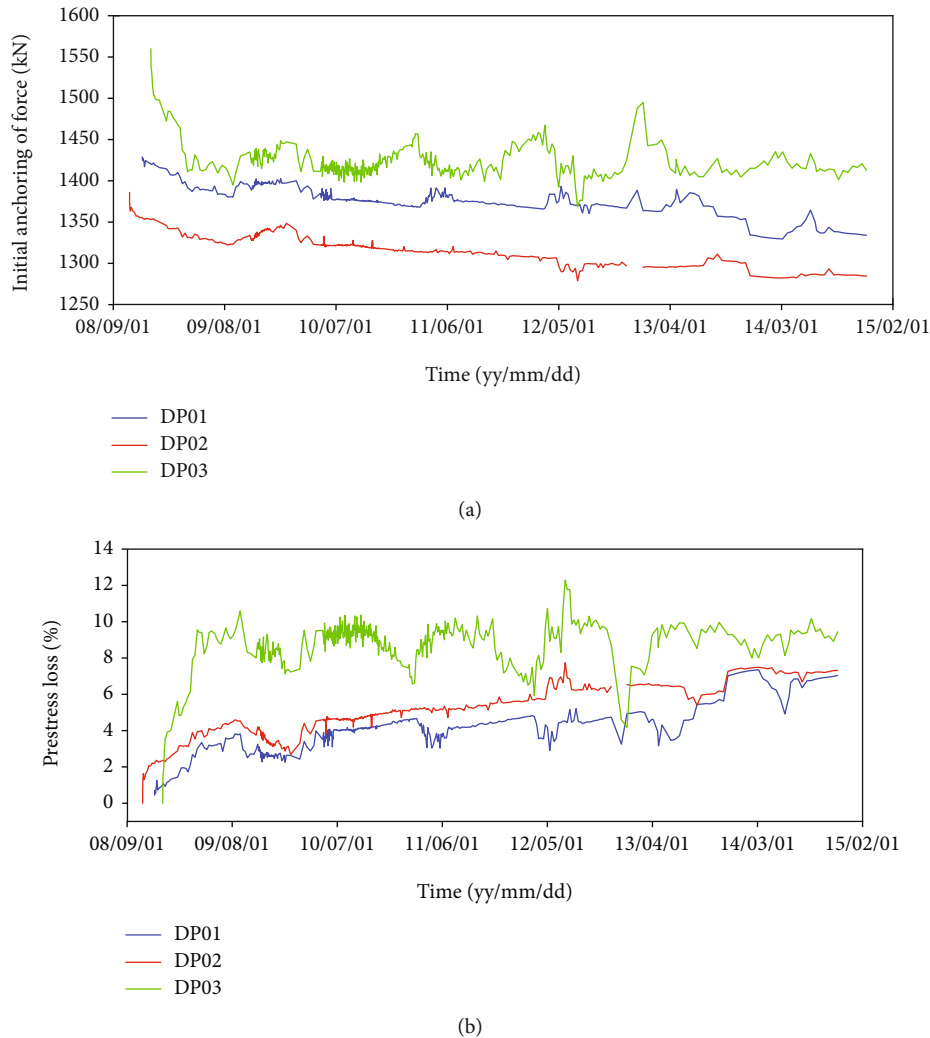
FIGURE 14: Typical monitoring results of anchor cable varied with time: (a) forces in anchor cables (3 measurement points); (b) force reduction of prestressed anchor cable (3 measurement points).

6.2.4. Monitoring Data Verification and Recommendations. As shown in Figure 14, the anchor cable generally experienced relatively minor relaxation and less than 13% in 7 years. Although these analyses prove that the reinforcement measures are very effective, most anchor cables do not penetrate the heavily loosened zone and cause discontinuous shear surfaces. The dislocation still went on due to shearing, and the main zone of movement is concentrated in area I (Figure 11(a)). We still recommend that the anchor cables should be long enough to extend as far as possible into the more stable zone (such as bedrock). Besides, the remaining 1020 anchor cables should be implemented as soon as possible.
