Failure Analysis of a Highway Cut Slope with Anti-Slide Piles

Landslides induced by engineering construction are very common in reality; it is necessary to clarify the causes of landslide failure to avoid similar accidents. A landslide induced by highway construction is taken as a case. Field observations, data collection, and analyses were used to investigate the deformation and causes of the landslide. The failed slope is mostly comprised of gravel soil, there were some shear cracks on both sides of the slope before sliding, and most tensile cracks were connected with shear cracks after sliding. The cut slope of this highway was designed to be protected by prestressed anchor sheet piles. However, in the construction process, the slope in front of the antipiles was removed when the piles were constructed without any anchor cables, which led to the shear damage of a row of anti-slide piles with a 15-meter-long cantilever. Moreover, continuous rainfall over several days aggravated the landslide damage because of increase of the self-weight and degradation of the mechanical parameters of the slope materials. The mechanical and simulation analyses both show that the resistance provid

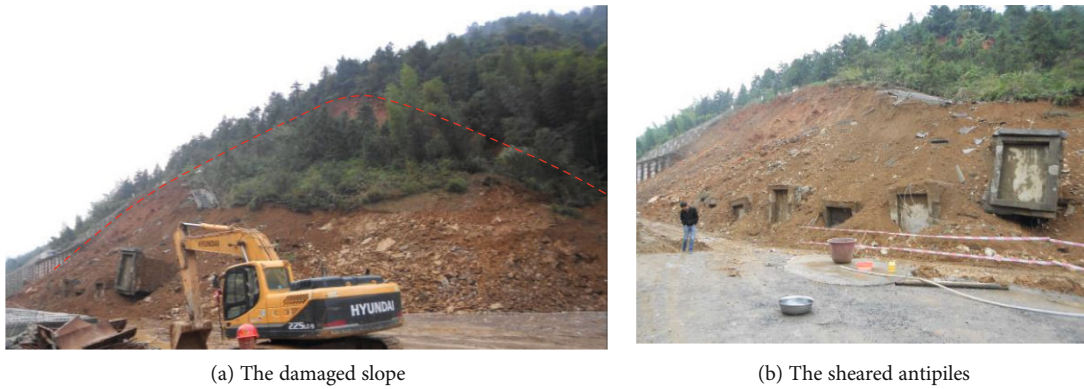
The excavation of the slope began on March 2nd, 2012. Excavation and anti-slide piles were not finished until October 8th, 2012. After continuous rainfall since November 2012, the cut slope on the right side of K19+060~K19+140 failed as a landslide on the morning of November 12th, 2012, as shown in Figure 5.

The landslide is approximately 80.7 m long, 39.8 m wide, and 15.4 m thick, and its sliding direction is towards S35°W. The altitude on the rear of rupture surface is approximately 352.5 m, and that on the toe of the rupture surface is 310.0 m, the same altitude as the pavement. The height difference between the rear and the toe is approximately 42.5 m. The area of this landslide is nearly 2,800 m², and the total

volume is approximately 23,500 m³. The landslide is largely composed of gravel soil of Q^{el+dl} and a little weathered siltstone lying in the toe of the landslide, which had been broken into fragments when the slope failed. The majority of the sliding surface is along the interface of gravel soil and siltstone, and it changes to the siltstone layer just in the toe of the landslide. Moreover, before the construction of anchor cables, the constructed anti-slide piles in K19+060~K19+140 had already been destroyed, such that the cantilever of each pile was totally sheared off.

Before the slope failed, there were some intermittent shear cracks on both sides of the slope. According to the survey on November 12th, 2012, the distance from the slope crest to the farthest arc crack was 20 m more than that to the designed intercepting ditch. Most tensile cracks were connected with shear fissures on both sides, and the fissures were less than 15 cm in width and no more than 0.6 m in depth. The vertical displacement of piles on the top was

FIGURE 5: Photos of the landslide failure.

approximately 25 cm, and the gap was 1-7 cm wide. Tensile fractures, distributed in the shape of a crown, were connected to the back scarp.

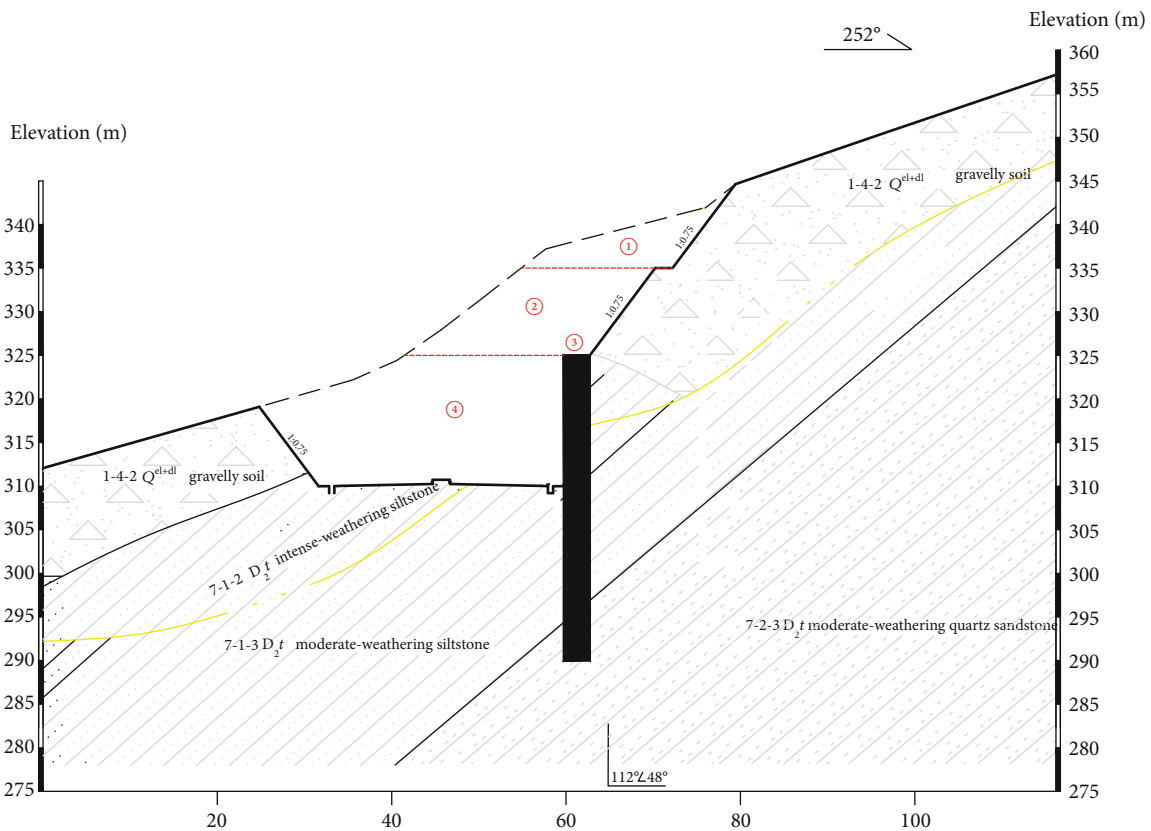
FIGURE 6: Actual construction steps.

4.1. Construction Process. The construction log shows that the actual construction process was run as the following order, as shown in Figure 6: ① excavation and protection of the upper slope above the pile tops; ② excavation and protec-

tion of the lower slope; ③ construction of the anti-slide piles, in which all were constructed with interval modes by manual excavation; and ④ rock and soil excavation in front of the piles. The slope failed just when the four steps above were finished; the subsequent procedures have not yet been implemented. Each step is reasonable according to the construction log; however, a severe danger is hidden. The design concept should be that the slope would be safe enough to reach the specification requirement when only the pre-stressed anchor sheet piles are implemented. Therefore, before the anchors and the retaining plates are implemented,

the rock and soil in the front of the anti-slide piles should not be excavated at once as in the fourth step. Obviously, such construction procedures went against the original design intention, which was meant to ensure the slope stability using both anti-slide piles and anchor cables.

The irrational construction process is the key factor causing the slope failure. The actual construction process led to anchor late cable implementation. Here, each anti-slide pile without the anchor turned into a 15-meter-long cantilever pile when the rock mass and soil in front of the piles were excavated. The greatest disadvantage of a cantilever pile is that its displacement is generally bigger than that of an embedded pile. Moreover, retaining plates between the piles had not yet been implemented. All of these would promote the rock and soil behind the piles moving towards the free face, and then the stress condition of the slope adjusted, which is a disadvantage to the stability of the slope. If anchor cables had been implemented in time, the displacement and the stress adjustment of the slope above the top of the anti-slide piles would have been well controlled, and the slope failure would not have happened.

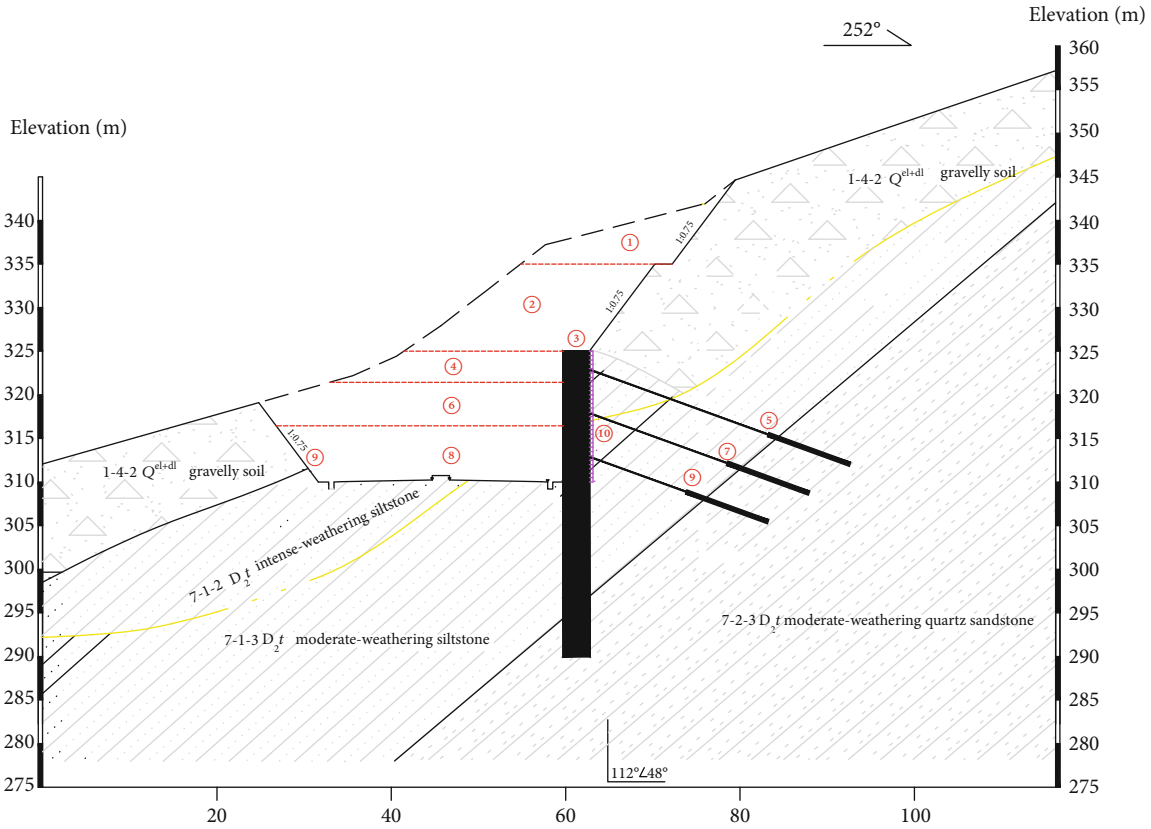
FIGURE 7: Suggested rational construction steps.

Based on the above analysis, the rational construction process is suggested and shown as Figure 7. The order is as follows: ①–② excavation and protection of the slope above the top of the anti-slide piles, ③ construction of anti-slide piles (steel tubes should be preburied at the position where the anchor cables would be constructed), ④ excavation of the rock and soil above the middle height of the upper two

rows of anchors, ⑤ construction of the first row of anchors, ⑥ excavation of the rock and soil above the middle height of the following two rows of anchors, ⑦ construction of the middle row anchors, ⑧ excavation of the remaining rock and soil, ⑨ construction of the last row of anchors, and ⑩ installation of prefabricated retaining plates.

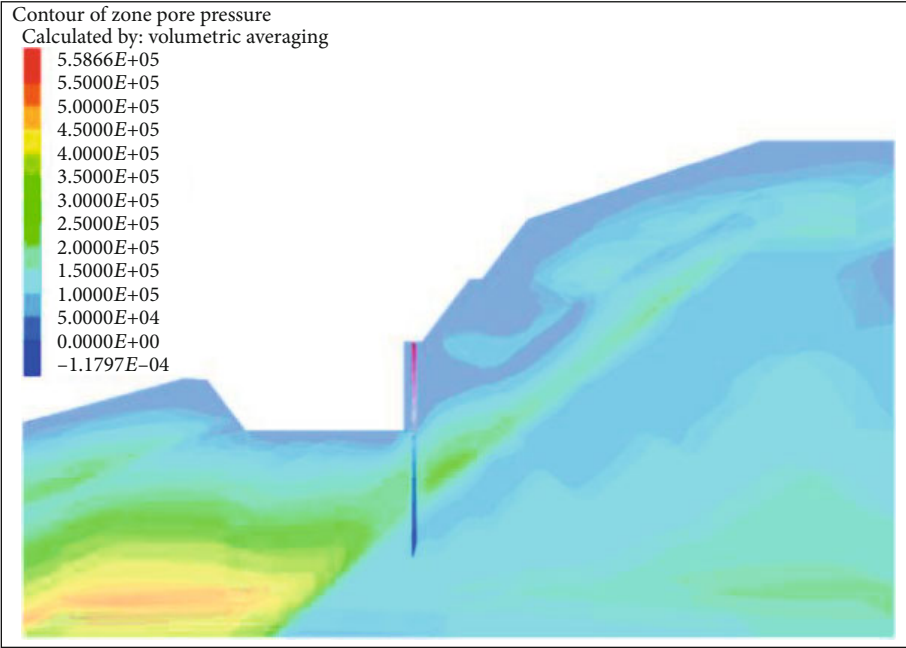
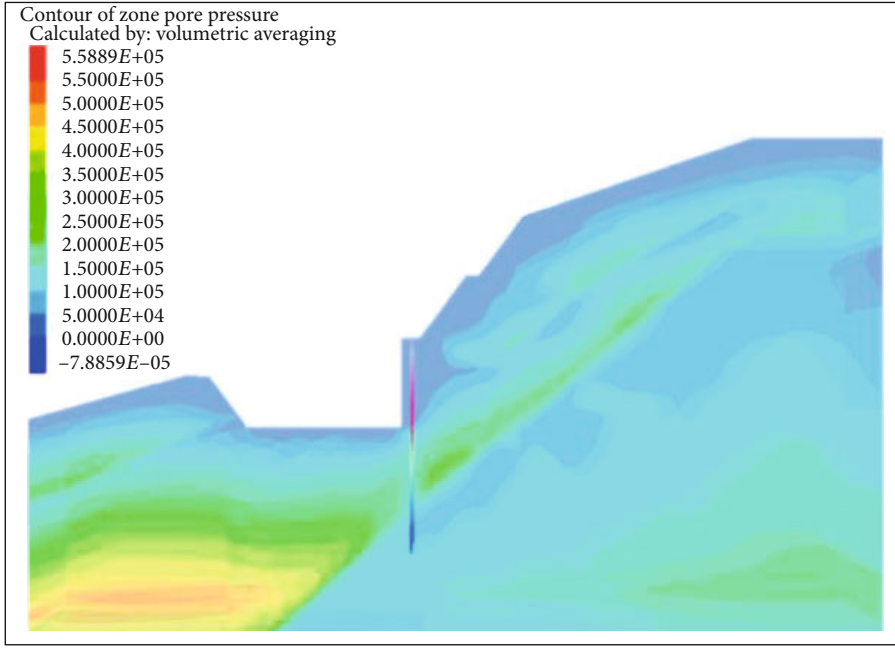
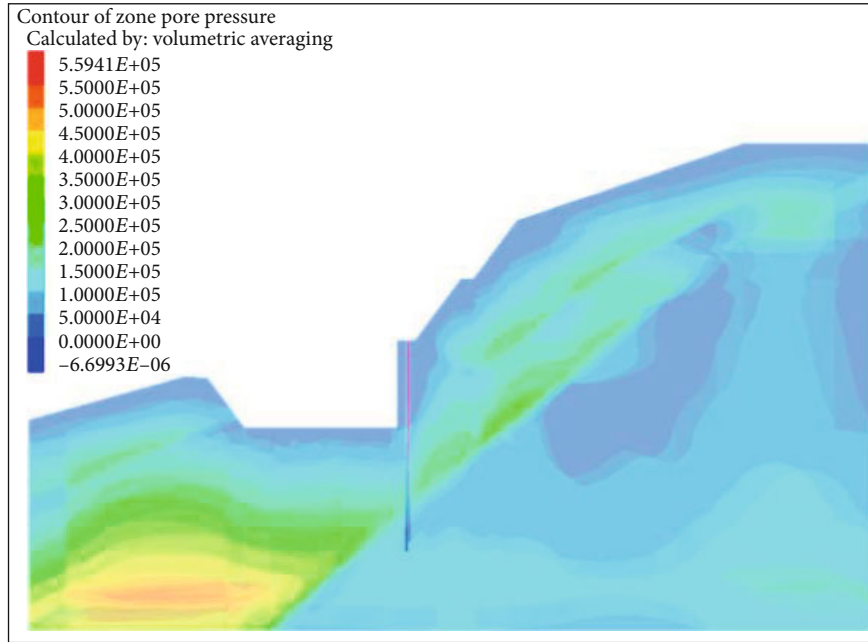
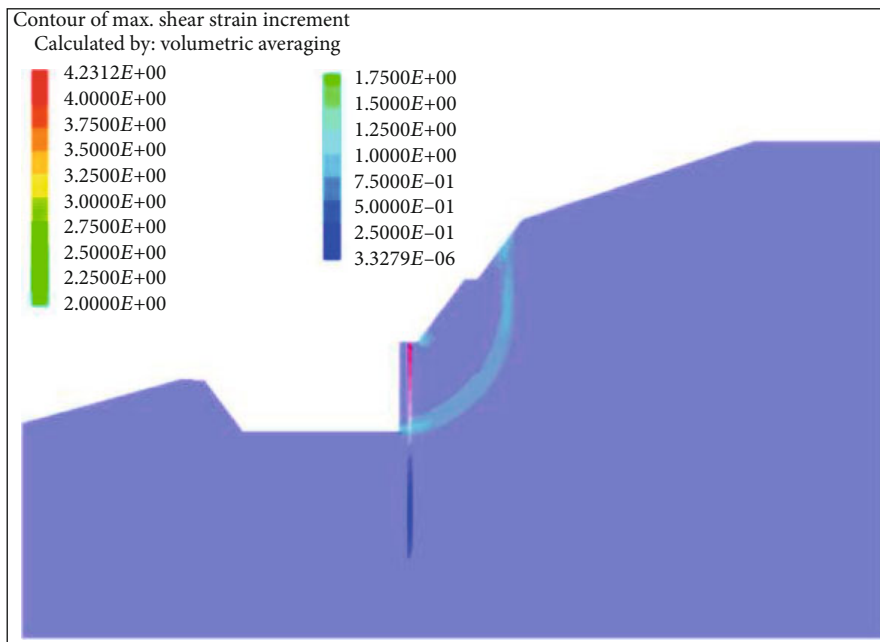
FIGURE 8: Coupled analysis results of the cut slope with the actual construction steps.

Because the failure of the slope is a sudden accident, there is no detailed data about water pore pressure. However, it is known that it rained continuously 5 days before the slope failed according to meteorological records. In order to remedy the lack of the water pore pressure, the seepage of the cut slope was simulated with FLAC^{3D}, and here, the rainfall intensity was considered as 40 mm/day. The distribution of pore water pressure and maximum shear stress increment are given in Figure 8. It shows that the pore water pressure near the slope surface increased continuously during the rainfall process. After 5 days of rainfall, only a small amount of negative pore water pressure exists, and a high saturation area is formed on the face, especially at the toe of the slope. The maximum shear strain increment extends from the top of the third grade slope to the toe of the slope, indicating that the whole slope is a failure.

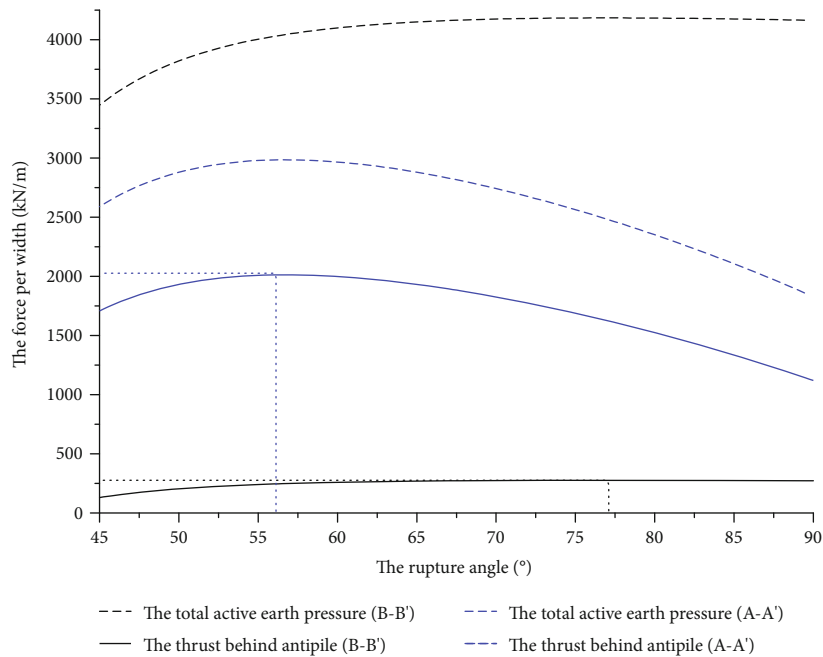
FIGURE 10: The active earth pressure and the thrust behind the antipiles with different rupture angles.

According to Equations (3) and (4), we can calculate the total active earth pressure and the thrust behind the piles under the assumption of different rupture angles. The result is shown in Figure 10. For the first section slope, the maximum active earth pressure per unit width is 2984.84 kN, and the thrust per unit width is 2013.19 kN when the rupture angle $\theta_0 = 56.75^\circ$. For the second section slope, the maximum active earth pressure per unit width is 4184.29 kN, and the thrust per unit width is 275.83 kN when the rupture angle $\theta_0 = 77.0^\circ$.

It shows rock mass between anti-slide piles, and soil in the second section slope eliminates the vast majority of active earth pressure, and then the thrust behind the piles of the second section slope is much smaller than that of the first section. The distance of the adjacent piles is 5 m, so the thrust on each pile of the first section slope should be 10065.97 kN, whereas it is only 1379.16 kN in the second section. Obviously, the first section slope is more dangerous than the second section, which is the mechanical reason of the cut slope failure.

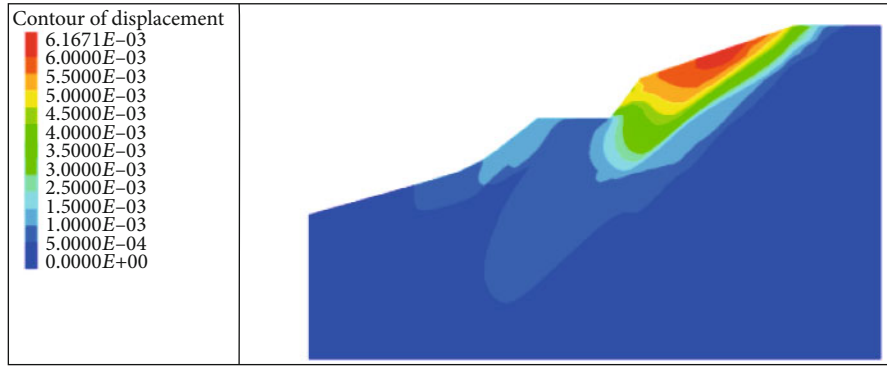
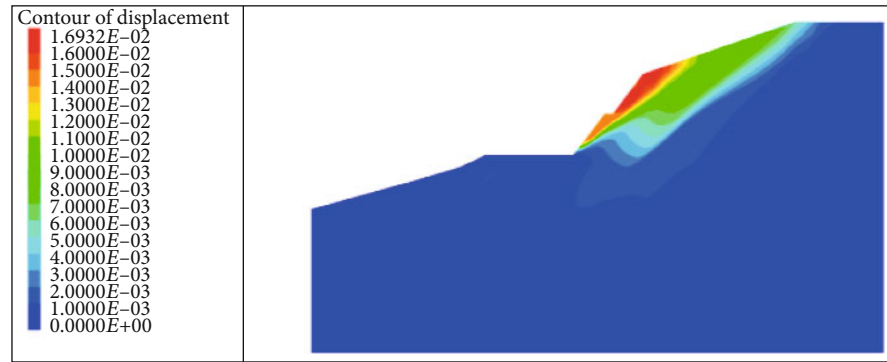
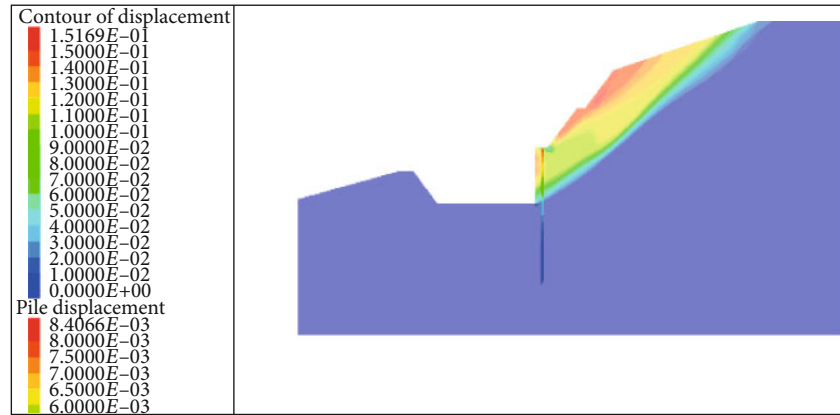
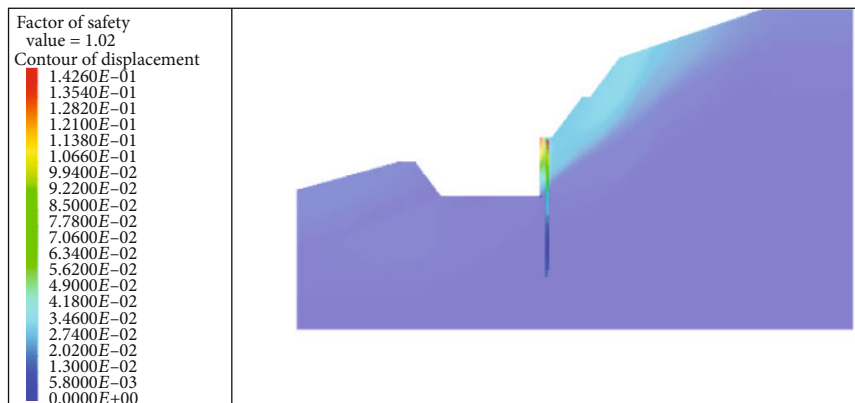
FIGURE 11: The displacement simulated from the actual construction process.

FLAC^{3D} is used to simulate the deformation and stability of the cut slope. The calculation results of the actual and rational construction processes are shown in Figures 11 and 12, respectively. Here, it should be pointed out that the first two steps of the two construction processes are the same; the difference just begins from the third step. Therefore, only the first two steps are given in Figures 11 and 12 which show just the following construction processes. According to the numerical simulation, the slope stability coefficient is 1.02 under the actual construction process and 1.27 under the rational construction process. Under the rational construction process, the anchor cables restrain effectively the deformation of rock and soil behind the piles, reducing the overall displacement of the slope. Therefore, rational construction process can effectively enhance the stability of the slope.

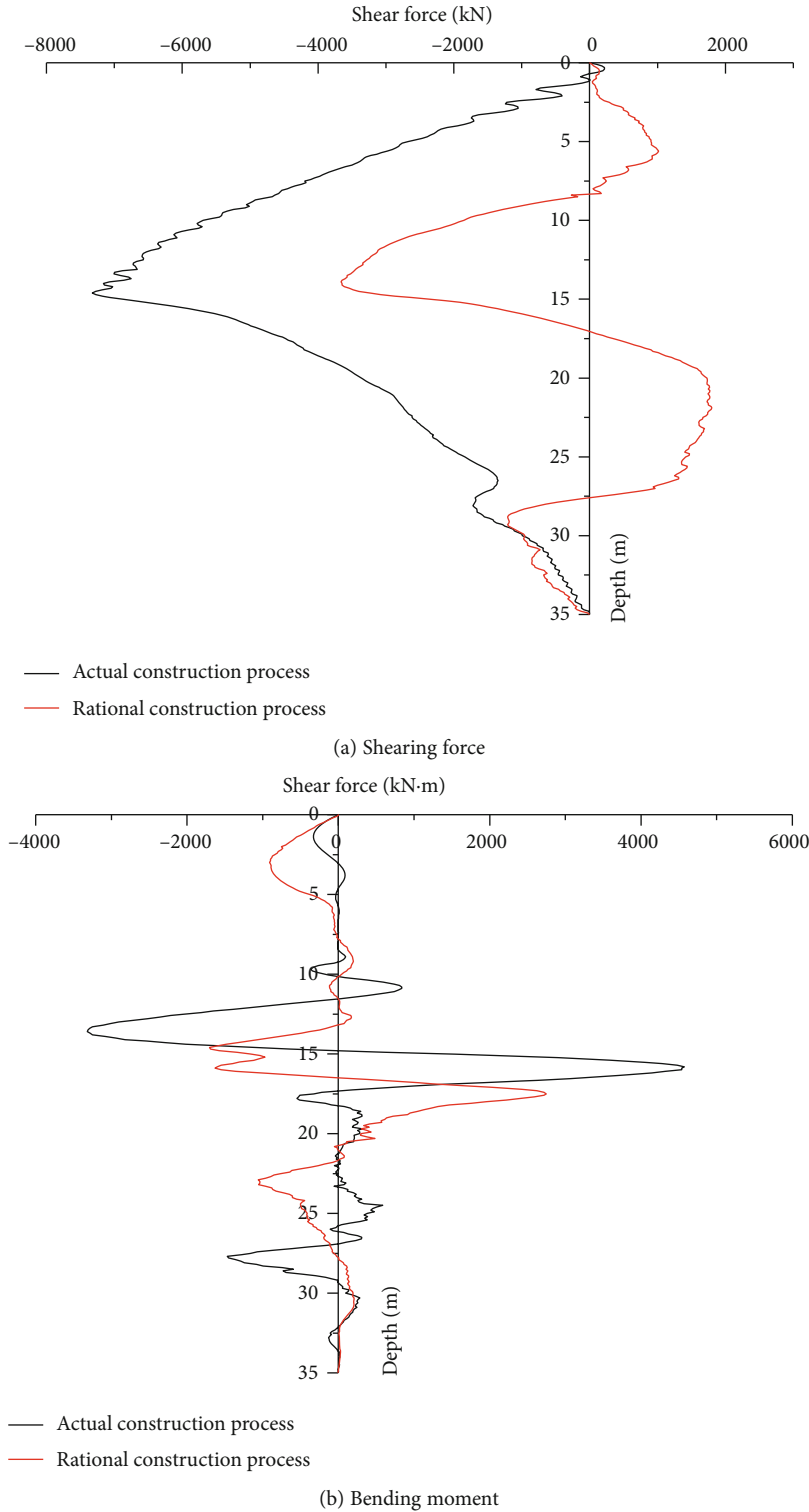
FIGURE 13: The internal force simulated from two different construction processes.

The internal force simulated from the two construction processes is shown in Figure 13. The internal force curves simulated are a little volatile, especially the bending moment. It may be caused by the spatial difference of strata. By comparing the shearing forces and bending moments of the two

construction processes, it shows that (1) No matter which construction process, the maximum internal force of the anti-slide pile is distributed near the slope toe. (2) The anchor cables reduce effectively the maximum internal force of the anti-slide pile and improve the internal force distribution of the pile. Furthermore, the shearing force of the rational construction process is decreased to the half of the actual construction process, and the bending moment almost drops down to the three-fifths. (3) The excessive internal force of the pile near the slope toe in the actual construction process is the mechanical mechanism of the cut slope failure.
