Research Article

Deformation and Failure Process of Slope Caused by Underground Mining: A Case Study of Pusa Collapse in Nayong County, Guizhou Province, China

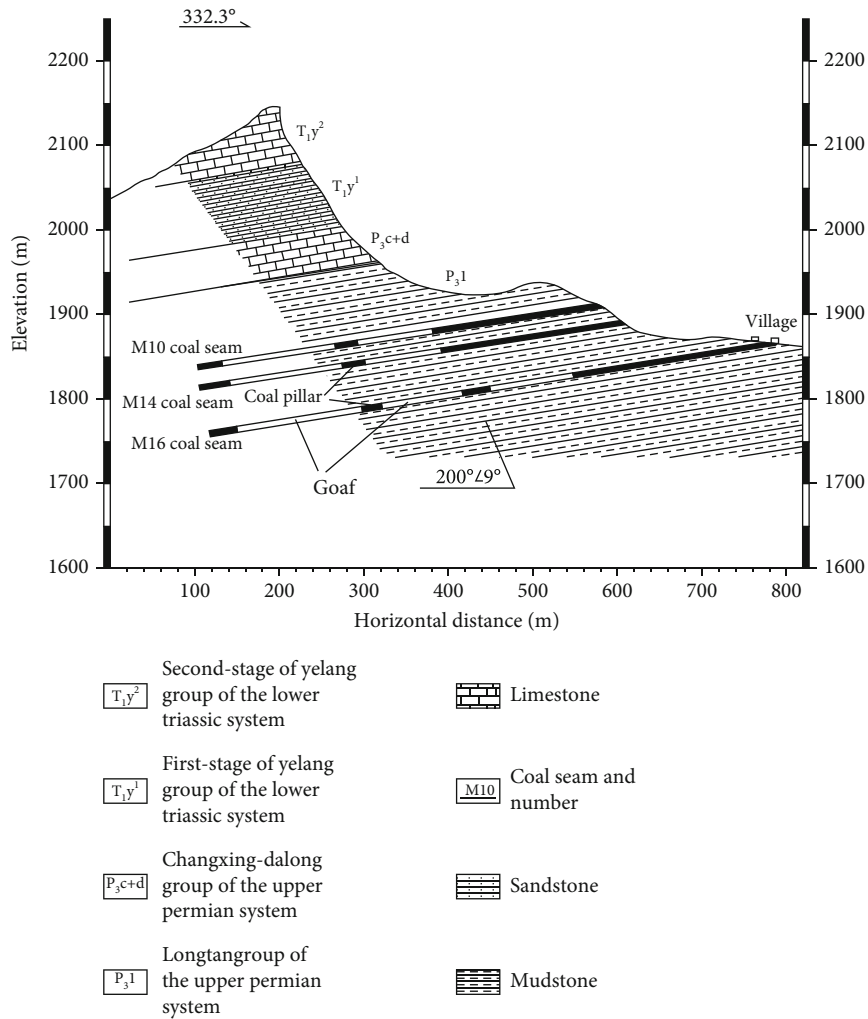
FIGURE 3: Typical cross-section of the slopes in the site (Profile I-I' as shown in Figure 2).

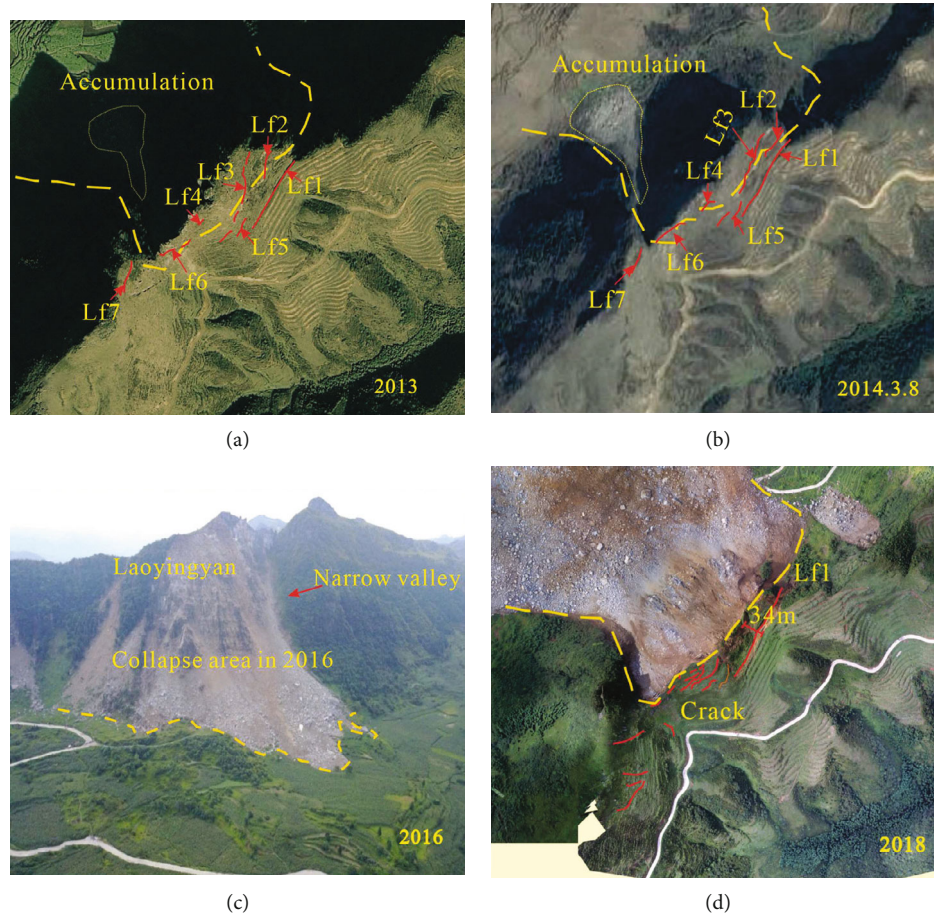
- (1) There were minor signs of deformation at the top of eagle rock mountain and small cracks in 2006. These tiny cracks gradually developed and expanded
- (2) Till 2013, a considerable number of long, wide cracks had already existed at the back of the Laoyingyan mountain. Among them, the width of the crack denoted as Lf1 was about 1–2 m, and the crack extended up to 215 m, which constituted the boundary of the whole mountain body that deformed. Lf2

and Lf3 were located at the back border of the collapse source area, and there were signs of further deformation. It can be seen a small, localized collapse occurred near another mountain on the south side of the slope (of which the estimated volume of about $3 \times 10^3 \text{ m}^3$) and that the collapsed debris accumulated on the slope surface (Figure 4(a))

- (3) In 2014, compared with cracks in 2013, Lf3 extended and connected with some small fractures with a length of 179 m. The width of the cracks found elsewhere on the collapsed slope also reached 40 cm, and the crack width is increasing every year. It was worth

noting that there have been several small local collapses on the left side of the source area of the collapse, and the accumulation has increased (of which the estimated volume of about $5 \times 10^3 \text{ m}^3$), which further indicates that the slope has undergone gradual deformation (Figure 4(b))

- (4) In 2016, due to the superposition of heavy rainfall and mining, large-scale gravel and clay collapse occurred on the right side of the collapse source area, covering previous collapse accumulations and blocking roads (Figure 4(c))
- (5) In July 2017, several collapses occurred in Laoyingyan mountain, and the slope also fell from time to time
- (6) On August 28, 2017, Pusa collapse occurred, and the rear side of Laoyingyan mountain had prominent subsidence characteristics, which was stepped. The rock mass at the top of the mountain was incredibly broken, and there were many tensile fractures, among which Lf1 extends to 180 m and width was 34 m (Figure 4(d))

FIGURE 4: Images of the source area showing the cracks. (a) UAV image, 2013; (b) UAV image, August 2018; (c) front view, July 2016; and (d) UAV image, August 2018. Note: UAV refers to unmanned aerial vehicle.

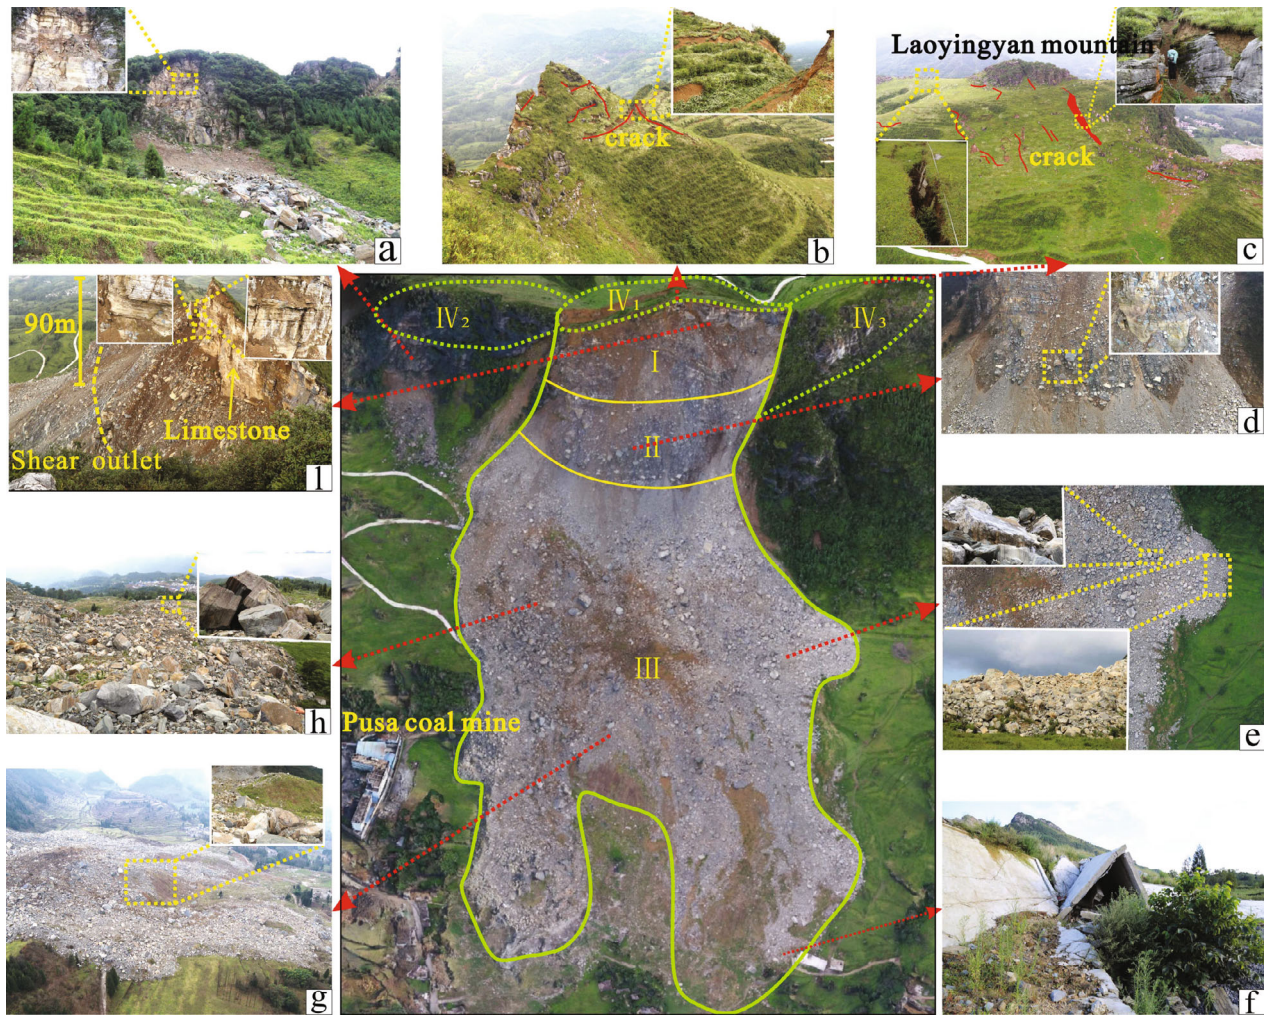
front edge of the accumulation area was about 660 m, and the average thickness of the accumulation area was about 4 m. The total amount of the collapse was about $82.4 \times 10^4 \text{ m}^3$. According to UAV aerial photography and field investigation, the collapse accumulation was divided into the collapse source area, falling scraping area, and circulation stop area, as shown in Figure 5.

3.2.1. Collapse Source Area. The collapse source area was located in the middle and upper part of the slope. The collapse shear outlet was found in the first member of the Yelang formation of the Lower Triassic system 60–90 m down the slope top (Figures 5(I) and 5(l)). According to UAV aerial photography and field investigation, the average height, width, and thickness of rock mass in the collapse source area were about 85 m, 145 m, and 40 m, respectively. The total volume was about $493,000 \text{ m}^3$.

3.2.3. Flow Stop Accumulation Area. The collapse accumulation area was located in the relatively open leading edge of the slow slope area (Figure 5(III)), and the overall slope was about $10\text{--}15^\circ$. There was a small hill at the front edge of the slope foot. The plane shape of the congeries was irregular fan-shaped, and it accumulated in two directions. The accumulation area was fish-tail, with a broad middle part and narrow front and rear edges. The width of the middle part of the accumulation area was about 360–380 m, extending to the SW–NE direction. The accumulation area was scraped by about $310,000 \text{ m}^3$ (see Figures 5(e)–5(h)).

3.2.4. Perturbation Area. With the mining of coal seam, a series of deformation and small-scale collapse has occurred (Figures 5(IV₂) and 5(a)–5(c)). Several small collapses occurred successively on the left side of the collapse source area, and the later collapse accumulation had covered the front collapse accumulation (Figure 5(IV₃)). Many cracks were developed in the disturbed area at the top of the slope (Figure 5(IV₁)). One of the deep cracks was 34 m in width and 180 m in length. The rock mass was broken. The resounding crack separated the collapsed body from the rock

FIGURE 5: The full picture of the collapse. (I) Collapse source area. (II) Falling scraping area. (III) Flow stop accumulation area. (IV₁) Perturbation area 1. (IV₂) Perturbation area 2. (IV₃) Perturbation area 3.

mass at the back edge. It was possible to slide again under external force.

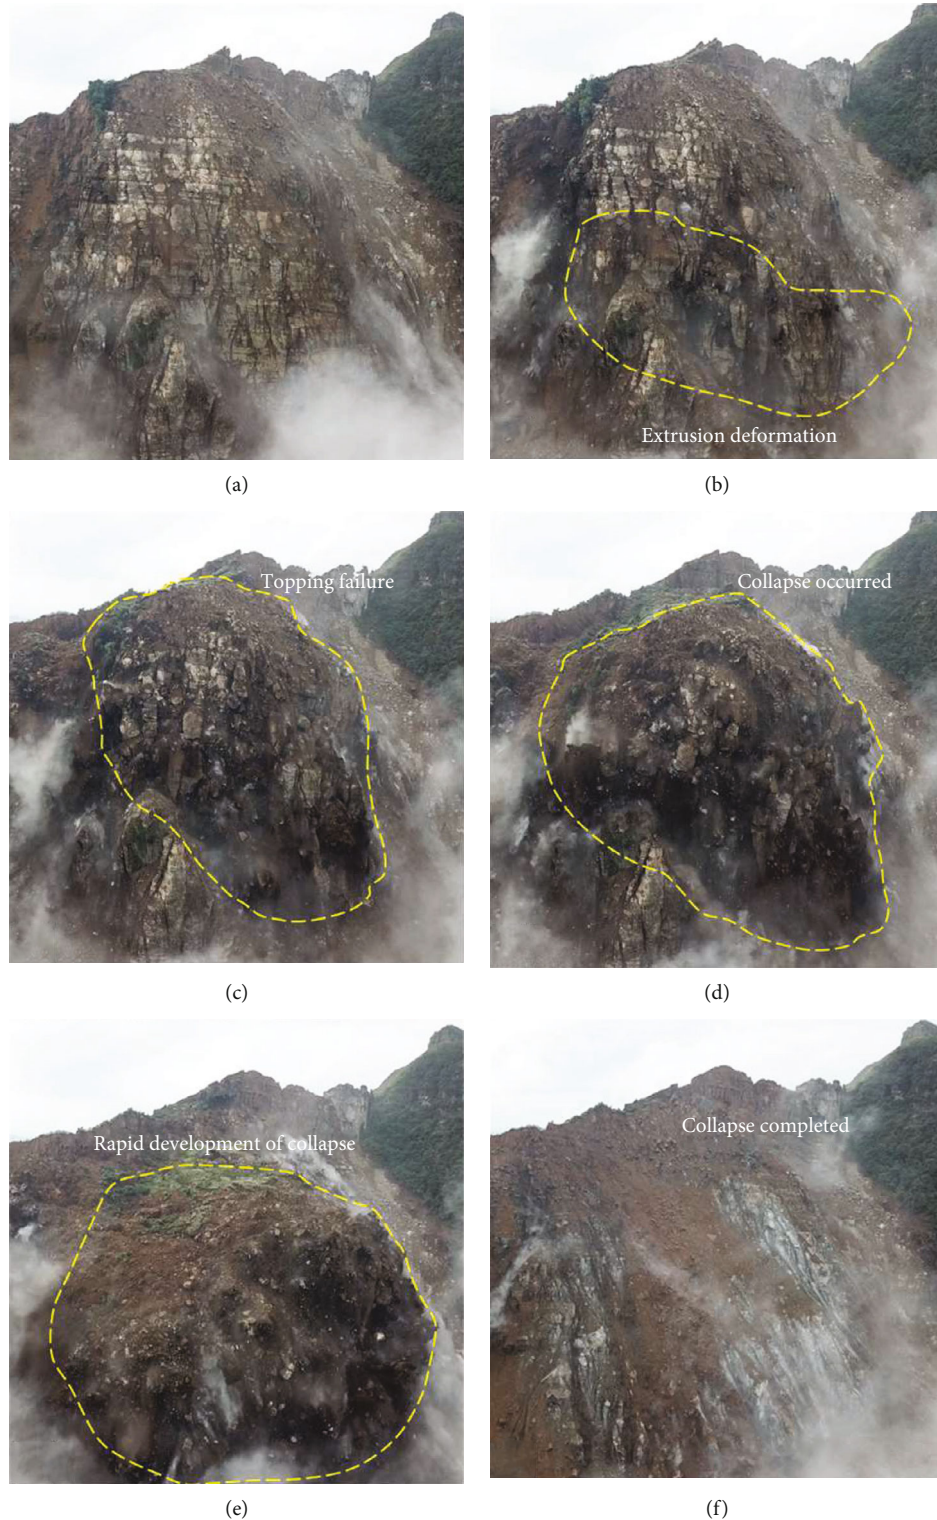
3.3. Analysis of Collapse Instability Process. When the collapse occurred, the on-site monitoring personnel recorded the whole process of collapse initiation through UAV (Figure 6). By analyzing the video captured by UAV, the starting process of collapse is observed. As can be seen from Figure 6(b), after multiple landslides on the slope, the outward extrusion deformation occurs in the middle of the collapsed body towards the free surface, the rock mass on the suitable surface of the collapsed body begins to fall off, and the cumulative damage occurs in the collapsed body. Then, the collapsed body was deformed violently, and the upper rock mass fell off due to the loss of support of the lower rock mass during outward deformation (Figure 6(c)). Then, the mountain collapses due to toppling deformation, generating tremendous kinetic energy (Figure 6(d)). Finally, the collapsed body develops rapidly and moves downward under the action of gravity. In contrast, the rock mass in the middle and lower part of the collapsed body is scraped by the high-

FIGURE 6: Eyewitness sample video frame for the progressive development of collapse.

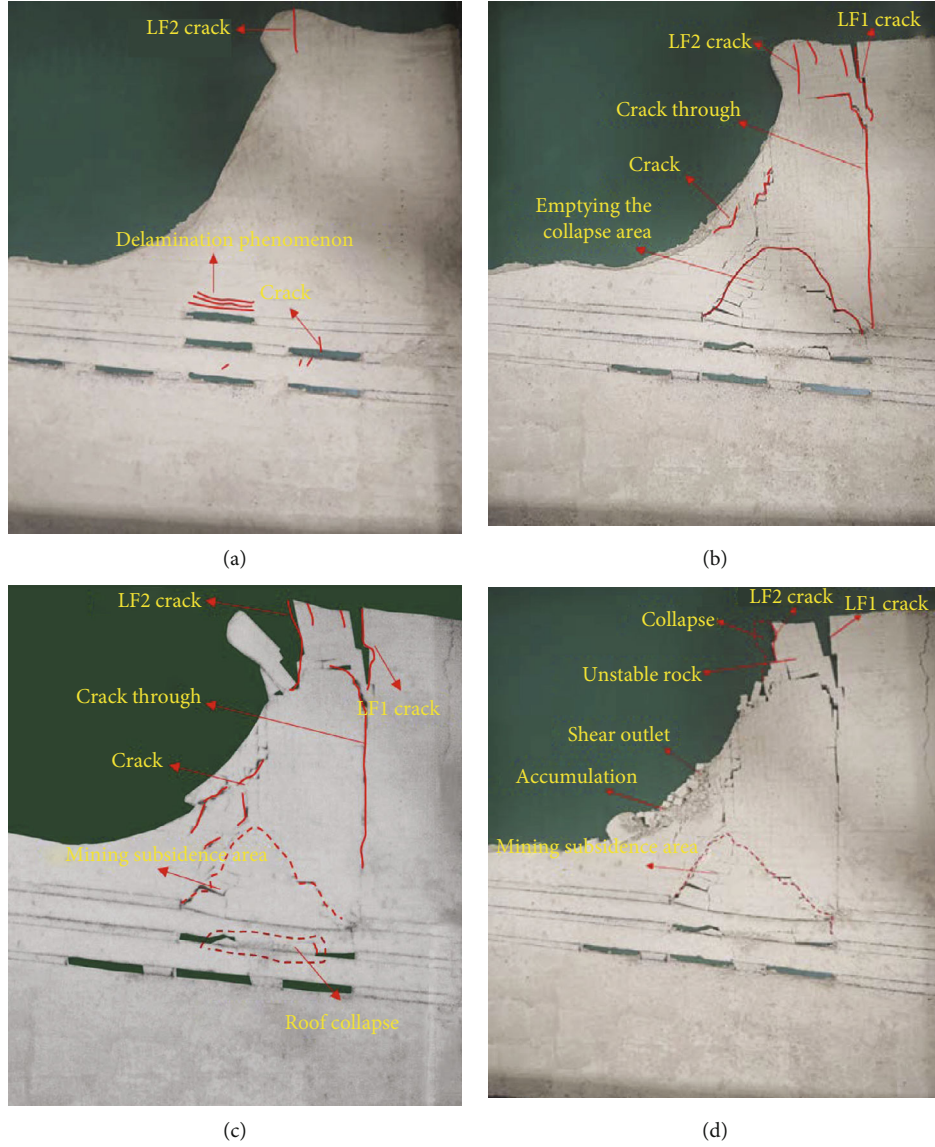
The M10 coal seams were excavated twice. After the first 10 cm, the coal seam was mined, the roof of the coal seam subsided, and there was a separation between the layers. The separation interval was about 1 mm. The joints on the top of the slope showed signs of being pulled apart and developing downward, and crack LF2 was gradually formed, as shown in Figure 10(a).

5.2.2. The Formation Stage of the Top Crack in Slope and Goaf Collapse. After the M10 coal seam and coal pillar of the M14 coal seam were mined, the roof of the coal seam bent and sunk to the goaf, and the overlying rock of the goaf formed a fracture zone and collapsed downward. With the continuous expansion of the collapse area, the upper rock mass bent downward and sunk layer by layer, which caused the collapsed arch to become larger and the cracks on the top of the slope to become wider. The tension cracks near the goaf continue to extend to the top of the slope. The main fracture of LF1 at the rear edge has been opened about 8 mm, and the lower crack also shows a trend of connecting. The rock mass in front of the slope opened along the primary structural plane and developed downward to form fracture LF2, as shown in Figure 10(b).

5.2.3. Stage of Crack Through and Slip Surface Formation. The main crack LF1 was gradually widened, the width was increased from the original 8 mm to 12 mm, and it ran down to the goaf to cut the rock bridge. The upper rock mass lost its support, the whole rock mass staggered downward, and the downward displacement was about 5 mm. Due to the influence of the free face of the front edge of the slope and the concave rock cavity in the lower part of the olecranon, the crack LF2 gradually widened, and the vertical structure of the track developed downward, with a width of about 2 mm. When the instrument ran for a while, the front edge

of the slope toppled forward, and the gravity center of the rock mass deflected. The cracks develop downward. Meanwhile, they were affected by the gravity deflection. When the cracks develop to the soft rock of the second member of Yelang formation in the lower part, the cracks no longer developed downward due to the low strength of the soft rock but cut out to the slope under the self-weight of the upper rock mass and shear the lower rock mass, as shown in Figure 10(c).

5.2.4. Failure Stage of Slope Instability. With the expansion of the influence scope of the collapse area, the cracks became wider and longer, and the rock mass became more damaged, which further aggravated the collapse failure of the rock mass to the free face. When the rock mass was constantly toppling towards the free face, the LF2 crack was pulled apart, and the distance between them became larger. Under gravity, LF2 fracture expanded downward, and rock mass collapse occurred. In the process of downward rolling, the avalanches collided with each other, disintegrated gradually, and accumulated in the front edge of the slope surface. The main fracture LF1 is pulled to 2.5 cm (Figure 10(d)).

FIGURE 10: Process of deformation before the toppling failure. (a) The deformation feature of the cladding rock. (b) Deformation of mined-out areas and cracks on the top of the slope. (c) Dumping damage feature map. (d) Slope failure after instability.

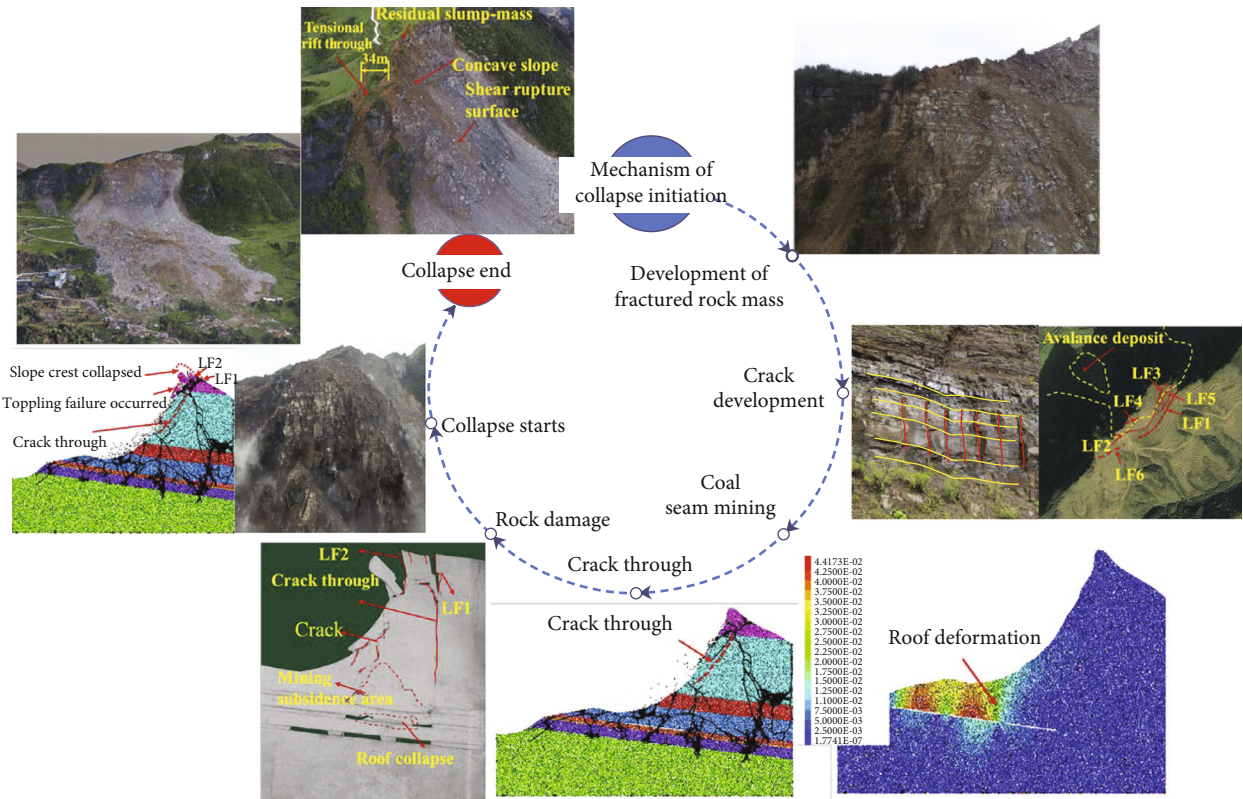
6.3. Numerical Simulation Results. Based on field data, numerical simulations, and a previous study [13], the destruction process of the collapse can be summarized in four stages [49], as shown in Figure 13.

FIGURE 13: The model-predicted initiation and evolution process of the slope collapse.

The occurrence of the collapse studied is caused by both internal and external factors. There are unique geological and stratigraphic structures in this area, and two groups of nearly vertical fractures have already existed within the slope. Such fractures cut the intact rock masses into discontinuous blocks and provide channels for infiltrated precipitation; thus, the rock masses of the slope are relatively fractured and disintegrated, which provides indispensable physical conditions triggering the development of the collapse (Figure 13).

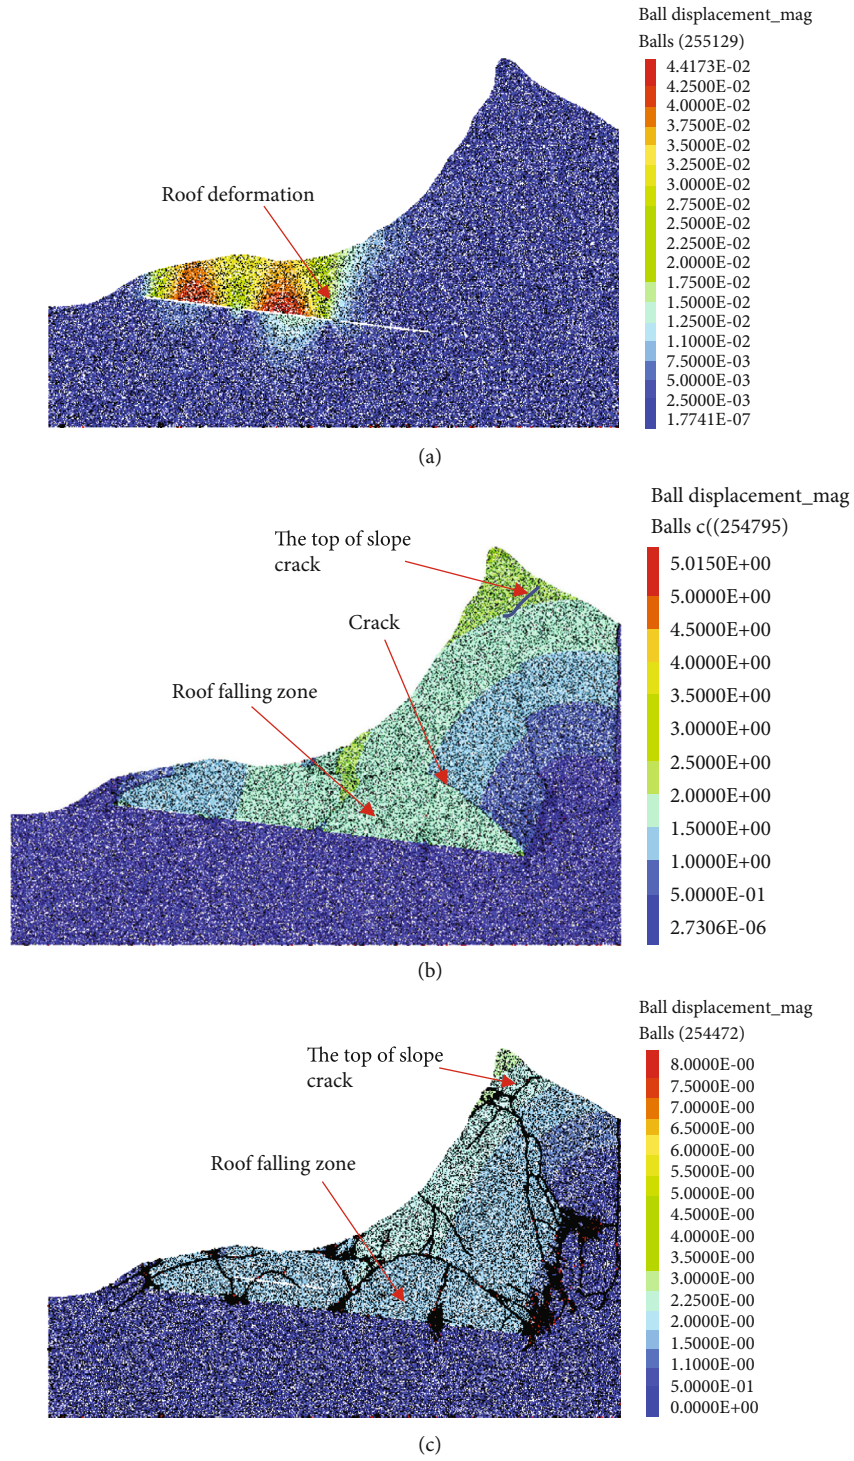
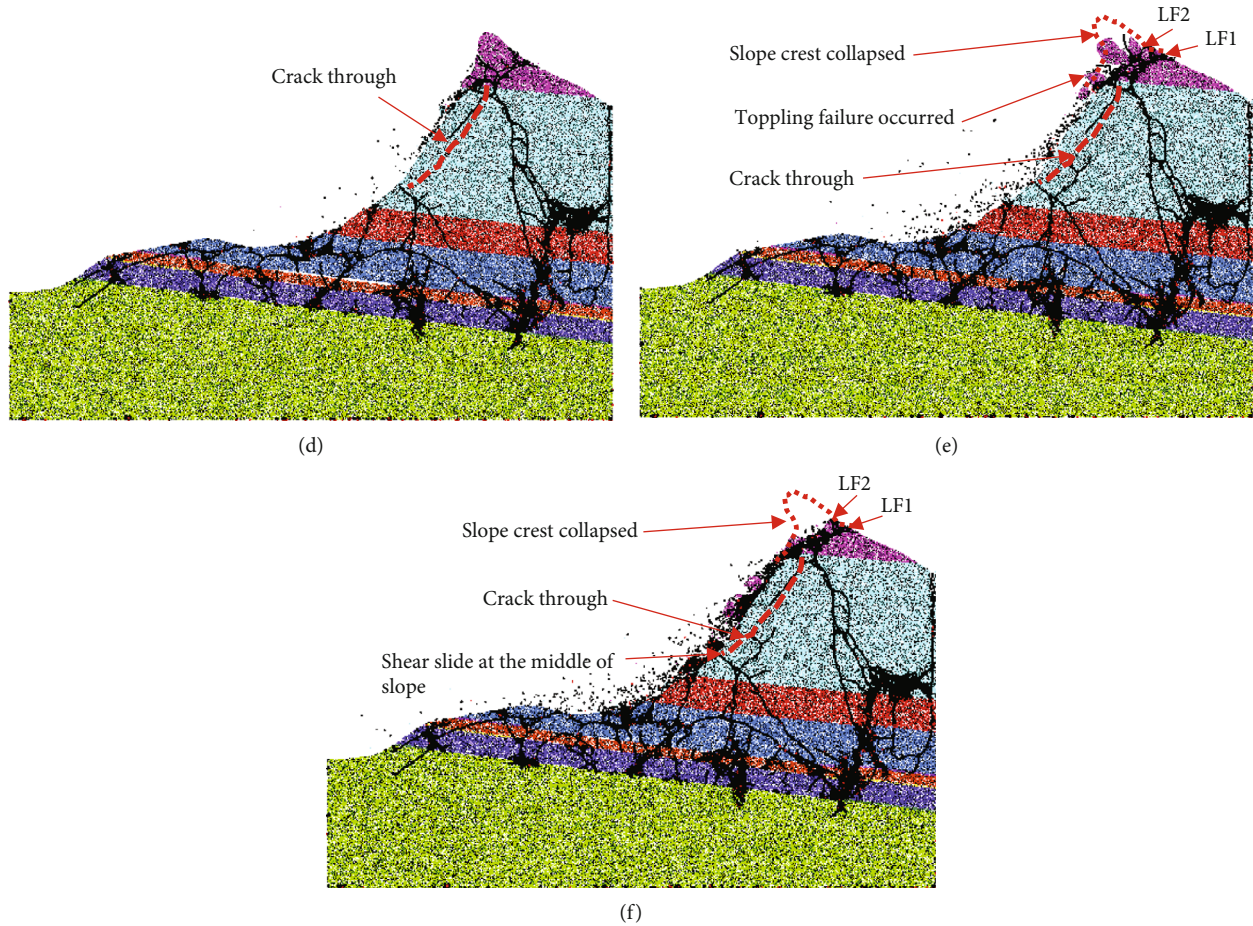
FIGURE 14: Failure process of the Pusa collapse.

roof began to crack apart, as shown in Figure 14(a). Then, the overlying rock mass on the goaf boundary deformed outwards and eventually developed deep tension cracks.

6.3.2. Formation Stage of Slope Top Crack. After a period of mining of M10 and M16 coal seams, the loss of support for the roof of goaf led to increased deformation and gradual destruction of overburden. At the same time, with the balance state being damaged near the goaf, the stress concentration area occurred, the cracks were produced and gradually developed upward, and the overburdened rock of the goaf formed fracture zone as shown in Figure 14(b). Then, the roof of the goaf also began to bend and sink. As mining activities continued, the roof of the goaf further subsided, deformed, and collapse, forming a caving zone and rapidly extended upward along the steep joint surface. With the development of deformation, cracks propagated to the crest of the slope, as shown in Figure 14(c).

and the rock bodies became more damaged. Meanwhile, the original cracks in the top of the slope increased, and the fissures above the mining area extended to the top of the slope, as shown in Figure 14(d). With the development of cracks, cracks also appeared in the middle of the slope. The top of the slope crack was also expanding downwards, gradually with the middle cracks, forming a potential slip surface. Due to the influence of the surface, the mining area, and the rainfall, the top rock mass of the slope began to decline.

6.3.4. Stage of Collapse. With the continuous upward development of the impact range of the collapse, more cracks emerged, and the whole slope produced an uneven settlement, resulting in a large number of cracks in the top of the slope. The increase in cracks led to a significant fragment of the rock, and dumping damage begins at the top of the slope, as shown in Figure 14(e). Tensile cracks in the upper hard rock formation form potential sliding surfaces by connecting. Under the pressure of the upper hard rock layer, the shear damage in the middle of the slope was formed in the soft and hard mutual layer, as shown in Figure 14(f). Under the external forces, the final collapse occurred, and the collapse was affected by the impact-shovel scraping, moving at high speed in the form of debris flow, piling up at the foot of the slope.
