Study on Deformation Mechanism and Control Measures of Tanziyan Landslide

Studying the deformation and failure mechanism of the Tanziyan landslide in Yesanguan Town, Badong County, and designing the controlling measures are of great significance to ensure the sustainable development of urban planning and construction. In this paper, stability of Tanziyan landslide is analyzed using the calculation method of complex plane slip surface. After consideration of the essential characteristics of the disaster body, the deformation and failure mechanism of the landslide is studied, and the corresponding landslide treatment measures are presented. Results show stability state of the landslide is understable to unstable as a whole, and the development process can be roughly divided into three stages: sliding, bending and the cracks are connected. Finally, it is proposed to cut and reshape the slope from the crack groove on the slope top to the national highway, and then lattice beams and anchor cables are presented to protect the reshaped slope surface. Ecological bags are used to stack and regreen between the lattice structures. A retaining wall is built on the inner side of the national h

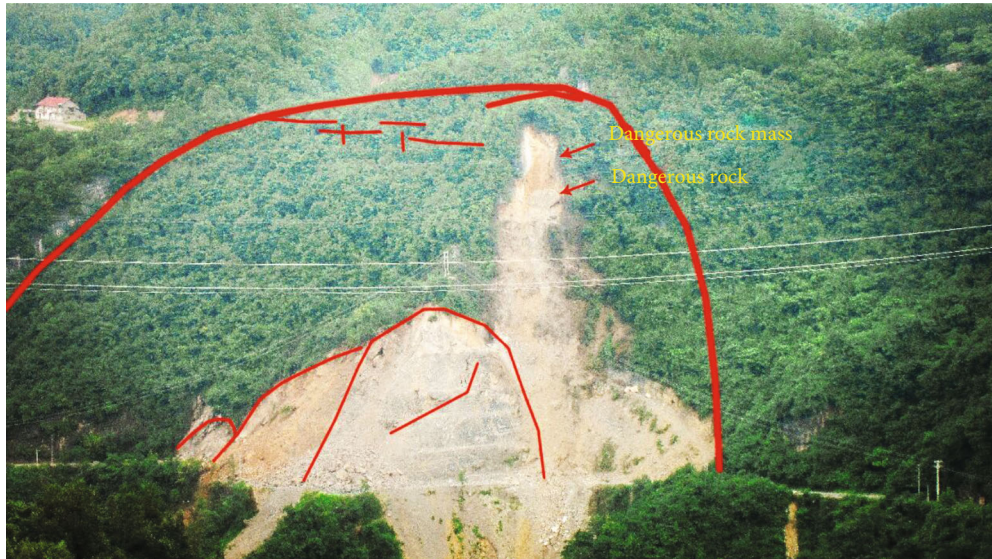
FIGURE 3: Overall view of Tanziyan landslide.

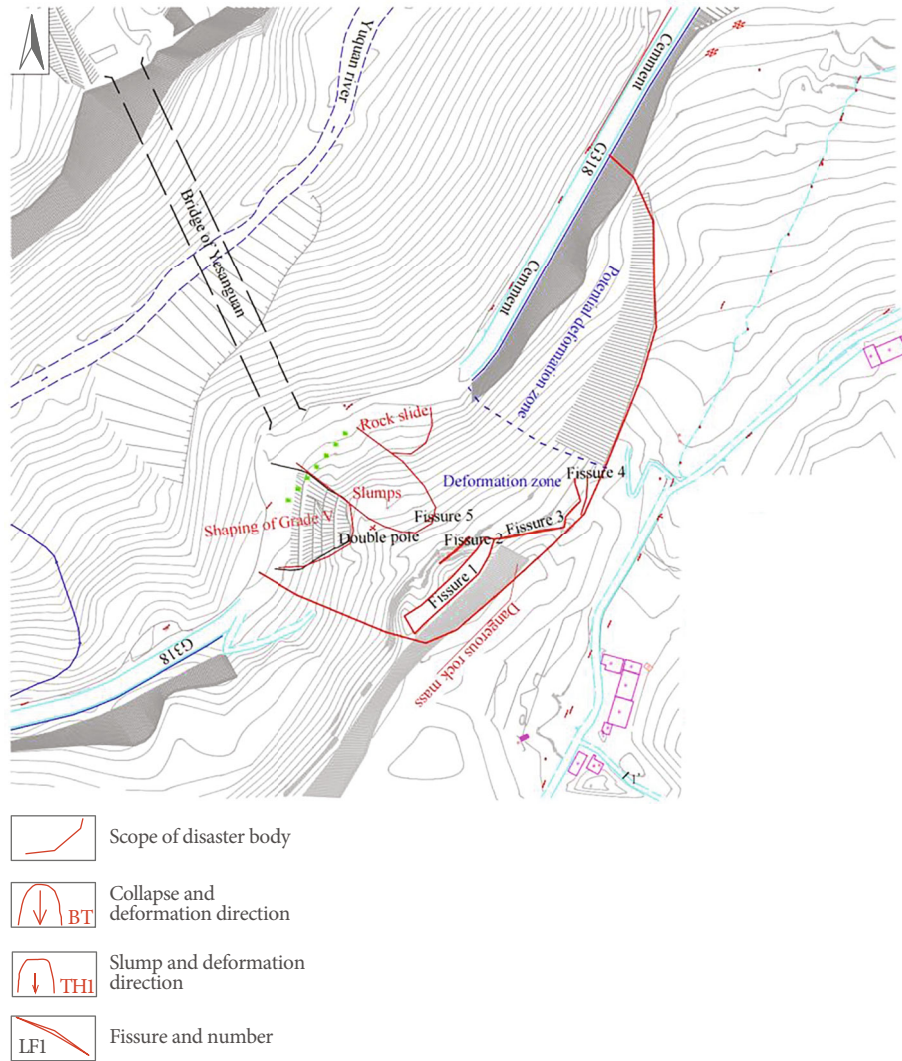
Tanzian landslide is divided into two areas according to the current deformation: deformation area and potential deformation area. The deformation area is located on the left side of the Tanzian landslide. The width of the deformation area is about 120 m. The primary deformation is top collapse, ground crack, and bottom collapse deformation. The potential deformation area is located on the right where no obvious deformation has been found. Still according to the

deformation mode of the Tanzhiyan landslide, the fracture will gradually develop to the northeast (right). The deformation zone is shown in Figure 4.

FIGURE 4: Plan diagram of Tanziyuan landslide geological hazard.

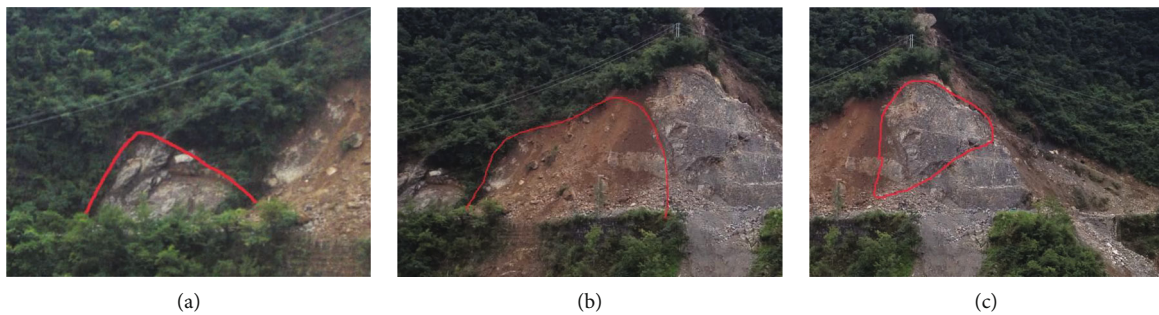
3.1.1. Sliding. The slide deformation occurs at the inner slope of G318 at the front edge of collapse, with a total of 3 places developed, namely, TH1, TH2, and TH3 (Figure 5), which are closely arranged from east to west. After the occurrence of slide TH1 and slide TH2, the professional monitoring of slide TH3 was focused. According to the professional deformation monitoring records, the displacement of collapse body was 0.3 m from June 30, 2018, to July 5, 2018 (Figure 6). In addition, from June 25, 2018, to June 30, 2018, the monitoring results of the high-pressure electrode slope on the upper part of the collapse TH3 were cracks, and the mountain displacement was 3.8 cm.

FIGURE 5: Location distribution of slump cloth.

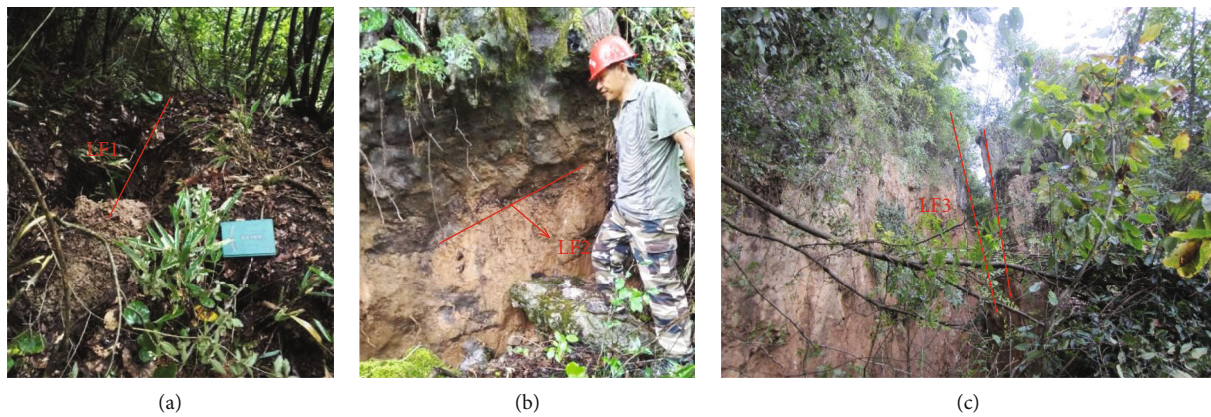
3.1.2. Mountain Fissures. Mountain fissure is one of the main deformations in the area, in which fissure LF2 and fissure LF3 are tension fissures and fissure LF1 is shear fissure. The fissure mentioned above LF3 with intense deformation forms a huge drawing crack trough at the ridge, showing a “thin strip of sky” landscape, which makes a vast rock mass wanting to separate from the rear mountain in the shape of a solitary peak. The three mountain fissures described in this paper are shown in Figure 7.

FIGURE 7: Fissure of Tanzhiyan landslide geological disaster.

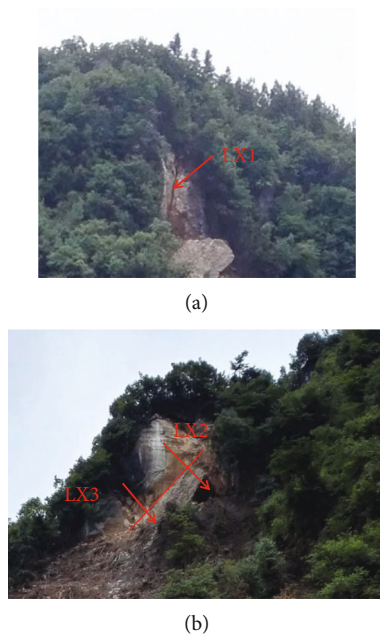
area are developed, and the cracks have apparent damage control on the rock mass. Five groups of fractures are mainly set in the study area, of which the rock stratum level and LX1 fracture (Figure 8(a)) are the principal structural planes of rock mass, with strong ductility. At the same time, it is cut by other groups of fractures, and the rock mass presents structural characteristics such as layered block fracture and rhombic wedge. As shown in Figure 8(b), LX2 and LX3 are conjugate fractures, developed in the shallow surface with good elasticity, with an extended height of 1.2–2.0 m, a length of 15 m can be seen locally, and the cutting layer is developed.

FIGURE 8: Distribution of joints and fissures in the investigation area.

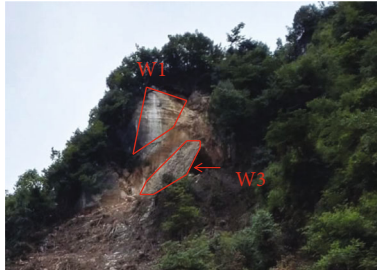
FIGURE 9: Distribution of dangerous rock masses in the survey area.

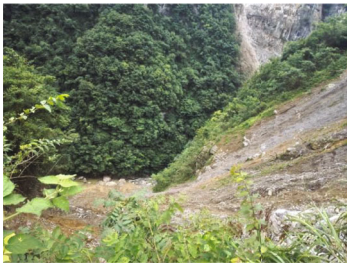
(2) *Characteristics of Talus Slope.* Most of the collapsed block stones in the area roll down to the Yuquan river valley (Figure 10(a)), with a volume of about 650 m³, a small part is accumulated at G318 (Figure 10(b)), and sporadic block stones are scattered on the groove slope. The plane of collapse accumulation body is long strip, with different thickness, thin at the top and thick at the bottom, with a thickness of 2.5–5 m. It is mainly composed of broken stones, with different diameters and angular shapes. The rock property of broken stones is flint nodule limestone.

FIGURE 10: Distribution of colluvium block stones at river bottom (a) and G318 (b).

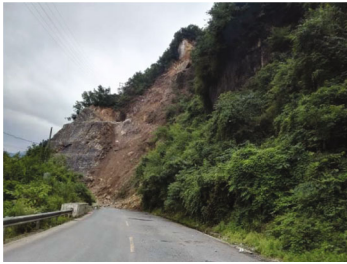
(b)

280° direction and rolled down with a high drop, with great potential energy and great damage. Nearly 60 m guardrails and embankments of the national highway were destroyed, and another culvert and 100 m drainage ditch were destroyed, resulting in the blockage of the national highway (Figure 10(b)).

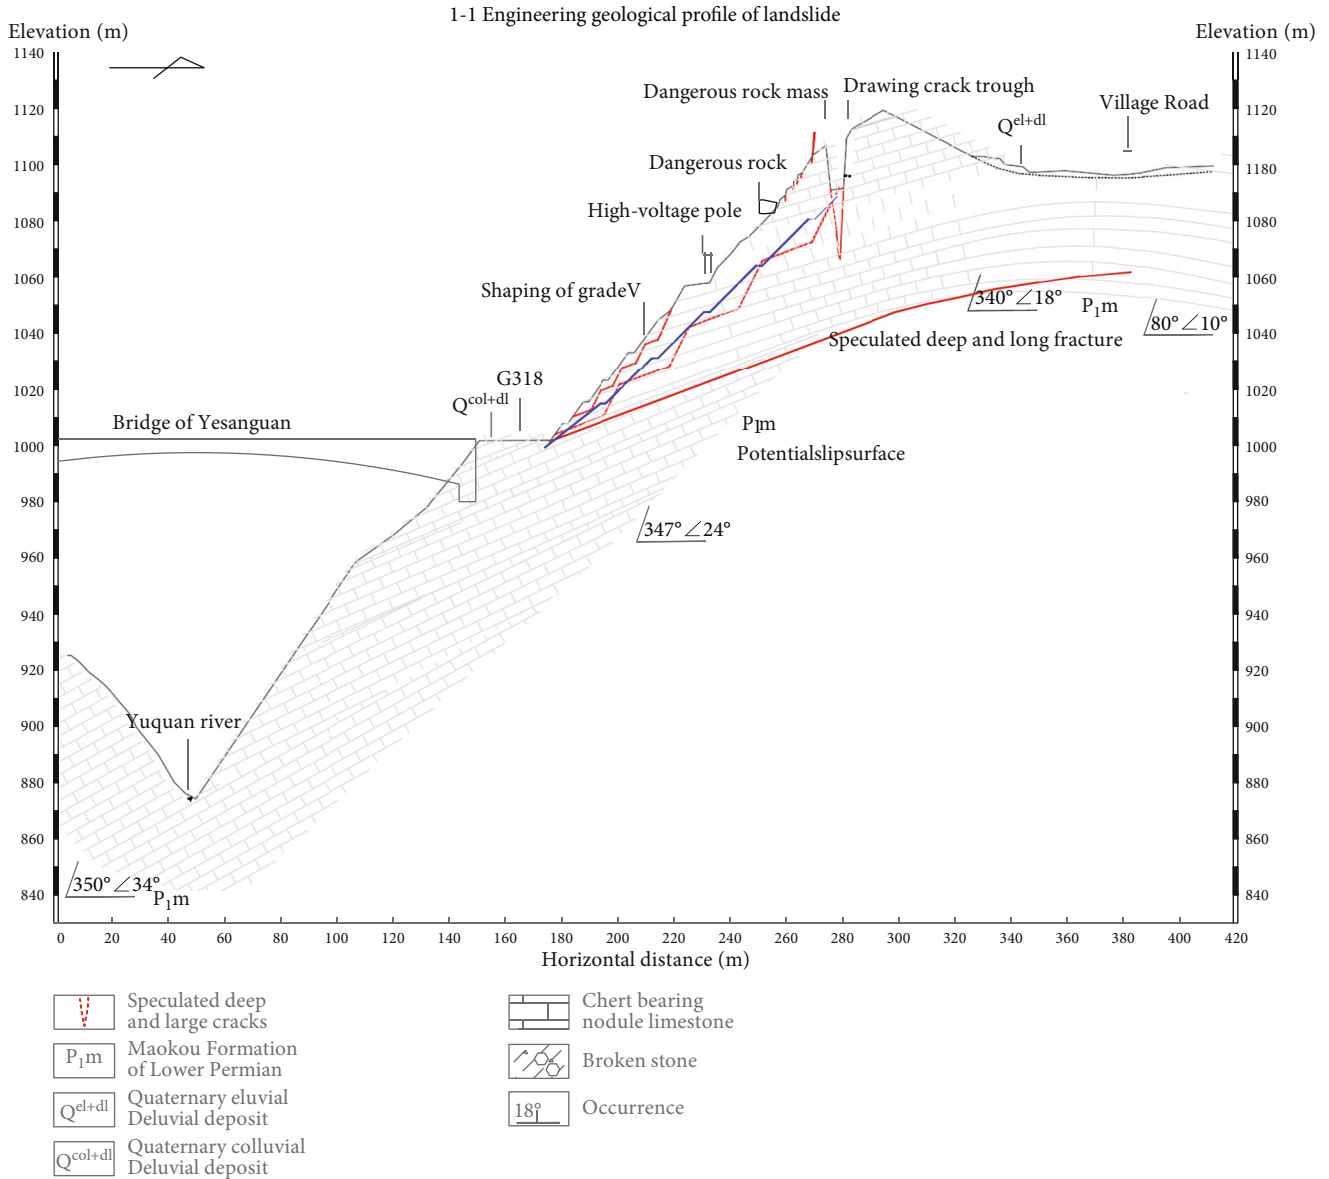
FIGURE 13: Schematic diagram of 1-1' section slope cutting.

According to the deformation characteristics and causes of Tanziyan landslide, slope cutting and shaping is adopted to eliminate dangerous rocks and improve the overall stability. For multiple cracks developed at the top, the form of crack sealing is adopted to prevent rainfall infiltration along the cracks. In order to further improve the overall stability, the construction method of lattice structure combined with anchor cable is adopted for anchoring.

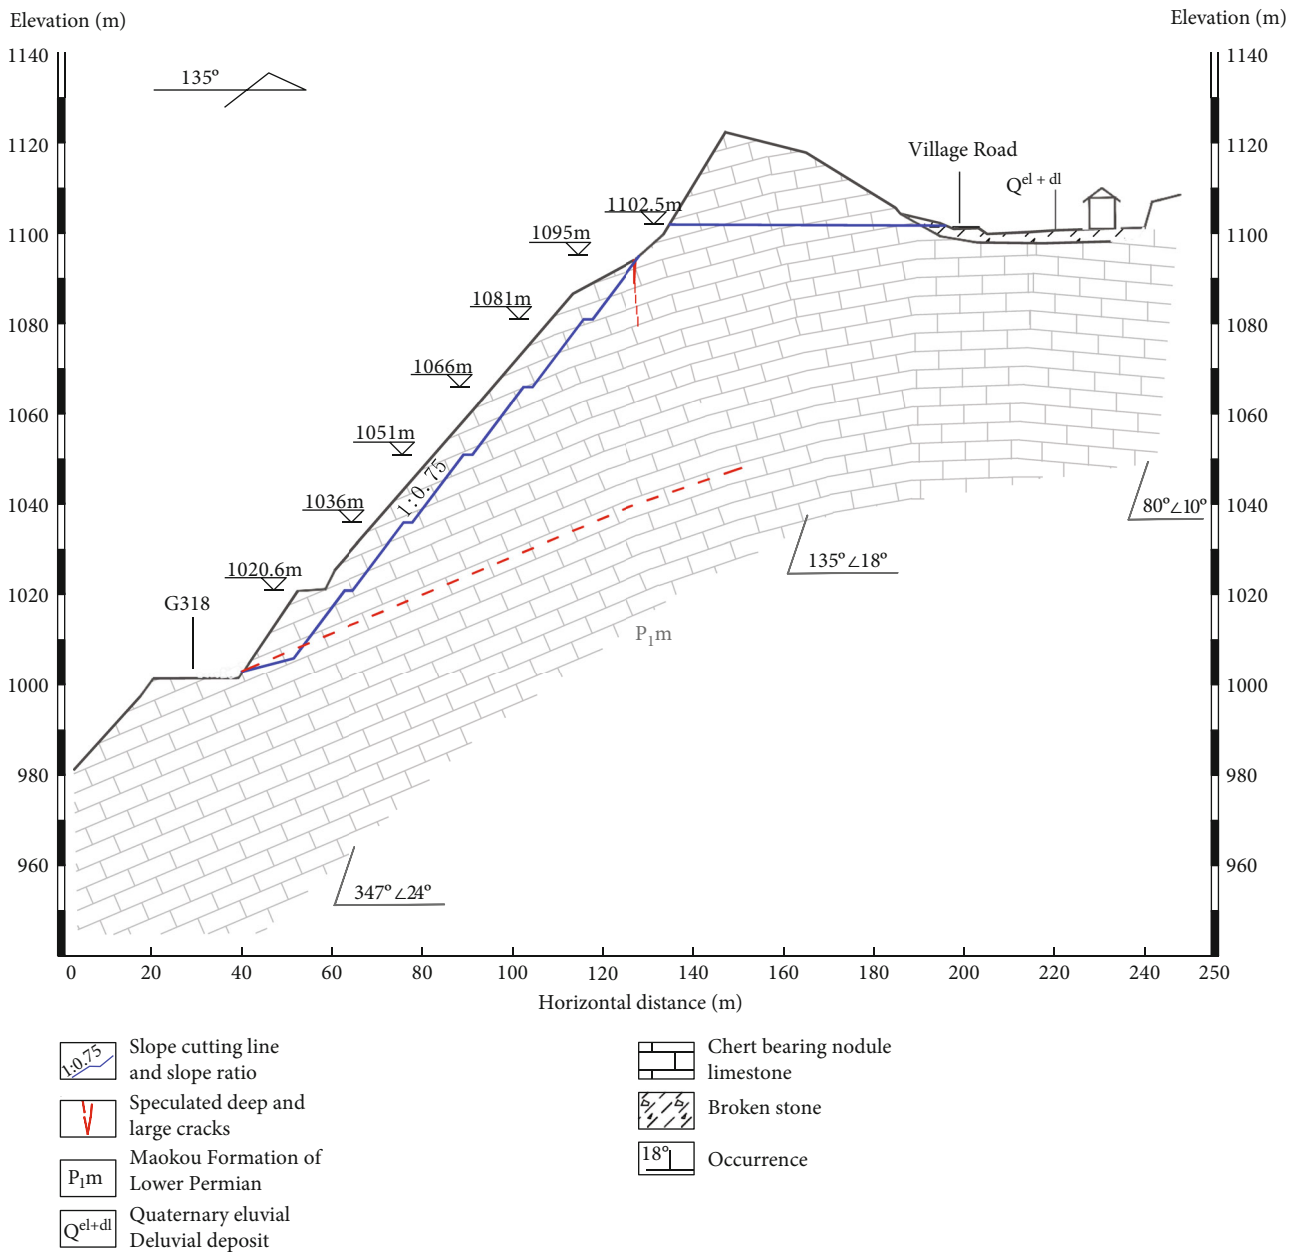
FIGURE 14: Schematic diagram of 4-4' section slope cutting.

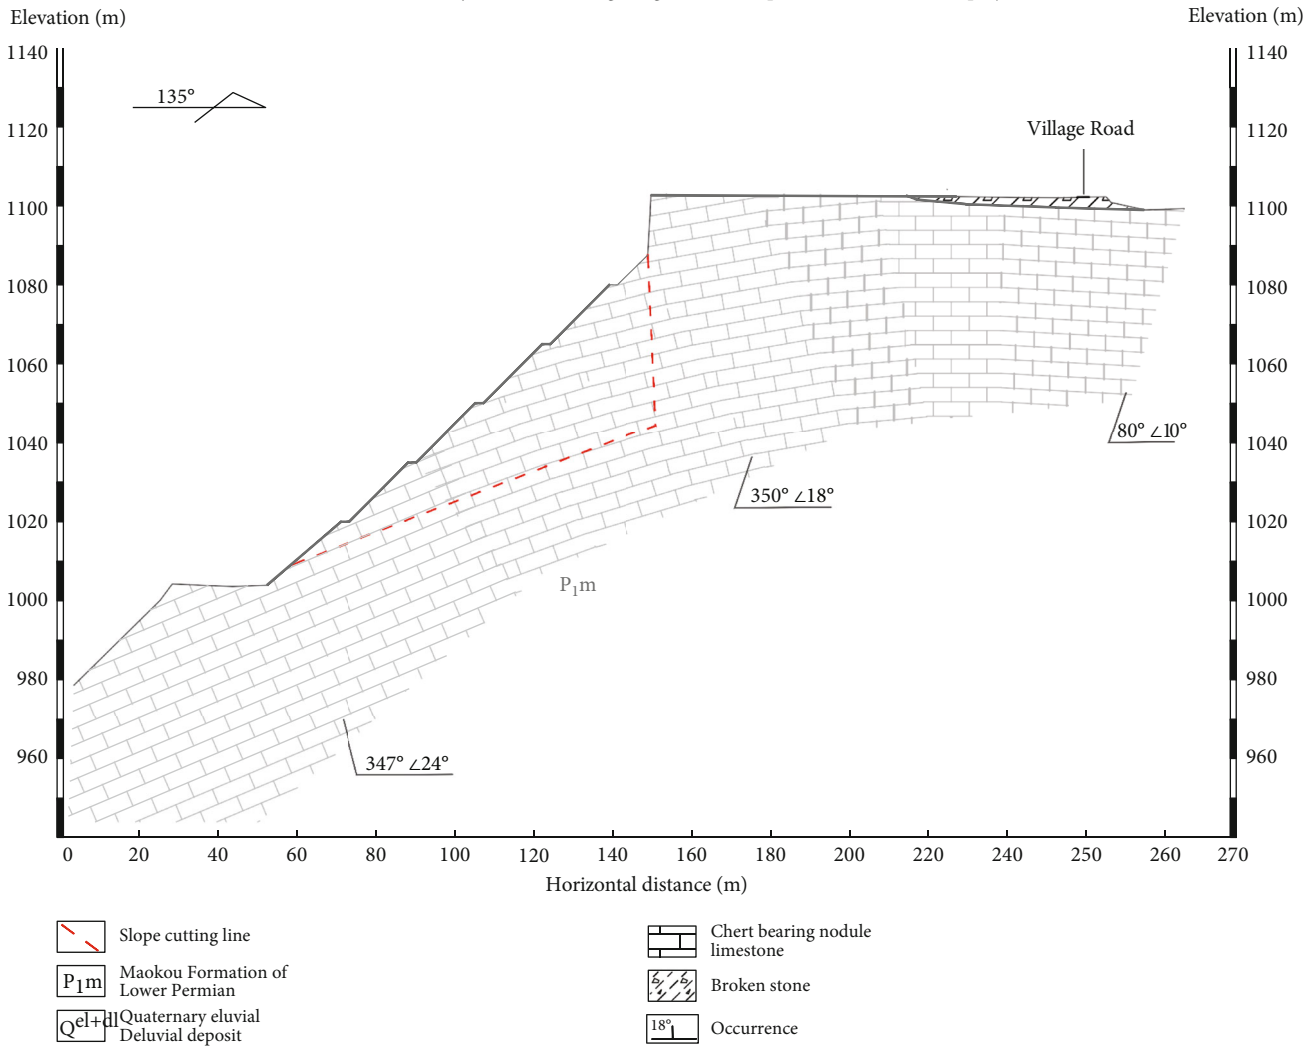
5.1.2. Stability Review. The slope cutting and shaping project basically eliminates the sliding deformation and failure controlled by the structural plane, but the downward extension distance of the crack is not clear in the top tensile crack groove. The rock mass after slope cutting forms a wedge under the joint action of the layer and the downward extension crack of the tensile crack groove, which may deform along the layer. Therefore, the bedding stability shall be rechecked according to the slope shape after slope cutting and shaping. The parameters are the same as above, and the calculation model is shown in Figure 15.

Through calculation, under condition 2, the stability factor is 1.017, which is in an unstable state and has not yet reached the safety factor of 1.1 required by the design. For the slope after shaping, other projects still need to be used for further support.

FIGURE 15: Stability calculation profile of 1-1' section after slope cutting and shaping.
