Integrated Geophysical and Geotechnical Approaches for Evaluating Dam Seepage in Lesser Himalayan Region of Pakistan

Dam leakage is a major problem in earth-filled reservoir dams. The present research is aimed at detecting the seepage zones in an earth-filled reservoir dam in the vicinity of Sarobi village, North Waziristan, Pakistan. The objective was achieved by integrating geological, geotechnical, and geophysical datasets. Geological survey was carried out in the area to identify the surface exposures. Geotechnical data involved was used to estimation of permeability and Lugeon values to identify network of joints/fractures whereas electrical resistivity tomography (ERT) technique (utilizing Wenner-Schlumberger configuration) was applied for the identification of the leakage zones. Geological data revealed highly deformed alluvium towards the right abutment underlain by compressed shale and highly fractured limestone beds. Geotechnical data indicated high permeability, Lugeon values, and concentration of sand and gravel towards the right abutment whereas low permeability, Lugeon values, and higher concentration of silt and clay were observed towards the left abutment. ERT data

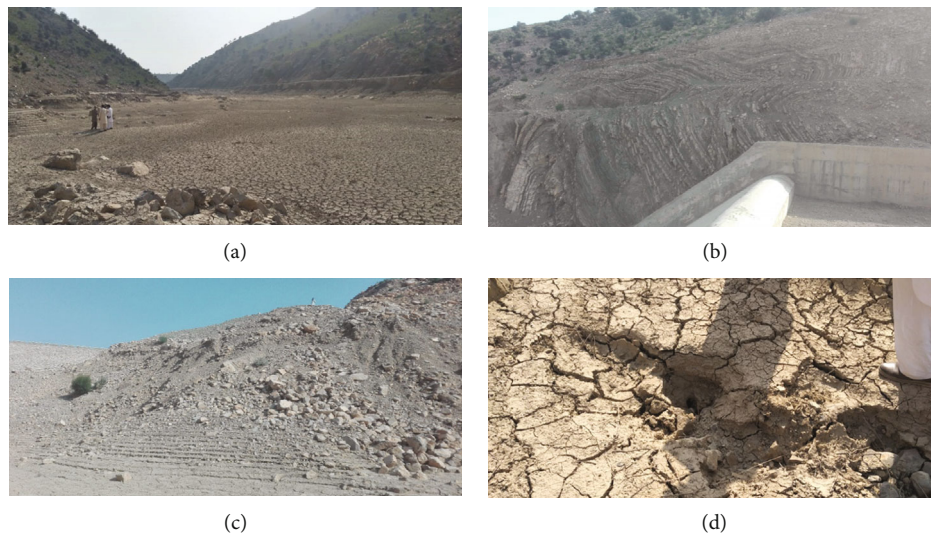
FIGURE 2: (a) Showing fluvial deposits, (b) showing crushed material towards right abutment, (c) alluvium towards the right abutment and water marks due to lowering of reservoir, and (d) mud cracks.

3.1. Geological Data. The surface geology of the dam’s reservoir area comprises mainly of Quaternary deposits, such as clays, sands, gravels, and boulders as shallow materials (Figure 2). The thickness of these deposits varies up to one meter. These alluvial deposits overlay the Jurassic to Cretaceous limestone with interbedded shale (Kurrum Group) that comprises the bedrock of the dam’s reservoir [44]. Kurrum Group rocks are dipping towards the upstream at an angle of 35-45 degrees; extensive fracturing and

karstification have been observed during the field investigation (Figure 2). The spillway of the dam is located on the right bank, and its upstream side has complexed geology (Figure 3). When the dam reservoir's water level is decreased, mud cracks were developed (Figure 2).

Surface geological conditions on the right abutment show a highly deformed zone indicating tectonic activities in the past (Figure 2). The southern right part of the ERT-2 below 160-300 m represents the deformed zone (Figure 6). This zone indicated high resistivity values ($500\text{-}2500\ \Omega\cdot m$), especially near the surface. An interesting anomaly having low resistivity values ($\geq 60\ \Omega\cdot m$) was found embedded within high resistivity values (Figure 6). This anomaly is attributed to fractures filled with dam seepage water [14].

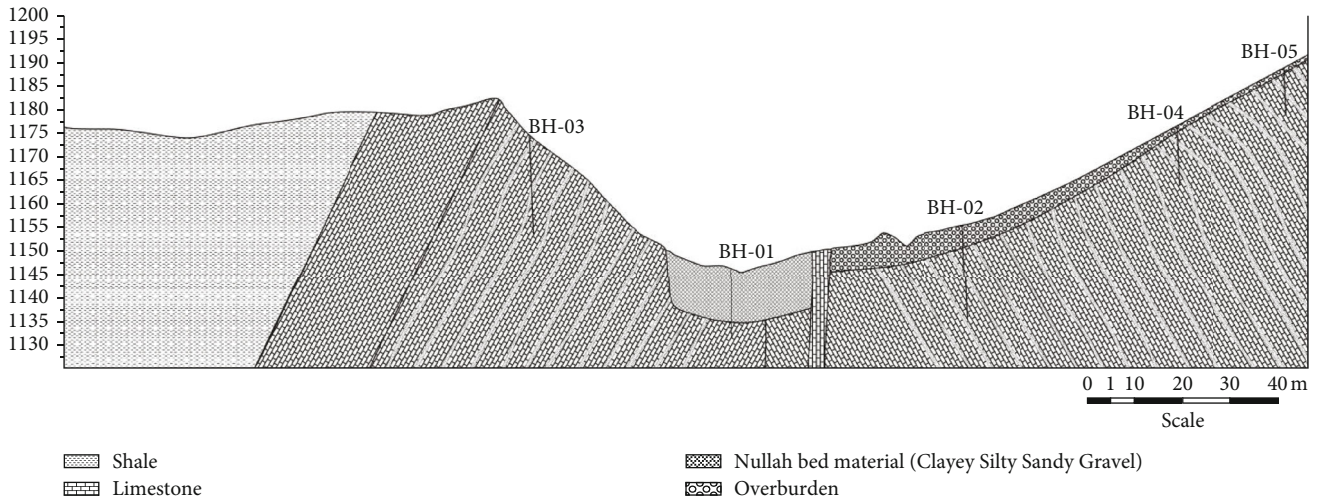
The overall structural geometry of the rock is dipping at the upstream side of the dam; however, due to the overturning of folded and thrust fault systems, the right abutment rock dips toward the downstream side (Figure 3). Therefore, the rock joints and fractures have similar trend to reservoir's water flow direction [45].

FIGURE 3: Geological cross-section of the dam indicating positions of the boreholes and lithological pattern.

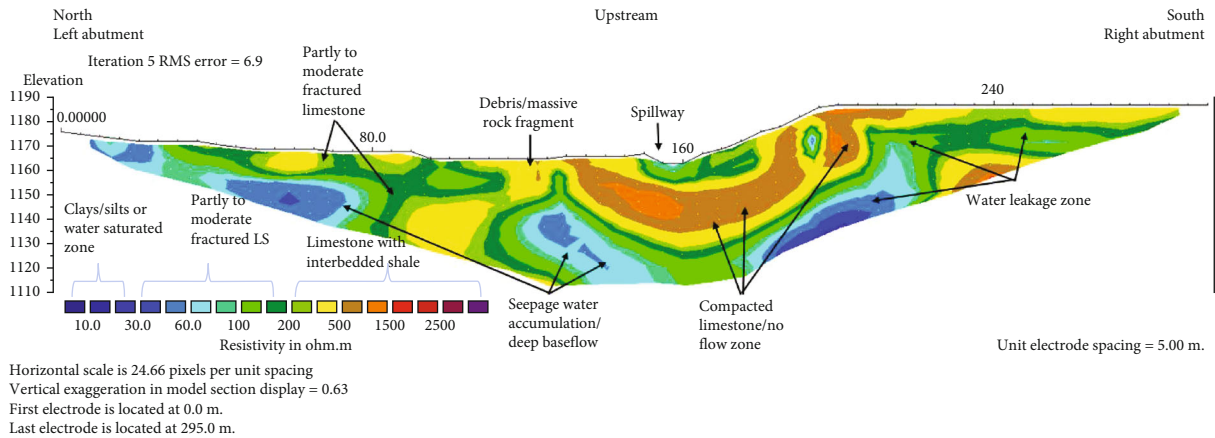
3.2.1. ERT-1 (Upstream). Figure 4 represents the inverted resistivity section of the ERT-1 profile. The profile is acquired in the upstream area having a length of 300 m. Clay, sands, and gravel, covering the shallow parts with moderate resistivity values ($200\text{-}500\ \Omega\cdot m$) of ERT-1. The alluvium appears to be irregular in thickness because of the irregularity of the eroded surface (Figure 4). The starting section of the ERT-1 profile shows low resistivity ($100\text{-}200\ \Omega\cdot m$) from the beginning to a horizontal distance of 80 m, comprising of fractured limestone, and is partly saturated (Figure 4). This decreases the overall electrical resistivity values of the upper zone [32]. The middle section of the profile (100 m to 150 m) comprises partly fractured 10 to 30 m thick bedrock ($200\text{-}500\ \Omega\cdot m$). This section is followed by a highly fractured carbonate rock (limestone) filled with dam reservoir's water seepage as indicated by low resistivity ($10\text{ to }60\ \Omega\cdot m$) (Figure 4). This low resistive zone is developed due to percolation of base flow beneath the main dam body [22, 32]. In Figure 4, the clear image of the approximately 10 m excavated zone at a distance of 160 m of the spillway is shown.

The upper portion of the end section of ERT-1 from 175 to 210 m comprises partly fractured limestone with moderate electrical resistivity values ($100\text{-}250\ \Omega\cdot m$). Nevertheless, the lower portion on the right side profile shows an anomalous zone (Figure 4) having resistive values of $<60\ \Omega\cdot m$. This anomalous feature is similar to ERT-3, which clearly indicates the linear correlation between upstream and downstream images (Figures 4 and 5). During the 2018 flash flood, seepage water was oozing on the right abutment side [29]. Hence, the correlation suggests that both the joints' sets are interconnected and cause the dam reservoir to leak [17].

FIGURE 4: ERT-1 acquired upstream of the Sarobi Dam.

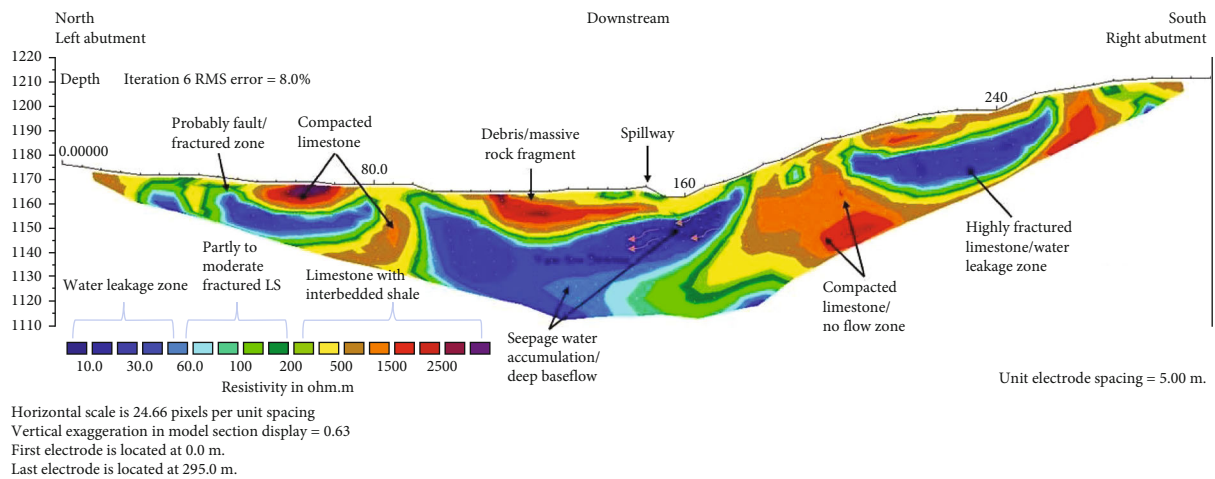
3.2.3. *ERT-3 (Downstream)*. The starting section (north) of the ERT-3 profile from the beginning to a horizontal distance of 80 m is composed of fractured limestone. It is partly saturated decreasing the overall electrical resistivity values of upper zone [22, 32, 49, 50] (Figure 5). The lower section (similar to ERT-1) is attributed to joint set at the left side of the dam abutment and facilitate in percolation of base groundwater flow passing beneath the main dam body. The middle section (100 to 150 m) comprised of partly fractured 10 to 30 m thick bedrock (10-20 Ω -m) having resistivity of 10-20 Ω -m. This section is followed by low resistivity (10-60 Ω -m) highly fractured carbonate rock filled with dam reservoir's seepage water (Figure 5). The excavated zone (10 m depth) of the spillway is clearly visible in Figure 5. The presence of very compact bedrock below spillway revealed about a barrier for any seepage.

The ending section (south) of ERT-3 profile from 175 to 210 m is composed of partly fractured limestone (500-1500 Ω -m) at the upper portion. Similar to ERT-1 and ERT-2, the lower portion (south of ERT-3) reveals an anomalous zone of low resistivity values < 60 Ω -m compared to surrounding strata that indicates a linear correlation between upstream and downstream anomalies (Figures 4 and 6).

FIGURE 5: ERT acquired downstream of the Sarobi Dam.

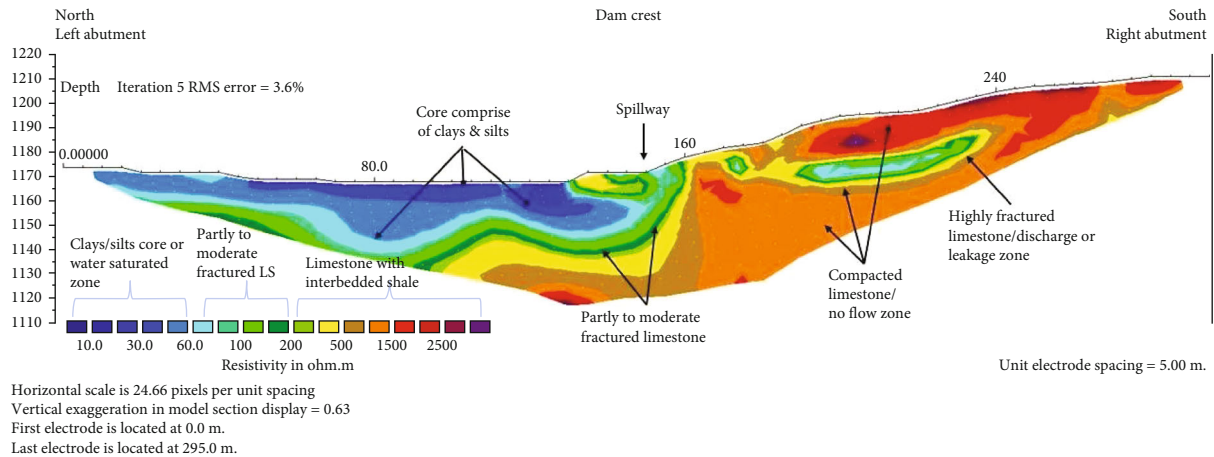
3.2.2. ERT-2 (Dam Crest). ERT-2 was acquired on the dam crest; having a spread length of 300 m. Figure 6 depicts an inverted cross-section of the ERT-2 profile. Half of the electrodes were installed on the dam crest, and the remaining was installed on the natural ground, hence resulting in an undulating topography (Figure 1). The main dam body is extending to a depth of 35 m, represented by ERT-2 profile, and is comprised of clay and silty material (Figures 3 and 6). The lower part of the core comprises coarser materials as indicated by resistivity values of $<30\text{ to } \sim 60\ \Omega\cdot m$. However, the upper part composes of mostly clayey material (Figure 6) that is often saturated as resistivity values ranges below $20\ \Omega\cdot m$ due to less permeability [14].

FIGURE 6: ERT acquired on crest of the Sarobi Dam.
