Fire-Side Corrosion: A Case Study of Failed Tubes of a Fossil Fuel Boiler

The failures of superheater and reheater boiler tubes operating in a power plant utilizing natural gas or mazut as a fuel have been analysed and the fire-side corrosion has been suggested as the main reason for the failure in boiler tubes. The tubes have been provided by a fossil fuel power plant in Iran and optical and electron microscopy investigations have been performed on the tubes as well as the corrosion products on their surfaces. The results showed that the thickness of the failed tubes is not uniform which suggests that fire-side corrosion has happened on the tubes. Fire-side corrosion is caused by the reaction of combustion products with oxide layers on the tube surface resulting in metal loss and consequently tubes fracture. However, the tubes corrosion behaviour did not follow the conventional models of the fire-side corrosion. Given that, using the corrosion monitoring techniques for these boiler tubes seems essential. As a result, the thickness of the boiler tubes in different parts of the boiler has been recorded and critical points are selected accordingly. Such critical points are selected

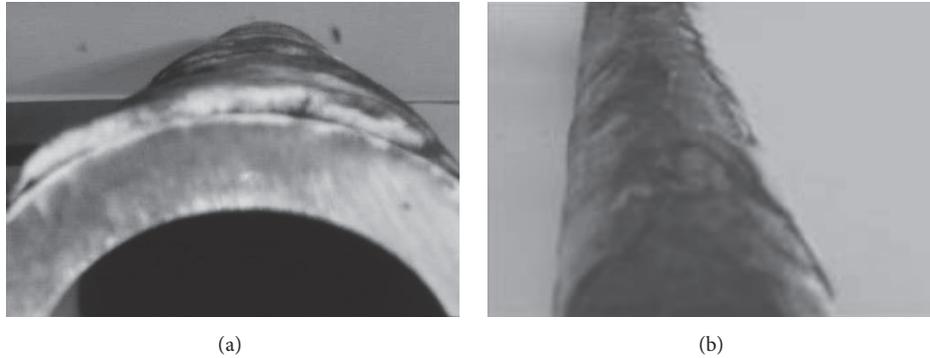
FIGURE 1: (a) Cross section of a boiler tube with deposits on the surface and (b) surface of a boiler tube after two years in the service condition.

Figure 1 depicts a superheater tube with the corrosion products and deposits on its surface. The surface of the tube which was exposed to fire is covered by a layer of thick, coarse, and adhesive deposit. Its yellow colour suggests the presence of sulphur in the layer.

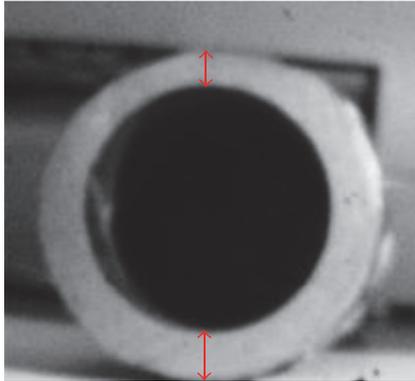
The thickness measurements indicate that thickness in failed tubes is dramatically decreased to values lower than the critical value for boiler tubes. According to Figure 2, this phenomenon is more apparent in the fire side of tubes.

FIGURE 2: Cross section of a failed boiler tube. Metal loss in fire side of the tube is clear.

However, Figure 2 shows a different behaviour from the aforementioned model and the most material loss was observed in the fire-side part. It means that the area is experiencing the highest level of corrosion and cannot be a cathode. Some tubes in this study were not following the normal fire-side corrosion mechanism and behave differently. It can be because of the low thickness of deposit layer and locally high temperature (800°C) of the material surface which is leading to uniformly melting the whole deposits on the fire side of tubes. As there is no comprehensive corrosion model to predict high-temperature corrosion of all tubes, thickness measurements and corrosion monitoring of boiler tubes seem necessary since the proposed mechanisms are not able to predict the metals corrosion in harsh condition. The present corrosion models are taking the temperature of system, metallurgical parameters, and to some extent the composition of fuel to the account, while system aerodynamic parameters and the temperature of metal surfaces are not considered.

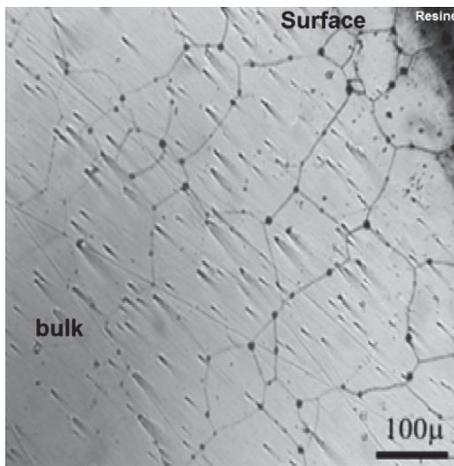
Figures 3–6 demonstrate the microstructures of boiler failed superheater and reheater tubes. Based on Figure 3, the structure of superheater in the surface vicinity is slightly different from the bulk material, with more spherical carbide in grain boundaries compared to the ferritic microstructure of the bulk material. Such difference in microstructure has previously been reported in the literature [6]. In Figure 4 a porous and nonuniform deposit layer on the tube is shown.

FIGURE 3: Optical microscopy image of superheater microstructure.

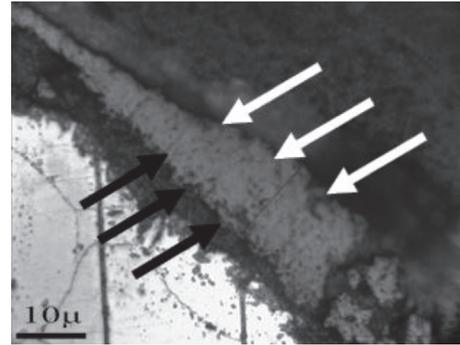
FIGURE 4: Optical microscopy image of corrosion products on the surfaces of superheater tubes.

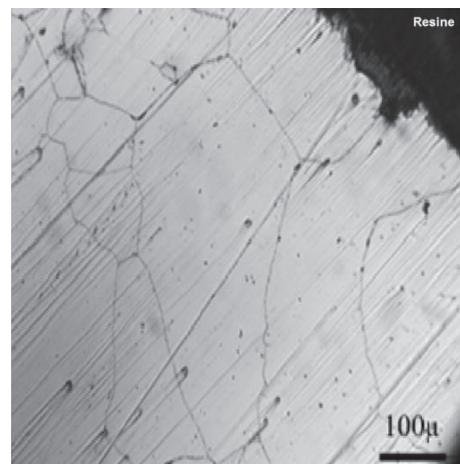
The microstructure of reheater tube is the same as the superheater; however, the deposit layers on the reheaters are uniform, suggesting a general corrosion on the reheater tube surfaces (see Figures 5 and 6).

FIGURE 5: Optical microscopy image of reheater microstructure.

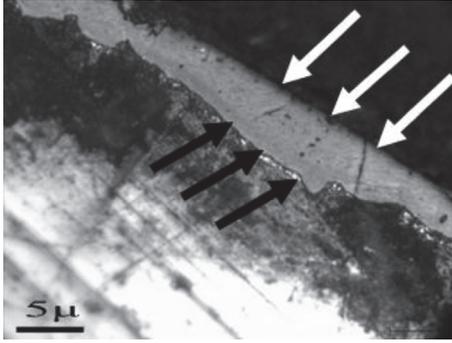
FIGURE 6: Optical microscopy image of corrosion products on the surfaces of reheater tubes.

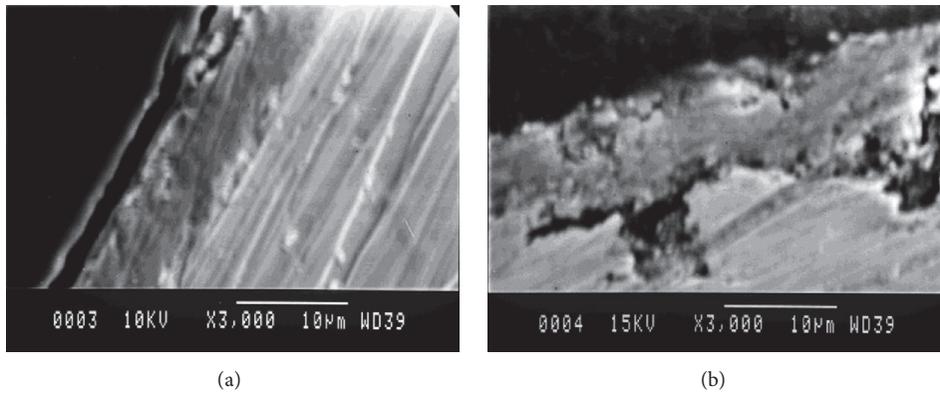
The morphology of deposit layers on the external surface of the reheater and superheater has further been studied by SEM and the images are shown in Figure 7.

FIGURE 7: SEM images of corrosion products and deposit on the surface of (a) reheater and (b) superheater tubes.

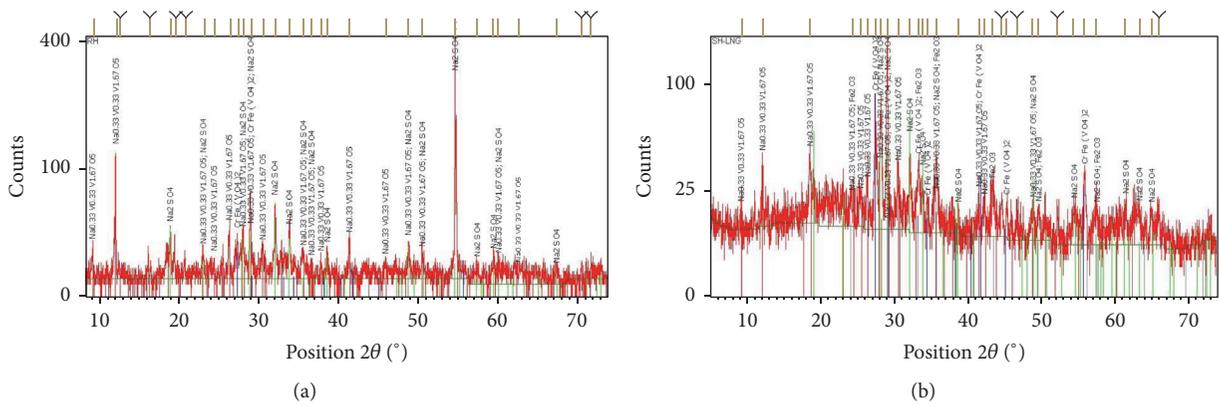
superheater tubes which are exposed to higher temperatures and also more fuel impurities, particularly alkali metal chlorides. The chemical composition and structure of corrosion products were investigated with XRD (Figure 8) and the results were summarized in Table 2 in which Na_2SO_4 and $\text{CrFe}(\text{VO}_4)_2$ are the major components. These results are consistent with Energy-Dispersive X-ray Spectroscopy (EDS) data which showed Fe, Cr, V, Na, O, and S in corrosion products.

FIGURE 8: XRD patterns of corrosion products and deposits on the surface of (a) reheater and (b) superheater tubes.

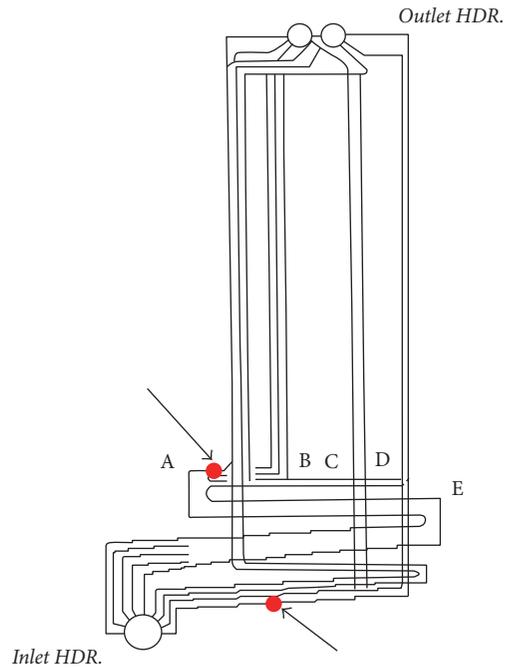
Figure 13, the tube thickness of the fire side in some areas (position 2) is less than critical thickness value. Critical thickness is a minimum required thickness of tubes to service with no damage and failure risk in the boiler temperature and pressure. These areas are shown with red points in Figure 12.

FIGURE 12: Schematic of the platen superheater with determined critical points.

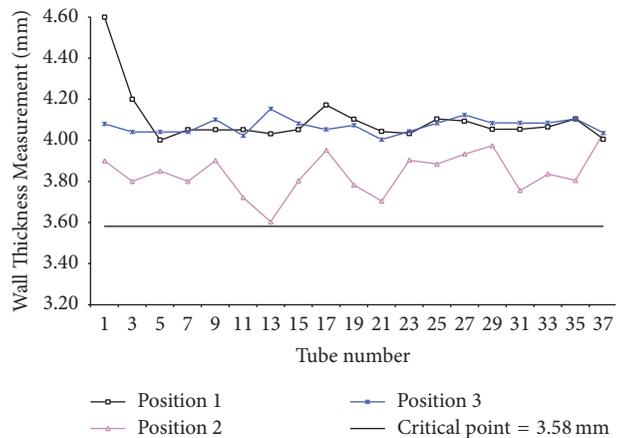
In this part, thickness measurement results are discussed. The measurement has been carried out in platen superheater, final superheater, medium reheater, and final reheater tubes of the boiler where they are prone to the high rate of damage and failure according to the power plant engineers and technical personnel. All measurements have been done three times at three different positions of the tube. Figure 12 shows the drawing of platen superheater. The nominal thickness of tubes in this part of the boiler is 4 mm and, as can be seen in

FIGURE 13: Thickness measurements of the platen superheater at zone A.

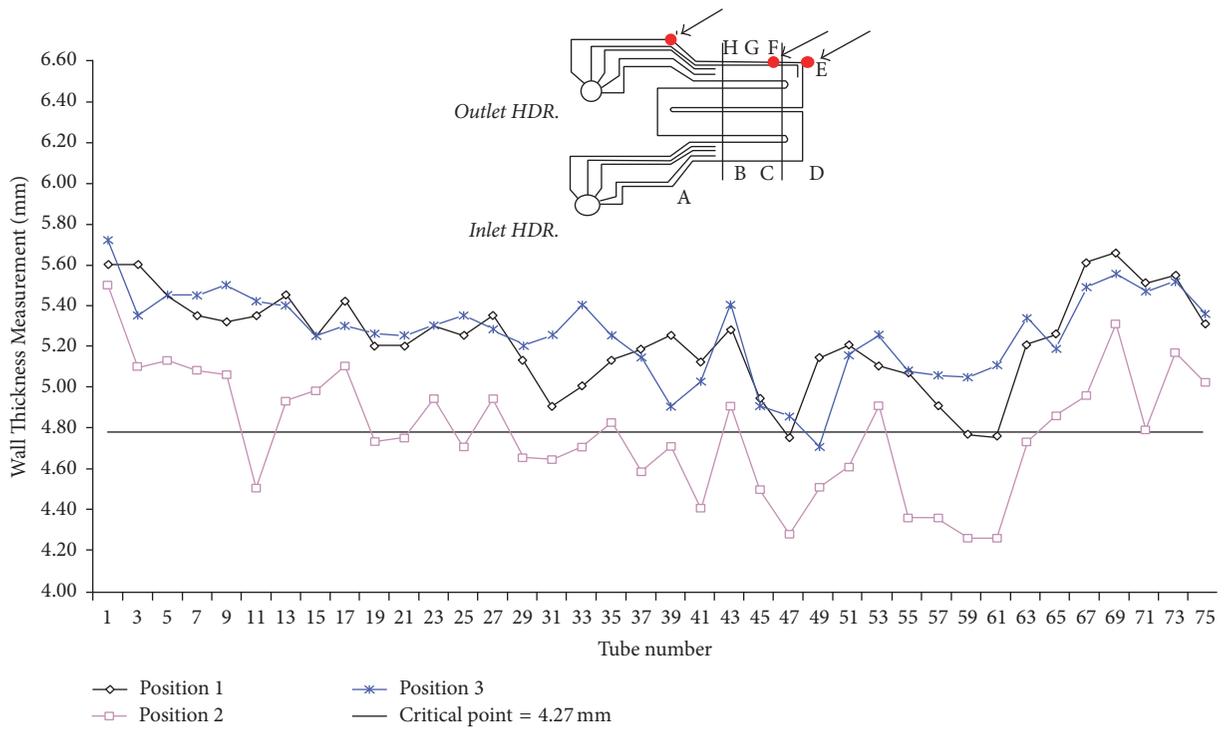
Similarly, some areas with a thickness lower than the critical thickness in final superheater with a nominal thickness of 5.3 mm were determined (Figure 14).

FIGURE 14: Schematic of the final superheater with determined critical points and thickness values of the tubes in zone E.

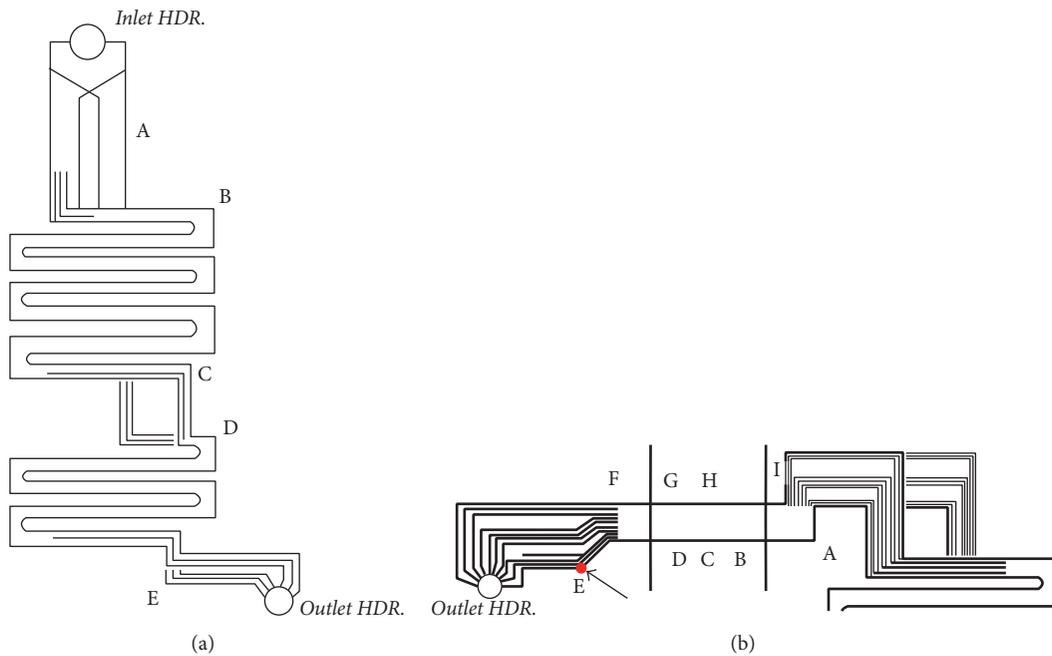
The nominal thickness in medium and final reheater tubes was 3.5 and 3.4 mm, respectively. The reheaters schematics with the critical points are indicated in Figure 15.

FIGURE 15: Schematic of (a) medium reheat and (b) final reheat with determined critical points.
