Research Article

Corrosion of Reinforced Concrete Structures Submerged by the 2004 Tsunami in West Aceh, Indonesia

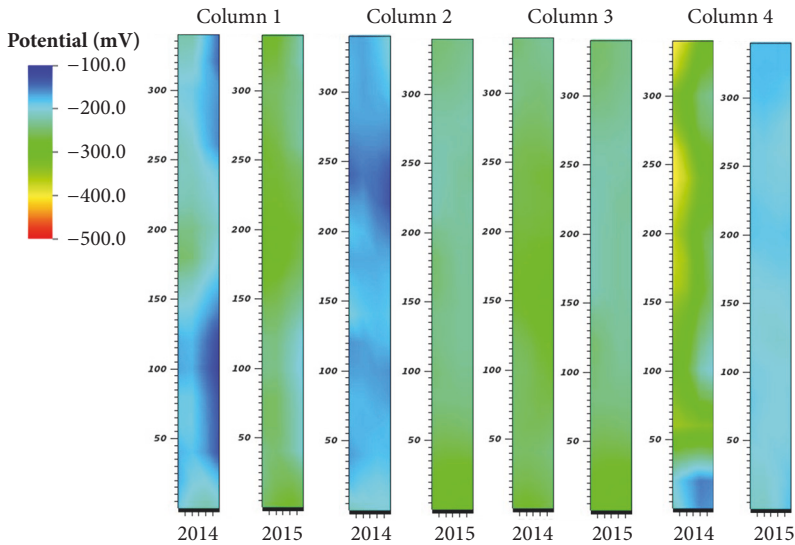
Figure 10 shows the corrosion risk assessment results for Object I in Suak Ribee submerged by the 2004 tsunami. The potential distributions on four columns were presented in the figure. The potential distribution of year 2014 for column 1, column 2, column 3, and column 4 ranged between (-100) and (-350) mV, < -200 mV, (-200) and (-350) mV, and (-100) and (-450) mV, respectively, while those potential distributions of the columns ranged between (-200) and (-350) mV, (-200) and (-350) mV, (-200) and (-350) mV, and (-200) and (-350) mV, respectively, of year 2015.

Referring to Table 1, the distribution of the potentials on the columns indicated that the corrosion risk level varied from low to high-risk level. Some parts of column 1 (especially lower part), column 2, and lower part column 4 were categorized into low corrosion risk level for the year 2014. In 2015, the corrosion risk level for those parts became intermediate risk level. The corrosion risk level for column 3 was intermediate risk level in 2014 and remained at this level in 2015. The high-risk level occurs in column 4. However, it became intermediate risk level in 2015. It might happen due to repassivation on the rebar. However, further study is needed.

FIGURE 10: The potential distribution on each column of Object I for 2014 and 2015.

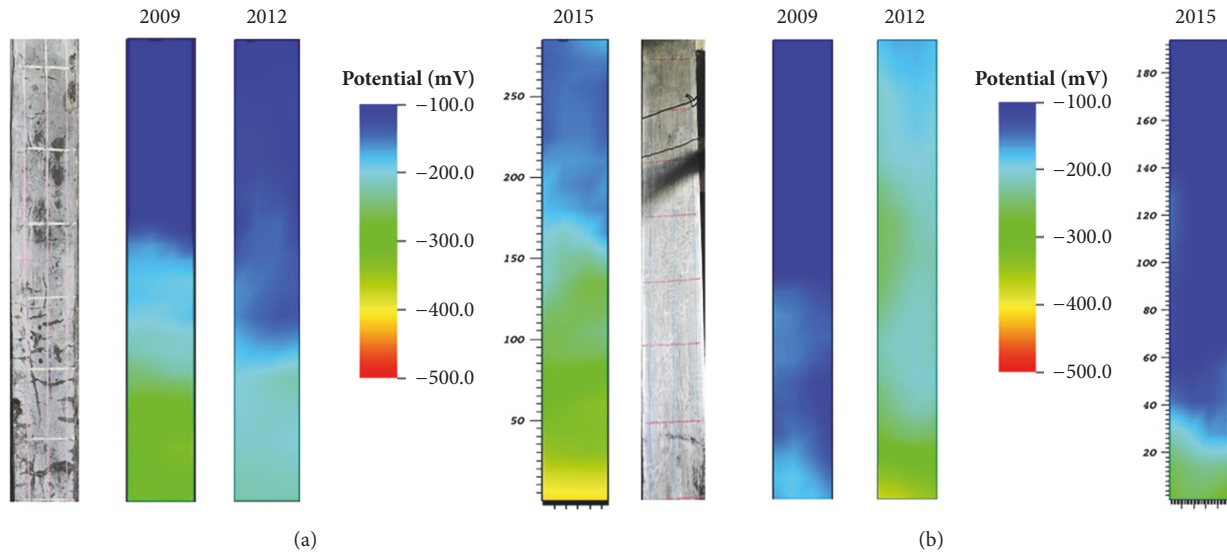
The increasing of corrosion risk level of the columns was consistent with the previous study conducting the half-cell potential mapping in Banda Aceh city, Indonesia [6] as seen in Figure 11(a). The indication of repassivation also occurred in the previous study that was shown in Figure 11(b) [6]. However, the corrosion risk generally tends to become higher by increasing the time for all columns in this study and also in the previous study [6].

FIGURE 11: The potential distribution on the column for the previous study in Banda Aceh city, Indonesia: (a) indicating an increase of corrosion risk and (b) indicating repassivation [6].

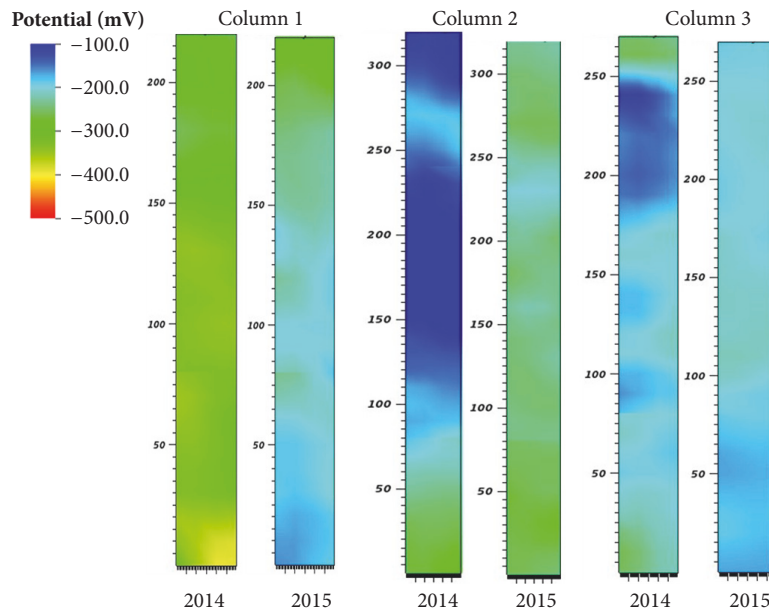
FIGURE 12: The potential distribution on each column of Object II for 2014 and 2015.

Seurahet. In 2014, the potential distribution for column 1, column 2, and column 3 ranged between (-200) and (-450) mV, (-100) and (-350) mV, and (-100) and (-350) mV, respectively. Thus, those potential distributions became in range between (-200) and (-350) mV, (-200) and (-350) mV, and (-200) and (-350) mV, respectively for 2015.

Using the criteria in Table 1, the potential on the columns of Object II was categorized into low to high corrosion risk level. Almost all of column 1 had completely fallen into intermediate corrosion risk, but the lower part was already at high corrosion risk level in 2014. However, the data in 2015 show that the potential value became less negative but is still into intermediate corrosion risk level. The corrosion risk level

for columns 2 and 3 falls into low and intermediate risk level in 2014. Thus, it completely became intermediate corrosion risk in 2015.

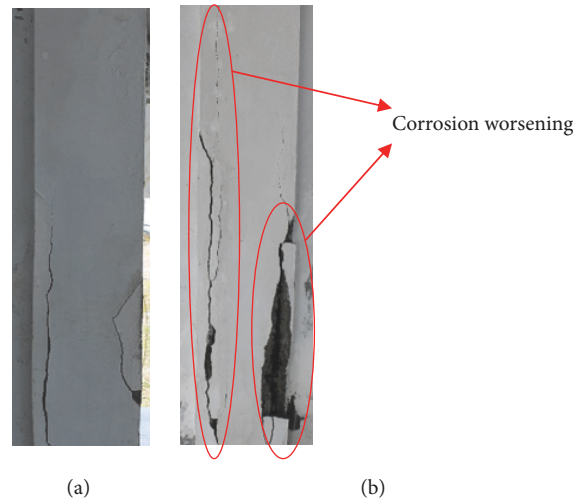
The phenomenon that the corrosion worsened by increasing time can be confirmed by looking at Figure 13. The figure shows the visual of a column condition of the year 2014 and 2015. Initially, there were cracks on the column in 2014, and the cracks became bigger and longer in 2015. Furthermore, the corroded rebar was also revealed in 2015. It occurred because the corrosion product will push the concrete cover with the load over the strength of concrete and so the crack might be initiated [10]. Finally, by increasing time, the concrete cover might collapse completely.

FIGURE 13: The visual of a column of Object II for (a) 2014 and (b) 2015.

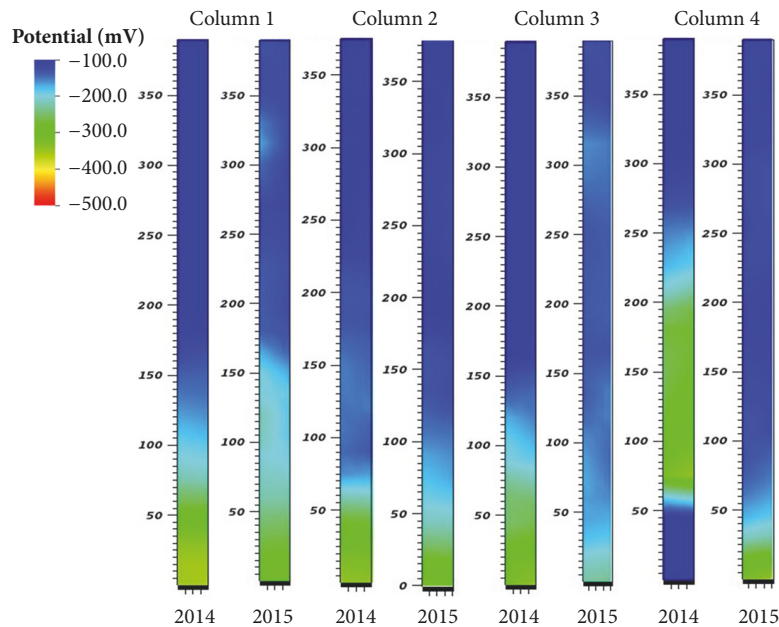
FIGURE 14: The potential distribution on each column of Object III for 2014 and 2015.

Moreover, the potential distribution for one of the infrastructures built in the tsunami-affected area (Object III) was shown in Figure 14. As mention before, this building is located in Suak Ribee. In 2014, the potential distribution for column 1, column 2, column 3, and column 4 was the same, i.e., ranging between (-100) and (-350) mV. Thus, it was found that those potential distribution values remain the same in 2015, i.e., (-100) and (-350) mV. However, there was difference in the potential distribution pattern comparing the 2014 data with the 2015 data.

The potential values on the columns of Object III might be categorized into low to intermediate corrosion risk level by referring to the criteria in Table 1. The majority of the columns lower part had completely fallen into intermediate

corrosion risk but the upper parts were at low corrosion risk level in 2014. However, it was found that an area on the lower part of column 4 is still in low-risk level. The data in 2015 show that the potential values for all columns tend the same. The corrosion risk level for all columns lower part falls into intermediate risk level and the upper parts are still at low-risk level. Thus, the lower parts of columns seem more susceptible to corrosion. This might be due to the capillarity of concrete that the lower part could obtain more water from the soil and/or rainwater than others part of the column. Hence, the possibility of corrosion to initiate becomes higher.

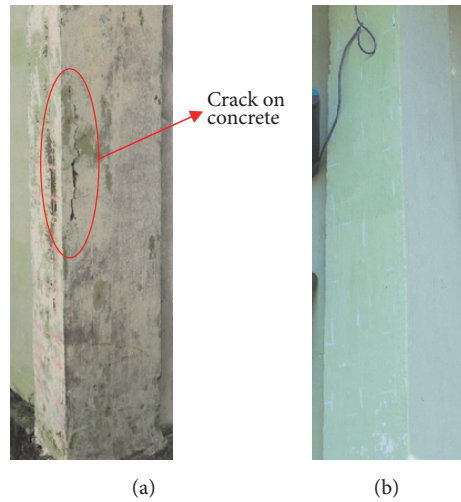
Furthermore, by conducting a visual inspection, it was found that there was a difference on the condition between the column directly facing the sea and the column facing the

FIGURE 15: The visual of a column of Object III for (a) directly facing to the sea and (b) facing to the opposite of sea.

opposite direction of the sea as seen in Figure 15. The figure shows that the column facing the sea already has a crack on it. The crack was an indication that the corrosion actively occurs [10] below the concrete surface at the region. This condition might happen due to the ion chloride more accumulated on the concrete. The ion chloride could be carried by the wind from the sea [11]. It was consistent with the previous research that the ion chloride content in the rainwater around the coastal area was relatively high (24 ppm) [12].

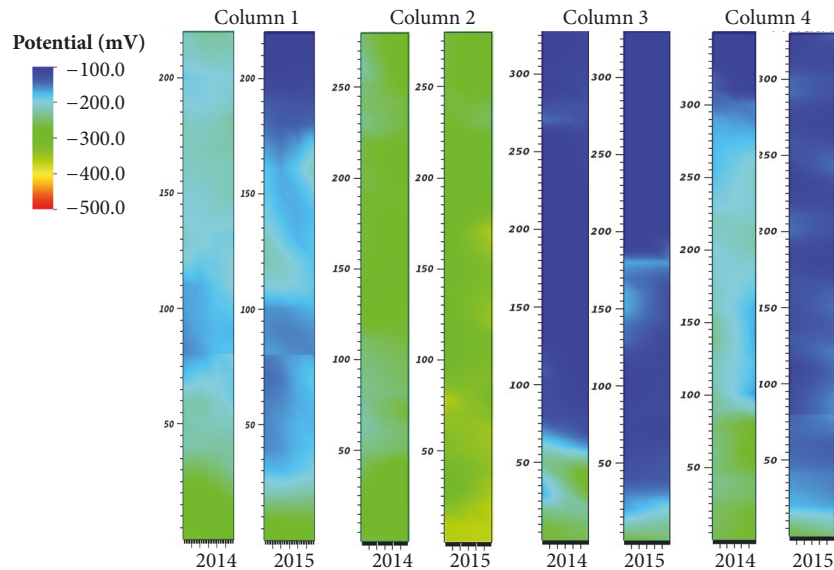
FIGURE 16: The potential distribution on each column of Object IV for 2014 and 2015.

The potential distribution for the last infrastructures was shown in Figure 16. This building was built in the tsunami-affected area (Object IV) and located in Ujong Kalak. In 2014, the potential distribution for column 1, column 2, column 3, and column 4 ranged between (-200) and (-350) mV, (-200) and (-450) mV, (-100) and (-350) mV, and (-100) and (-350) mV, respectively. Thus, it was found that those potential distribution values for column 1 tend to become more positive

in 2015, i.e., (-100) and (-350) mV. The potential on column 2 became more negative in 2015, i.e., (-300) and (-450) mV. Lastly, the potential values for column 3 and column 4 tend to be more positive but remain in the same range in 2015, i.e., (-100) and (-350) mV.

Based on the criteria in Table 1, the corrosion risk level for the columns could be determined. The corrosion risk level for column 1 and column 2 was already at intermediate risk in 2014. In 2015, the risk level tends to become higher for column 2. The below part was at a high-risk level. This condition was suspected because of the position of column 2 directly facing the sea and, thus, it might be more exposed to ion chloride from the sea. However, the upper part of column 1 became low-risk level in 2015, while the corrosion risk level for column 3 and column 4 was relatively the same at intermediate risk for 2014 and 2015.

By comparing the assessment results of the 2014 and 2015 data, a tendency of increasing the negativity of corrosion potential values is shown. This means that the corrosion actively occurred on the reinforcing steels. Furthermore, this shows that the new structures built in the tsunami-affected area would be susceptible to corrosion attack indicated by its intermediate corrosion risk level. These results were consistent with assessment results conducted around Banda Aceh city [6]. Therefore, it is important to take action to stop the corrosion, so the sudden failure of the structures could be prevented.
