# Detection of Degradation Effects in Field-Aged c-Si Solar Cells through IR Thermography and Digital Image Processing

**E. Kaplani**

*Mechanical Engineering Department, T.E.I. of Patras, Megalou Alexandrou 1, 26334 Patra, Greece*

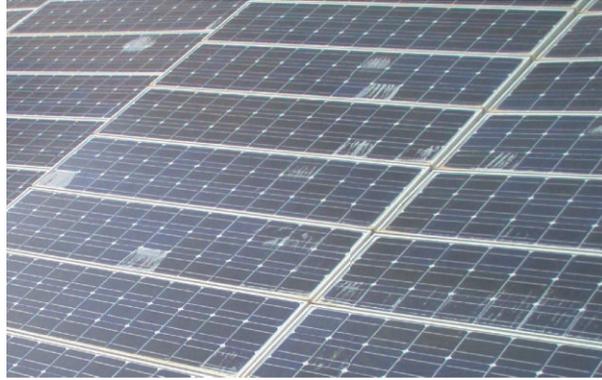
Several SIEMENS M55 PV panels operating for 18 years in the T.E.I. of Patras, Greece, were visually examined for signs of optical degradation. The panels have been exposed to the rather hot and dry Greek climate, and about 10 years ago lumps of mortar were incidentally shed on the PV array and covered several cells for a prolonged period of several months (see Figure 1).

FIGURE 1: SIEMENS M55 PV generator subjected to lumps of mortar during the past.

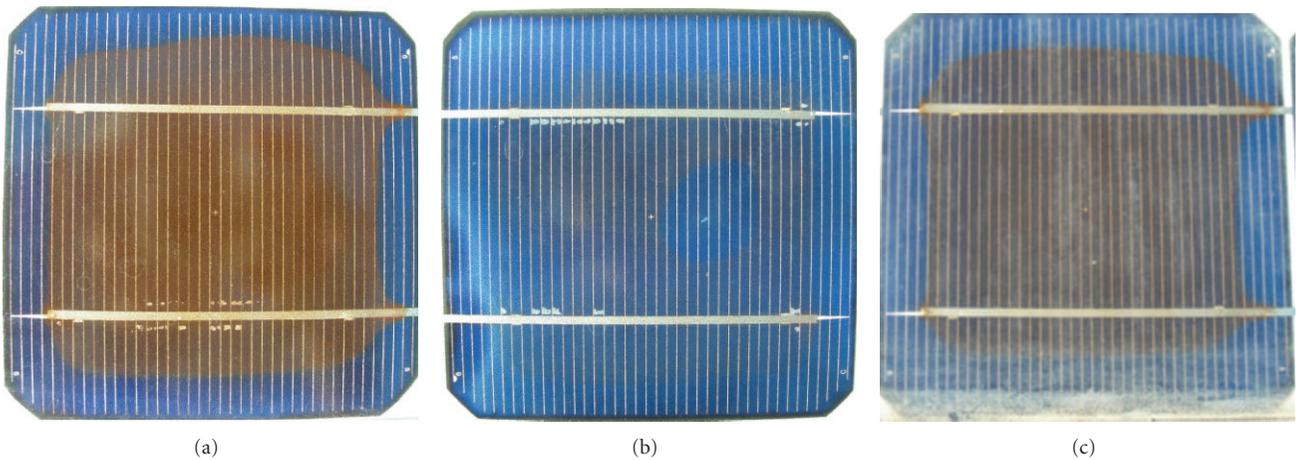
Although EVA discoloration in panels is known to be heterogeneous, the fact that some cells exhibit a significantly higher degree of browning is highly considered to be because of the shading effect caused by the layer of mortar. This induced shading effect caused the cells covered by this layer of mortar to operate under reverse bias mode, developing higher temperatures within the cell due to Joule effect. These modules exhibit now different types of degradation effects and to a different degree. These include browning due to EVA discoloration, corrosion of contacts and fingers, delamination, and humidity ingress, see Figure 2.

FIGURE 2: Various degradation effects observed in 18-year-old SIEMENS M55 PV cells.

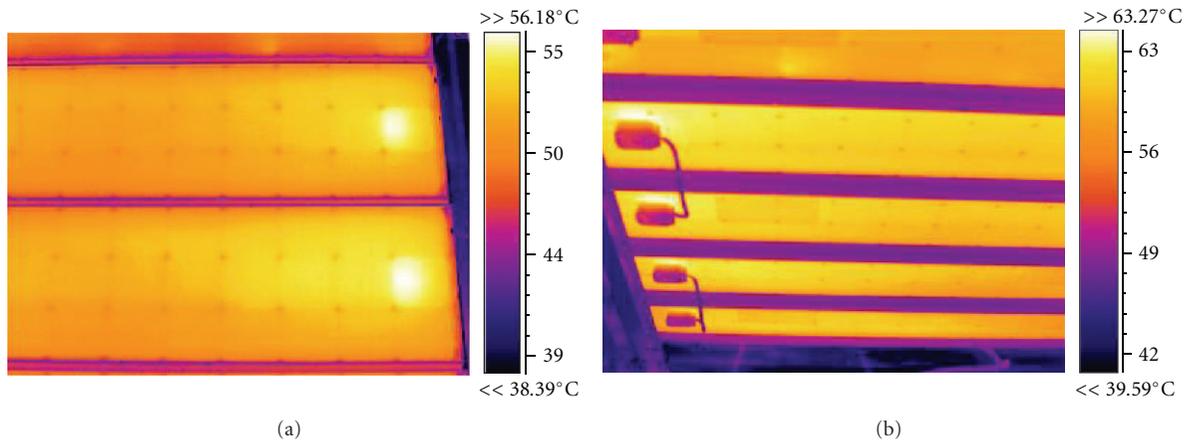
IR thermography shows the temperature distribution on the PV surface. When taken from a distance only large temperature variations can be observed. Figure 3 shows the front and back of two PV modules. A hot spot area with an increased temperature of about  $7^{\circ}\text{C}$  compared to the temperature of the rest of the module is shown at the cell where the bypass diode box lies. The IR image of the back of the modules shows an even higher temperature at the sealant of the junction box. This temperature increase at the cell where the junction box lies causes a difference in voltage  $\delta V_{oc}$ , resulting in mismatch between the cells equivalent to partial shadowing effects and leads to a  $\delta P_m$  reduction in the power output. As this effect is constant, the cell operating under increased temperature will eventually experience a slow physical degradation leading to permanently reduced power output.

Furthermore, cell temperatures measured at the back of the panel are observed to be higher by about  $7\text{--}10^{\circ}\text{C}$  from temperatures measured at the front. This is due to the increase of the thermal resistance added by the tedlar insulation at the back of the module. Based on the heat conduction law, the temperature at the back due to higher

FIGURE 3: IR image of PV modules showing hot area at the junction box, (a) at the front of the panels, and (b) at the back of the panels.

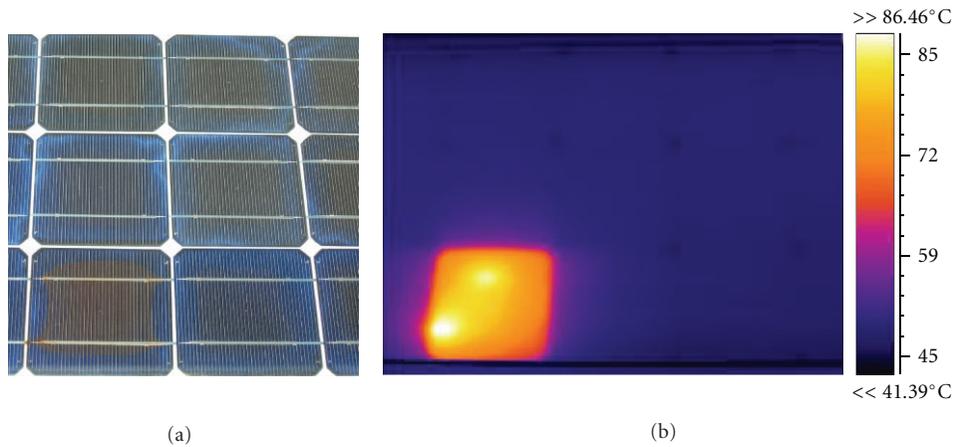
**4.2. Browning and Bus Bar Degradation Effects.** The IR images of cells exhibiting different degree of browning were captured for the determination of any temperature degradation effects. Figures 4(a) and 4(b) show the digital image and the IR image of a c-Si cell neighborhood from a SIEMENS M55 panel, whereby the bottom corner cell with severe EVA discoloration is shown in the IR image to display an average temperature increase by about  $25^{\circ}\text{C}$  compared to the temperature of the nearby cells exhibiting browning to a lesser degree. Furthermore, the IR image reveals the existence of two hot spots reaching  $86^{\circ}\text{C}$ , a relative increase by more than  $35^{\circ}\text{C}$  with respect to the temperature of the nearby cells. Due to the overall conductance of the PV module front cover, heat propagates around the hot spots, while the tedlar insulation at the back of the panel having low conductivity discloses the hot spots more clearly. The IR image at the back side tedlar surface of the cell reveals that these two hot spots are located on the bus bars of the cell, see Figure 5(b). The larger one appears at the soldering bond where the contact is corroded (see Figure 4(a)). The temperature of these hot spots at the back side of the cell reaches  $96^{\circ}\text{C}$ ,

FIGURE 4: (a) Digital and (b) IR image, of browned cell and neighboring cells. IR image reveals two hot spots at the severely browned cell.

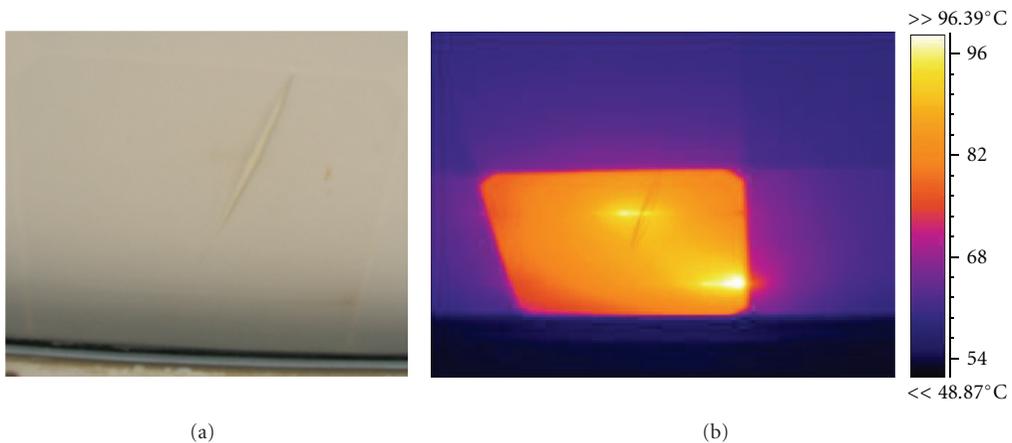
FIGURE 5: (a) Digital and (b) IR image, of the back of the severely browned cell of Figure 4. IR images reveals the two hot spots are located on the two bus bars. The tear of the tedlar sheet also appears in the IR image.

Figure 5(a) also shows a tear in the tedlar sheet, which also appears in the IR image crossing through the bus bar at the hot spot and displaying slightly lower temperature at the edges of the tear (see Figure 5(b)). The temperature data extracted from the back side of the cell of Figure 5(b) were also analysed in MATLAB. The data were filtered with a 3 × 3 median filter. The 3D temperature plot is shown in Figure 6. The two hot spots appear clearly and the small temperature decrease at the place of the tear is now obvious. A temperature pattern appears, due to heat propagation, between the two hot spots which replicates the exact temperature pattern observed at the front side of the cell.

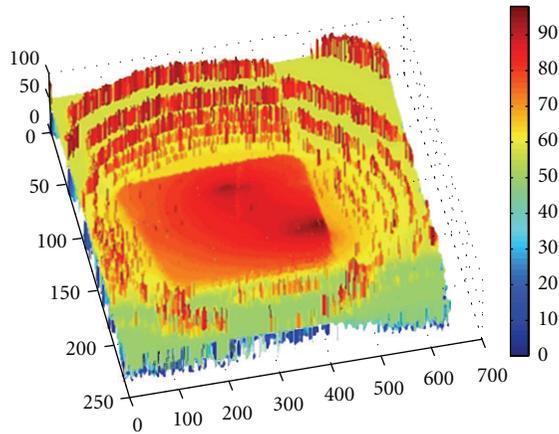
FIGURE 6: 3D temperature plot of IR data extracted from the back of the cell of Figure 5(b).

which is detrimental to the operational lifetime of the cell. At the time of the experiment, the ambient temperature was 32.2°C, the wind speed was 2.2 m/sec, and the global solar radiation at horizontal was 607.1 W/m<sup>2</sup>. During summer higher temperatures have been recorded, with the hot spot reaching temperatures above 100°C.

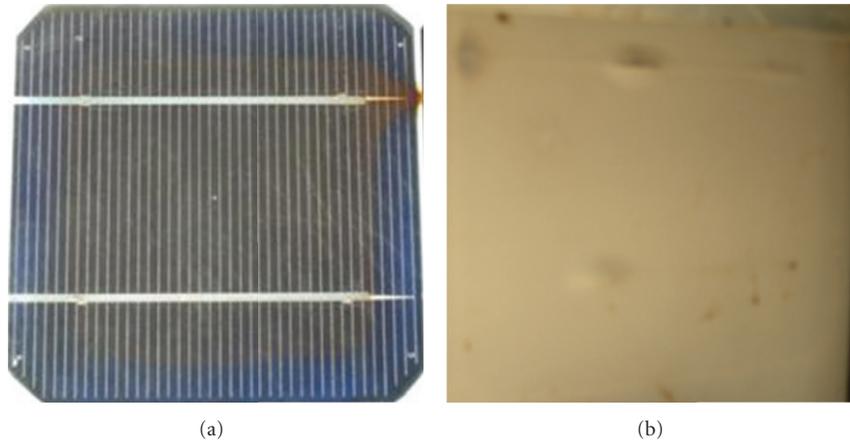
**4.3. Blister Effects.** Another SIEMENS M55 c-Si cell exhibiting severe browning discoloration, particularly evident at the bus bar contacts and solder bond, is displayed in Figure 7(a). The image of the back of the cell (Figure 7(b)) exhibits a large blister at the bottom bus bar and a smaller blister at the top bus bar. The browning at the bus bar and solder bond is also visible at the back of the cell. The IR image at the front and back side of the cell are displayed in Figures 8(a) and 8(b), respectively. The ambient temperature recorded was 36.5°C, the wind speed was 1.7 m/sec, and the global solar radiation at horizontal was 717.1 W/m<sup>2</sup>.

FIGURE 7: Digital image (a) front and (b) back, of a SIEMENS M55 c-Si cell exhibiting browning, degradation at bus bars and solder bond, and the appearance of blisters at the back sheet tedlar cover.

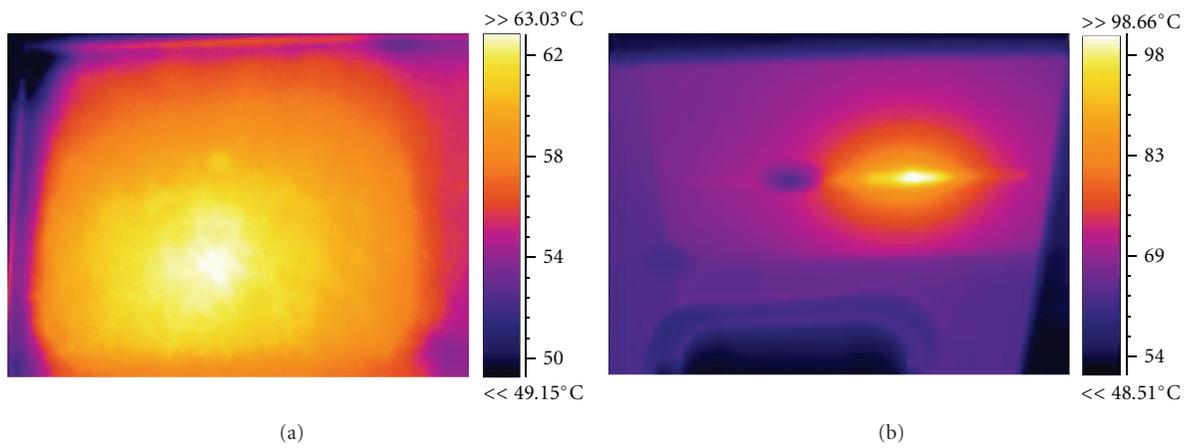
A large hot spot area is visible in the front IR image, while the IR image at the back displays more information. A hot spot appears on the bus bar with its temperature reaching nearly 99°C, extremely detrimental for the operational health of the cell, which is higher by about 30°C from the remaining part of the cell. An extended part of the bus bar around the hot spot appears with also an increased temperature by 15–25°C compared to the temperature of the remaining part of the cell. An effect of this extreme temperature of the bus bar

is a blister which has formed at the tedlar backsheet cover located on the bus bar at the edges of this hot area. The blister exhibits lower temperature 63°C, about 6–7°C below the temperature of the remaining part of the cell.

FIGURE 8: IR image (a) front and (b) back, of the cell displayed in Figure 7, exhibiting a large hot spot area at the front and increased temperature on the bus bar and blister at the back.

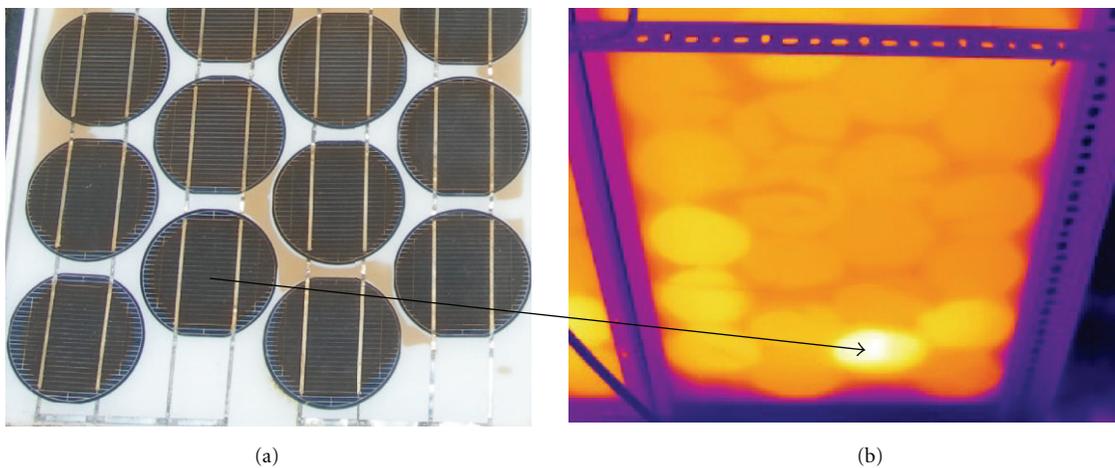
**4.4. Natural Discoloration, Hot Spots and Hot Areas.** A 22-year-old c-Si BP B 1233 PV module examined revealed natural EVA discoloration on all of its cells covering about 90% of the cell area. The EVA discoloration appears not only on the surface of the cell but also on the street surface between the cells. The digital image of the lower part of the panel is displayed in Figure 9(a). The IR image of the back of the panel reveals one of the cells to exhibit higher temperature than the others (see Figure 9(b)).

FIGURE 9: (a) Digital image of the lower part of a BP B 1233 c-Si PV panel; (b) IR image of the back of the panel revealing a hot cell in reverse order as illustrated by the arrow.

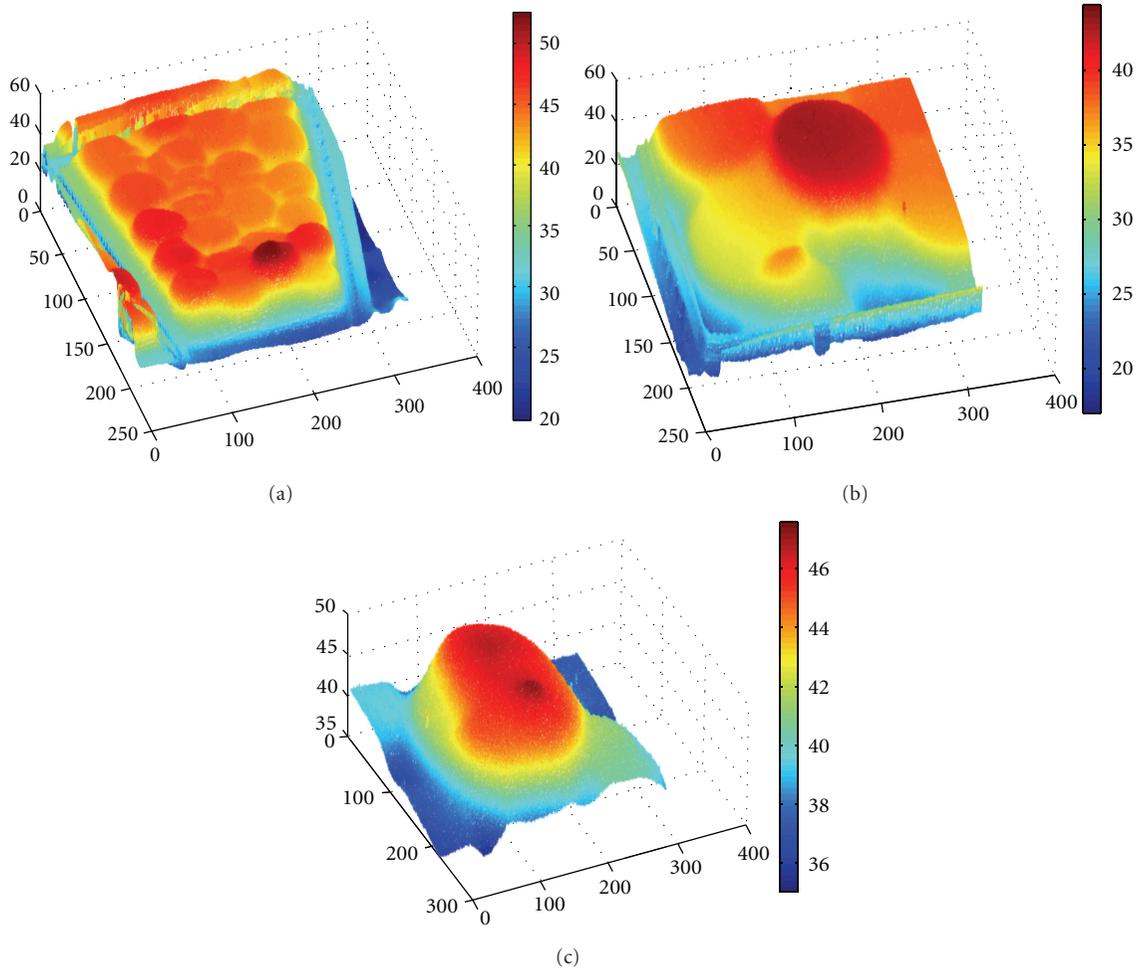
The temperature data extracted from the back of the panel were further analysed in MATLAB, and the 3D temperature plot is displayed in Figure 10(a). A temperature pattern with a hot area reaching 53°C appears on the cell indicated by the arrow. Temperature data extracted from the IR images capturing this cell from the front glass side are plotted in Figure 10(b) together with neighbouring cells and in Figure 10(c) the temperature pattern of this cell alone. The temperature data of the cell neighborhood identify the defected cell having about 10°C higher temperature than the nearby cells. The temperature distribution of the defected cell alone (Figure 10(c)) reveals the existence of a large hot spot and hot area in the middle of the cell area. The highest temperature at the hot spot was 47°C due to the low irradiation 550 W/m<sup>2</sup> at the time of the experiment, while ambient temperature was 17°C. The relative temperature differences compared to the remaining part of the cell can be observed.

FIGURE 10: 3D temperature plot of defected cell and neighboring cells as seen in clockwise order (a) from the back of the panel (in reverse order), (b) the front side lower corner of the panel, and (c) the temperature plot of the defected cell alone revealing a hot spot and hot area.

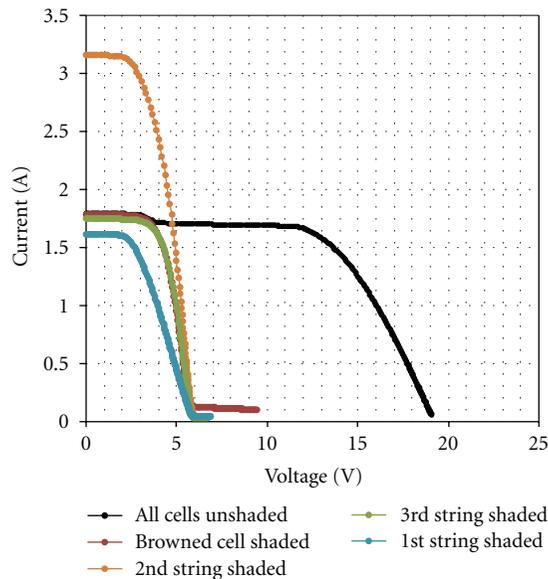
FIGURE 11: *I-V* curves obtained from the aged SIEMENS M55 PV module under the various configurations.

The  $I$ - $V$  curve of the PV module in Figure 11, when all cells are unshaded, displays a step-wise decrease, which reveals the existence of deteriorated cell(s). The decreased slope at  $V_{oc}$  proves the existence of a high parasitic series resistance  $R_s$ . On the other hand, the small slope at  $I_{sc}$  indicates high  $R_{sh}$  and therefore a small parasitic shunt resistance. Parasitic shunt resistances arise from high conductivity paths (shunts) in or at the edges of the cell [8], while series resistances arise from contact resistance, bus bar resistance, and fingers [14]. Thus, the  $I$ - $V$  curve of the PV module shows that the deterioration in PV performance is mainly due to high resistance at the cell bus bars and contacts.

Due to the connection of the diodes earlier explained, when the first string was entirely shaded, the PV module operated through the cells of the third string. The  $I$ - $V$  curve obtained under this configuration (see Figure 11) displays an increased  $R_s$  illustrated by the decreased slope at  $V_{oc}$ . This indicates the existence of a high parasitic resistance in the third string. On the other hand, for the configurations whereby the browned cell was shaded or the third string was entirely shaded, which means that the PV module operated through the cells of the first string, the  $I_{sc}$  remains as high as the initial  $I$ - $V$  of the module and the slope at  $V_{oc}$  is now steep indicating a significantly smaller series resistance. Thus, the location of the increased parasitic series resistance is the browned cell located in the third string, as identified by the thermography, which detected in this severely browned cell an increased bus bar resistance due to the high temperature observed at the hot spots located on both bus bars (see Figures 4 and 5).

An indication of the overall PV module performance degradation may be shown through the reduced  $P_m = 47.7$  W and  $FF = 61.7\%$  when converted to standard test conditions (STC). The reduction of  $P_m$  from the nominal 53 W value,  $\delta P_m/P_m$ , is 10%. It should be noted that a small deviation in the measured power losses may be observed due to spectral variations and sky conditions. While the reduction is obvious and significant, considering the 18 years of field operation of the PV panel, the technology used at the time of production, the optical and electrical degradation which it exhibits, it may be said that the degradation is smaller than expected.

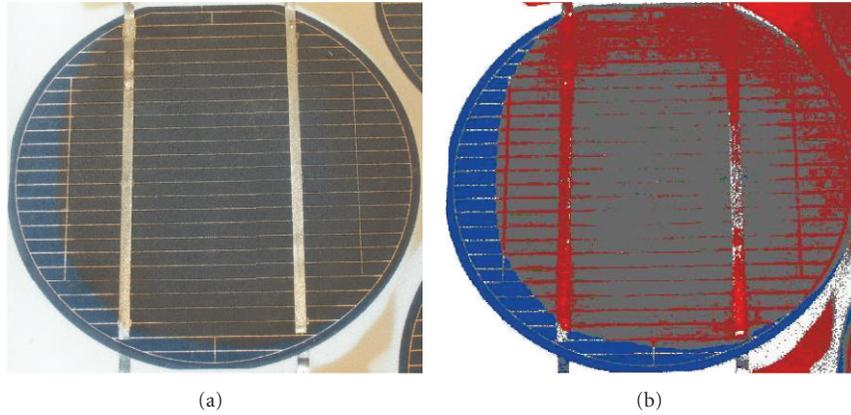
FIGURE 12: (a) Original digital image of a c-Si BP B1233 cell, (b) respective pseudocolor image provided by the proposed segmentation algorithm.

Figures 12(a) and 12(b) show, respectively, the original digital image of an aged c-Si cell from the BP B 1233 PV module, and the pseudocolor image produced by the segmentation algorithm. It may be observed in the pseudocolor image that the undamaged part of the cell has been accurately detected, and the nonbrowned part of the street surface around the cell. Furthermore, the browning has been accurately detected on all affected areas, which is shown in red and dark red color in the pseudocolor image. Also, areas exhibiting different severity of browning appear in grey color in the pseudocolor image. The browning which appears on the bus bars and fingers has also been accurately detected. Figure 13(b) displays the resulting pseudocolor

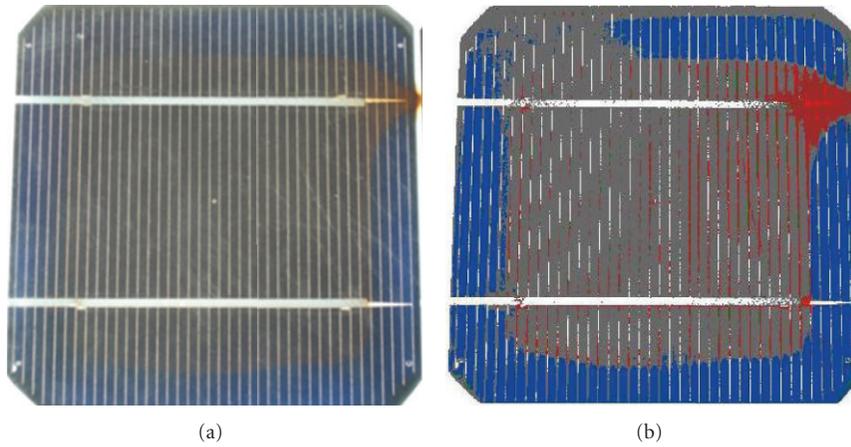
FIGURE 13: (a) Original digital image of a c-Si SIEMENS M55 cell, (b) respective pseudocolor image provided by the proposed segmentation algorithm.

image for a browned c-Si cell from a SIEMENS M55 module (Figure 13(a)). It is evident that the pseudocolor image produced has accurately detected the undamaged and damaged parts of the cell. The browning which appears on both bus bars and soldering bond is clearly detected and appears in red in the pseudocolor image. The small browning at the lower bus bar, which could have been passed unnoticed during a visual inspection, has been correctly identified and appears in red in the pseudocolor image.
