## Research Article

# The Sulphate Effect on Lijiaxia Concrete Dam (China) Gallery

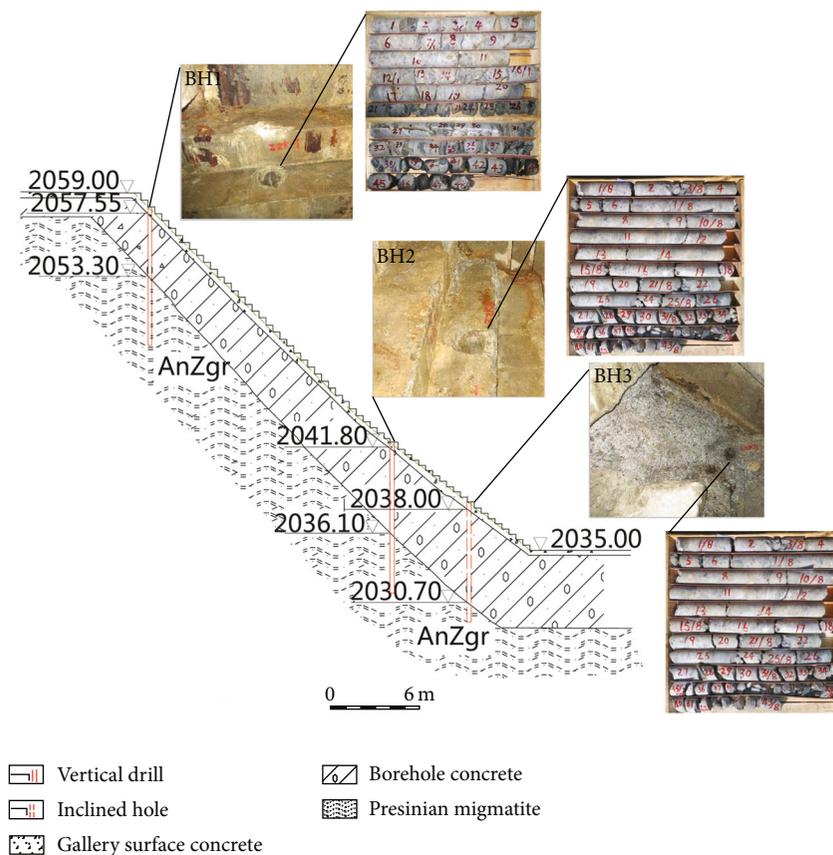
The schematic of the hydropower station dam gallery and the location details of sampling are shown in Figure 2. The field investigation shows that the worst location of degradation is BH3 (elevation: 2038); the degradation degree of the surface concrete is dramatic. Lots of local apophysis and desquamate phenomena could be seen on the concrete step at the BH3 position. Conversely, the degradation degrees of the surface concrete around the BH1 and BH2 are not that terrible. Only several local apophysis and desquamate phenomena could be found on the step (Figure 2). Three concrete samples beside the three boreholes and eight concrete samples from different depths of borehole cores were taken. The depth details of each borehole core sample are shown in Table 1. In order to clarify the mechanism of this dam gallery concrete degradation, several laboratory tests including XRF, XRD, SEM, and EDS were conducted to inspect the concrete degradation and degradation degree of the concrete for both borehole and gallery surface samples.

FIGURE 2: The details of the sampling locations and the concrete corrosion photos.

Three concrete samples from the dam gallery surface, which are in serious degradation according to the site survey (Figure 2), were also taken to do the XRF test. The average LOI value is 21.76%, which means there are lots of materials lost at 1000–1100°C heat for the degradation concrete of the dam gallery surface. The average mass fraction percentages of SiO<sub>2</sub> are only 17.43%, which is less than half of that of borehole samples. Nevertheless, the average mass fraction percentage of SO<sub>3</sub> reaches 33.38%.

have to be conducted to limit further degradation and make sure the safety of dam construction. Firstly, the dam gallery surface concrete is corroded seriously, which has to be reinforced. According to the water quality analysis results, the sulphate resistant concrete is suggested to be used in the reinforcement. In addition, the drainage holes in the gallery are suggested to be checked over to clarify whether they are effectively plugged or not. The plugged drainage holes have to be cleared to restore the water drainage function, which could decrease the alternate dry and wet of the gallery concrete.

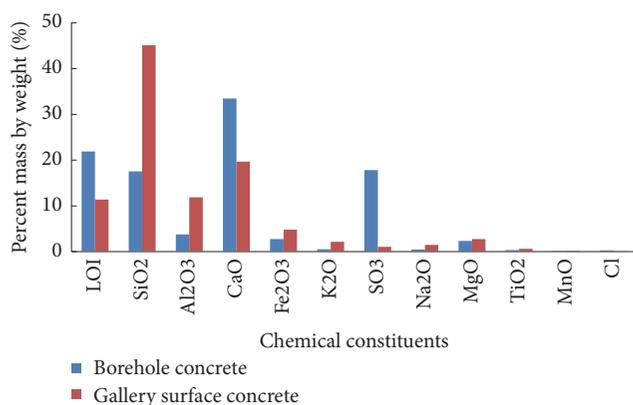
The comparison of chemical constituents and LOI between surface and borehole concrete samples is shown in Figure 3. The main differences between seriously corroded concrete, taken from the gallery surface, and fairly intact concrete are the SiO<sub>2</sub>, CaO, Al<sub>2</sub>O<sub>3</sub>, and SO<sub>3</sub> contents. For the fairly intact concrete, the contents of SiO<sub>2</sub> and Al<sub>2</sub>O<sub>3</sub> are more than those of degradation concrete. Conversely, the contents of CaO and SO<sub>3</sub> of fairly intact concrete are less than those of degradation concrete. All the above test results indicate that the concrete degradation at Lijiaxia dam gallery concrete belongs to sulphate attack. In order to analyze

FIGURE 3: The comparison XRF tests results between gallery surface and borehole concrete specimens.

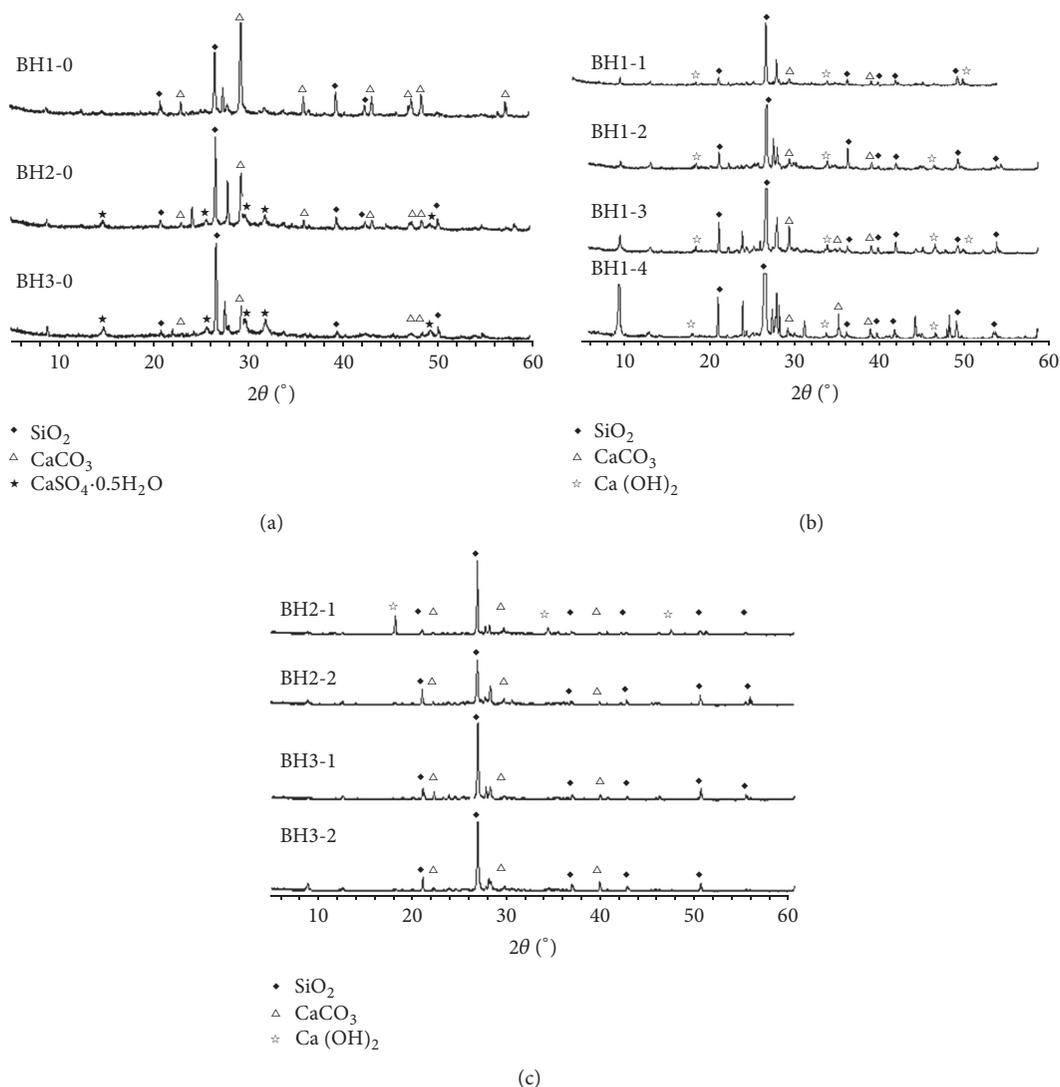
Similar XRD tests results of the borehole samples were obtained from the three difference locations (Figure 4). However, the gallery surface samples vary with the borehole samples, even though they are from the same location. The main reason might be that the degradation degrees are different, which also could be found by the site survey and XRF test results. The SiO<sub>2</sub> and CaCO<sub>3</sub> are the main matters of the samples, including surface and borehole samples, where the SiO<sub>2</sub> is from the concrete aggregate, while CaCO<sub>3</sub> indicates that the carbonization happened in the concrete. The main difference between the borehole concrete and gallery surface is the set cement which is composed of the hydrated cement products, such as Ca(OH)<sub>2</sub>. The set cement could not be found in the seriously corroded gallery surface samples by the XRD test but was found in the borehole samples. The difference confirms that samples from gallery surface have been eroded in the corrosive medium environment. Moreover, the CaSO<sub>4</sub>·0.5H<sub>2</sub>O were detected in the samples from BH2-0 and BH3-0 locations, which is the typical mineral of the concrete degradation by the sulphate solution [17, 25]. The CaSO<sub>4</sub>·0.5H<sub>2</sub>O mineral shows that the concrete degradations from BH2-0 and BH3-0 are the most severe locations among all 11 samples.

Another interesting thing found from the XRD spectra result is that the ettringite might exist in BH1-3 and BH1-4 samples ( $2\theta = 8.75$ ,  $d = 9.97\sim 10.11$ ) (Figure 4). In order to make it clear whether the ettringite exists as the degradation products, SEM and EDS tests were conducted on BH1-3 and BH1-4 samples.

FIGURE 4: The XRD spectrum results: (a) the gallery surface; (b) samples from BHI; (c) samples from BH2 and BH3.

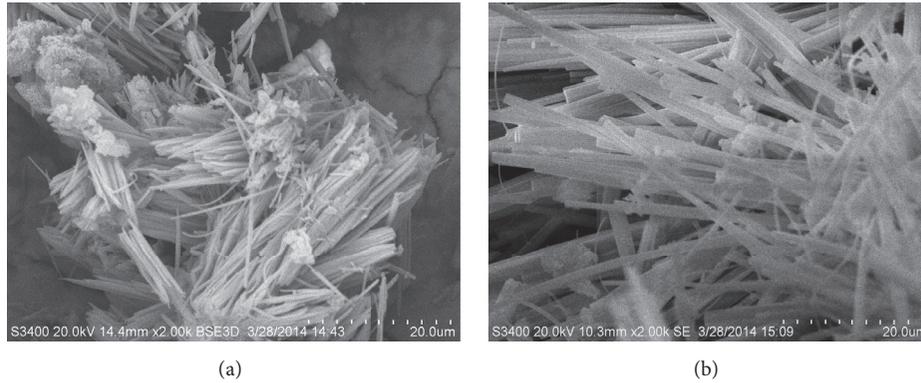
S-3400N II scanning electron microscope, and the SEM images of BH1-3 and BH1-4 samples are shown in Figure 5. The relative concentration rod-like crystalline contents could be seen in both of two samples, which is very similar to the crystal shape of ettringite ( $3\text{CaO}\cdot\text{Al}_2\text{O}_3\cdot 3\text{CaSO}_4\cdot 32\text{H}_2\text{O}$ ) [17].

FIGURE 5: The SEM images of the concrete samples from BHI: BHI-3 (a) and BHI-4 (b) sample.

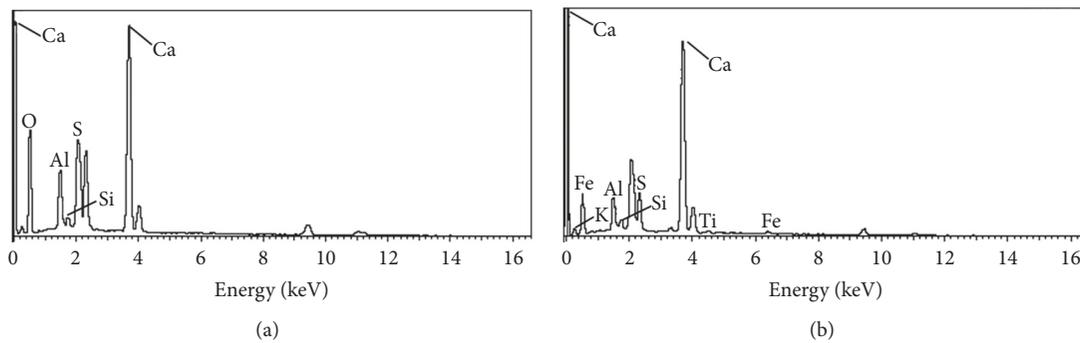
Meanwhile, the EDS spectra results are shown in Figure 6, which indicate that the major elements of the rod-like crystalline contents and the adjacent mineral are Ca, S, and Al. The corresponding oxides of Ca, S, and Al are  $\text{CaO}$ ,  $\text{SO}_3$ , and  $\text{Al}_2\text{O}_3$ , and the total mass contents of these oxides are 91.86% and 95.80% for BH1-3 and BH1-4 samples, respectively. Moreover, Ca, S, and Al are the basic elements of ettringite, and the total contents of the corresponding oxides are over 90%. Hence, it is confirmed that the ettringite mineral is generated in the BHI [17, 25, 26], which is the typical sulphate attack product. Hence, proper precautions have to be taken on this hydropower station dam gallery, especially for the sulphate attack prevention.

FIGURE 6: The EDS spectra of the concrete samples from BHI: (a) BHI-3 sample; (b) BHI-4 sample.
