Research on Deformation and Failure Evolution of Deep Rock Burst Drivage Roadway Surrounding Rock under Dynamic Disturbance

Based on the existing research results, this paper takes the No. 3 connection roadway of drainage roadway at panel 1303 in the “10.20” Rock Burst Accident of Longyun Coal Industry as the engineering background. By using the finite difference numerical simulation method of engineering scale, the deformation and failure evolution of surrounding rock under the superposition of mining disturbance and external dynamic load, and the mechanism of instability causing the disaster are deeply studied through the detailed simulation of the process of roadway formation in the accident roadway and the application of dynamic load. The research methods and results can provide an important basis for research in related fields.

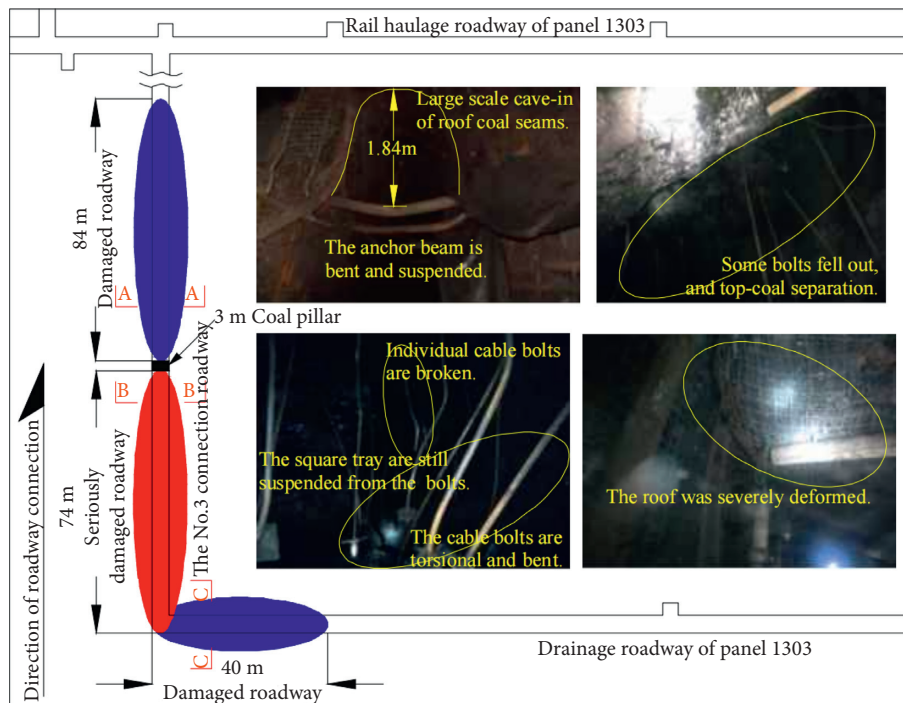
severely damaged the 198 m section, and killed 21 miners. The accident area and roadway damage are shown in Figure 4.

After the occurrence of rock burst, the scene investigation showed that there was a failure area of 84 m behind the stop heading face of the No. 3 connection roadway; meanwhile, the cable bolts, rebar bolts, and anchor beams showed different forms of distortion and cracking, and the roadway roof obviously subsided and the two ribs converged. The damage of roadway in accident area is shown in Figure 4. The roadway at the A-A section has a width of 3.44 m and a height of 2.16 m. It was found that individual cable bolts were broken, the anchor beams were cracked, the rebar bolts were suspended from the roof but not broken, and individual rebar bolts were struck whole into the roof. The 74 m roadway behind the heading face of the No. 3 connection roadway was a severely damaged area. The two ribs of the B-B section converged to 1.5~2.0 m, the roof sag

FIGURE 4: Accident area and roadway damage.

1.0~2.5 m, the anchor beams were bent and sag seriously, the roof near the excavator was broken, and the roadway was deformed seriously. There was a 40 m damaged area in the drainage roadway at panel 1303. The roof at the C-C section collapses to the immediate roof of the No.3 coal seam, the two ribs converged, and part of the roof anchor beams was bent and suspended; meanwhile, the roof cable bolts and rebar bolts were still suspended from the roof; there were individual cable bolts and rebar bolts that were broken.
