Research Article

Deformation and Failure Evolution Law and Support Optimization of Gob-Side Entry in Weakly Cemented Soft Rock under the Influence of Fault

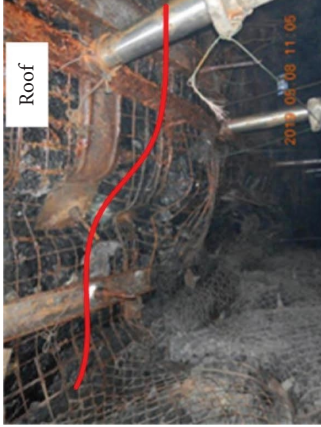
<p>The photograph shows a roadway roof with a red line tracing a significant downward curve, labeled 'Roof'. A timestamp '2015-03-09 11:05' is visible in the bottom right corner.</p>
3#	Regional roof subsidence occurs in the roadway, the roadway roof is poorly formed, the floor heave is slight, and no obvious wall heave occurs

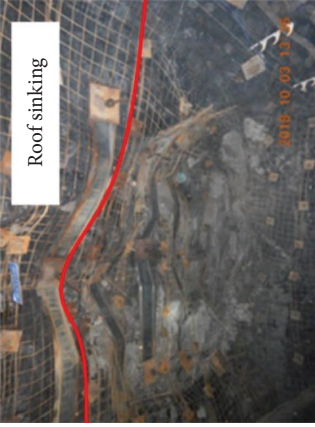
<p>The photograph shows a roadway with a red line tracing a curve in the roof, labeled 'Roof sinking'. A timestamp '2015-10-03 13:29' is visible in the bottom right corner.</p>

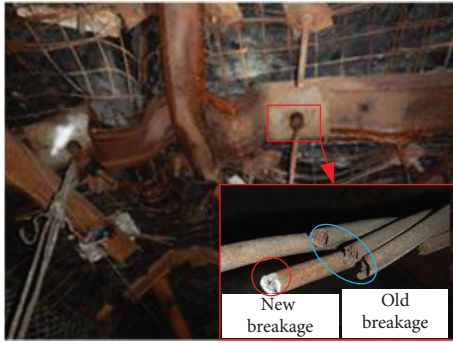
FIGURE 3: Photo of partial strand breaking cable in the fault area.

At the same time, the gob-side tunnel has obvious failure phenomena such as cables in the fault area. According to the breaking situation of cables on-site, most of the cables are broken in strands, and the breaking time of each strand is inconsistent. As shown in Figure 3, the length of the broken cable is 0.2 m–0.6 m (regardless of the exposed end), and the fracture is uneven. According to the corrosion degree of the fracture surface, the breaking sequence of each strand can be judged. Most of the seven strands of cable are broken 2-3 times.

The failure characteristics of the cable are mainly brittle fracture at the fracture of each steel strand, and the diameter shrinkage is not obvious. The failure of the cable in the fault area is characterized by dynamic load fracture. As

can be seen from Figure 4, the gob-side roadway in the fault area receives a high static load, and the cable is in a tension state. At this time, the dynamic load disturbance transmitted with mining and other roof activities is easy to break when the individual steel strand reaches the tension deformation limit, and the tensile capacity of the cable decreases. Other steel strands break under high static load, resulting in obviously broken characteristics. However, the form of steel strand breakage at the center of the cable is different, which is mainly related to factors such as the

installation angle of the cable. When the cable is perpendicular to the coal wall, it is easy for the steel strand at the center position to break.

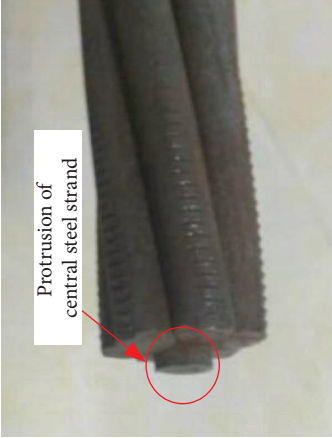
Failure form	Failure characteristics	Picture of actual failure on-site
The central steel strand is broken first	The central steel strand of the exposed end cable is "protruding," and the cable is broken by several times

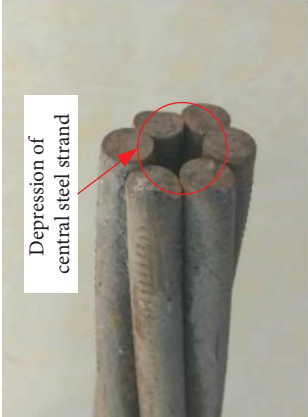
Final breaking of central steel strand	The central steel strand of the exposed end cable is in the form of "core pulling," and the cable is broken several times

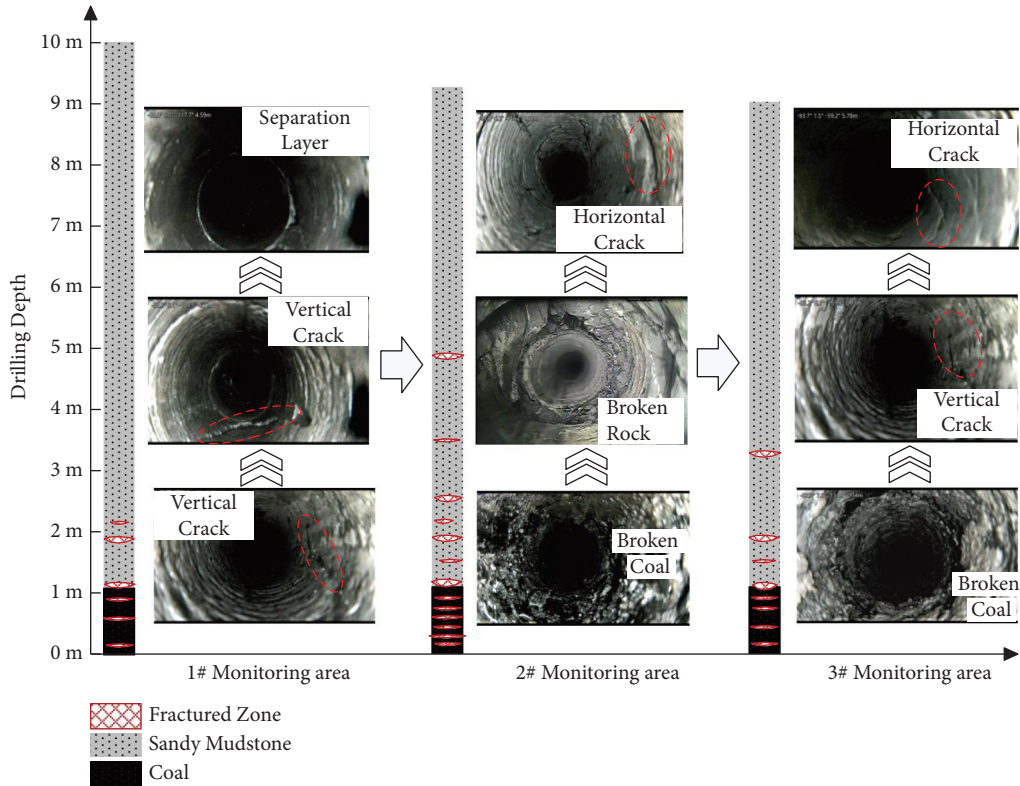
FIGURE 4: Results of the borehole TV survey.

3.2.2. Borehole Television Detection. The roof of three different monitoring areas was peeped through boreholes, and the specific detection results are shown in Figure 4. In the three monitoring areas, there are obvious fractures in the top coal area and a large degree of separation between the top coal and roof mudstone. The roof damage range of the area not affected by the fault (1 # survey area and 3 # survey area) is within the depth range of 0–3 m, and the overall roadway roof fragmentation and damage range are small. In the area affected by the fault (2 # survey area), the main roof separation fracture area is mainly distributed within the range of 0–5 m drilling depth. The specific fracture locations are 0–1 m (located in the top coal), 1.1 m~1.2 m (located at the coal rock boundary), 1.4 m, 1.8 m, 2.5 m, 3.5 m, and 5 m. Among them, the separation layer at the coal rock interface is cracked most seriously, and the scope and extent of roof damage have increased significantly. At this time, the roof at the free section of the cable has a large area of separation layer subsidence, leading to a significant reduction in the integrity of the roadway, and the cable is seriously ineffective under the effect of high stress and large deformation.

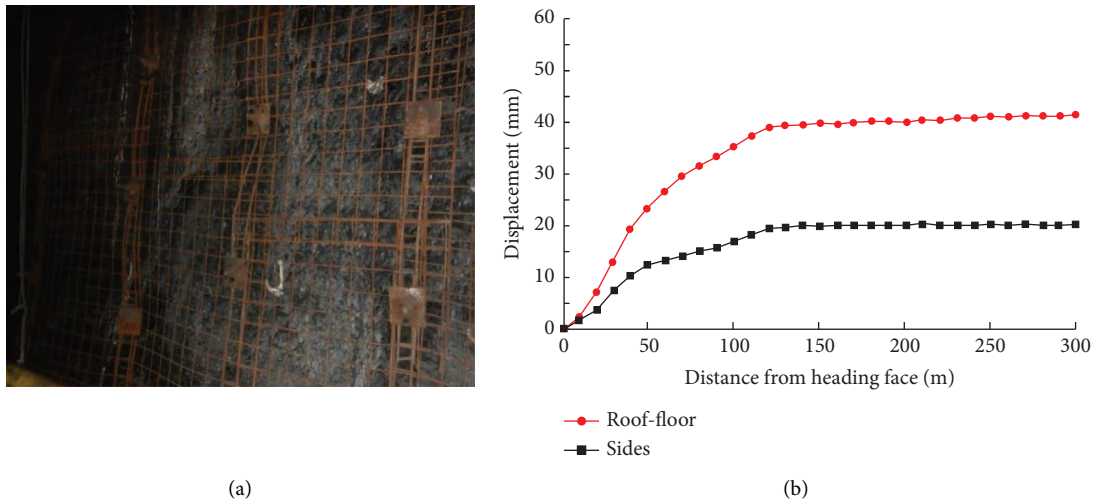
FIGURE 11: Roadway deformation after support optimization. (a) Actual effect of roadway. (b) Surface displacement characteristics.

As shown in Figure 11, the deformation of the surrounding rock tends to be stable when it is about 120 m away from the heading face, the roof subsidence is about 42 mm,

and the movement of the two sides is 18 mm. The survey station shows that the deformation and stability time of the surrounding rock is shortened after the tunnel heading, the roof subsidence and the movement of two sides are not large, both within the controllable range, and the stability of the surrounding rock is good.

4.3. Field Application Effect. Eight working faces are arranged in the 3-1 coal seam of Hongqingliang Coal Mine in the west. The return air gateway of the 11303 working face is used as the gob-side roadway. There is a large fault near the main roadway. The above optimization measures for support are applied. The specific support and reinforcement measures are as follows: increase the pre-tightening force of the bolt to 70 kN, increase the pre-tightening force of the cable to 180 kN, increase the single hydraulic prop in the fault area, with the spacing of single pillars of 1 m, each row of single pillars is 3 for passive support, pressure relief holes with a diameter of 110 mm shall be drilled at the upper part, and the spacing between pressure relief holes shall be 1 m.
