Case Report

Splinting of Longitudinal Fracture: An Innovative Approach

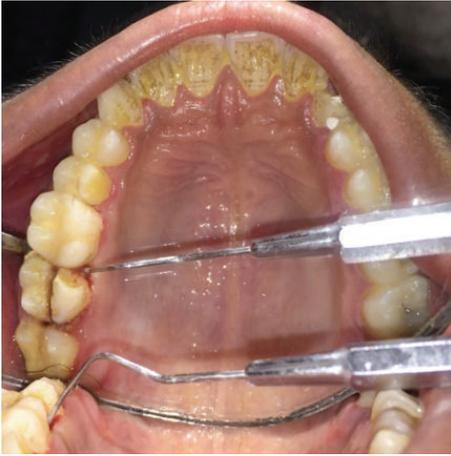
On visual inspection of 27, the fracture line was running mesiodistally involving both the marginal ridges (Figures 2 and 7). The fracture segments cannot be displaced, but they can be visualized by wedging with a probe (Figure 2). There was no dentine between the fractured segments on the pulpal floor. The fracture line had extended subgingivally through the pulp chamber into the furcation area. Exploration of periodontium along the fracture line indicates no sign of periodontal attachment loss, although tooth was tender on percussion and nonvital on pulp testing. An intraoral periapical radiograph revealed that lamina dura of mesiobuccal

FIGURE 2: Preoperative photograph showing split tooth of 27.

Immediately after the diagnosis, the tooth was stabilized using orthodontic band (RMO 0.180 × 0.005 mm) (Figure 10). In the same appointment, endodontic treatment was initiated. Fracture line was cleaned of any debris with

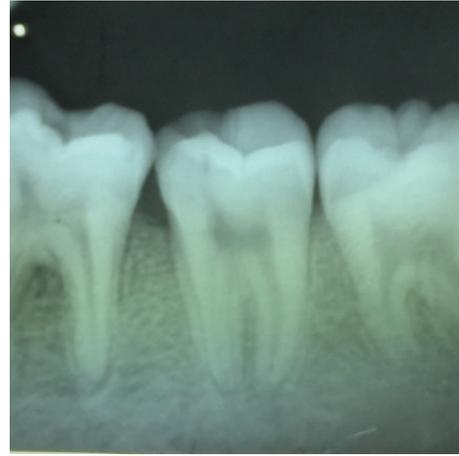
FIGURE 5: Preoperative radiograph of 37.

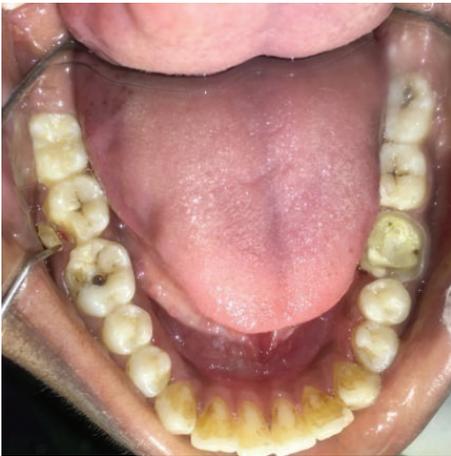
FIGURE 3: Preoperative photograph showing fractured cusps in 37 and 46.

On examination of the lower left quadrant, there was a fracture of a mesiobuccal cusp with respect to 37. The fracture line had both mesiodistal and buccolingual components. It was running cervically from buccal groove towards the centre of occlusal surface and then extending mesially involving the mesial marginal ridge (Figure 8). Both fractured segments were in position but can be visualized by exploring with a probe (Figure 3). Further, the subgingival extent of fracture line was 1 mm below the cemento-enamel junction (CEJ), and it was not involving the pulp chamber. Periodontium was intact along the fracture line. An intraoral periapical radiograph revealed intact lamina dura (Figure 5). The tooth was not mobile and not tender on percussion. Vitality test was positive. It was diagnosed as fractured mesiobuccal cusp with respect to 37, not involving the pulp.

On examination of the lower right quadrant, there was a fracture of mesiolingual cusp with respect to 46. The fractured segments were not displaced but could be separated by exploration with the probe. Further, the fracture line was extending up to the coronal third of the root surface, without involving the pulpal floor (Figure 9). Periodontium was not compromised along the fracture line and percussion test was negative. Vitality test was positive. Intraoral periapical radiograph revealed fracture line (Figure 6). It was diagnosed as fractured mesiolingual cusp with respect to 46.

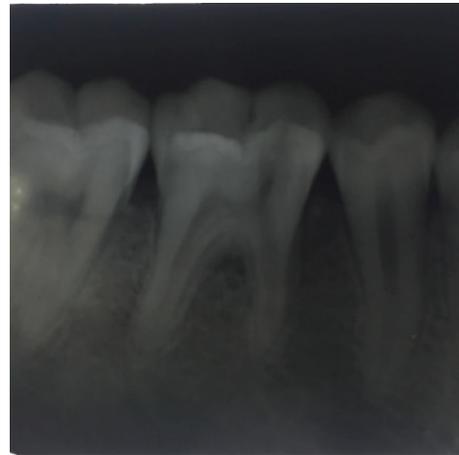
FIGURE 6: Preoperative radiograph of 46.

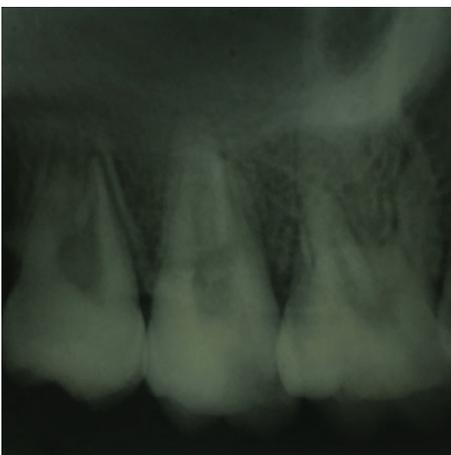
FIGURE 4: Preoperative radiograph of 27.

and distobuccal root was involved. Fracture line was not appreciable on the radiograph (Figure 4). It was diagnosed as a split tooth of 27 involving the pulpal floor.

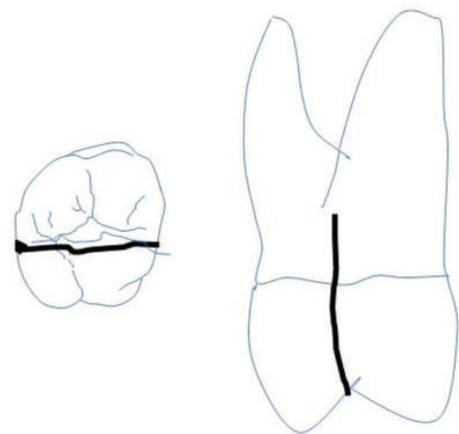
FIGURE 7: Extent of fracture line in 27.

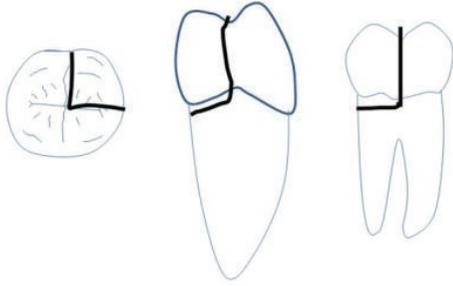
FIGURE 8: Extent of fracture line in 37.

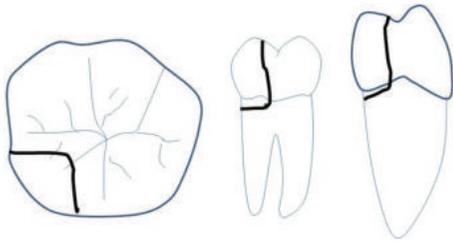
FIGURE 9: Extent of fracture line in 46.

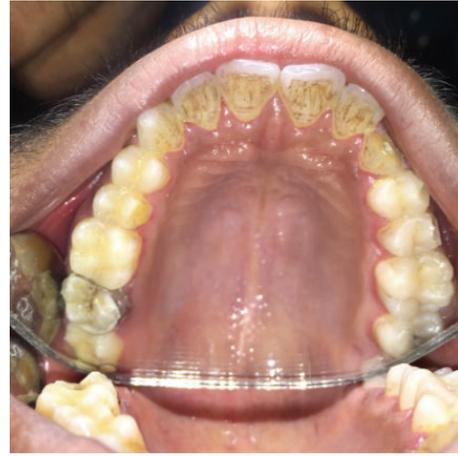
FIGURE 10: Photograph showing stabilization of split tooth with respect to 27 using orthodontic band.

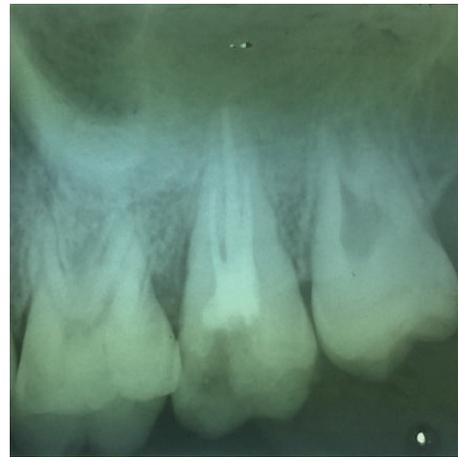
FIGURE 11: Post-obturation radiograph with respect to 27.

30% H₂O₂ (Shree Sai Chemicals, Ghaziabad, Uttar Pradesh, India). The biomechanical preparation was done using Rotary V-Taper (30/0.04%) (SS White) (Figure 11). Single cone gutta-percha obturation using MTA Fillapex, as the root canal sealer, was completed. Mineral Trioxide Aggregate (ProRoot MTA, Dentsply, DeTrey, Germany) was placed on the pulpal floor at the fracture site where dentine was missing. A wet cotton pellet was placed in the pulp chamber followed by temporary restoration. The patient was recalled after 3 days. In the next appointment, temporary restoration was removed and access cavity was thoroughly debrided with saline and dried. From each canal, 3 mm of gutta-percha was removed with Peeso Reamer size-3 (Dentsply Maillefer, Ballaigues, Switzerland), and preparation was checked radiographically (Figure 12). Three pieces of 1 cm Ribbond (Ribbond Inc., USA) fibre were taken. The root canal orifices were etched and rinsed and bonding agent was applied. Into each of the three canals, 3 mm of Ribbond fibres was inserted and was stabilized in the root canal with the help of flowable composite (G-aenial Universal Flo, GC Corporation, Tokyo,

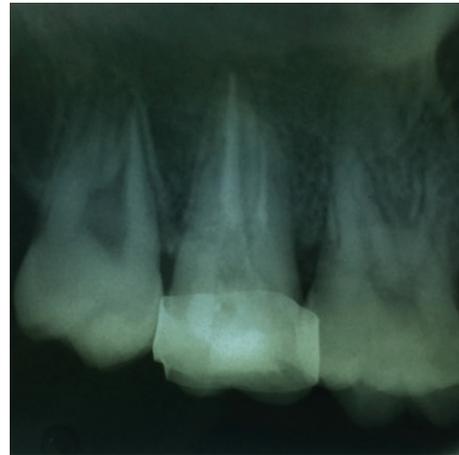
FIGURE 15: Radiograph showing internal reinforcement with Ribbond in 27.

Japan) and cured (Figure 13). After curing, around 7 mm of remaining fibres was kept outside the canal orifice. Then, these fibres were spread on the floor of the pulp chamber and intermingled to create a meshwork for the internal reinforcement (Figure 14). A flowable composite was placed over this fibrous meshwork and manipulated slightly with the help of plastic instrument (API) along the buccolingual and mesiodistal directions so as to form a unique composite Ribbond meshwork along the floor of the pulp chamber which was later cured. Subsequently, core buildup composite (Tetric Ceram Ivoclar Vivadent, Germany) was done. After 15 days, the orthodontic band was removed and crown preparation was done. Temporary crown was cemented which was later replaced by metal ceramic crown (Figures 15 and 16).

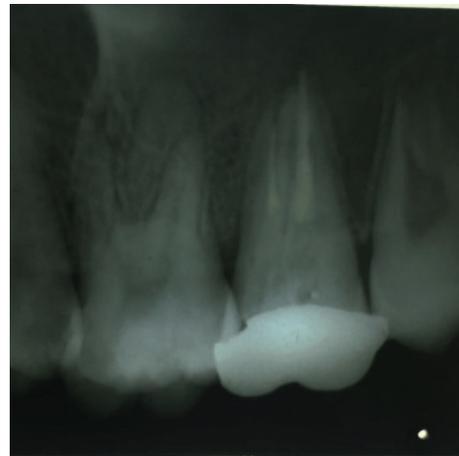
FIGURE 16: Radiograph showing external reinforcement with metal crown in tooth 27.

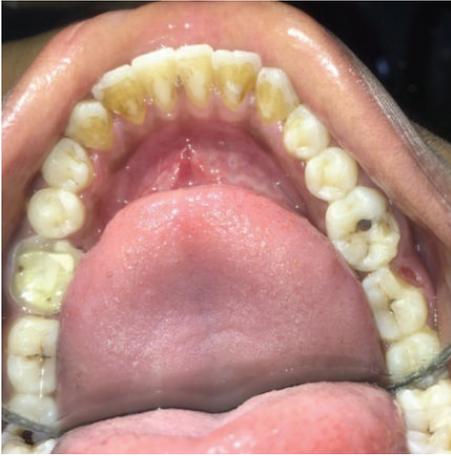
FIGURE 17: Mesiobuccal cusp in tooth 37 removed.

Fractured mesiobuccal cusp in 37 was removed carefully (Figure 17) and tooth preparation was done for class II cast metal inlay with cusp capping. Tooth preparation was extended more apically, and an indirect pattern was fabricated (Figures 18 and 19). Cast gold inlay was fabricated, luted

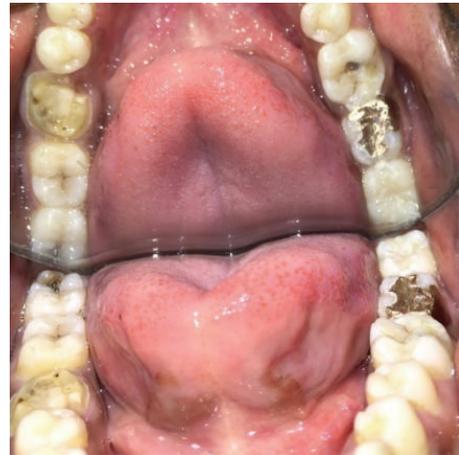
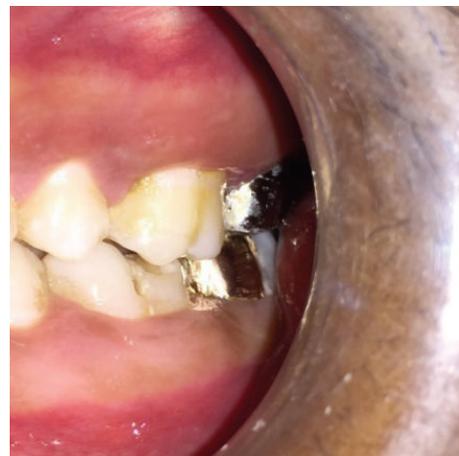
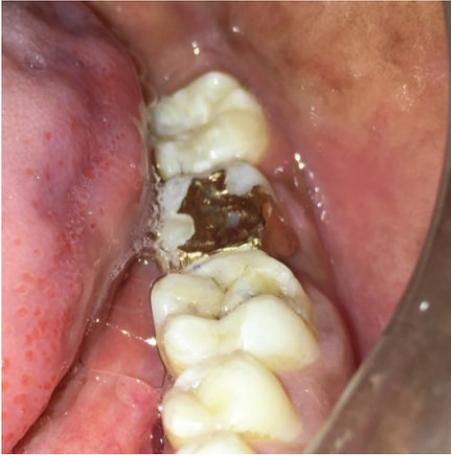
FIGURE 20: Photograph showing inlay luted with respect to 37 (occlusal view).

FIGURE 21: Photograph showing inlay luted with respect to 37 (buccal view).

FIGURE 22: Photograph showing inlay luted with respect to 37 (occlusal view).

using glass ionomer cement type I (GC Corporation, Tokyo, Japan) (Figures 20, 21, and 22), and checked radiographically (Figure 23).

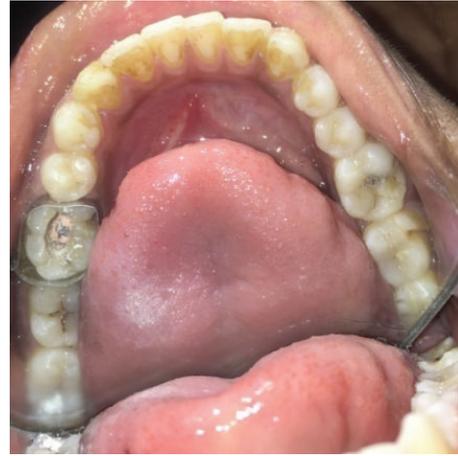
FIGURE 24: Photograph showing stabilization of fractured cusp with respect to 46.

As the fracture line was not involving the pulp chamber in 46 but was extending subgingivally, and tooth was vital initially, the fractured cusp was not removed; instead it was bonded with the help of composite resin and stabilized with orthodontic band (Figure 24). On subsequent appointment, the tooth had become nonvital and a sinus tract had also appeared in its relation. Hence, endodontic treatment was completed (Figure 25). Internal and external reinforcement were achieved in the same manner as mentioned for tooth 27.

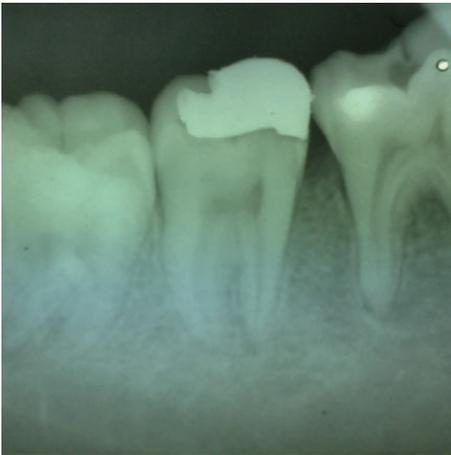
FIGURE 23: Radiograph showing luted inlay with respect to 37.

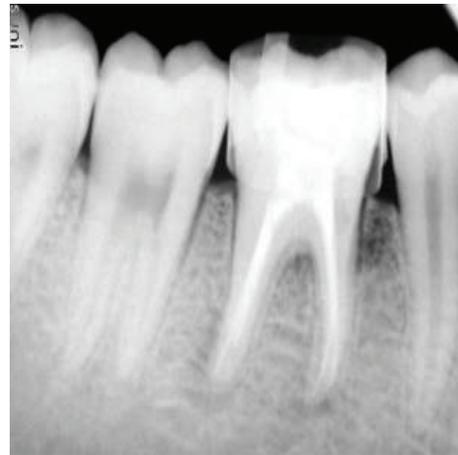
FIGURE 25: Postobturation radiograph of 46.

Tooth 46 was vital and fracture line was not involving the pulp. Hence, initially, fracture segment was reattached with composite and stabilized with orthodontic bands. The tooth was examined periodically. After two weeks, tooth became nonresponsive to vitality test and an intraoral sinus also developed in its relation. So root canal treatment was initiated and completed. The tooth was restored and permanently stabilized by internal and external reinforcement as done for tooth #27.
