Research Article

Numerical and Experimental Failure Analysis of Carbon Fiber-Reinforced Polymer-Based Pyrotechnic Separation Device

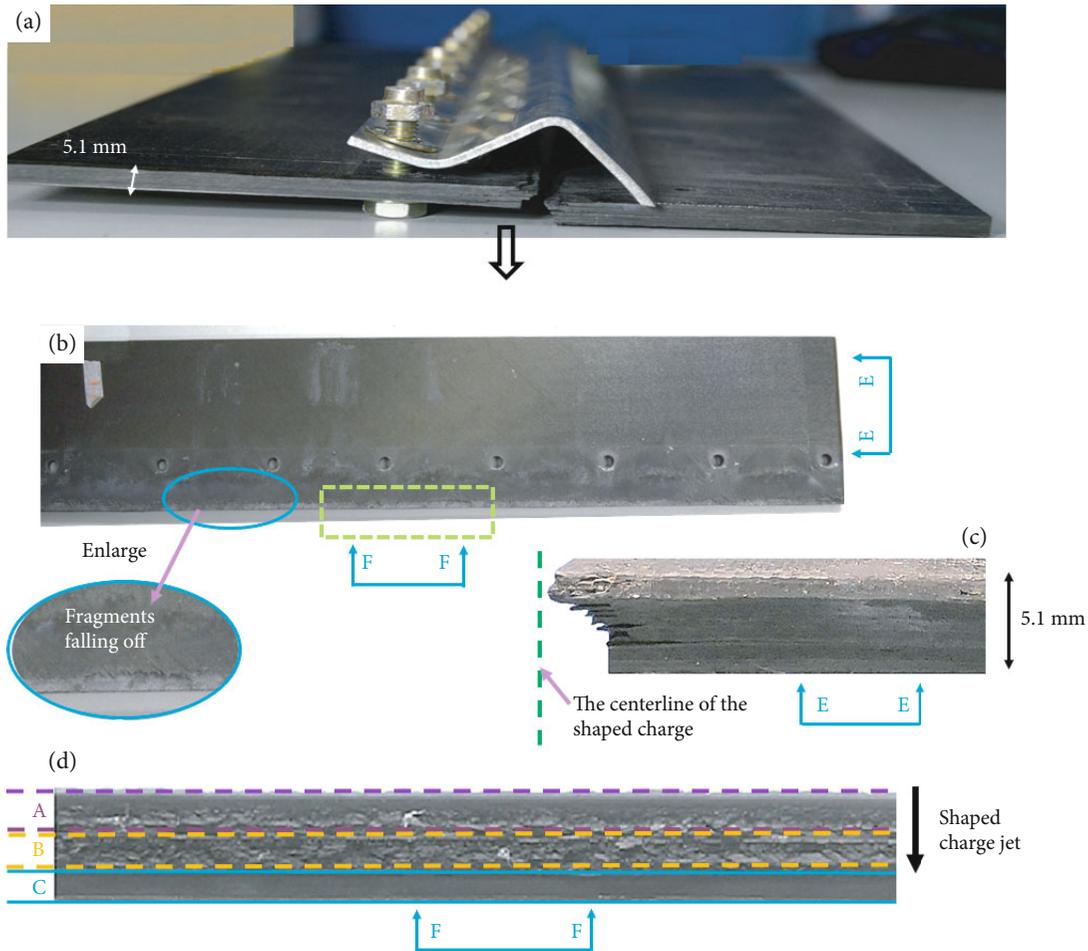
3.1. Macroscopic Analysis of the Cutting Fracture. Figure 6(a) shows the separation performance of composites separation device subjected to LSC jet and the laminate was divided into two plates. Since the jet is in the thickness direction, the failure initiates from the top surface of the laminate. Figure 6(b) represents one-half of the laminate after cutting. It can be found that most of the laminate materials stay intact after the laminate is subjected to the detonation impact. The enlarged view indicates a certain width of the laminate within the distance of the weakened groove has completely break into small debris. The surface near the LSC shows some single-layer fragments falling off but not completely. This phenomenon comes out of the joint effect of initial cutting of LSC jet and the action of tensile stress wave. The tensile stress wave is the reflection of the compressive wave gener-

ated by the jet impact on the free surface. In addition, it can be found that delamination occurred along the laminate thickness direction and the delamination phenomenon near the weakened groove is also more significant as shown in Figure 6(c). It is also found that the cutting width of the B region is larger than that of the A region. In Figure 6(d), for the cutting fracture, A region (away from the weakened groove) is relatively flat and B region (near the weakened groove) is rough with more prominent serrated burrs.

FIGURE 6: Macroscopic analysis. (a) Composites separation device. (b) Front view. (c) Side view. (d) Cutting fracture.

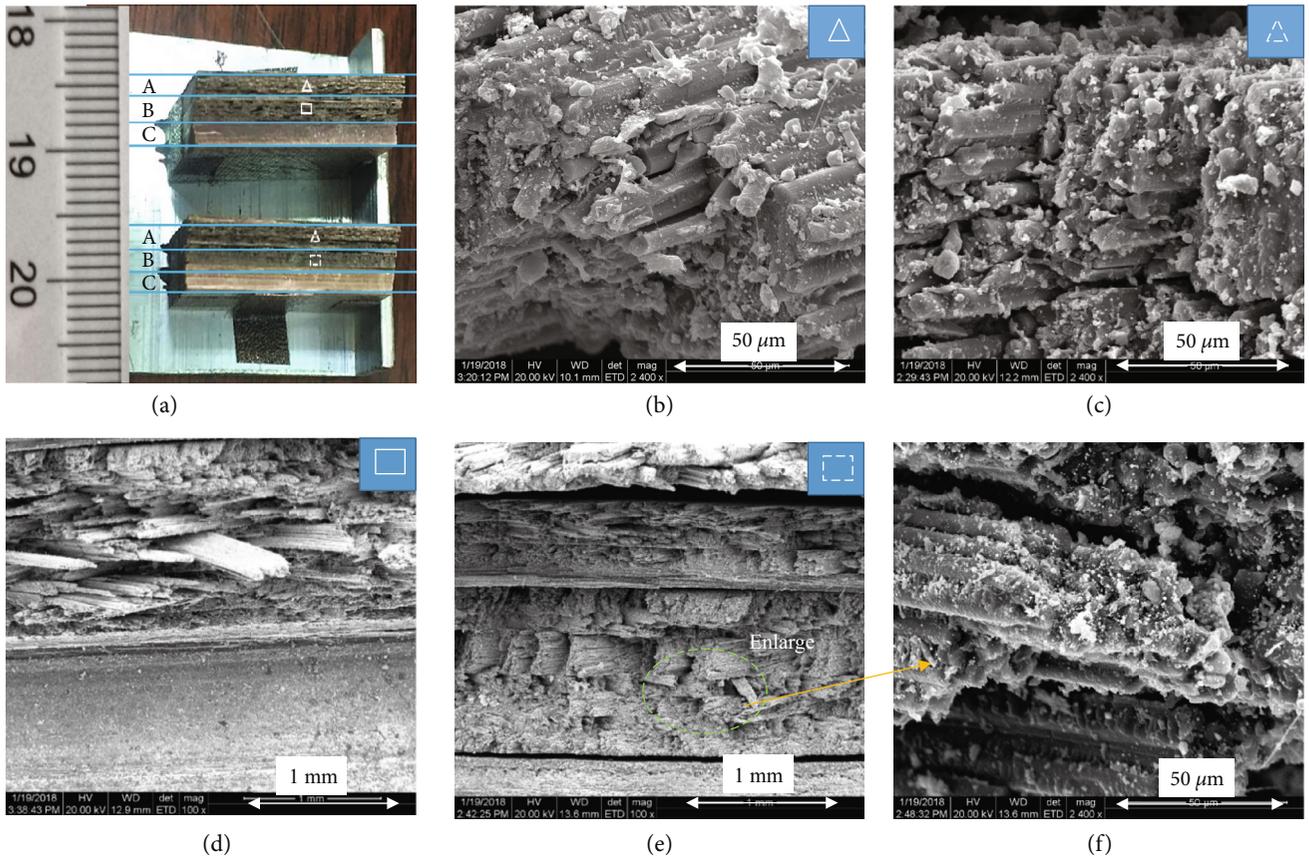
3.2. Microscopic Analysis of the Cutting Fracture. In order to study the microscopic fracture of CFRP composites after cutting, SEM (Hitachi S-4800) is used to analyze the failure cross-section of the laminates after cutting by LSC jet. In order to facilitate the observation, the size of the observation area of specimens from the cutting plate is about 20 cm × 15 cm. The microscopic images corresponding to triangles and rectangles are as marked in Figure 7(a).

The SEM images of CFRP specimens tested under LSC jet are shown in Figures 7(b)–7(f). These micrographs clearly illustrate the dominant failure mode of the laminates due to three factors: shear brittle fracture of the fiber, delamination of the composite laminates, and tensile failure of the laminates. The laminate behaves more like brittle materials because of the presence of inertia and wave propagation effects [18]. The ends of the broken fiber are flat, indicating a brittle failure which is caused by the shear loading, as shown in Figures 7(b) and 7(c). Similar phenomena can also be observed in the impact tests of the other composite laminates that are not used as a separation device [19]. There are also signs of matrix adhering to the fibers, which indicates an ideal bond on the fiber-matrix interface. The phenomenon of fiber pullout implies that the impact of jet and shock waves can cause the laminate materials at different ply angles to break under tensile loading, as shown in Figure 7(d). There are many pits formed when tensile load is applied as shown in Figure 7(e) [20]. In addition, the phenomenon of delamination along the thickness direction caused by weak interface

can be observed. It should be pointed out that single fiber is almost wrapped up and only fiber bundles are visible in Figure 7(f). For this phenomenon, two possible reasons are provided in this paper. Firstly, the resin is melted by high temperature and it is possible to wrap the fiber under the action of the jet. Secondly, as the cutting depth increases, the metal jet will accumulate at the bottom of the laminate and will also cover the fiber.

FIGURE 7: Cutting specimens and SEM micrographs. (a) Cutting specimens for SEM analysis. (b, c) Shear brittle fracture of fibers. (d–f) Tensile failure. Indicators A, B, and C represent the region away from weakened groove, the region near weakened groove, and the weakened groove, respectively.

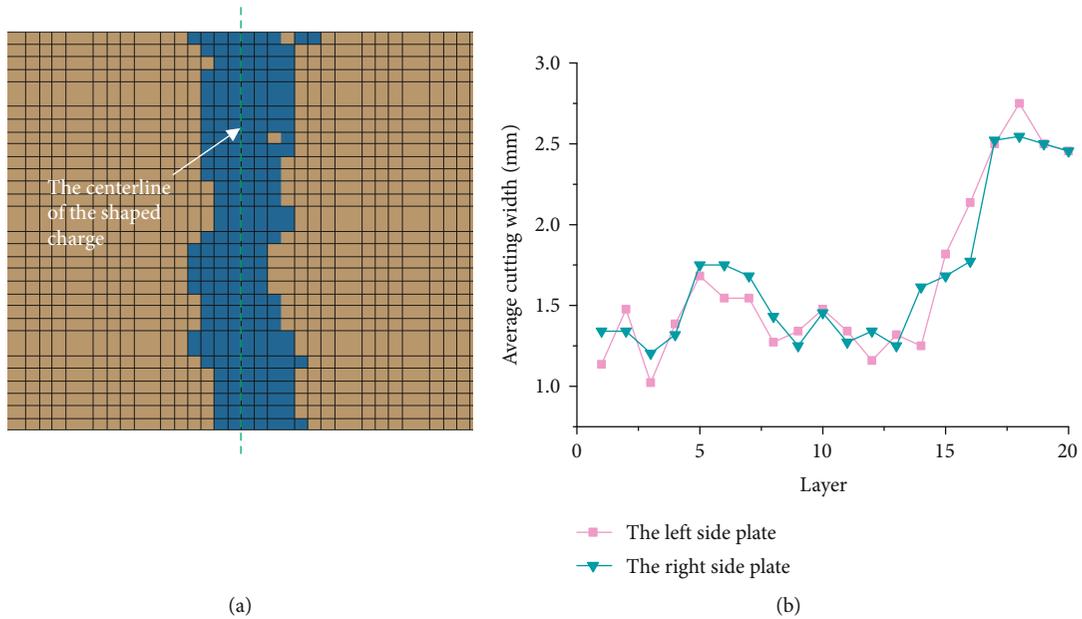
3.3.1. The Cutting Process of the Laminate. In this paper, the cutting width represents the distance between failure elements and the centerline of LSC as shown in Figure 8(a). The laminate is cut into two plates and the average cutting width of the left plate and the right plate is obtained based on the definition of cutting, and the results are provided in Figure 8. The average cutting width of the sublayers has an increasing trend with the growth of cutting depth. The damage of the laminate mainly shows within 6mm from the weakened groove. Figure 9 shows the cutting process of the laminate. It is clear that the cutting width is smaller by the side of the shaped charge and the width is larger by the side of the weakened groove, indicating the both side cutting frac-

tures of the laminate have shear failure and tensile failure, respectively. The reason is in the initial stage of the cutting process; the materials neighboring to the high speed jet has limited time to respond and result in a local transverse shear failure under high-speed and high-pressure conditions. The layers near the back of the composite mostly show tensile failure mode. Similar phenomena were observed in the impact tests of some other CFRP composites [21] and high-velocity impact simulation of the laminates [22].

FIGURE 8: Cutting width. (a) Statistical view of cutting width (blue elements represent failure elements). (b) Average cutting width of the sublayers.

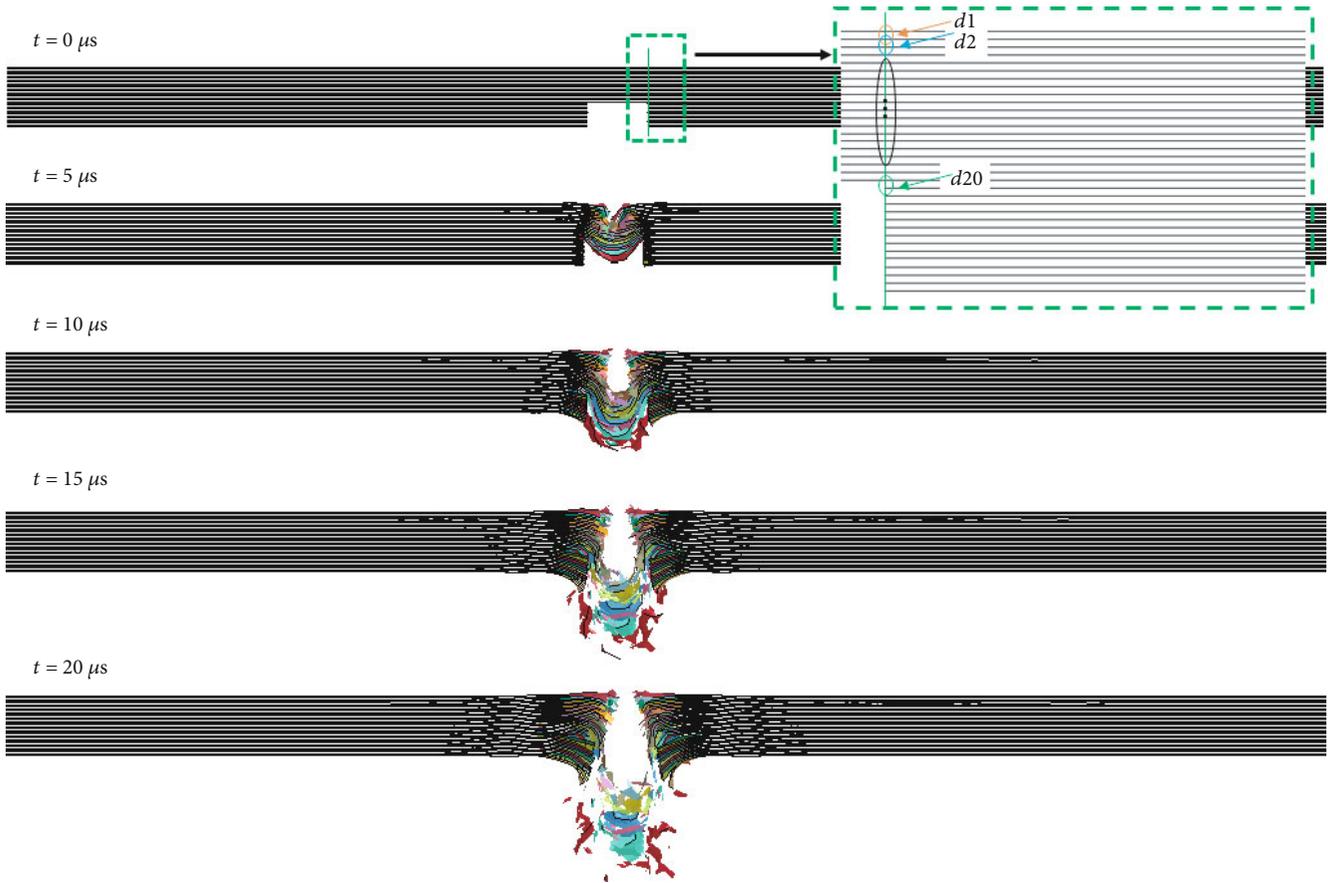
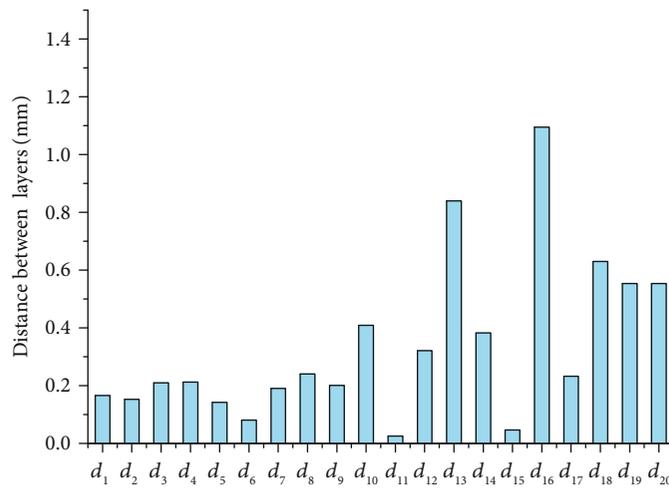
In term of the delamination, the distance change between layers, from layer 1 to layer 21, is obtained according to the enlarged area as shown in Figure 9. The distance between adjacent layers is 0.15 mm before cutting. Figure 10 shows the distance change between layers after cutting. It shall be noted that there are some delamination distances less than 0.15 mm, which may caused by the laminate warping under the action of detonation. Different the cutting stage will show different failure mode. The 20 layers are divided into a front 10 layers and a back 10 layers, and the average delamination distance between the front 10 layers is 0.20 mm and that between the back 10 layers is 0.47. It is clear that the delamination of the back 10 layers is larger than that of the front 10 layers, and the delamination phenomenon of the laminate near the weakened groove is much larger than that of far

away from the weakened groove, which is consistent with experiment results.

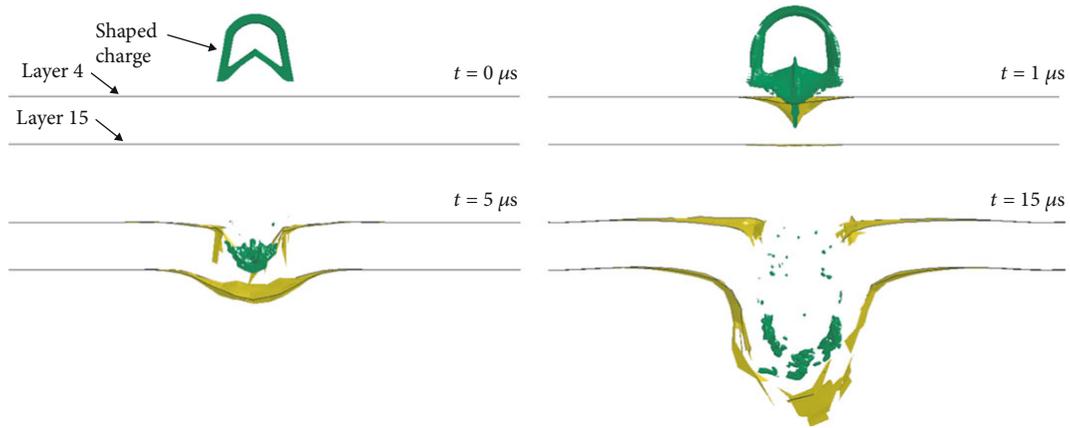
3.3.3. In-Plane Failure in the Cutting Process of the Laminate. The cutting process of the sublayers of the laminate is analyzed in Figure 12. Layer 4 is away from the weakened groove and layer 15 is near the weakened groove. The layer directions of layer 4 and layer 15 are both 45° . It is obvious that layer 4 is cut directly by the jet. As the cutting proceeding, the jet morphology collapses and the stress wave arrives the subsequent laminate before the jet; the stress wave forms a tensile effect on the free surface reflection of the laminate [23]. Therefore, layer 15 is cut by the action of both jet and stress wave.

FIGURE 12: Cutting process of the sublayer.

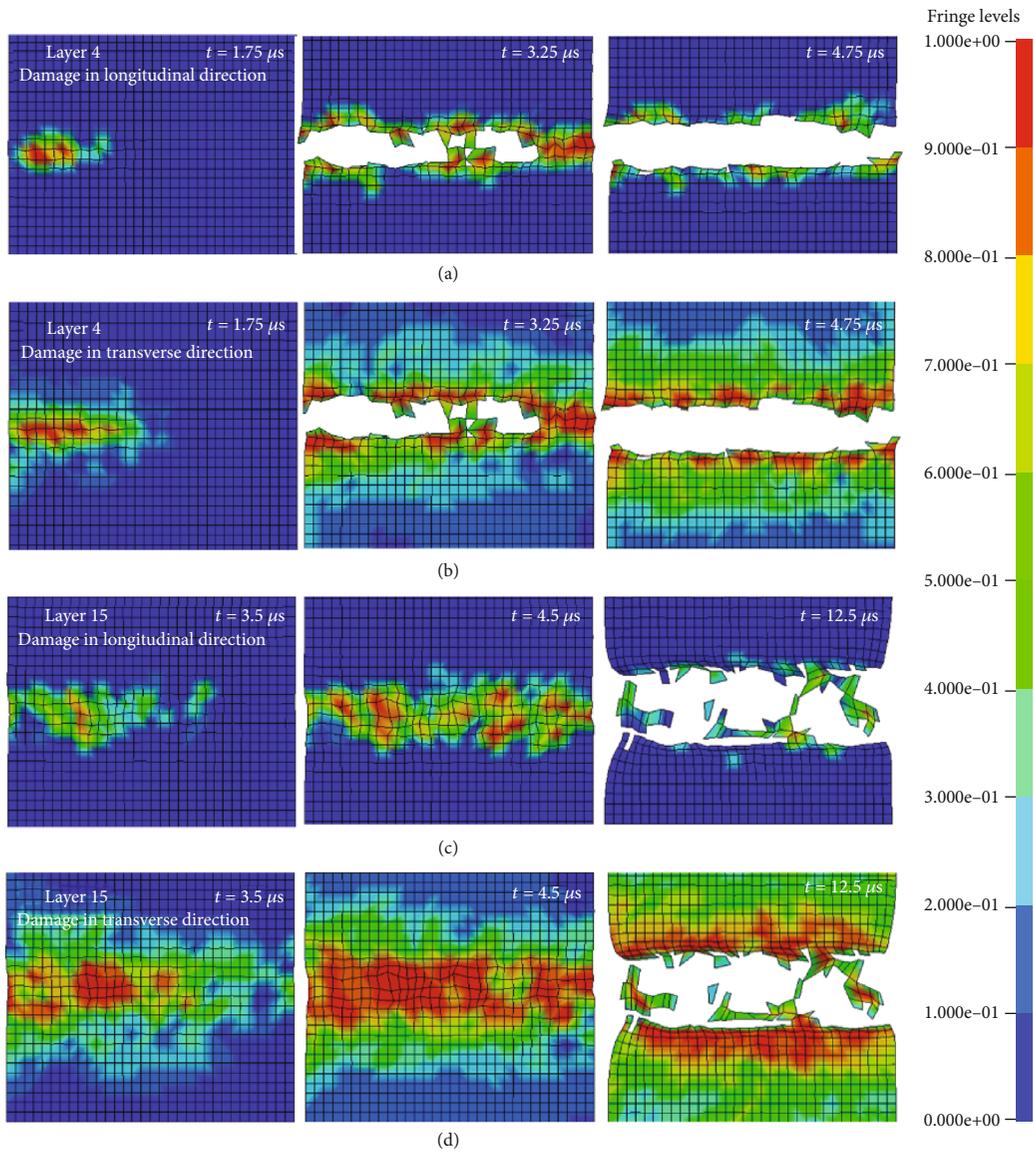
Figure 13 shows the in-plane failure of the sublayers over time. The above simulation has pointed out that the longitudinal and the transverse represent fiber and matrix, respectively. The right fringe levels show the damage degree of elements. The blue paint represents no damage while the red paint represents the greatest damage. For layer 4, the initial time of damage of the fiber and the matrix near the shaped charge shows less difference at $t = 1.75 \mu s$. As for the cutting progress, there is no significant difference between the damage area in fiber and matrix. Under the initial high-speed jet, the damage of the fiber and the matrix has limited time to respond to the stress wave, and the materials mostly fail due to the direct shear loading. Layer 4 shows a uniform and flat cross-section along the shaped charge direction after cutting, which is a typical shear failure. In terms of layer 15, the damaged area of the matrix is significantly larger than that of the fiber at $t = 3.5 \mu s$, and the rate of damage in the matrix increases in the later cutting stage. In this case, the fibers are directly exposed to the air after the matrix damage, and the fracture of layer 15 is relatively rough when the jet velocity reduces and the jet form collapses. Therefore, the shear failure is the dominant failure mode at the areas away from weakened grooves, while the tensile failure is the dominant failure mode at the areas near the weakened groove.

FIGURE 13: Comparison of in-plane failure in the sublayers (a, c). Damage in longitudinal direction for layer 4 and layer 15 (b, d). Damage in transverse direction for layer 4 and layer 15.
