Research Article Shield Cutting Pile-Group Implementation Effects on the Superstructure

Chi Zhang,¹ Shiju Ma^(b),² Yuancheng Guo,¹ Mingyu Li,¹ and Kui Fu³

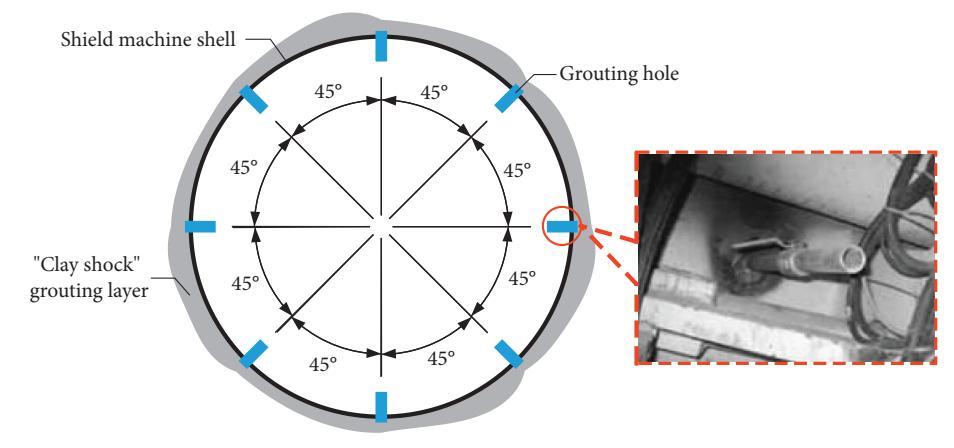
FIGURE 4: The layout of grouting holes in the shield machine shell.

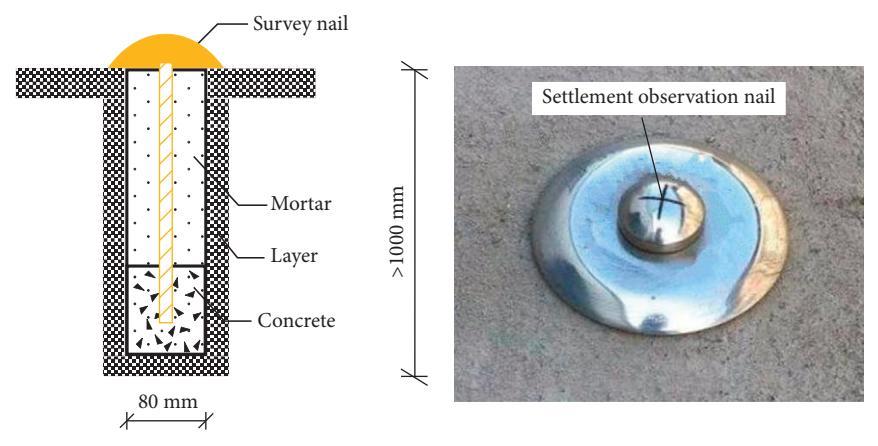
FIGURE 6: Buried method and physical map of surface subsidence measuring points.

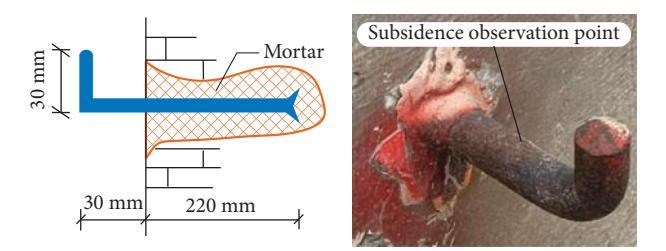
FIGURE 7: Layout method and physical map of building foundation settlement monitoring points.

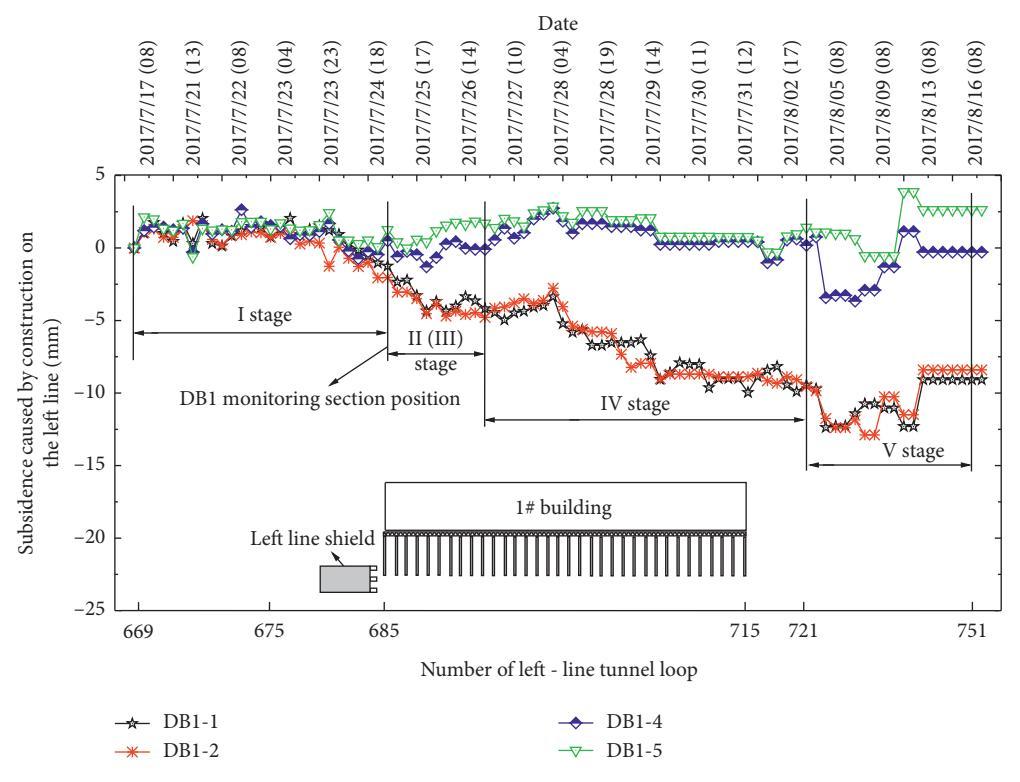
FIGURE 8: Monitoring time-history curve of surface subsidence of section 1.

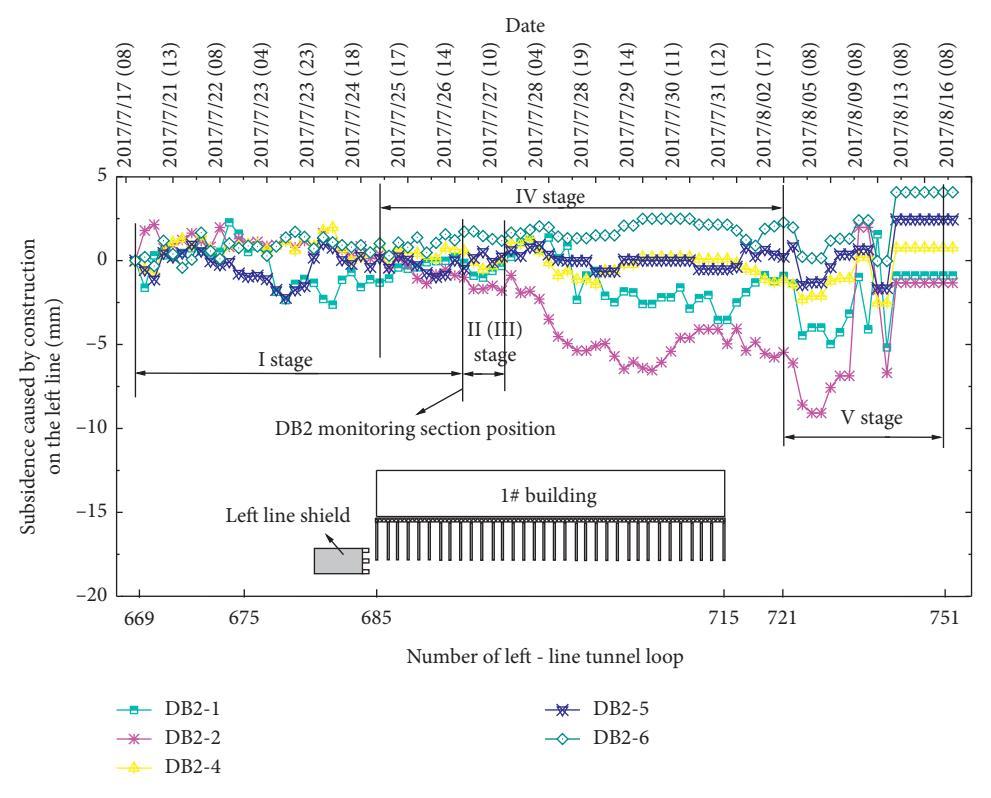
FIGURE 9: Monitoring time-history curve of surface subsidence of section 2.

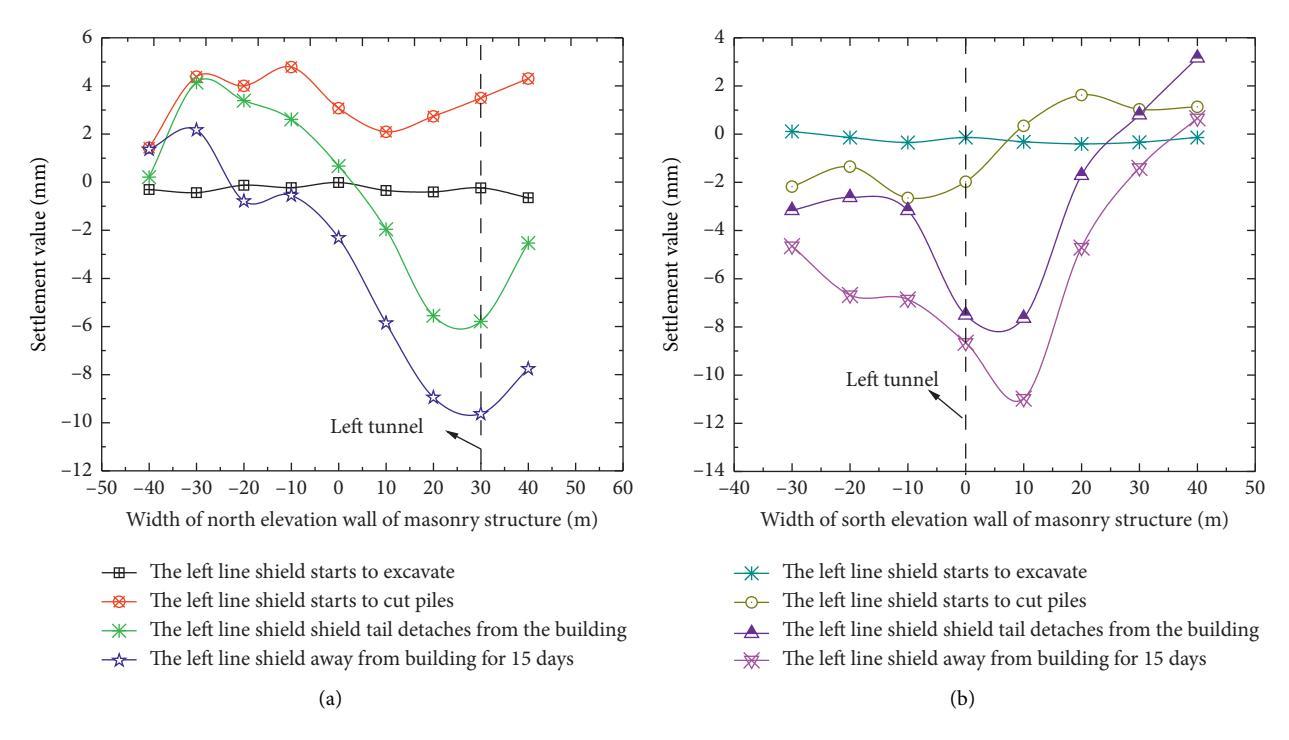
FIGURE 13: The settlement curve: (a) north facade and (b) south facade wall of the building at the critical moment.

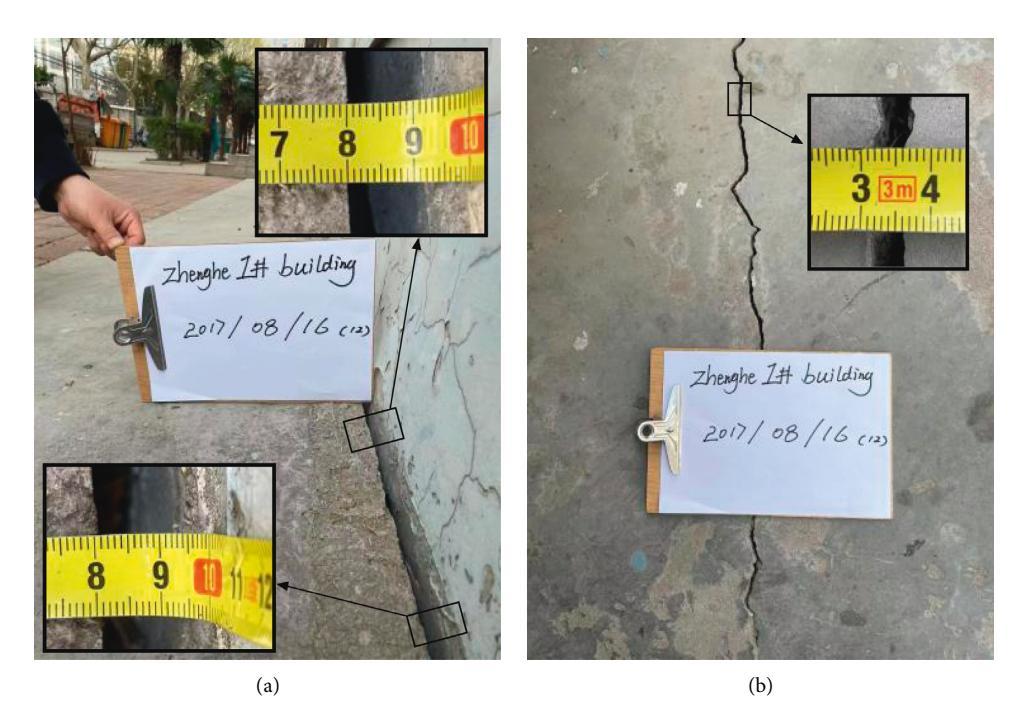
FIGURE 14: Cracks (a) between the wall and outside apron slope and (b) on the basement floor.

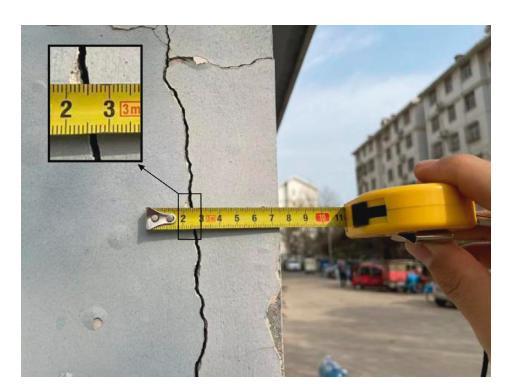
FIGURE 15: Cracks on the first floor of the masonry structure.
