Research Article

Corrosion Investigation of Rock Anchors Served over 10 Years in Underground Powerhouse of a Hydropower Station

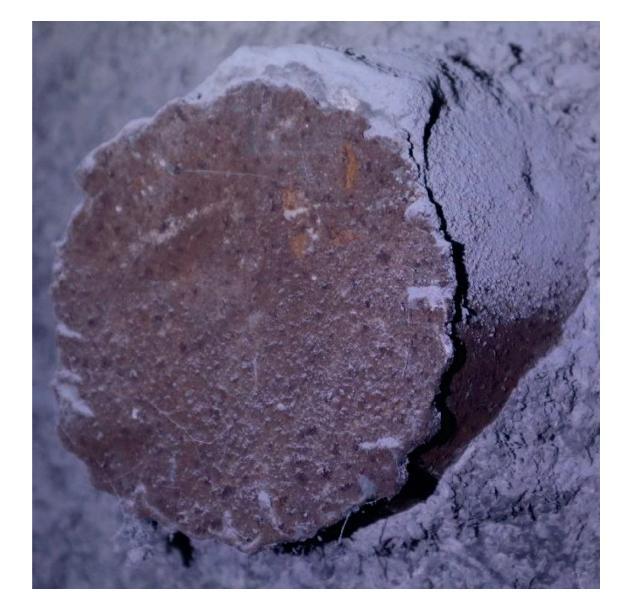
Different from the design, the anchor head is equipped with a steel protective cap (Figure 4), which serves as an additional protective layer between the anchor head and the mortar layer.

FIGURE 4: Protective cap on the anchorage top of the anchor head.

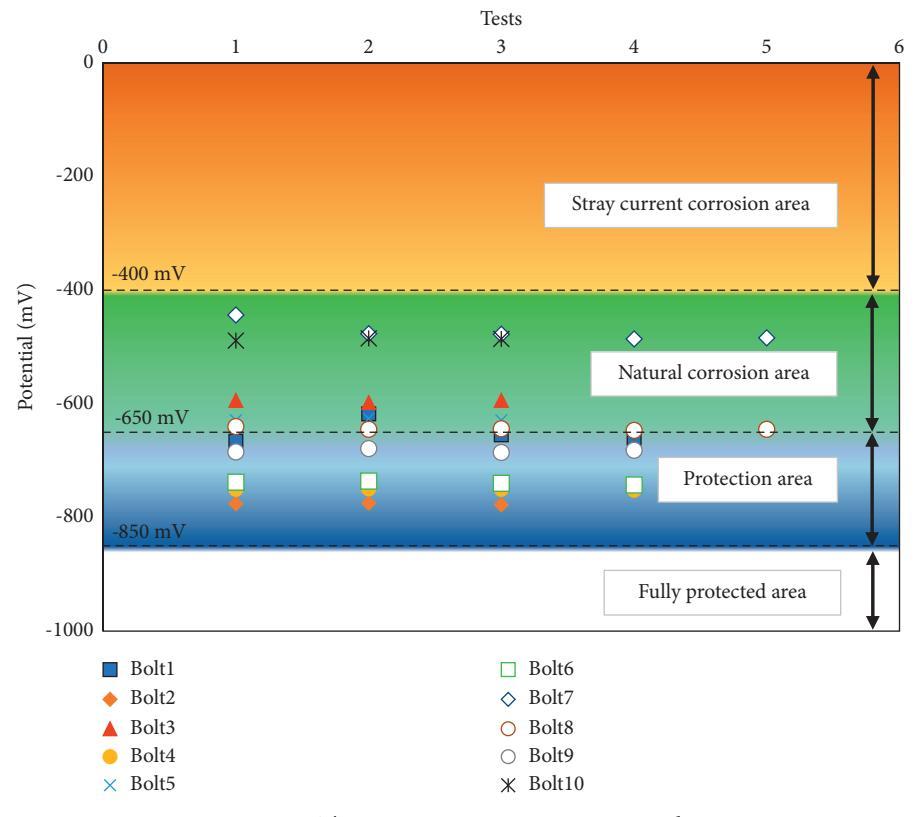
metal is in a natural corrosion state. When the measured potential is greater than -400 mV, there is stray current corrosion in the metal. As shown in Figure 7, Bolt7 and Bolt 10 have high potentials, however, they are still in the natural corrosion potential region. In general, half of the bolt potential is in the protected range, indicating that there should

be no stray current in the rock near the tailrace surge chamber. In conclusion, the influence of the stray current on the anchor cable corrosion can be ignored in the chamber.

FIGURE 9: The stray current measurement results.

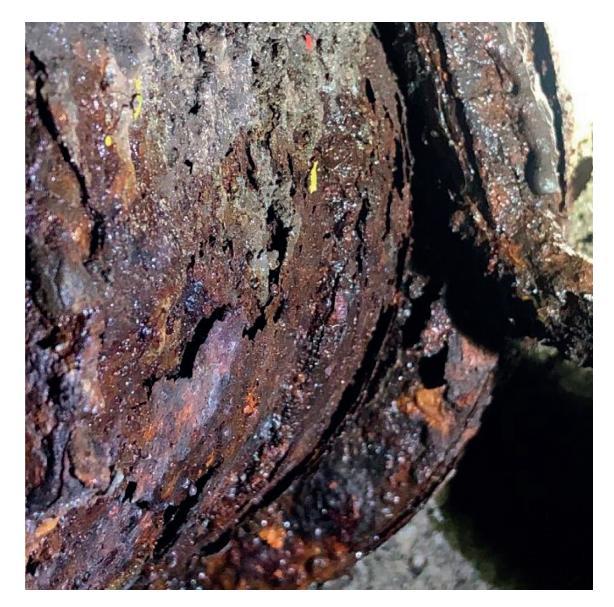
deformation of rocks. The anchor heads exposed to the corrosive environment formed different levels of rust and even severe rust in the local area (Figure 10).

FIGURE 10: Severely rusted anchor head in the tailrace surge chamber.

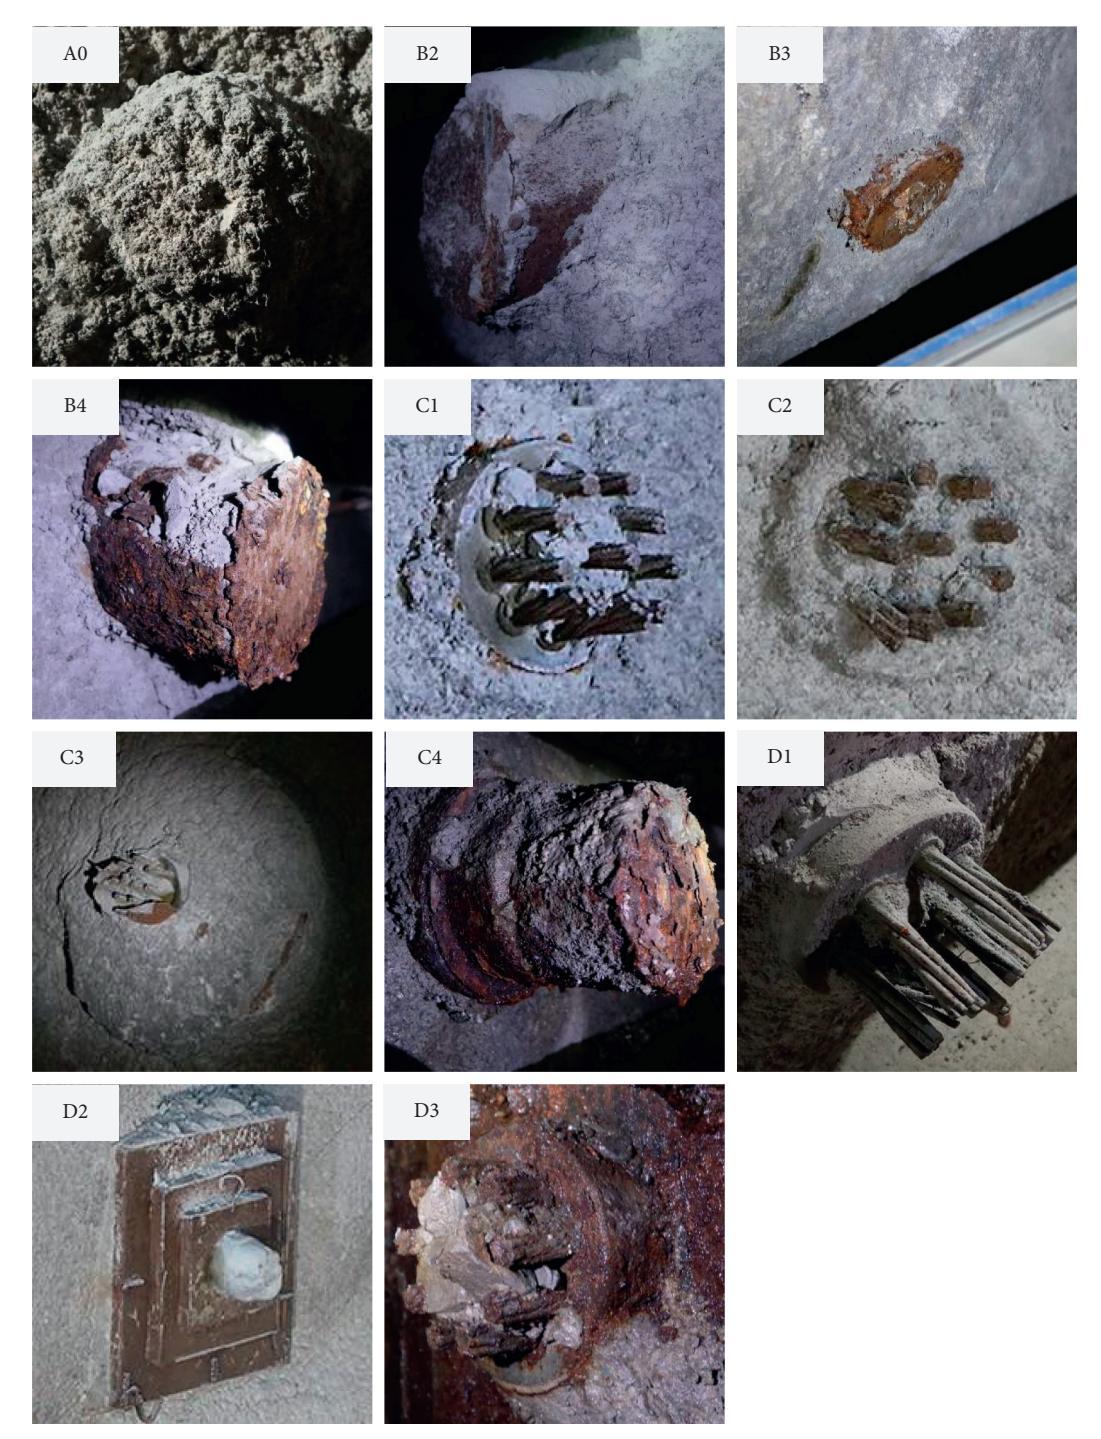
According to Table 10, half of the anchor head structures have been obviously rusted (Level 2). Nearly 1/4 of the anchor heads have been severely rusted (Level 4). Table 11 shows the combined ratings of anchor heads in the tailrace surge chamber. It reveals that all the exposed anchor heads have different extents of rust. Figure 12 displays the anchor heads with different combined ratings.

FIGURE 12: Anchor heads with different combined ratings.

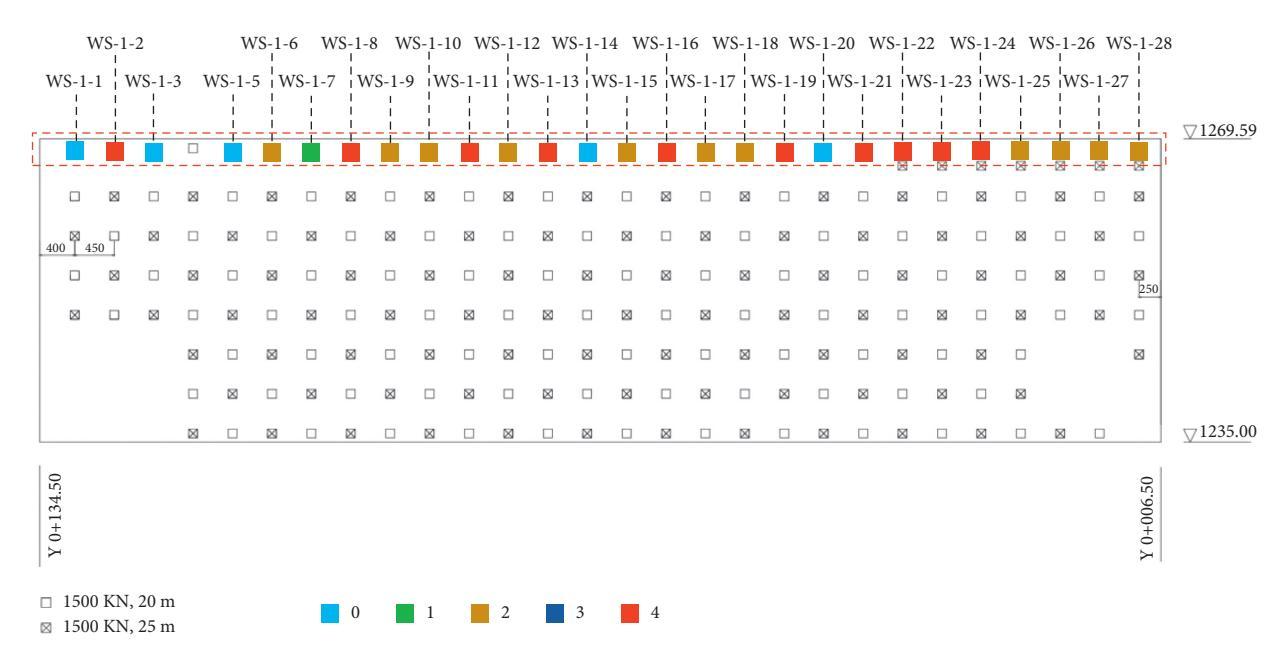
As shown in Figure 13, severely rusted anchor heads on the upstream sidewall are located between anchor WS-1-19 and anchor WS-1-24 with the elevation 1268.50 m, and the pile number from Y 0+049.5 to Y 0+027.0. This corrosion degree is consistent with the geology conditions of the site that there is an F2 fault in this area (Pile No. Y 0+033.1) according to the geological investigation report. The monitoring data also show a large deformation of the surrounding rock near the fault. The cover layer of nearby anchor heads was destructed gradually by the deformed surrounding rock in this area, resulting in the exposure of the anchor head components. The high humidity caused by the groundwater seepage through the fault sped up the corrosion of the anchor head. It also proved that the condition rating method of the anchor head established in this study was reasonable and reliable.

FIGURE 13: Distribution of corrosion degrees of anchor heads on the upstream sidewall of tailrace surge chamber.

Corrosion degree ratings of the anchor head structure indicate that 50.65% of the anchor heads suffer obvious corrosion, and 24.03% of the anchor heads suffer severe corrosion. Severely rusted anchor heads should be marked, and the progress of the corrosion shall be investigated in routine inspection. According to the investigation results, 6.49% anchor heads suffer the exposure of the load bearing structure and severe corrosion (C4 and D4), which should be brought to the forefront and considered to be replaced or substituted.
