## Research Article

# In Vitro Repair of Fractured Fiber-Reinforced Cusp-Replacing Composite Restorations

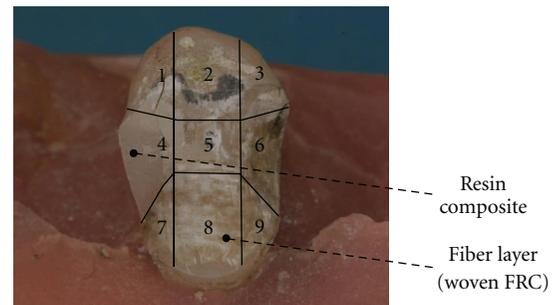
Before repair, the fracture surfaces of the specimens were visually evaluated for three characteristics: (1) presence of resin composite material, (2) presence of fiber layers, and (3) fibers being loose. To do so, the repair surface of each specimen was divided in nine areas (Figure 2), and each area was assessed. Assessment was based on a two-examiner

FIGURE 2: Example of specimen before repair with areas for repair surface evaluation. Surface areas 1–3 include the palatal cusp; 4 and 6 include the mesial/distal box; 5 includes the step; 7–9 include the buccal cusp.

agreement. The nine areas were grouped into four major restoration zones, and for each zone per group the status was described (Table 1). The bulk of the resin composite material was not present anymore for all of the restorations, while for the majority of the specimens of original Groups (A) and (B), the resin composite material and the fiber layers covering the palatal cusp were still present. The fiber layers at the occlusal step were present in all specimens. In the mesial and distal boxes and on the buccal cusp about 50–75% of the fiber layers was still present, with more fiber-reinforced material left in Group (B) than in Group (A). Loose fiber layers at the step, in the boxes, and at the buccal cusp were observed for about 10–45% of the fiber layers present. These loose fibers were observed more frequently in original Group (A) than in original Group (B).

**2.2. Repair.** Each specimen was sandblasted with  $\text{Al}_2\text{O}_3$  ( $50\ \mu\text{m}$ , 3.2 bar, 10 seconds) and etched for 20 seconds using a 37% phosphoric acid etch-gel (Superlux-Thixo Etch, DMG, Hamburg, Germany). Subsequently, the fracture surface was rinsed thoroughly and air-dried gently. Dentin primer, adhesive, and silanization fluid were applied according to the manufacturers' instructions (Clearfil SA primer, Clearfil Photobond and Activator, Kuraray, Osaka, Japan).

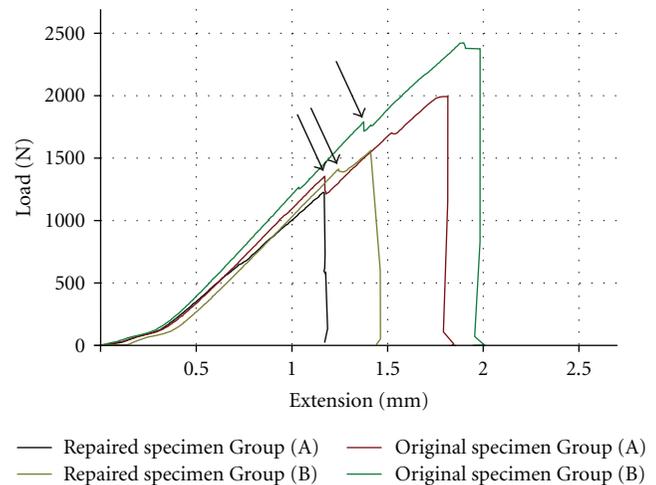
FIGURE 3: Representative fracture graphs from the repaired and the original specimens (arrows indicate initial failure).

Repaired specimens fractured at failure loads of 820 N up to 1559 N (Table 2). The differences in fracture loads between the repaired Groups (A) and (B) were not statistically significant ( $P = 0.34$ ). Furthermore, the fracture loads of the repaired specimens in this study were significantly lower than those of the original specimens ( $P = 0.02$  for Group (A) and  $P < 0.001$  for Group (B)). Representative fracture graphs from the repaired and the original specimens are shown in Figure 3. The failure of the repaired specimen in Group (A) in particular was more sudden when compared to the other three graphs, which showed a preceding initial failure.

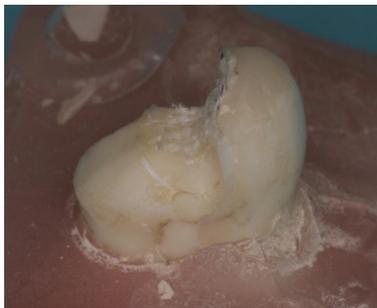
FIGURE 4: Examples of repaired specimens with woven FRC basing after the load test; fracture along the repaired surface (a) and vertical root fracture, indicated by the arrow (b).

Different failure modes were observed (Table 3 and Figure 4). The majority of specimens showed failure along the repaired surface. Furthermore, all but one specimen in repaired Group (B) (89%) showed fracture of the restoration without fracture of tooth substrate (Table 3). In repaired Group (A) such an intact tooth substrate after restoration fracture was observed in two cases (28%). This difference in proportions was statistically significant ( $P = 0.04$ ).

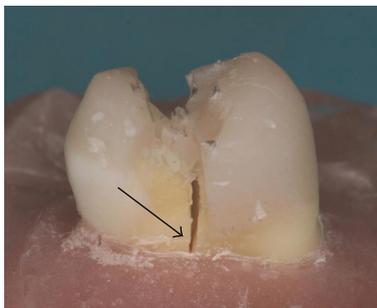
(b)

surface (Table 3). The vertical root fractures in repaired Group (A) did not show adhesive failure along the repaired surface, but cohesive fracture of the resin composite material in the central part of the restoration.
