Research Article Failure Analysis of Tubing Collapse in a Gas Well

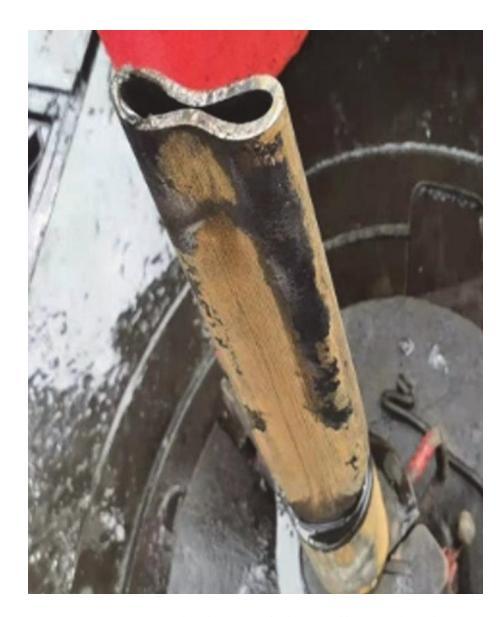
FIGURE 1: Morphology of the collapsed tubing.

truck was pressurized to 42.5 MPa, a muffled sound was heard on the ground, and there was an obvious vibration at the choke and kill manifold. Then, the casing pressure drop was 0 MPa. The subsequent inspection found that the 105th tubing located 999.16 m underground collapsed. The specification of the collapsed tubing is Φ 88.9 mm × 6.45 mm 110SS, and the ordering technical standard is API Spec 5CT-2018 and additional technical agreement. Figure 1 shows the morphology of the failed sample.

3.2. Macroscopic Observation. The collapsed tubing was severely deformed, flat, yellowish brown on the surface, and rusted. From the both ends of the collapsed tubing, the cross-section of the tubing was in the shape of "8." In order to master the internal situation of the failed tubing, cut the collapsed tubing along the two ends of the extruded flattened tubing (Figure 4), and there was no blocking foreign matter on the inner wall of the collapsed tubing.

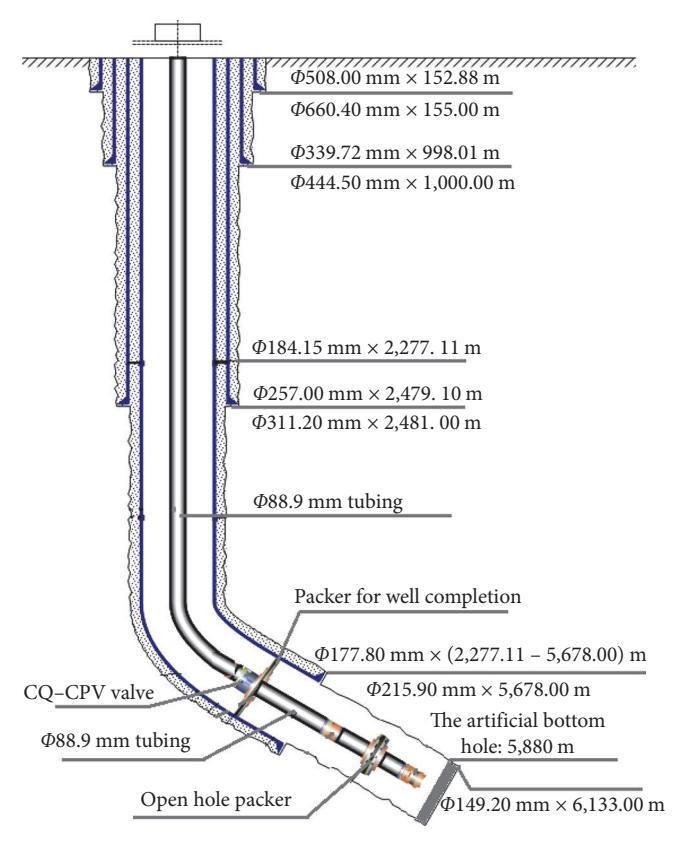
FIGURE 3: Schematic diagram of wellbore structure.

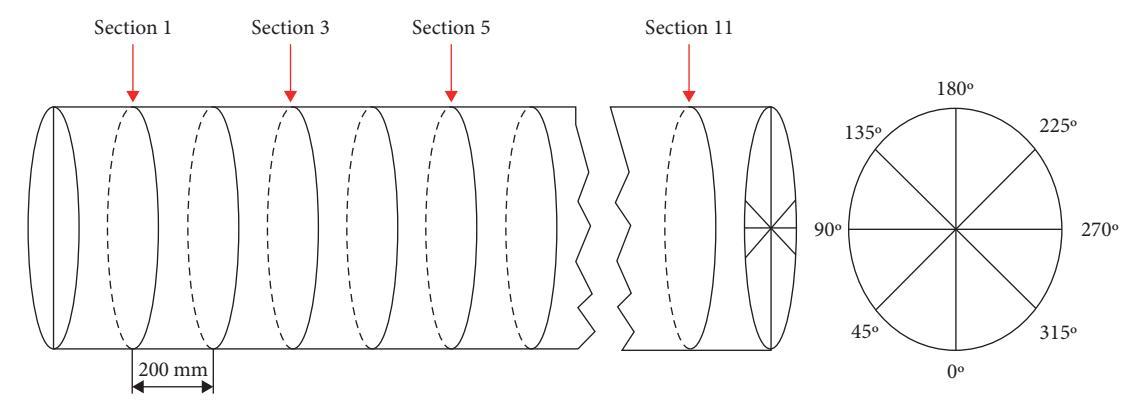
The wall thickness and outer diameter of the same batch of used tubing without failure were measured. The measurement position is the longitudinal section of the tubing body, and the spacing of each section is 200 mm. The wall thickness of each section is measured at eight positions in the circumferential direction (0°, 45°, 90° 135°, 180°, 225°, 270°, and 315°). Figure 5 shows the measurement distribution diagram. The results showed that the outer diameter and wall thickness of the same batch of tubing were in line with the requirements of the order technology.

FIGURE 5: Schematic diagram of geometric dimension measurement of tubing body used in the same batch.

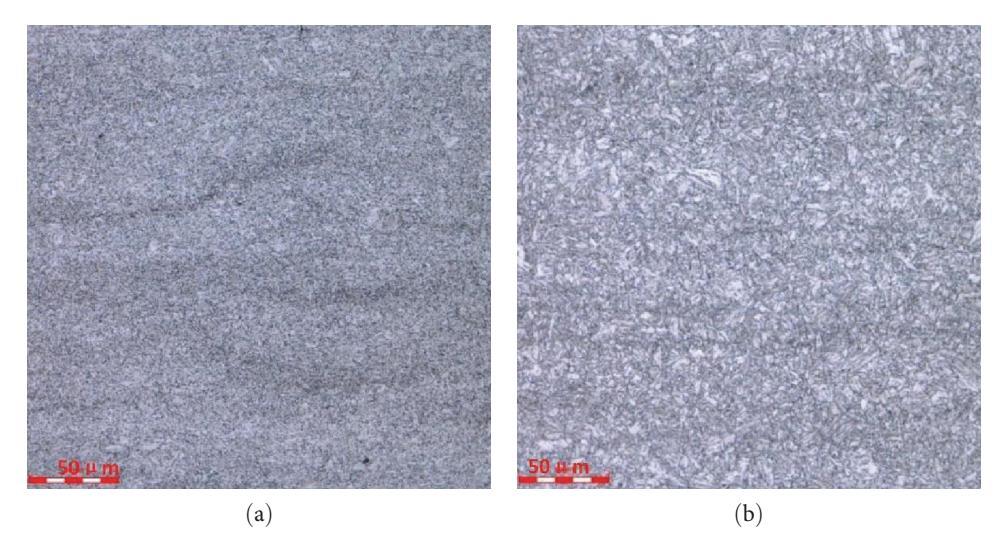
According to ASTM E3-11 (2017), ASTM E45-13, and ASTM E112-13, the microstructure, grain size, and inclusions of failed tubing and the same batch of tubing that had not failed were analyzed. Table 5 and Figure 6 show the results of the microstructure, grain size, and inclusions. The analysis results showed that the metallographic structure of the tubing body was tempered sorbite, the grain size was grade 9.5, and the nonmetallic inclusions in the tubing body were very small. The results showed that there was no abnormal microstructure in the failed tubing.

FIGURE 6: Metallographic structure of the tubings: (a) metallographic structure of the failed pipe body; (b) metallographic structure of the pipe body in the same batch.

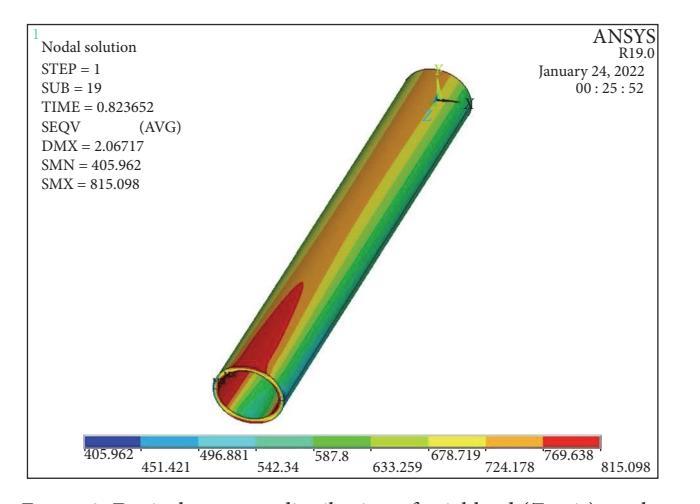
FIGURE 9: Equivalent stress distribution of axial load (Z-axis) on the same batch of tubing.

the collapse resistance of the tubing in different axial loads., as shown in Figure 9. According to the calculation of the finite element model, if the oil pipe is subjected to an axial load of 1,146 kN in actual service, its collapse strength is 30.75 MPa. Figure 10 shows the calculation results. Therefore, if the packer slip fails in the well, it can slide freely, resulting in an axial load of 1,146 kN. When the external pressure is greater than 30.75 MPa, it will inevitably lead to collapse failure.

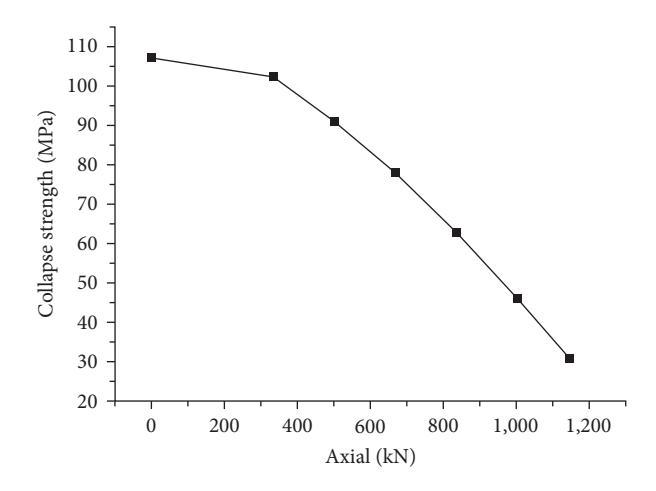
FIGURE 10: Relationship between axial load and collapse strength of tubing in the same batch.

- (4) The FEA calculation results show that the lower the yield strength of the tubing body, the lower the collapse strength of the tubing. When the external pressure is greater than 30.75 MPa, it will inevitably lead to collapse failure in case of packer is unsealed.
