# A METALLURGICAL APPROACH TO THE CRACKING RESISTANCE OF HOT-DIP GALVANIZED ZINC COATINGS

The texture of zinc coatings influences to a large extent their formability, due to the anisotropic properties of zinc. The (0002) basal plane is the easiest slip plane in zinc crystal. Its inclination to the deformation axis and direction directly influences the deformation behaviour. This work deals with the effect of the texture and microstructure on the cracking behaviour of zinc coatings. For this purpose, twelve different commercial hot-dip zinc coatings have been studied.

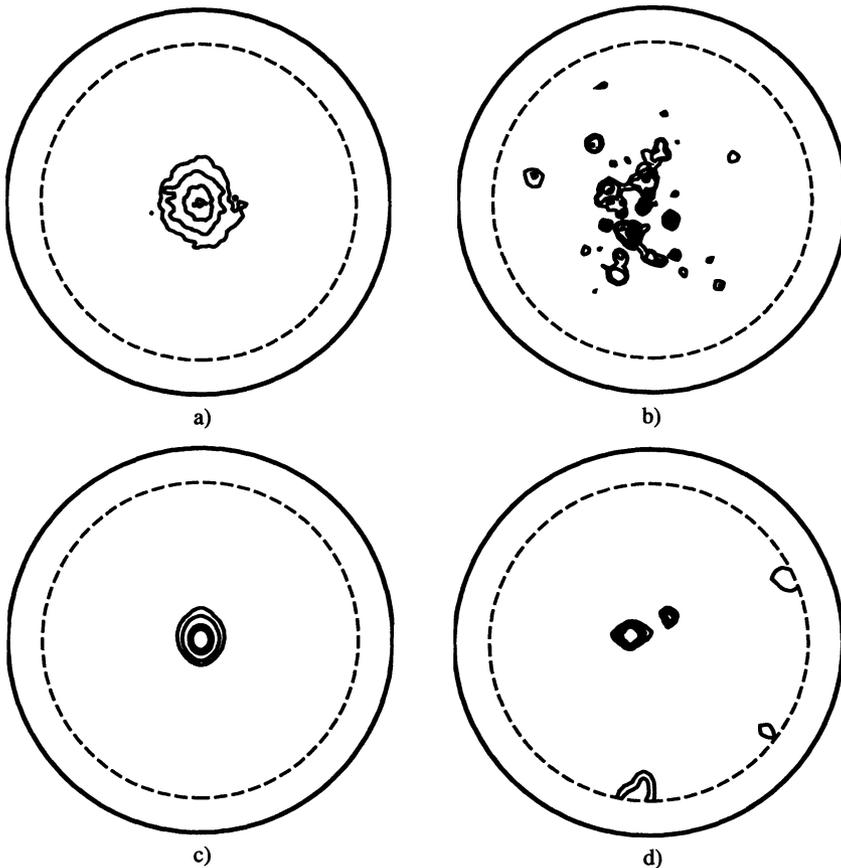
It can be seen in Figure 1a, that the maximum intensity of the basal planes is located at the pole-figure centre, but the peak shows a broad dispersion and a weak intensity. This indicates that most basal planes are parallel or slightly tilted to the substrate surface, but no strong texture exists. The first group contains samples 03, 07 and 12.

**Figure 1** (0002) pole figures of four types of commercial hot-dip coatings, a) sample 07, b) sample 04, c) sample 01 and d) sample 02.

Several single peaks are distributed around the pole-figure centre in pole figure 1b. The maximum intensity is generally located at the pole-figure centre, but separated single orientation peaks appear around the centre even at some distance from it. The maximum intensity is weak or medium as compared to the others, indicating that the texture is not sharp. In addition, little differences in orientation exist inside the grains, as can be inferred from the broadening of the single peaks and metallographical observations. The second group contains samples 04, 06 and 08.

The maximum intensity in Figure 1c is situated in the pole-figure centre, i.e. the basal planes are parallel to the substrate surface. The peak is small and sharp. A strong  $\langle 0001 \rangle$  fibre texture exists. The third group contains samples 01, 05, 10 and 11.

Several strong single peaks with very high intensities are distributed over the pole figure in Figure 1d. Each single peak in this pole figures can be attributed to the diffraction of one single grain respectively. No reliable statements about the texture are possible due to the poor grain statistics. The fourth group contains samples 02 and 09.

The samples can be categorized into four groups, according to their (0002) pole figures. A representative example for each group can be seen in Figure 1.

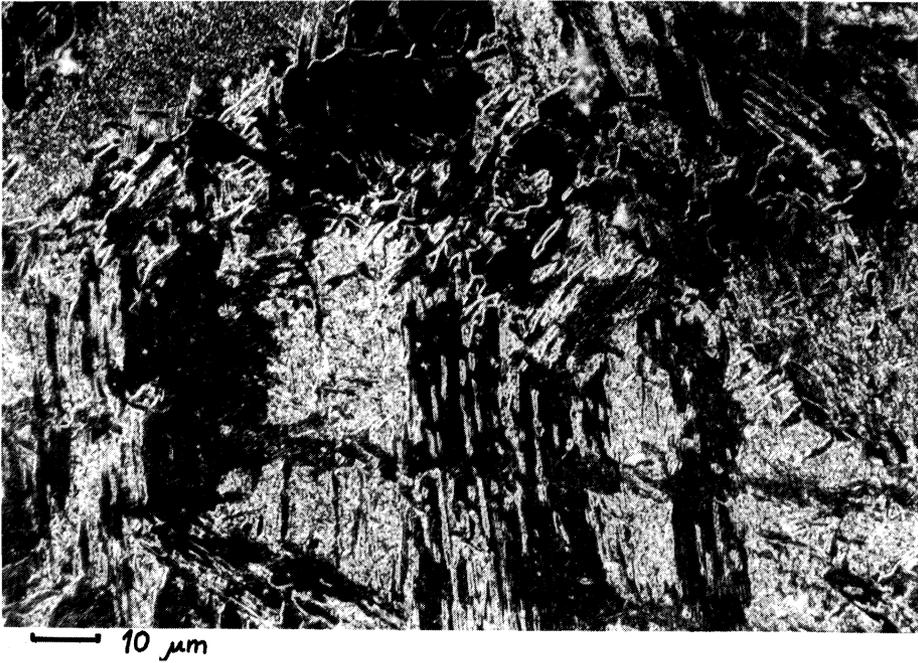
In samples 03 and 04 twins have been found to be very disturbed. The parts of former twins within a same grain do not always remain exactly parallel. The microstructure of sample 03, for example, can be seen in Figure 2. The grain boundaries are locally very disturbed, especially in this sample. Furthermore first recrystallized grains exist already in both samples.

**Figure 2** Micrograph of sample 03 showing disturbed twins and recrystallized grains. Polarized light.

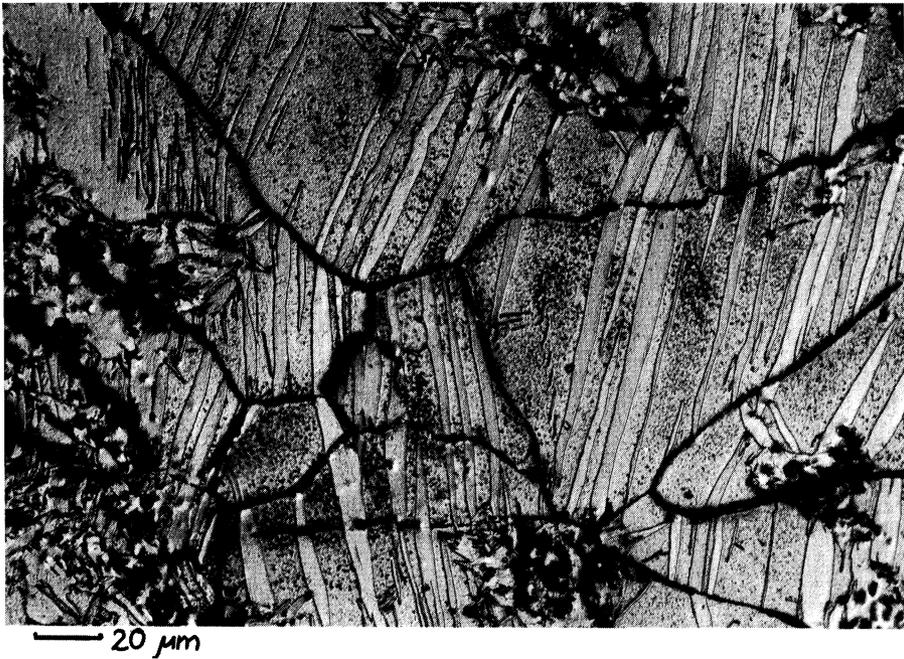
Less disturbed twins have been found in samples 01, 05, 06, 07 and in sample 02. The microstructure of sample 01 (Figure 3) is similar to that of sample 05. However, an extensive intermetallic layer between the zinc coating and the steel substrate exists in sample 05. Recrystallized grains exist to a large extent in sample 06. Figure 4 shows the microstructure of this coating at low magnification. Large grains with twins can be seen, in which small recrystallized grains without twins are seen. Because of the polarized light used, the various grey nuances are originated by different orientations. In the coating of sample 07 first eutectic precipitations can be found, especially at grain boundaries.

**Figure 3** Micrograph of sample 01 showing twins in different grains.

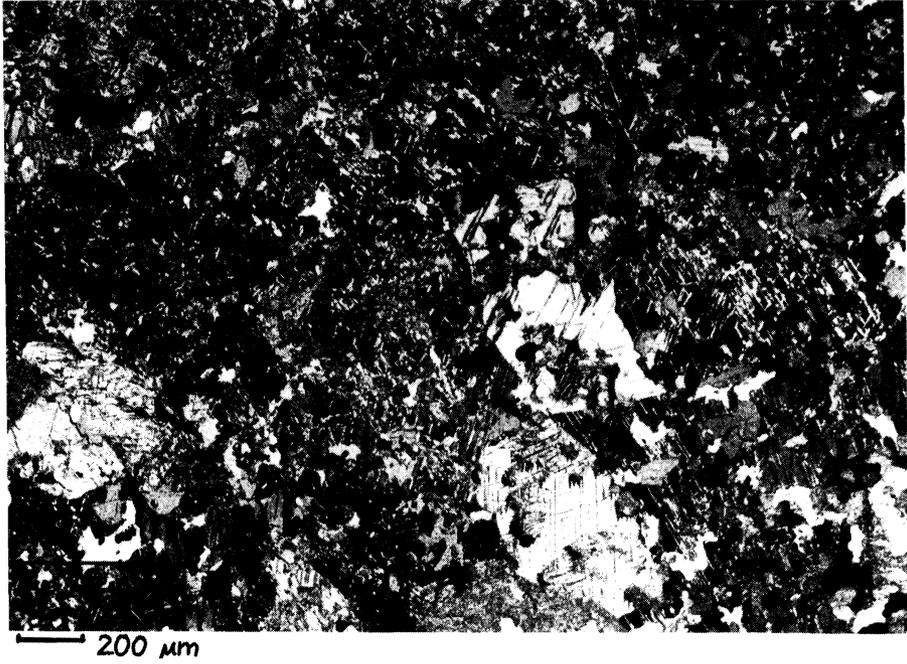
**Figure 4** Micrograph of sample 06 showing large grains with twins and little recrystallized grains. Polarized light.

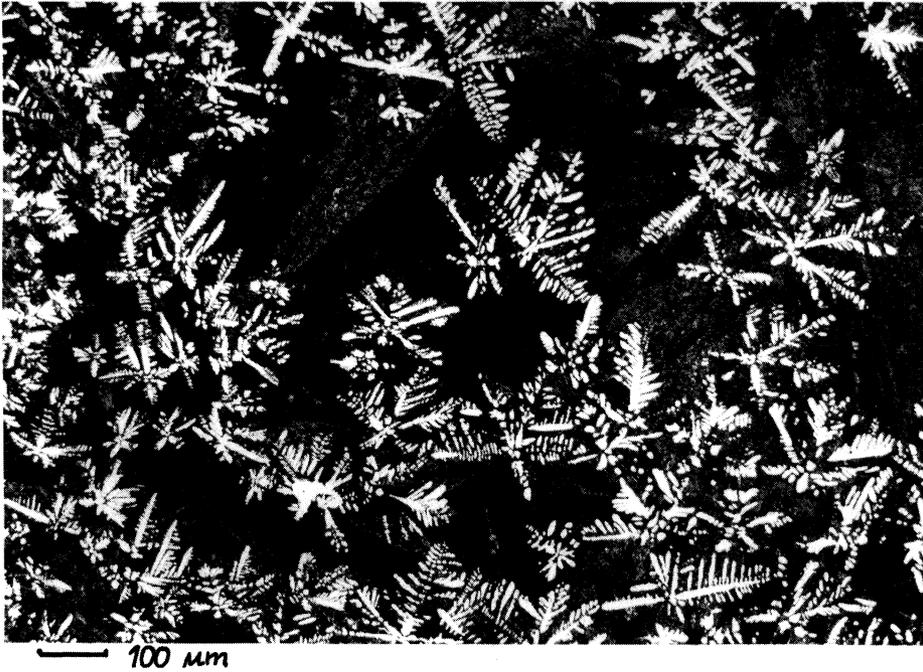
The microstructure of the nearly eutectic coating of sample 12 is characterized by a two-phase alloy, the zinc-rich proeutectic phase being surrounded by an eutectic phase (Figure 5). The eutectic phase consists of alpha aluminium and zinc-rich eta-phase lamellae. The grains appear like rosettes and are divided into many smaller grains or colonies. The dendritic structure of the proeutectic zinc (white) can be observed in the grains.

**Figure 5** Micrograph of sample 12 showing the Galfan alloy, white Zn dendrites inside the eutectic flowers. Dark field.

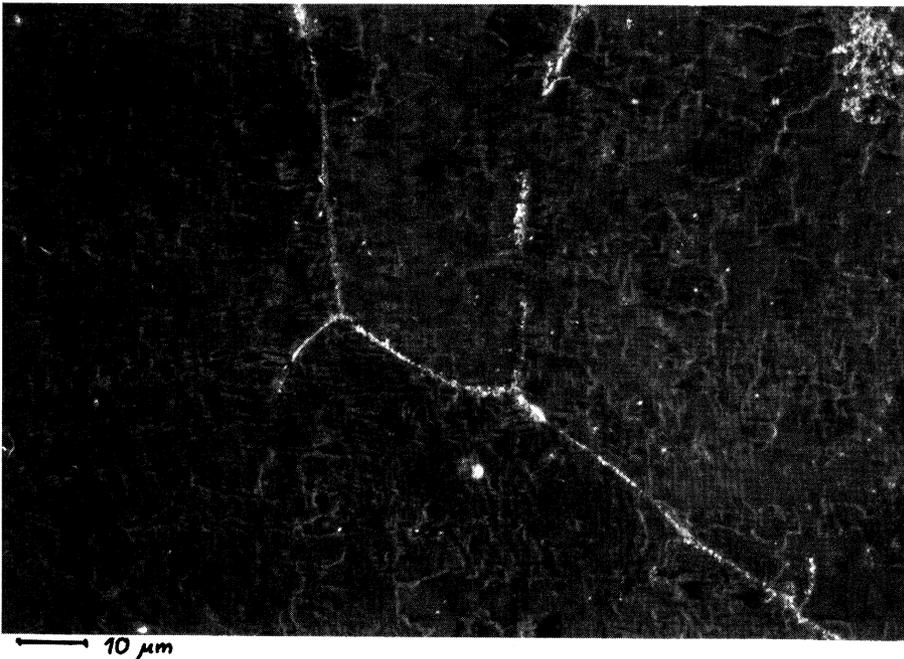
Samples 08, 09, 10 and 11 show similarities in their microstructures. Clearly visible twins have not been found. However, subgrains were observed in samples 08, 09 and 11 (e.g. sample 08 in Figure 6). The microstructure of sample 10 is more homogeneous than that of sample 11 (type 10 with skin pass), but an extensive intermetallic layer was found at the interface.

**Figure 6** Micrography of sample 08, subgrains into grains. Polarized light.

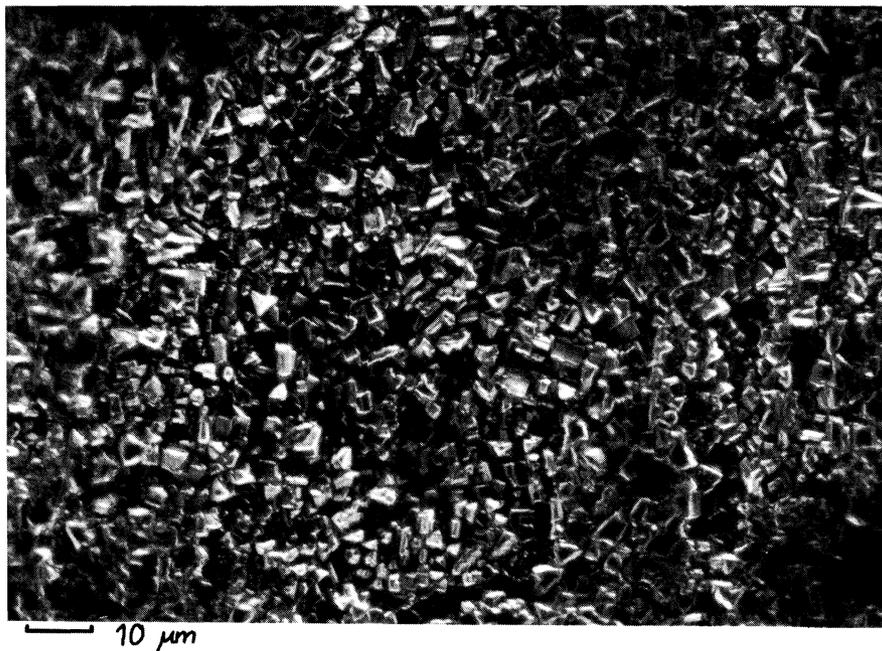
Intermetallic layers were found in samples 01, 02, 05 and 11. A view of such a layer, e.g. in sample 11, after removing the zinc layer, can be seen in Figure 7.

**Figure 7** Micrograph of the intermetallic layer, sample 11. Dark field.

Although the pole figure and the microstructure of sample 11 looks similar to sample 10, low cracking resistance was found. This is probably due to the intermetallic layer, which had not been found in sample 10.

A brittle layer cannot deform plastically and may induce cracking of the coating during deformation. Particularly, addition of Al prevents the formation of a thick intermetallic layer.
