## Research Article

# Exploration of Mechanisms of Joint Deterioration in Concrete Pavements regarding Interfacial Transition Zone

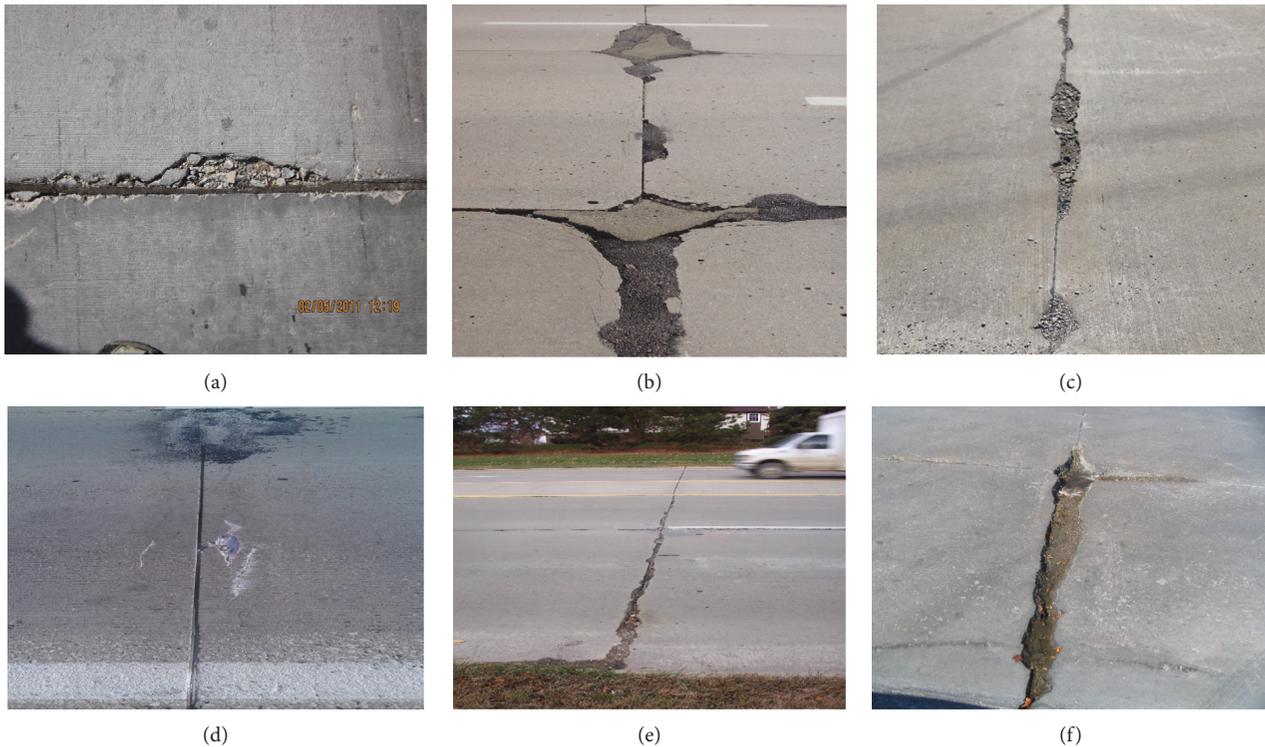
FIGURE 1: Photos of joint deterioration from multiple states. (a) Arizona, 2011. (b) Colorado, 2010. (c) Illinois, 2014. (d) Kansas, 2012. (e) Missouri, 2005. (f) Nebraska, 2010.

Performance and service life of concrete pavements are heavily dependent on the performance of the joints. Hence, premature joint deterioration is a great concern, particularly in cold weather regions. Figure 1 shows multiple forms of pavement joint deterioration observed in different states [2]. To control or eliminate such pavement deterioration, it is necessary to understand the mechanisms of joint damage.

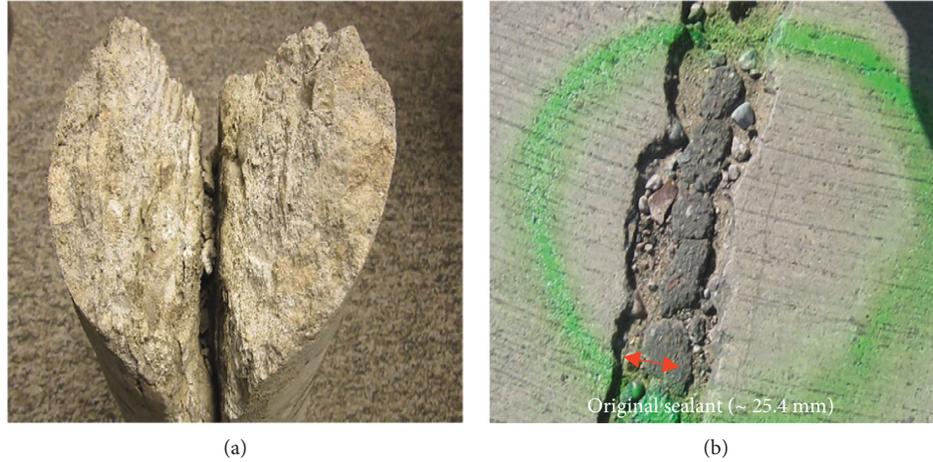
FIGURE 2: Typical F-T deterioration: (a) F-T damage and (b) joint deterioration.

Damage is typically observed in two different forms. The first is the formation of small flakes in the paste near the joint (Figure 2(a)). The other form is where cracks form about 25.4 mm from the exposed face, and exposed aggregate particles are observed (Figure 2(b)). In the latter case, the concrete between the crack and the face is often in good condition. Typically, the crack will form around the coarse aggregate leaving it unusually free of mortar. The cause of this distress has been less well understood.

To explain the phenomenon in Figure 2(b), the following mechanisms may be occurring:

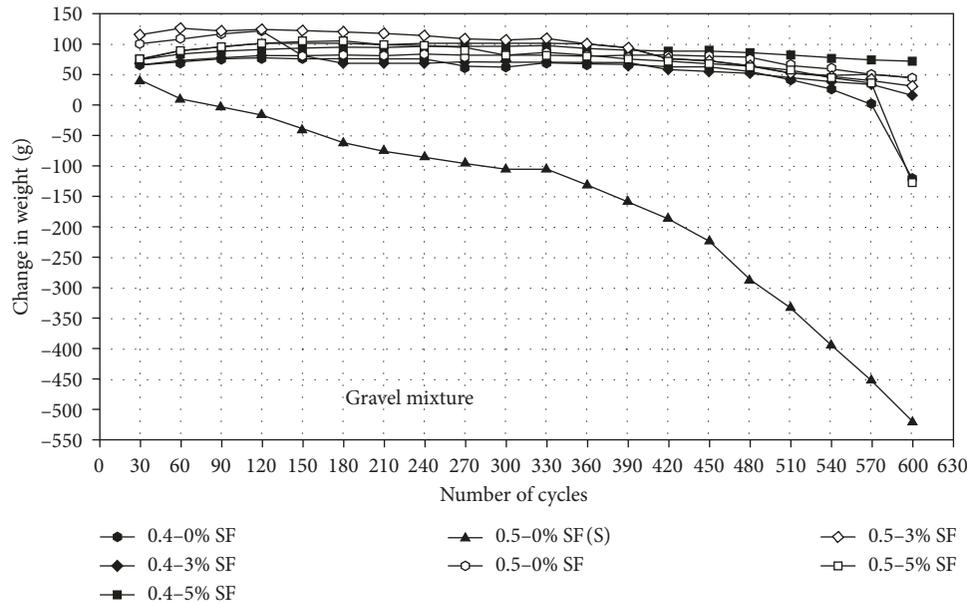
FIGURE 3: Weight change of beams for 600 freezing and thawing cycles (W/C ratio 0.4/0.5; silica fume content 0%, 3%, and 5%; 0.5-0% SF (S) sample with W/C = 0.5, 0% silica fume, soaked in NaCl).

In a previously reported project, Taylor et al. [17] observed mass loss in samples cycled in 3% sodium chloride solution using ASTM C666 (Figure 3). In comparing with samples with no silica fume, samples with an improved ITZ by silica fume were more durable. It was also reported that chloride and calcium ions appeared concentrated in the ITZ near the surface in these samples, indicating that the interfacial transition zone could be preferentially penetrated and attacked by deicers (Figure 4). They concluded that the ITZ is playing a significant part in the formation of incremental cracks about 25.4 mm from, and parallel to, the joint surface.

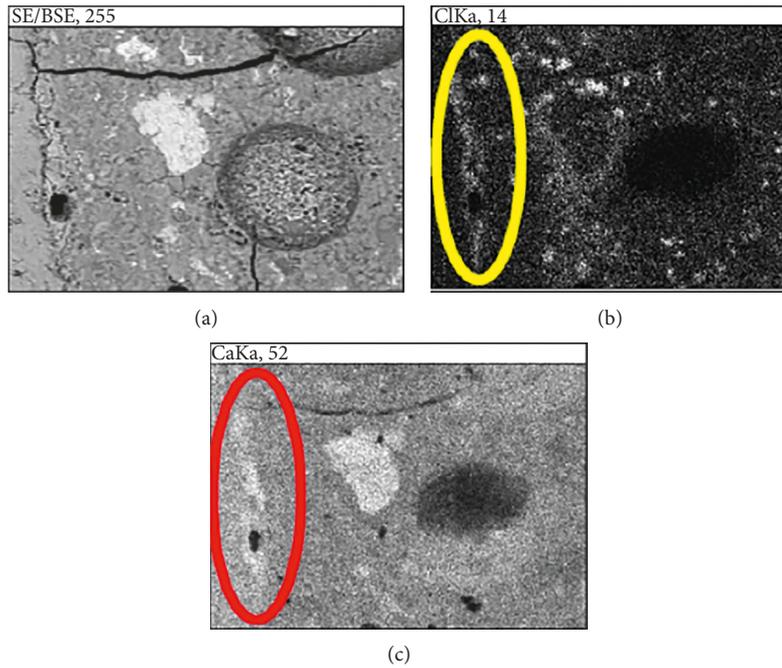
FIGURE 4: SEM map analysis on distressed samples under cyclic freeze thaw in CaCl<sub>2</sub> (calcium and sodium).

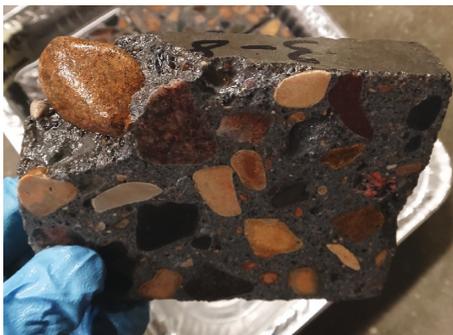
FIGURE 5: Sample exposed to 3% NaCl solution showing washed aggregate on the corner.

Figure 5 shows a deteriorated sample exposed to 3% NaCl solution, and part of aggregate on the corner is smooth and

clean with no mortar after 10 cycles of F-T. This is a concrete sample with 0.45 water-to-cementitious material ratio and 10% silica fume. The flexural strength of the sample was likely above 4500 kPa [22] which is greater than the imposed stress. The cumulative pressure caused by osmotic pressure and salt crystallization is therefore not enough to cause the deterioration in Figure 5. This suggests that some other mechanism is in play, such as calcium oxychloride expansion, resulting in the paste being separated from the aggregate in the ITZ.

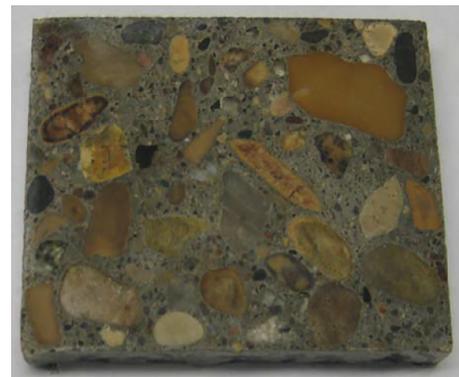
FIGURE 6: Saw cut slice sample from concrete beam.

Concrete mixing and curing were conducted in accordance with ASTM C 192. Air content, slump, and unit weight were measured after mixing. Two 7.6 × 10.2 × 40.6 cm beams were cast from each mix. Sample preparation comprised 3 days wet curing followed by exposure to air until 28 days of age. Beams were cut into 7.6 × 10.2 × 6.35 cm prisms using

a diamond saw at 28 days (Figure 6). The section thickness was selected to increase the likelihood that a single aggregate, and its associated ITZ, would percolate from face to face thus accelerating distress effects associated with the ITZ.

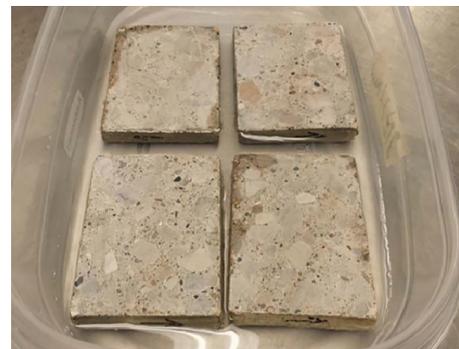
FIGURE 7: Samples partially immersed in deicers.

3.2. Test Procedures. Six slices were placed in a pan, partially submerged in assigned solutions (Figure 7), and stored at 4°C for 56 days. The low, constant temperature was selected to remove the effects of freezing, while enhancing potential

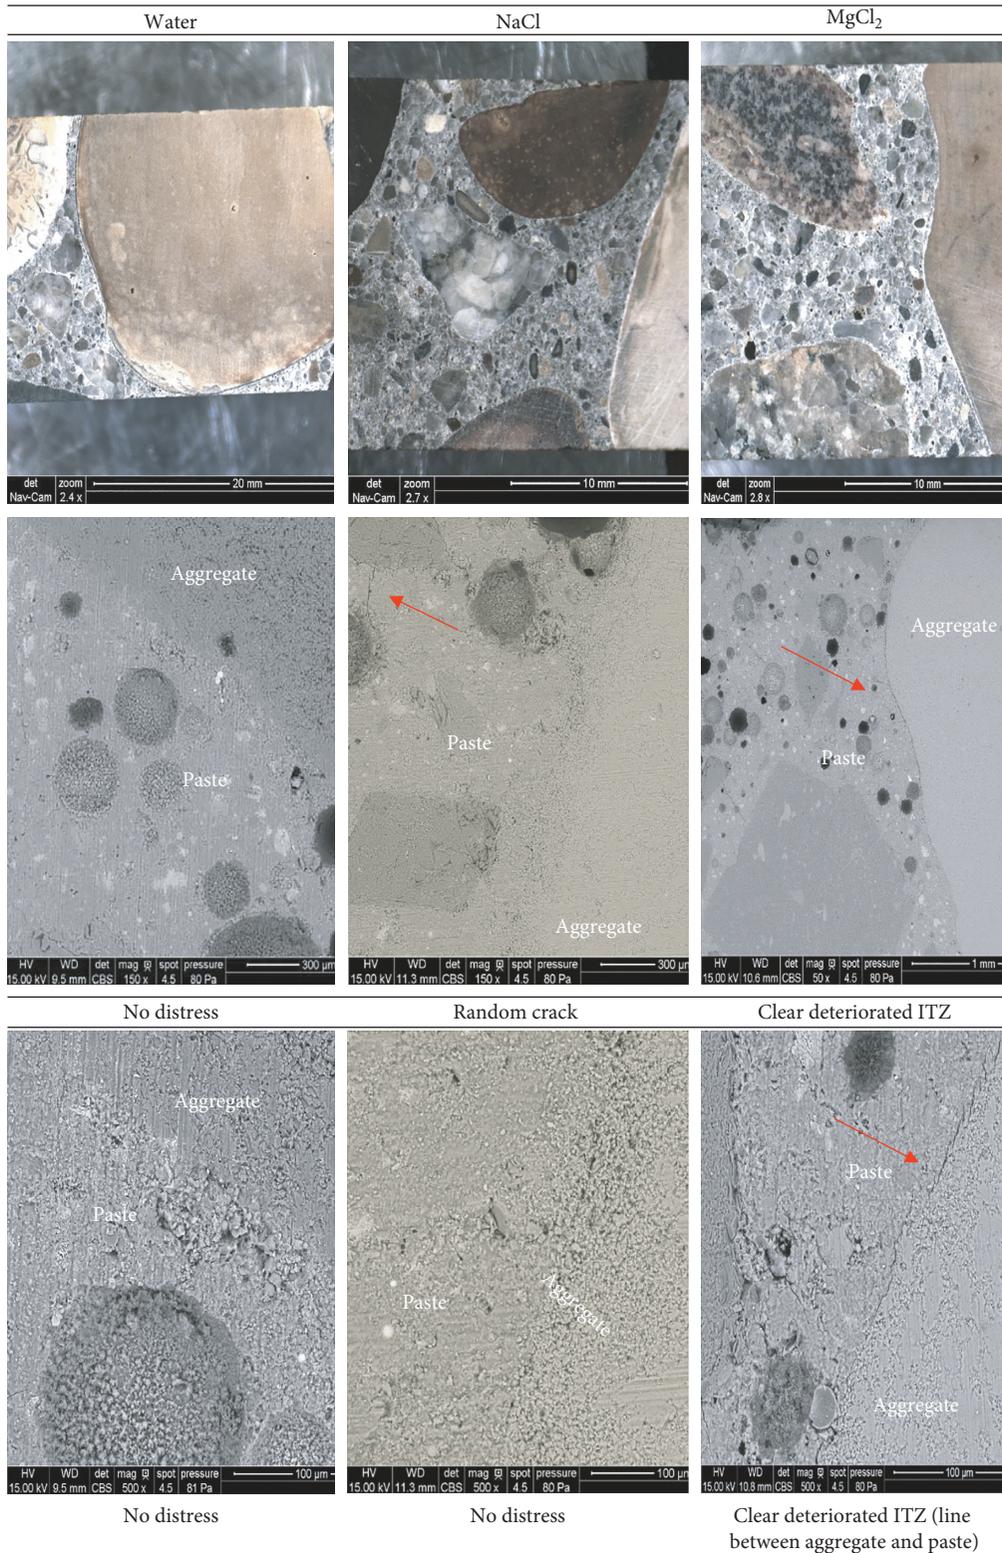
FIGURE 8: SEM images of sample soaked in water, NaCl, and MgCl<sub>2</sub> for 56 days.

dissolution of calcium compounds and formation of oxy-chloride compounds. The temperature was also selected based on distress reported by Sutter et al. [6]. Photos were taken regularly to track the condition of the sample surface. After 56 days of testing, specimens were split and polished before being examined in a scanning electron microscope. Samples were examined under FEI Quanta 250 FE-SEM at a voltage of 15 kV. SEM images from samples are presented in Figure 8.

SEM images of samples soaked in  $MgCl_2$  showed cracking in the boundary between aggregate and paste (Figure 8). In addition, Figure 9 shows that the paste was pushed above the aggregate, indicating expansion in the paste. It is likely that the damage is due to the paste expanding away from the aggregate particles. This type of deterioration was more prevalent closer to the face of the sample exposed to solution, which is consistent with distress being associated with solutions penetrating the system from an exposed face.

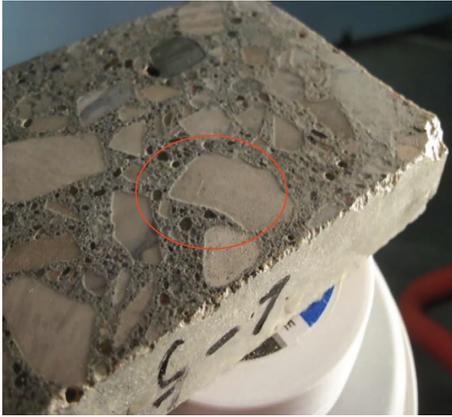
FIGURE 9: Photo of sample after 56 days in  $MgCl_2$ ; paste was pushed above aggregate.

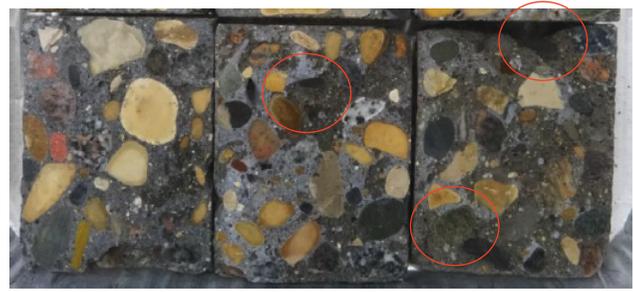
FIGURE 10: Samples exposed to  $MgCl_2$  solution during F-T. Left to right: 10%, 5%, and 0% silica fumes [23]; sample on right with no silica fume lost some aggregates during F-T.

For samples soaked in 3%  $MgCl_2$ , whole aggregate particles were observed to be removed in several samples

(Figure 10). This is again an indicative of aggregate particles being separated from the paste, likely due to expansion of the paste tied with damage in the ITZ.

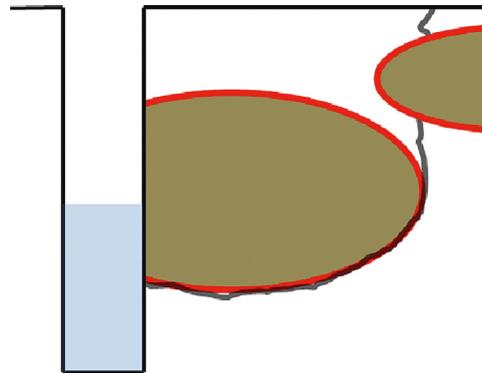
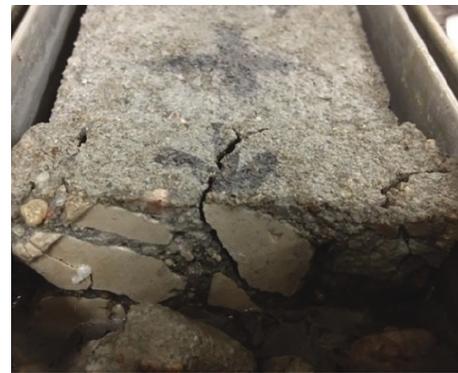
FIGURE 11: Crack developing out of a saturated ITZ. (a) Schematic sketch of the theory. (b) Laboratory observation supporting the theory.
