Research Article

Stability Analysis and Reinforcement of a High-Steep Rock Slope with Faults: Numerical Analysis and Field Monitoring

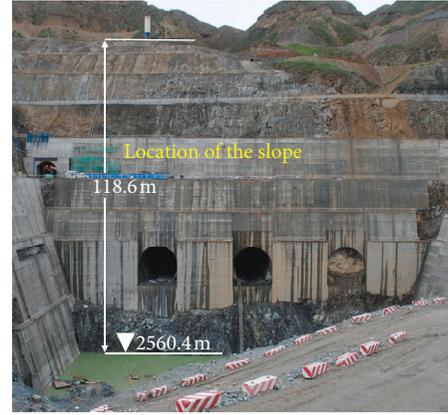
FIGURE 1: The rock slope of Yangqu hydropower station.

2.1. Site Descriptions. The rock slope is a cutting slope located behind the powerhouse of the Yangqu hydropower station at the Hainan Tibetan Autonomous Prefecture in Qinghai province, China (Figure 1). The height of the slope is 118.6 m, and the elevation at the toe of the slope is 2560.4 m.
