# Influences of Water Vapor on Roof Fall Accidents in Selected Underground Coal Mines in Malawi

To develop affordable countermeasures against the roof falls, the accident records of Mchenga Mine were investigated as the first step. Based on the accident records, it was found that roof falls occurred most in April and May. Humidity measurements were taken both in the underground mine and at surface, and humidity peak appeared in April. The accident occurrence and the underground humidity had a positive correlation in which no roof falls could be expected under a humidity of less than a certain value. Effect of humidity on the indirect tensile strength of the rock samples collected from the mine was investigated, and it showed that the indirect tensile strength decreased with humidity. The diffusion coefficient was measured for the rock samples collected from Mchenga Mine as well as from Kaziwiziwi Mine, and the migration of water vapor into rock mass in the roof was calculated for Mchenga case. It was clarified that the weakening of tensile strength was transmitted upward at several centimeters per day from the immediate roof. This could explain the slight difference of the acciden

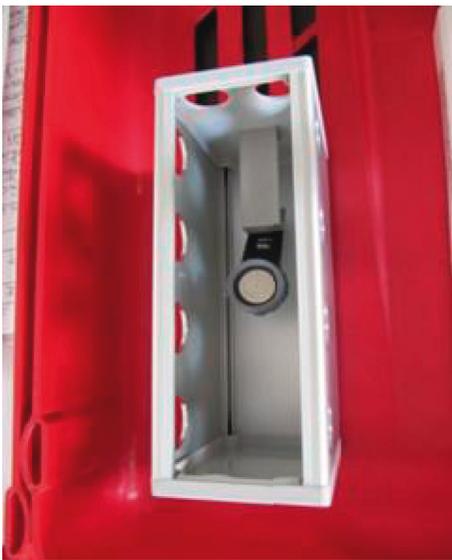
FIGURE 4: Coin-type data logger.

**2.4. Humidity Measurement.** Seven, coin-type data loggers (Figure 4) were installed at varying levels in and close to the working face with an average depth of 130 m from the ground surface (Figure 5) in mine adits of Mchenga Coal Mine. The instruments were fixed in matt packs not to be damaged or stolen. Hence, there was not enough airflow. Therefore, the recorded humidity may be higher than the surrounding atmosphere. In addition, one data logger was installed at the mine office at the ground surface.

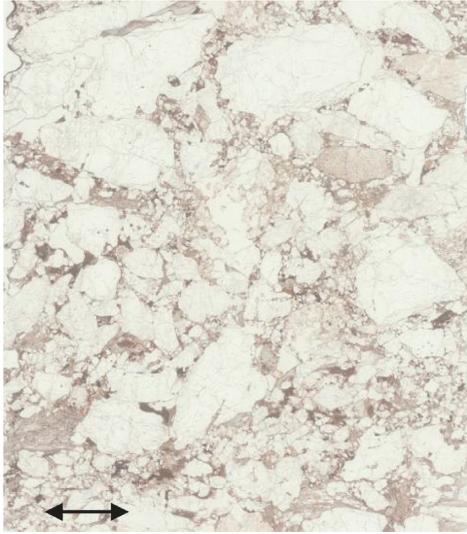
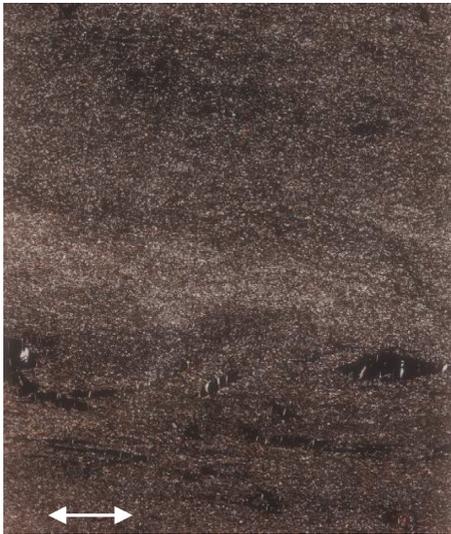
FIGURE 10: Scanned thin section images. The arrow length is 2.5 mm. (a) Kaziwiziwi conglomerate. (b) Kaziwiziwi carbonaceous sandstone.

**3.2. Kaziwiziwi Rocks.** Conglomerate and carbonaceous sandstone samples from Kaziwiziwi Coal Mine were also observed. The scanned image of the thin section of the conglomerate showed irregularities of minerals which indicates obvious open pore spaces (Figure 10(a)), while that of Kaziwiziwi carbonaceous sandstone exhibited a uniform color and texture (Figure 10(b)). The effective porosity for the conglomerate and the carbonaceous sandstone was 11.2% and 9.3%, respectively.
